**NATIONAL TRANSPORTATION SAFETY BOARD
OFFICE OF HIGHWAY SAFETY
WASHINGTON, D.C.**

**VEHICLE FACTORS GROUP CHAIRMAN'S
FACTUAL REPORT**

Vehicle 1: 2017 Freightliner, Embassy body 37- passenger medium-size bus

NTSB #: **HWY19MH012**

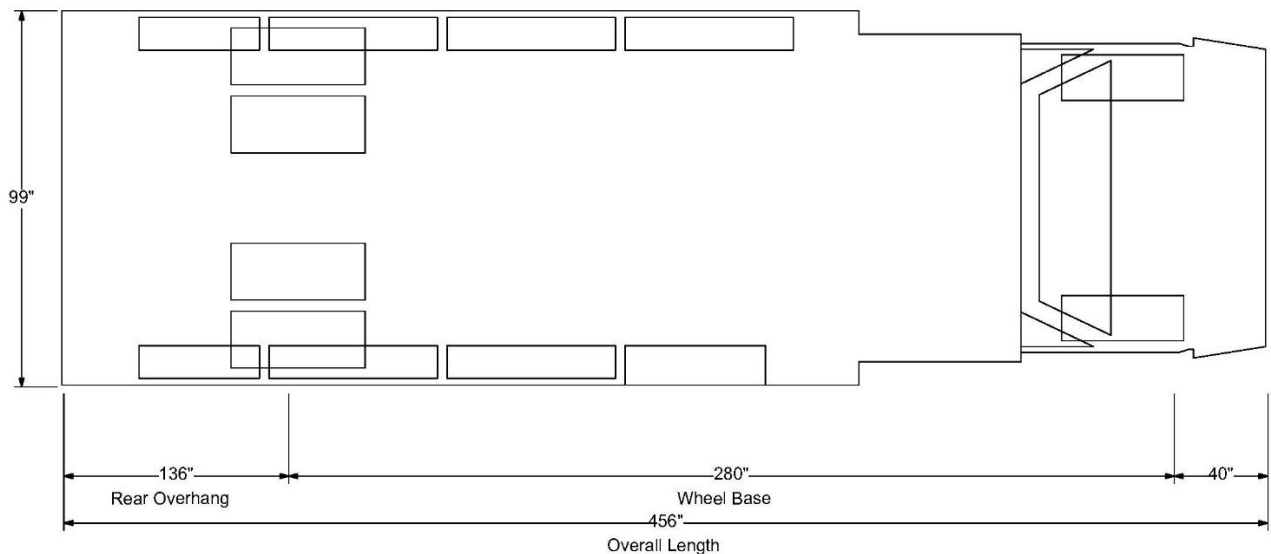
Figure 6: 2017 Freightliner Dimensions

Figure 6 shows the outside dimensions of the 2017 Freightliner as measured at inspection.
