# ENGINE EXAMINATION REPORT

<b>ENGINE MODEL</b>	O-300-D (6B)
<b>ENGINE SERIAL NUMBER</b>	27160-D-2-D
<b>AIRCRAFT MAKE &amp; MODEL</b>	1958 Cessna 172
<b>AIRCRAFT SERIAL NUMBER</b>	36320
<b>AIRCRAFT REGISTRATION</b>	N8620B
<b>FILE NUMBER</b>	18-370

EXAMINATION		ACCIDENT DATA	
<b>DATE</b>	6-17-2019	<b>NTSB ACCIDENT #</b>	CEN19FA099
<b>FACILITY</b>	Continental Aerospace Technologies-Analytical	<b>NTSB INVESTIGATOR</b>	Michael Hodges, IIC Central Region
<b>ADDRESS</b>	2039 South Broad Street Mobile, Alabama	<b>FAA INVESTIGATOR</b>	NA
		<b>ACCIDENT DATE</b>	3-14-2019
		<b>ACCIDENT LOCATION</b>	Lakeway, TX

The engine was disassembled and inspected under the supervision of the NTSB IIC. This inspection did not reveal any pre-impact anomalies that would have prevented its ability to produce rated horsepower.

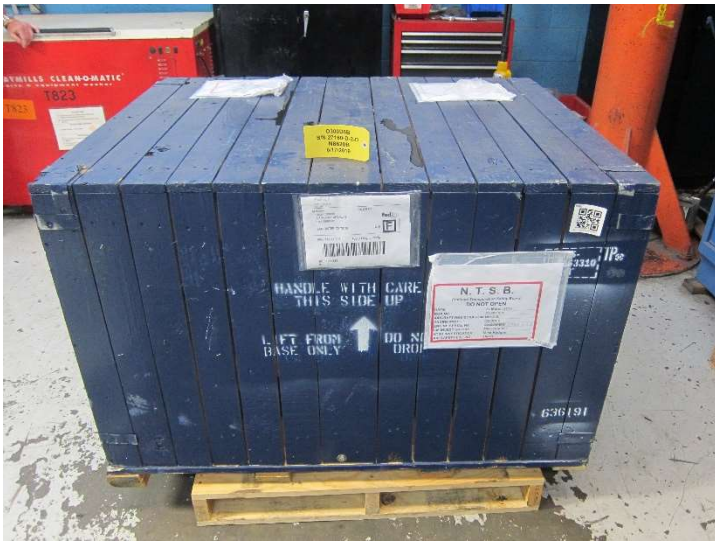
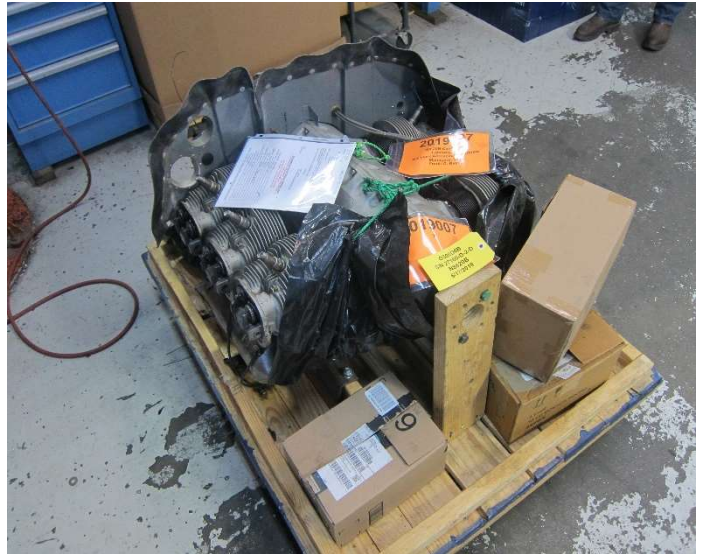
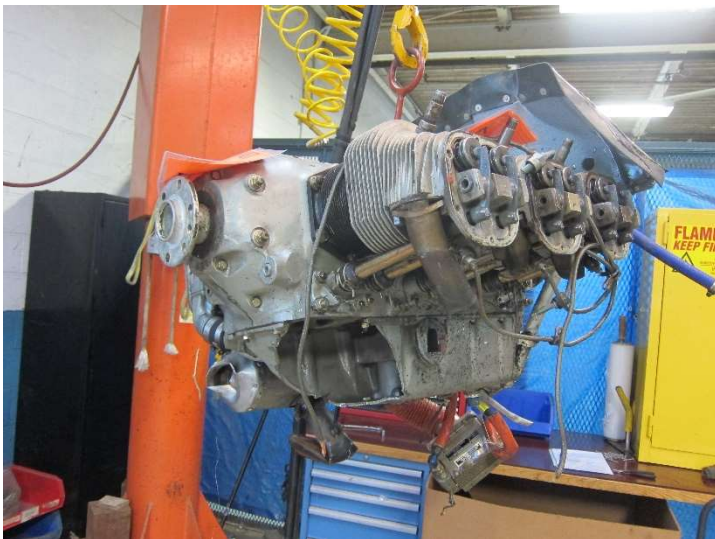
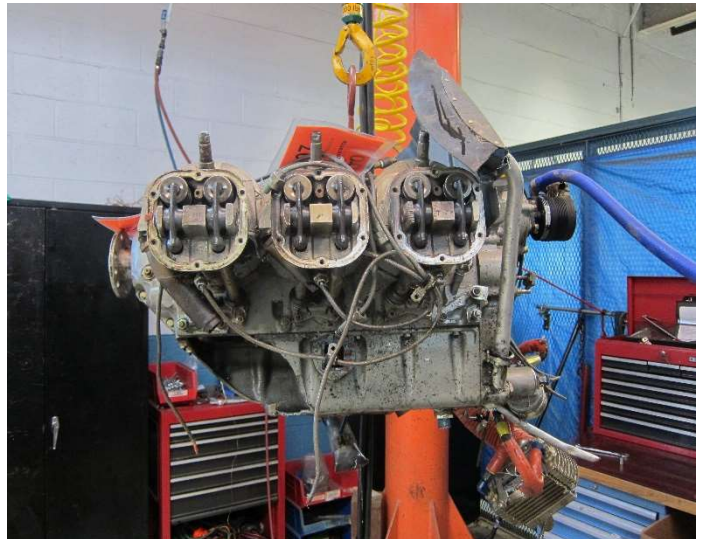
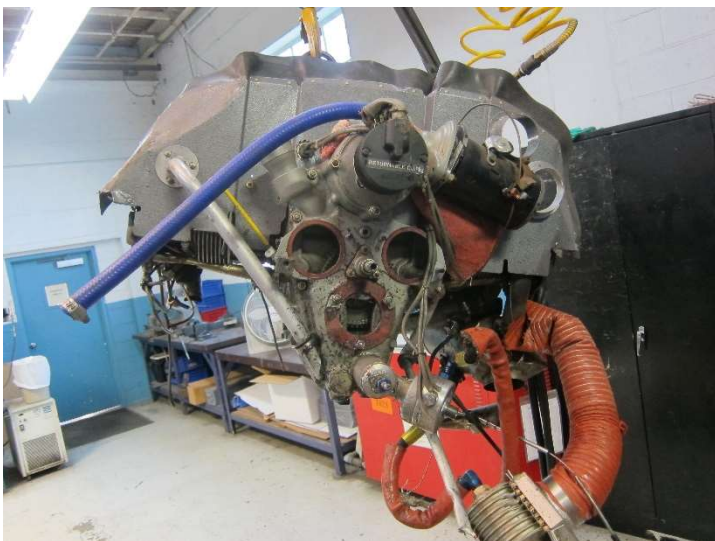
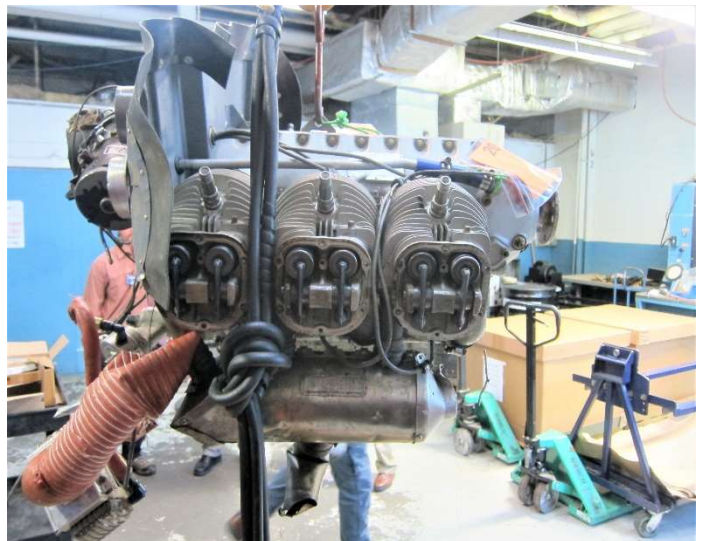
Engine mounts were broken. The oil sump was impact damaged and the left forward/side separated. Cylinder # 2 intake and exhaust push rods and push rod tubes were impact damaged.

Exhaust mufflers, tailpipes and risers were impact damaged.

Left induction manifold was impact damaged.

Ignition harness leads were cut and pinched.

Carburetor was impact damaged and shipped loose.

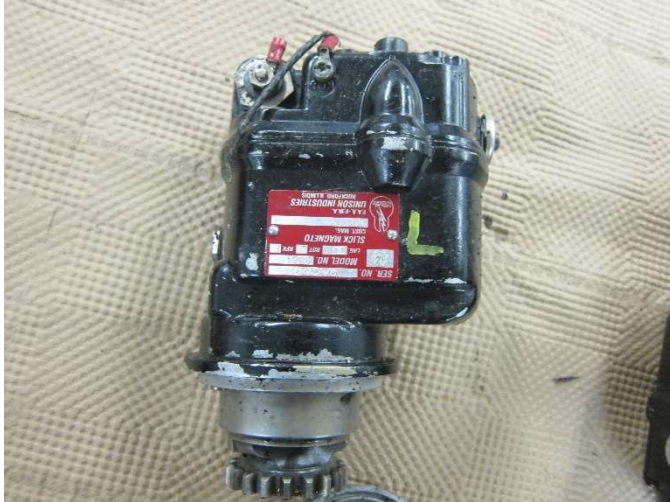
<b>LEFT MAGNETO</b>	Manufacturer: Slick-Unison Industries	M/N: 6364	S/N: 07090201
Condition:	The magneto had been removed during the initial recovery examination. The magneto and tested by manually rotating the drive and noting spark at all six ignition leads. The magneto was shipped loose in the shipping container. The magneto was bench tested and functioned normally.

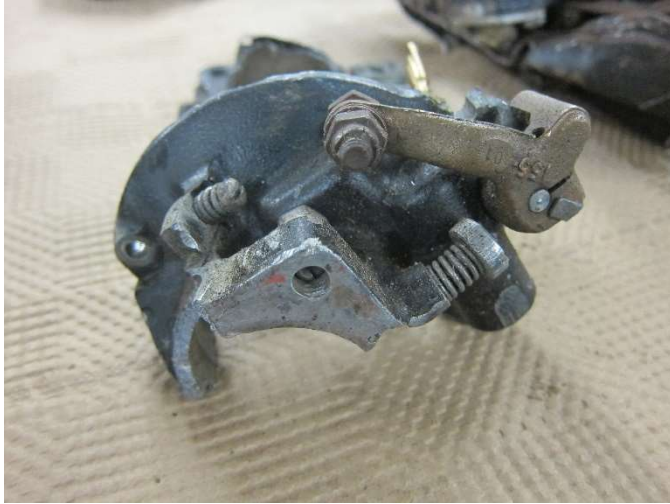
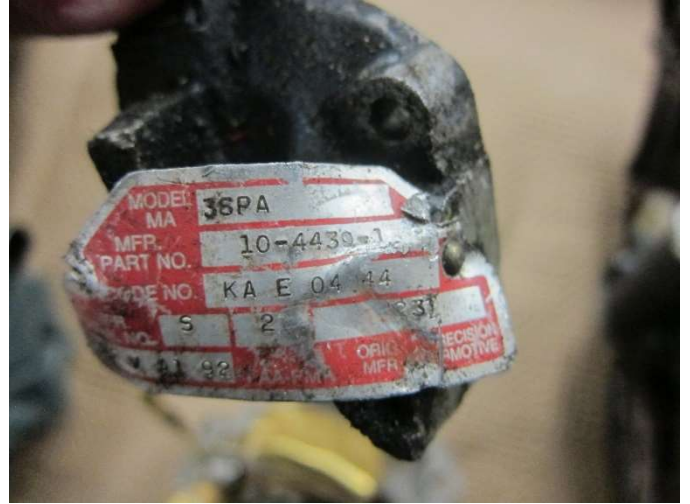
The airframe airbox and carburetor were impact separated at impact. The carburetor was destroyed by impact forces. Metal floats exhibited "hydraulic" damage consistent with fuel in the carburetor bowl at impact.

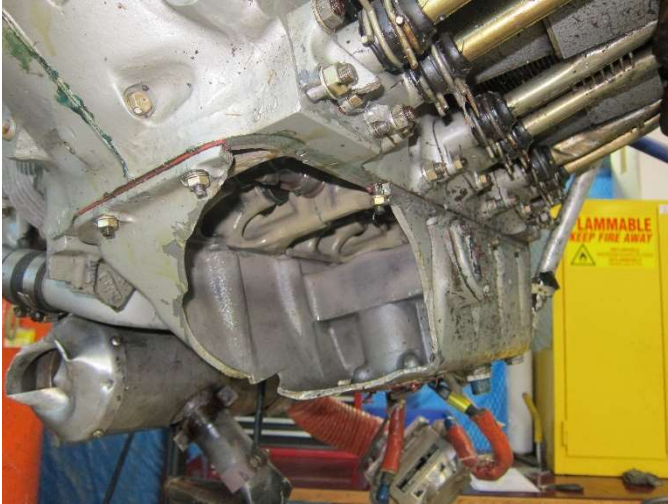
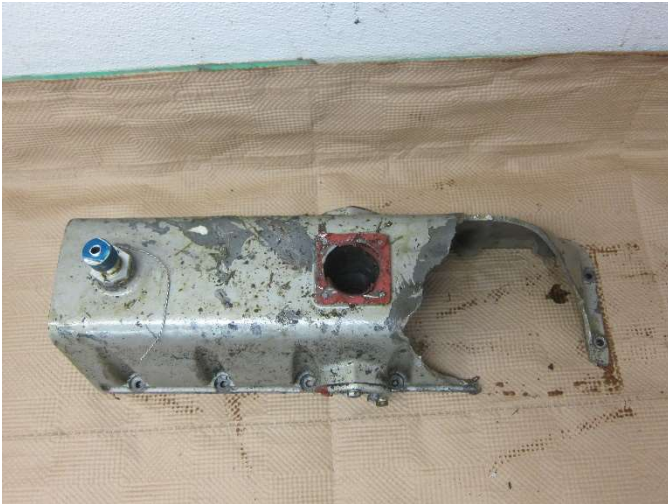
The oil sump was impact damaged. The left-forward section impact separated.

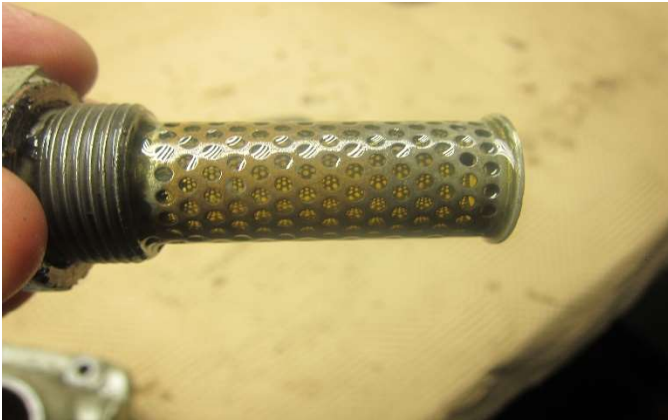
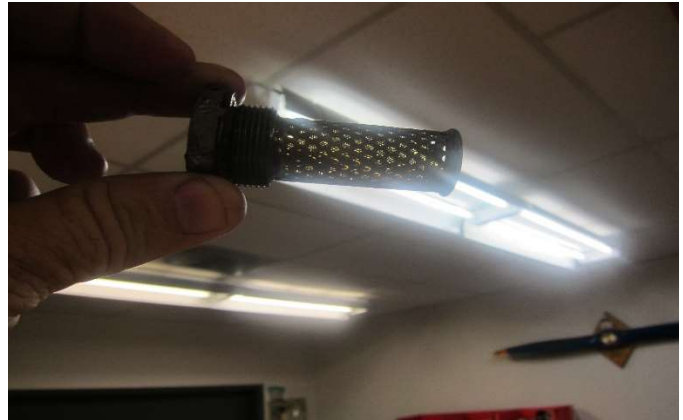
**Condition:** The oil pick-up screen was uncontaminated.

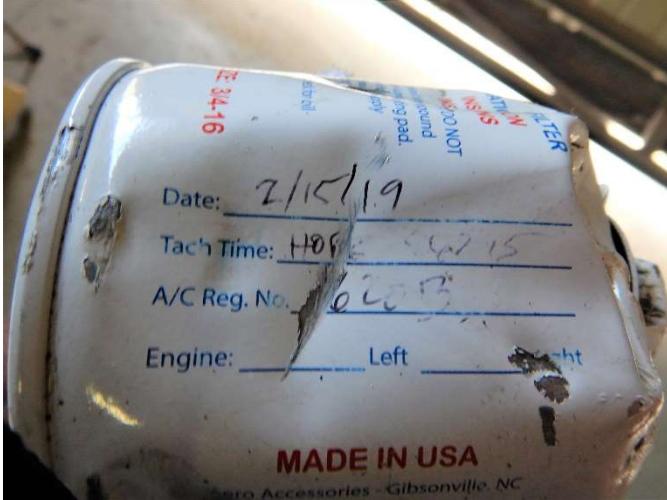
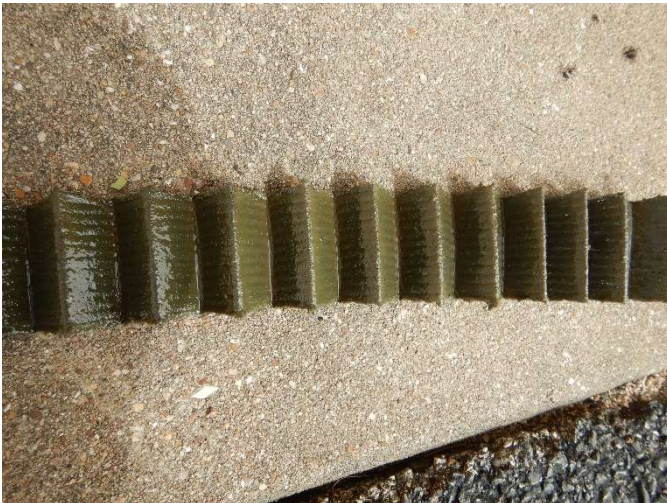
The spin-on oil filter had been previously removed at the recovery inspection and cut open for inspection. There was no metal contamination noted. Four photos below were taken at the recovery examination.

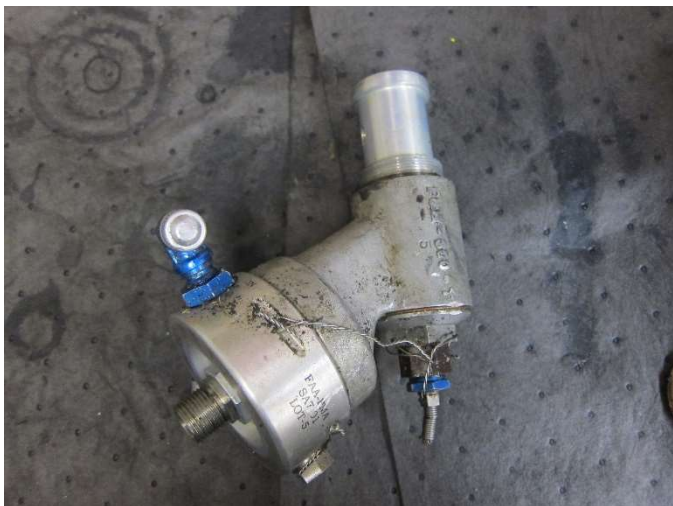
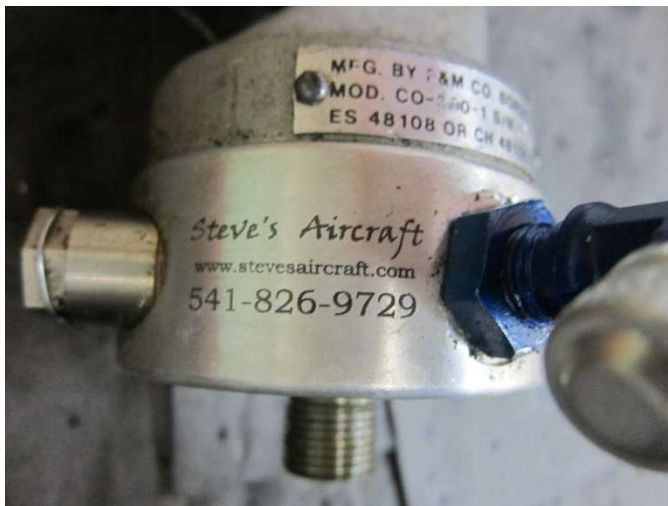
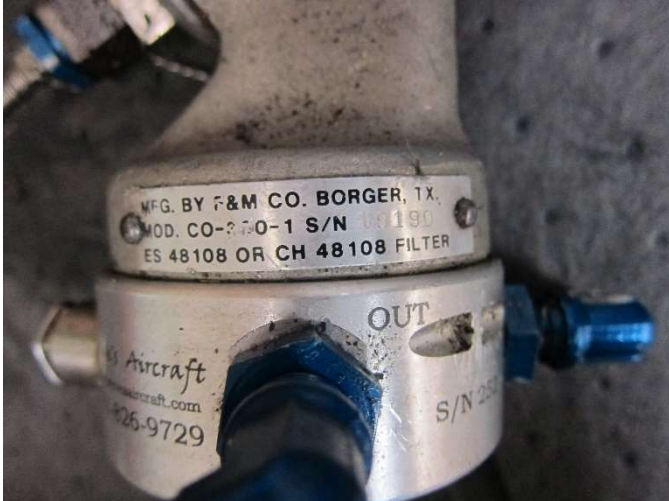
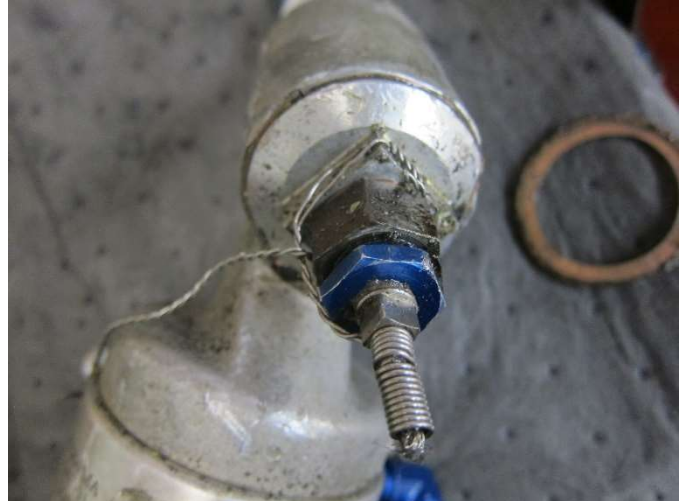
<b>FILTER ADAPTER</b>	M/N: F&M 370-1	S/N: 10190
<b>OIL COOLER ADAPTER</b>	STEVE'S AIRCRAFT	S/N: 252

NOTE: The accident engine was equipped with an F&M aftermarket spin-on oil filter adapter model CO-300-1, serial number 10190. In addition, another aftermarket device was attached where the spin-on oil filter normally would be attached to the F&M adapter. This device had a placard indicating that it was manufactured by "Steve's Aircraft", serial number 252. This adapter included two flexible oil hoses attached which bypassed to the oil cooler. It was not determined if the two unrelated STC'd appliances were joined within the scope of either STC or with permission of either STC holder.

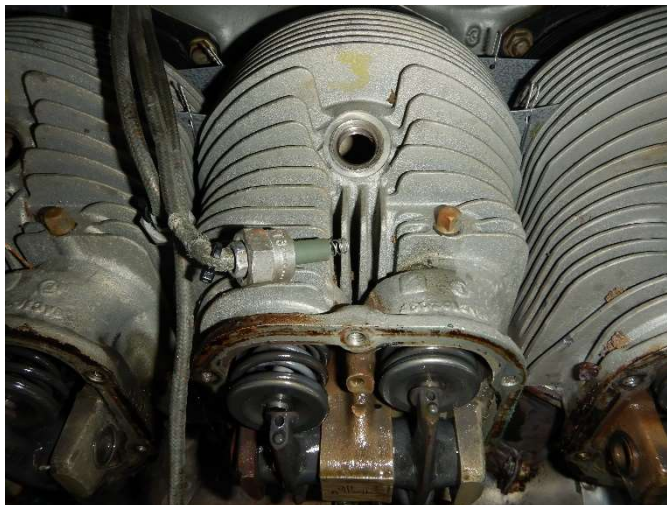
<b>CYLINDER #3</b>	P/N: SA 10200-A1	S/N:20-C15-41893	Head Date: Undetermined
Work Orders:	B-03291		
Condition:	Intake and exhaust push rods and push rod tubes were impact damaged.

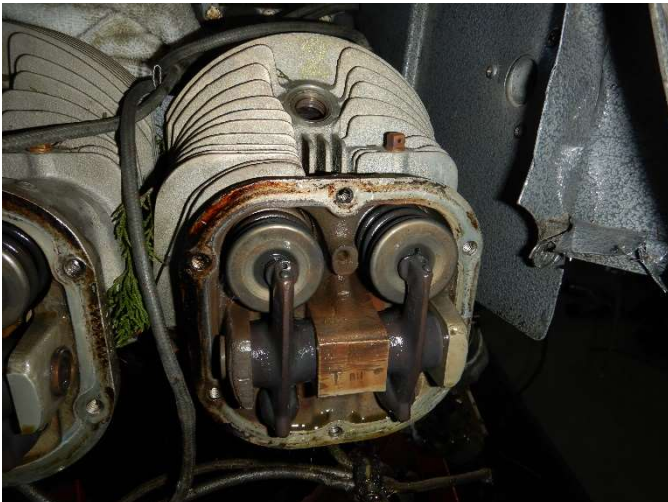
No damage was noted except impact damage to pushrod tubes and pushrods

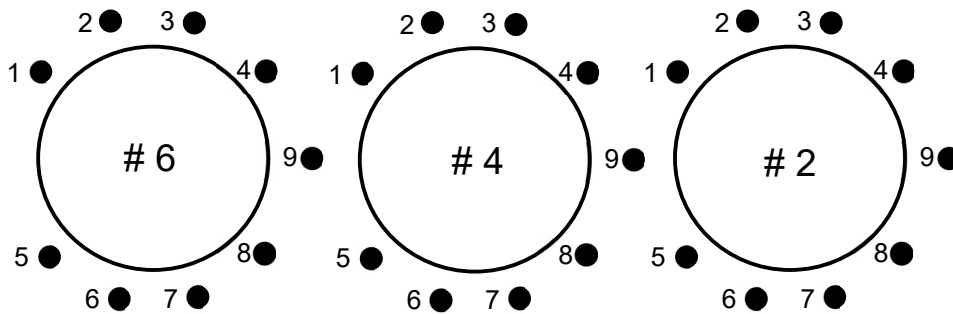
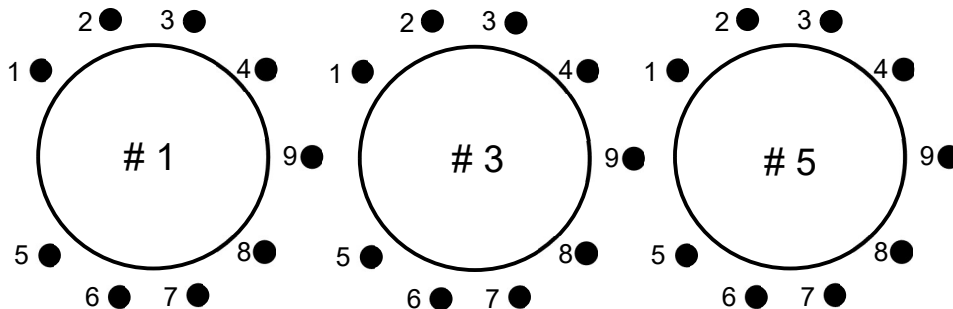
### Cylinder Through-Bolt and Deck Stud Break-Away (Tightening/Loosening) Torque Measurements (in-lbs.)

Bolt 1	Stud 2	Stud 3	Stud 4	Bolt 5	Stud 6	Stud 7	Stud 8	Stud 9
	Tight / Loose	Tight / Loose	Tight / Loose	Tight / Loose	Tight / Loose	Tight / Loose	Tight / Loose	Tight / Loose	Tight / Loose
Cylinder #2	563 / 430	570 / 390	626 / 473	N/A	598 / 450	565 / 450	746 / 589	N/A	N/A
Cylinder #4	550 / 449	586 / 428	673 / 483	N/A	487 / 467	593 / 466	694 / 516	N/A	N/A
Cylinder #6	668 / 523	660 / 606	748 / 617	N/A	670 / 576	654 / 572	851 / 730	N/A	N/A

Bolt 1	Stud 2	Stud 3	Stud 4	Bolt 5	Stud 6	Stud 7	Stud 8	Stud 9
	Tight / Loose	Tight / Loose	Tight / Loose	Tight / Loose	Tight / Loose	Tight / Loose	Tight / Loose	Tight / Loose	Tight / Loose
Cylinder # 1	517 / 584	631 / 557	748 / 647	N/A	653 / 598	530 / 454	752 / 659	N/A	N/A
Cylinder # 3	Loose	527 / 430	682 / 540	N/A	Loose	465 / 434	706 / 605	N/A	N/A
Cylinder # 5	405 / 373	615 / 608	761 / 664	N/A	626 / 542	565 / 517	653 / 565	N/A	N/A

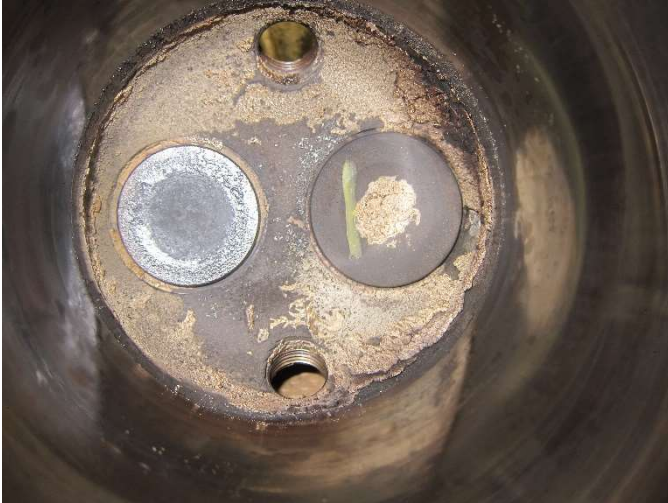
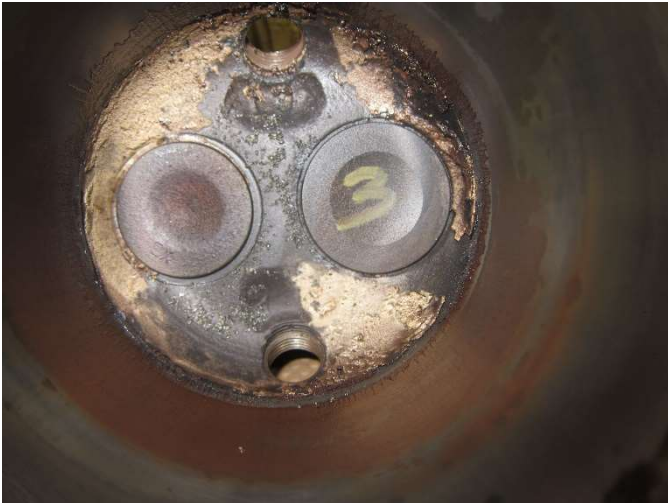
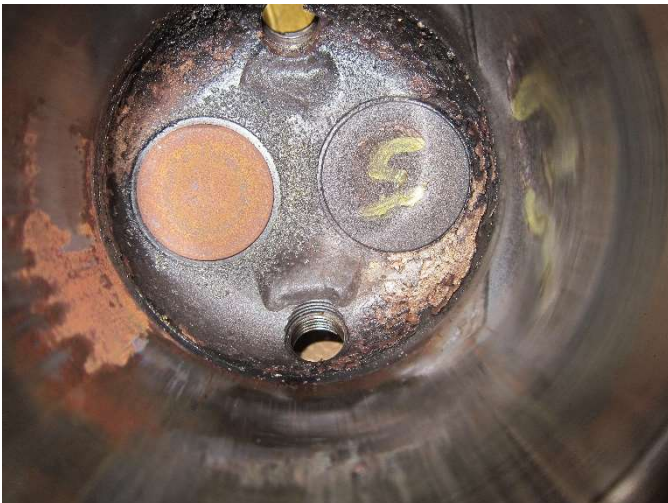
All intake and exhaust valves were intact and exhibited normal combustion signatures.

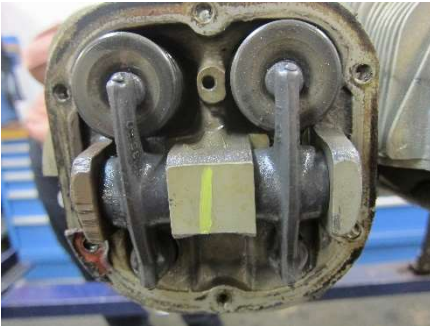
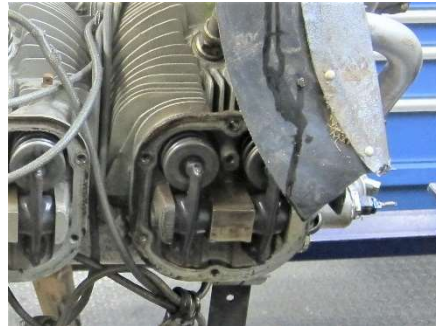
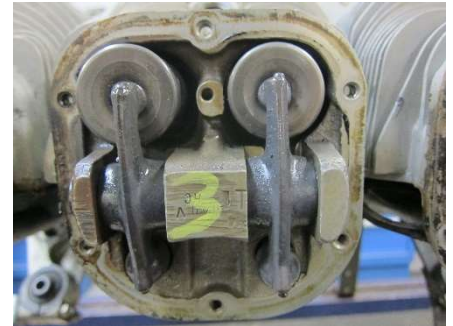
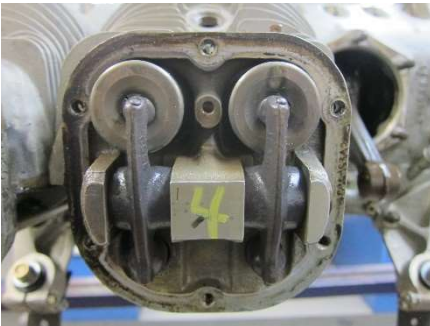
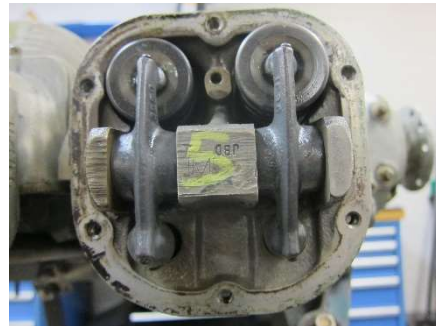
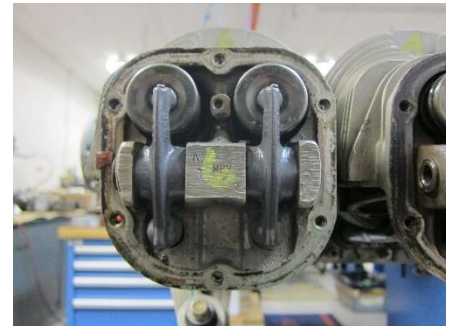
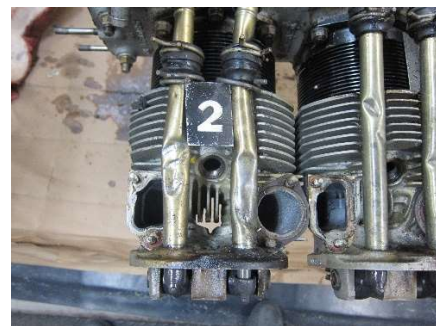
## ROCKER ARMS AND SHAFTS

Condition: All rocker arms and shafts were intact and moved normally when the engine was rotated manually except cylinder 2 which sustained impact damage to the intake and exhaust pushrods.

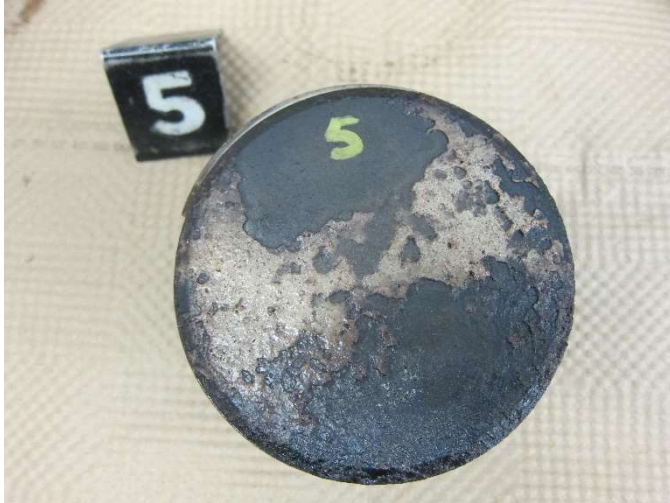
Normal combustion signatures and wear patterns

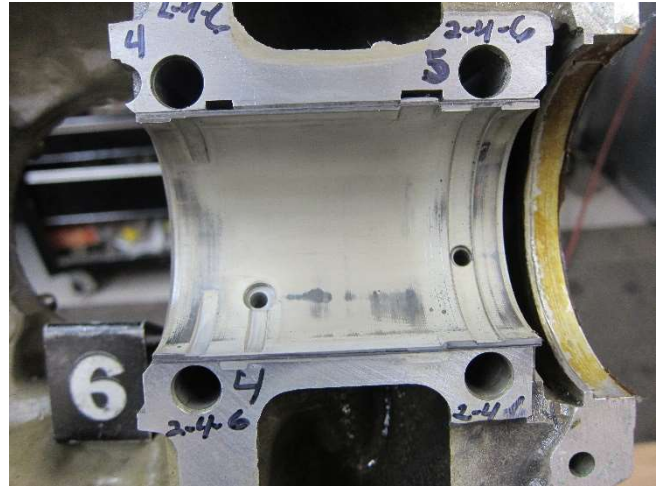
Exhibited normal operating signatures

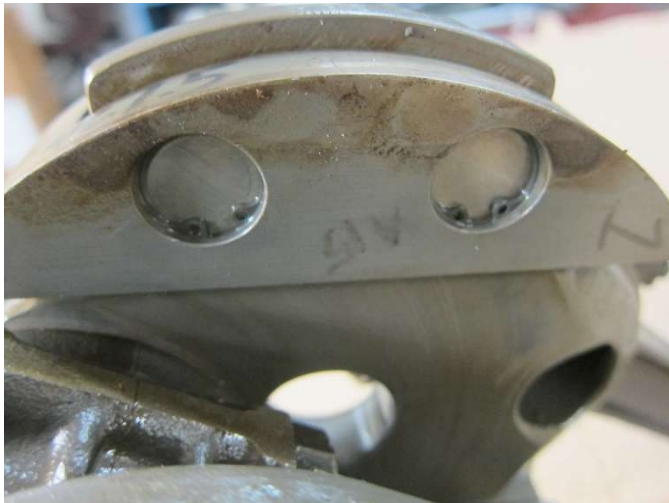
Dampers were free to move on pins. All plates and snap-rings were intact.

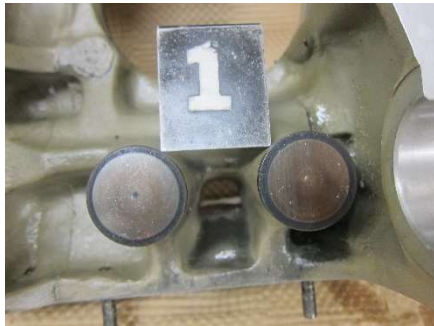
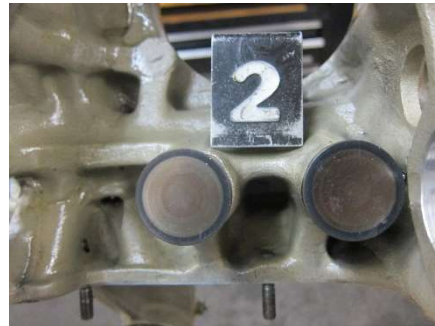
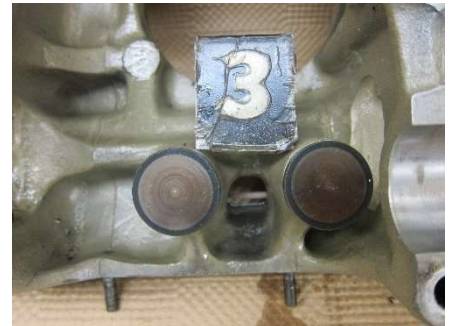
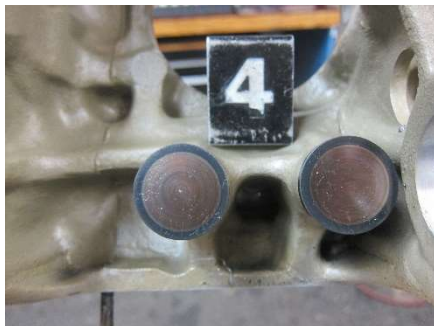
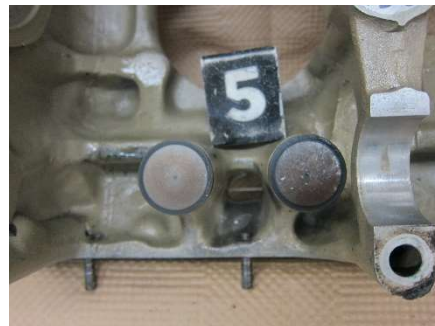
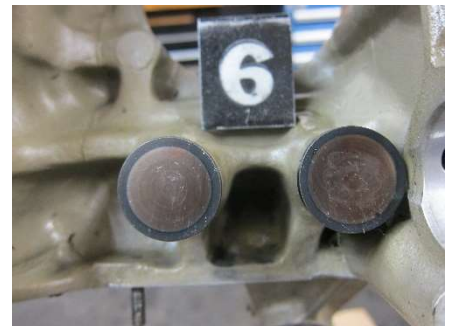
All lifter surfaces exhibited normal operating signatures

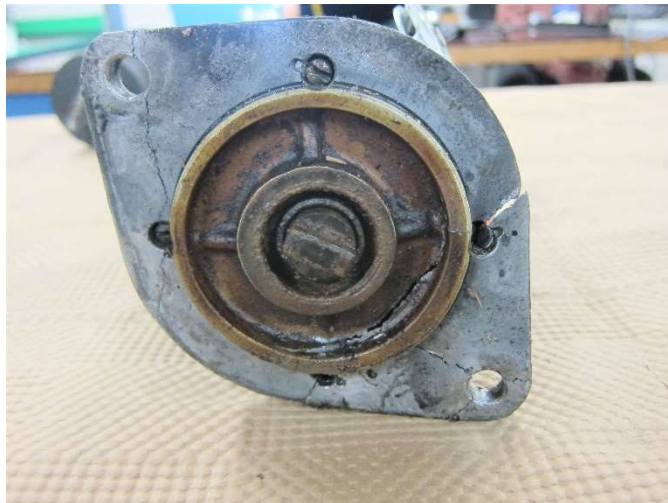
Condition:	The starter motor mounting collar was impact damaged.
------------	---

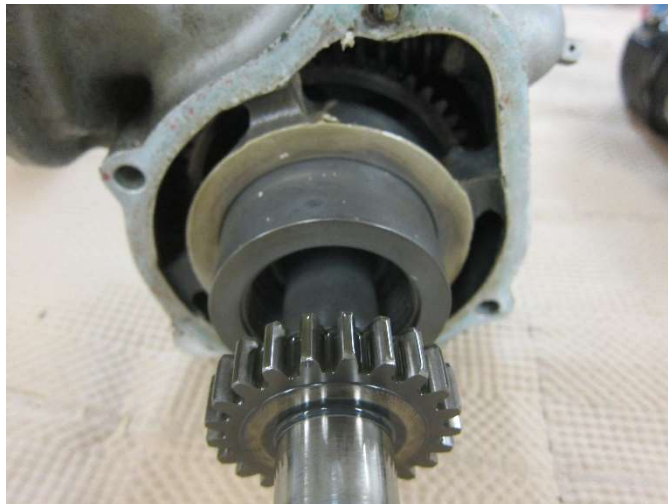
Condition:	The starter adapter was undamaged and rotated normally.
------------	---

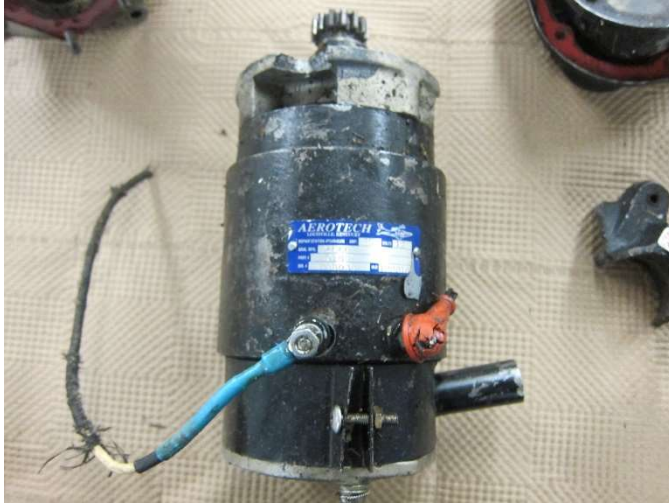
The generator had been previously removed during the recovery examination. Impact damage was noted on the mounting ring and the electrical posts were damaged.

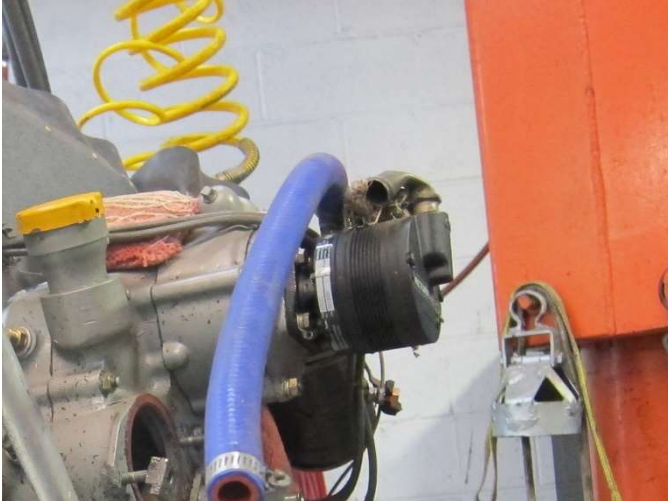
The instrument air pump was rotated by hand. The pump rotated smoothly thumb suction was achieved. The plastic drive coupling was intact.
