Tamarack Aerospace Group Submission to the National Transportation Safety Board

**Collision of Cessna 525A (N525EG) With Terrain Near  
Memphis, IN, November 30, 2018**

**CEN19FA036**

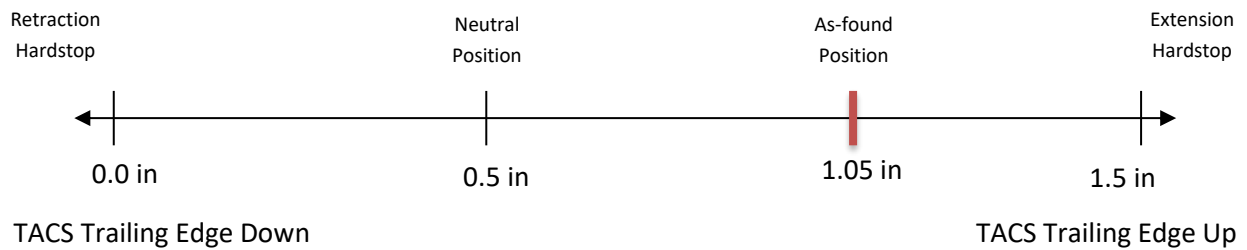
Figure 2-7 Distance from ball nut to retracted hard stop (nominal)

The CT revealed that the distance from the retracted hard stop of the actuator to the ball screw face was approximately 26.7 mm (1.05 in). When the actuator is in its neutral position (*i.e.*, the TCU is not responding to any gust), the distance between these two faces would nominally be approximately 0.5 in. The distance would be slightly greater than 1.5 in if the actuator were fully extended.

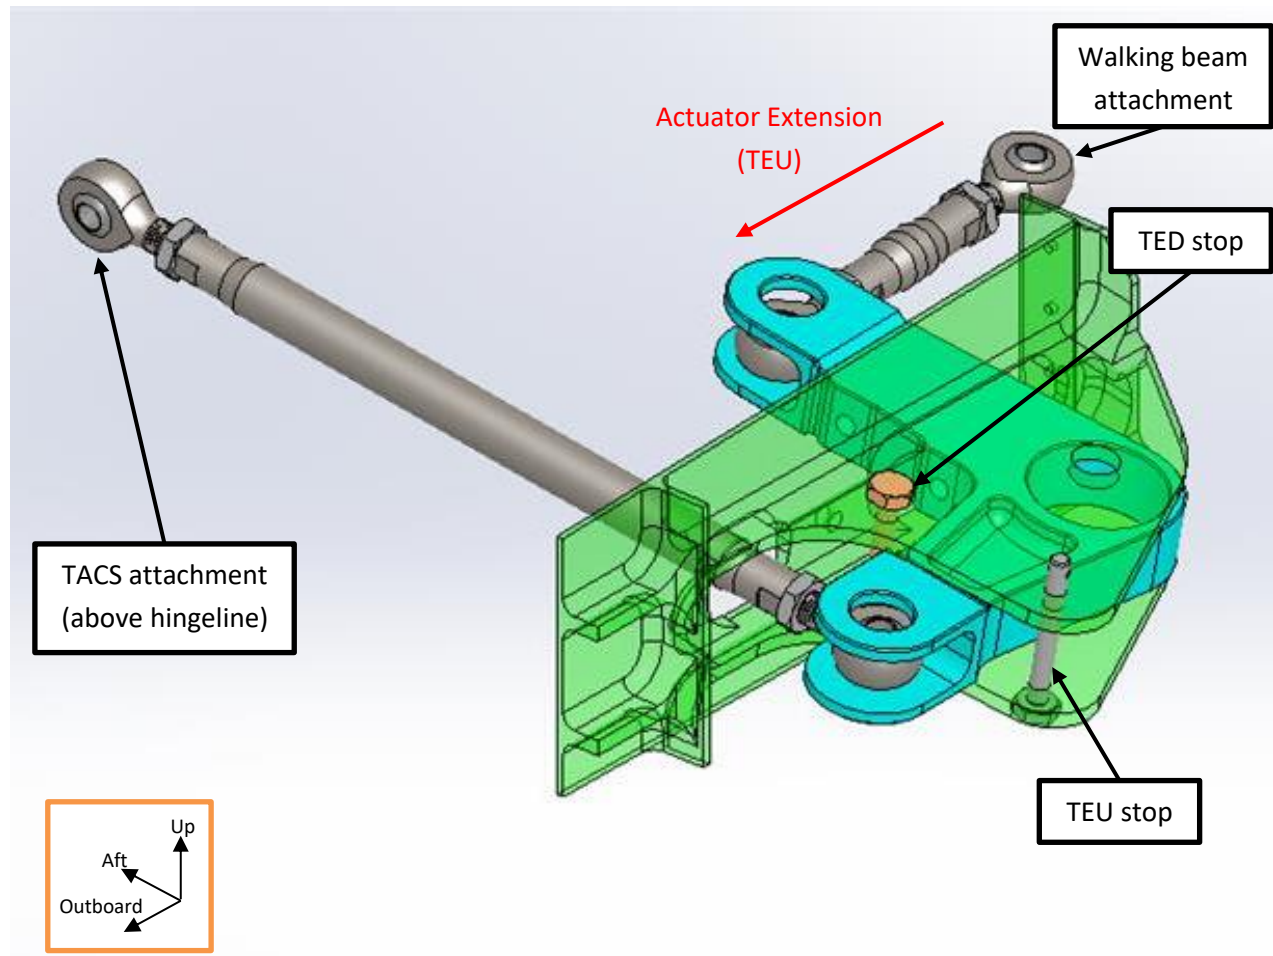
Figure 2-10 Bell crank assembly view (simplified, RH shown)

The stop corresponding to a trailing edge down deployment is a sleeved AN3-14A bolt installed through the bell crank bracket. The trailing edge down stop was severely deformed the as-found condition of the right wing extension. This does not match the position of the ball nut and the witness marks found within the actuator, which indicate an extended condition (corresponding to a trailing edge up deployment). The deformation of the trailing edge down bell crank stop most likely happened during impact after the actuator ram tube was separated from the TCU, as the actuator is not capable of producing the force required to deform this bolt to the extent it was found.

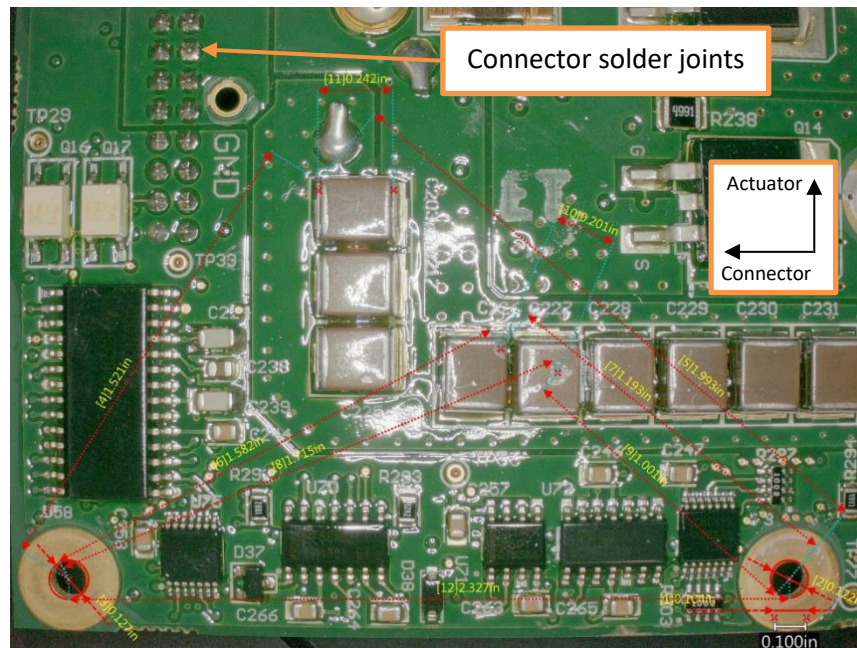
Figure 2-19 TCU control board lower surface view with key features annotated

Initial electrical testing of the LH TCU found that pins 33 and 35 were open. Pin 33 connects to pin A of the external connector, carrying a discrete enable signal from the ACU. Pin 35 connects to pin D of the external connector, carrying the analog actuator command signal.

There is evidence to suggest that the pins were bent by a substantial flexure of the PCBA during the impact event. The lower surface of the PCBA is populated in part with two rows of capacitors, visible in

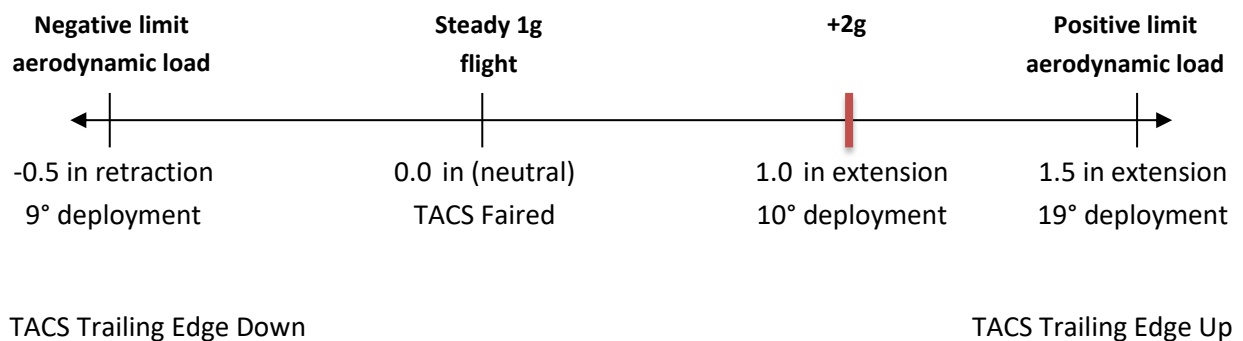
Figure 2-23 525A simplified TACS deployment schedule

A ball nut position of 0.45 in from the extended hard stop on the LH actuator corresponds with approximately a 0.55 in extension from the TACS faired position. Similarly, the RH actuator position of 0.55 in from the extended hard stop corresponds to an approximate extension of 0.45 in from the TACS faired position. These positions nominally correspond to TACS deployments of 9° (LH) and 10° (RH). This is

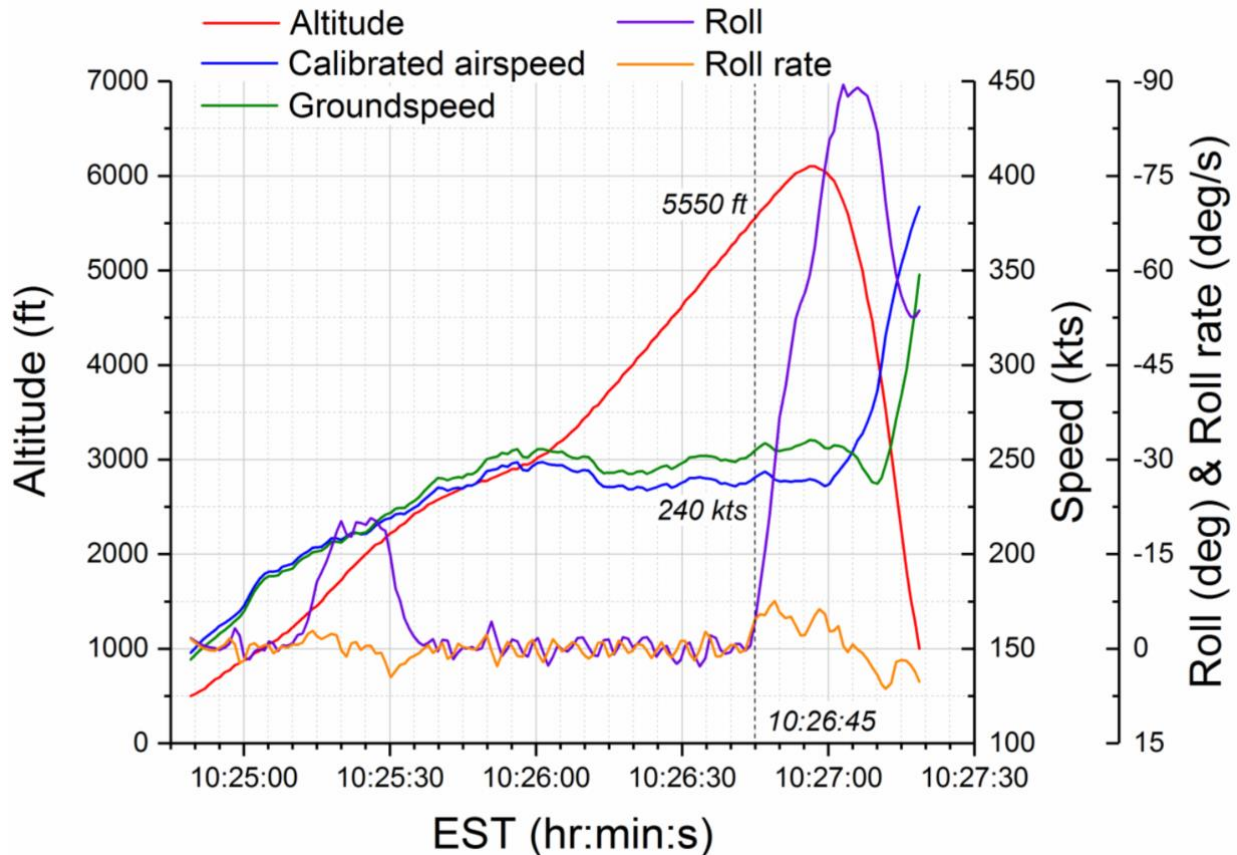
Figure 3-1 Flight condition time history (excerpt from Performance Study)

After the onset of roll at approximately 10:26:45, the rate of roll fluctuates, appearing to average approximately 5 degree/second for approximately fifteen seconds, with a brief dip approximately ten seconds after the onset of the roll.

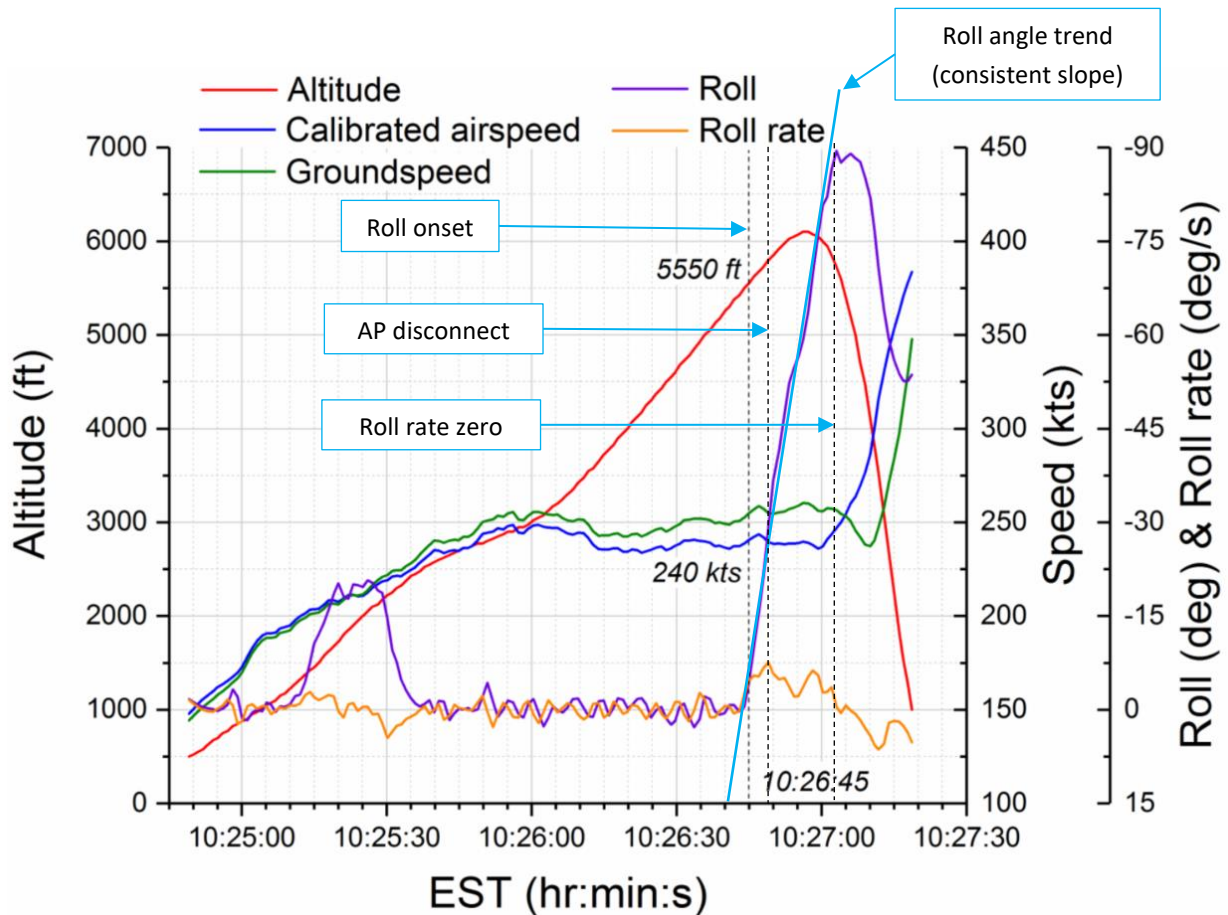
Figure 3-3 Annotated performance survey excerpt

The onset of the roll event occurred just before 10:26:45, indicated in Figure 3-3. The roll onset is easily identified by the start of a steady increase in roll angle. Based on the performance survey, it is apparent that the roll angle increased for approximately twenty seconds, until approximately 10:27:04. At this point, the bank angle stabilized for 3-5 seconds before starting to reverse.

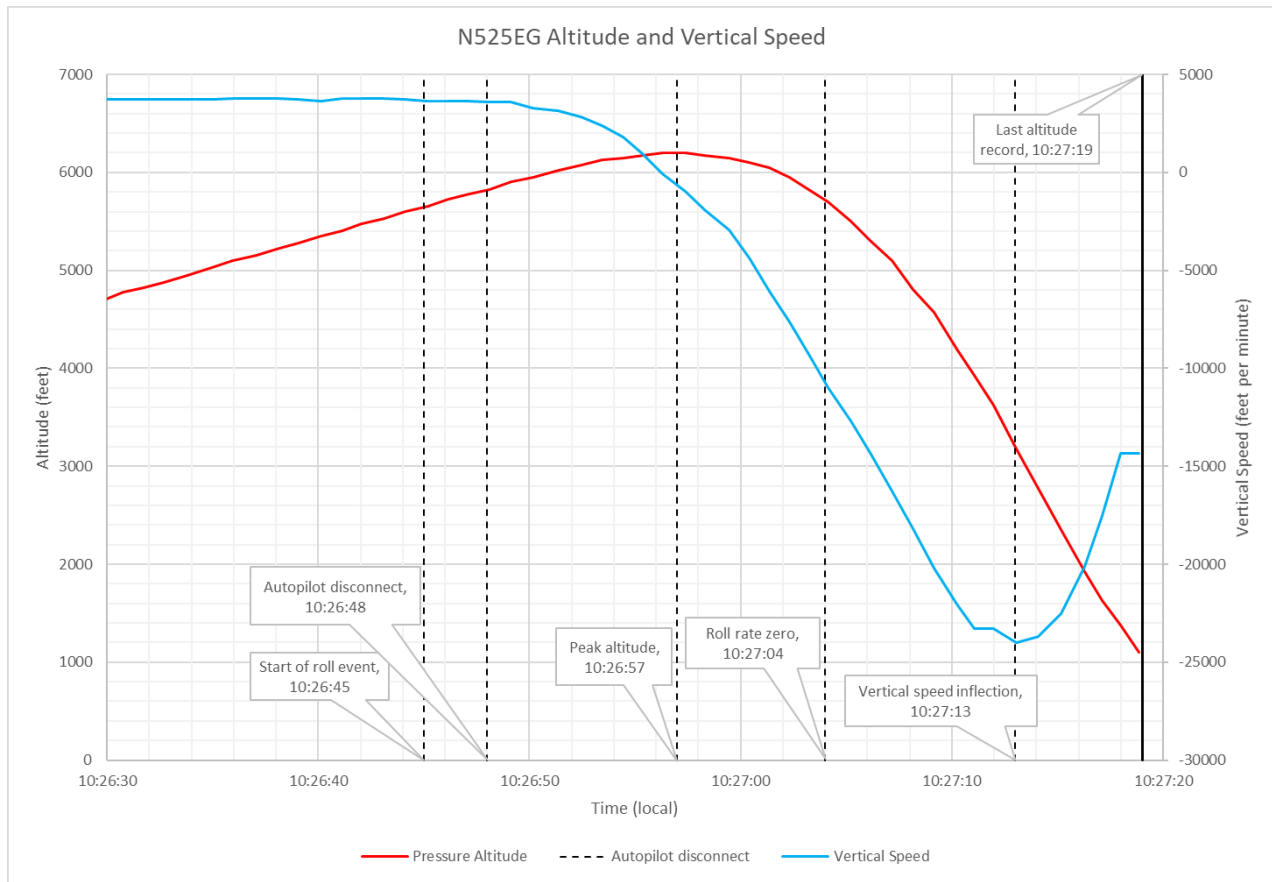
Figure 3-4 Altitude and vertical speed time history, detail view

A supplemental Tamarack analysis of the time history of altitude and vertical speed recovered from the ADS-B data indicates that an attempt to raise the nose of the airplane was initiated just before 10:27:13, nearly 30 seconds after the roll onset. At 10:27:13, the trend of the vertical speed reversed, reaching a

peak descent rate of 24,000 fpm. The rate of descent was reduced to approximately 14,000 fpm in the final seconds before impact. A section of the altitude and vertical speed data is presented in Figure 3-4.

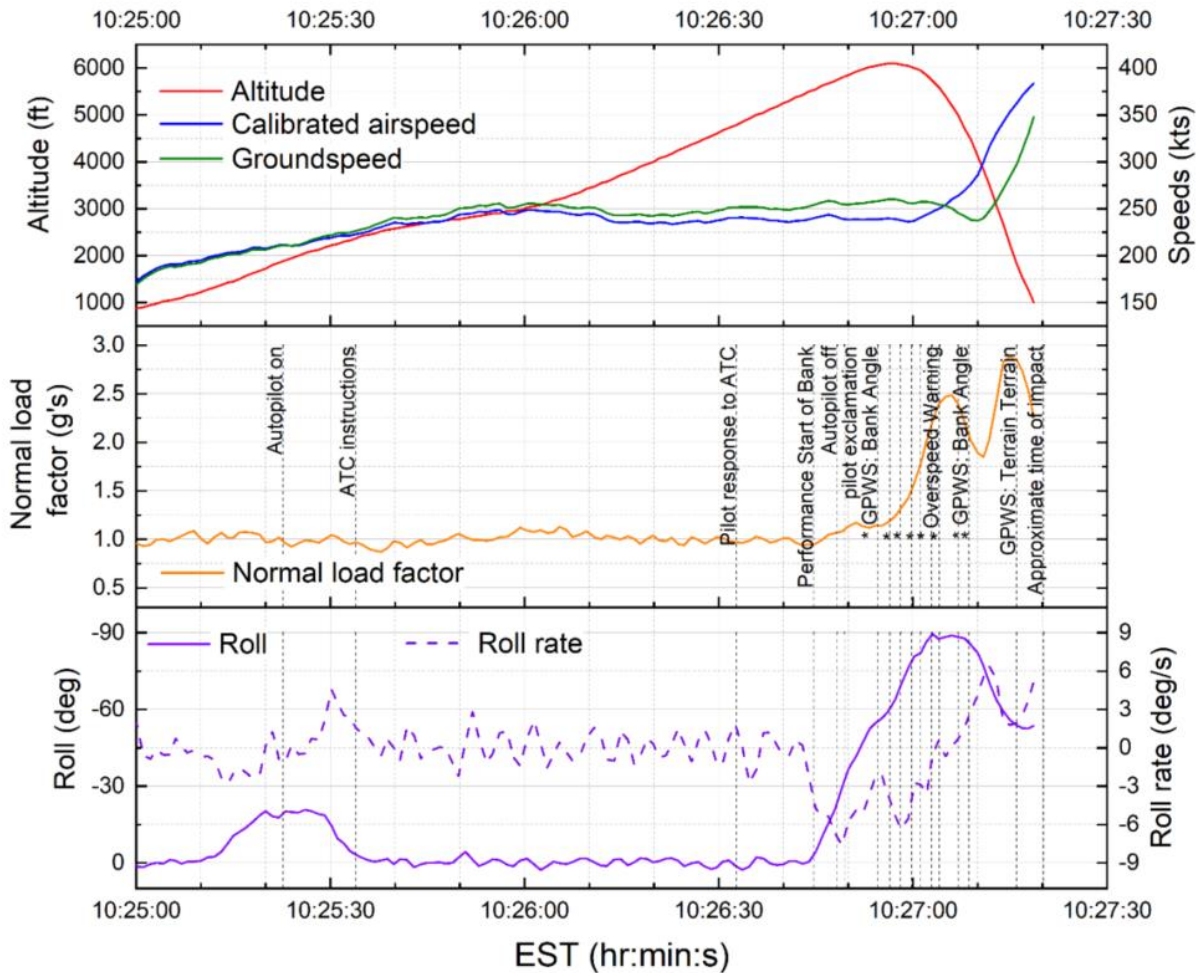
Figure 3-5 Comprehensive view of NTSB performance survey data

It is important to note that this data is based on ADS-B data, taken at one second intervals. Therefore, transient load factors acting on the airplane on very short timeframes would not be calculable. The trend of load factor indicates a peak at approximately 3g at a timestamp of 10:27:13, corresponding to the minimum vertical speed. This is expected, as this is the point at which the largest forces would be acting on the airplane to reverse the rate of change of vertical speed while still at a large bank angle.
