**Specialist's Factual Report – Attachment 3**

**Flight Track Graphics**

**AIR TRAFFIC CONTROL**

CEN19FA161

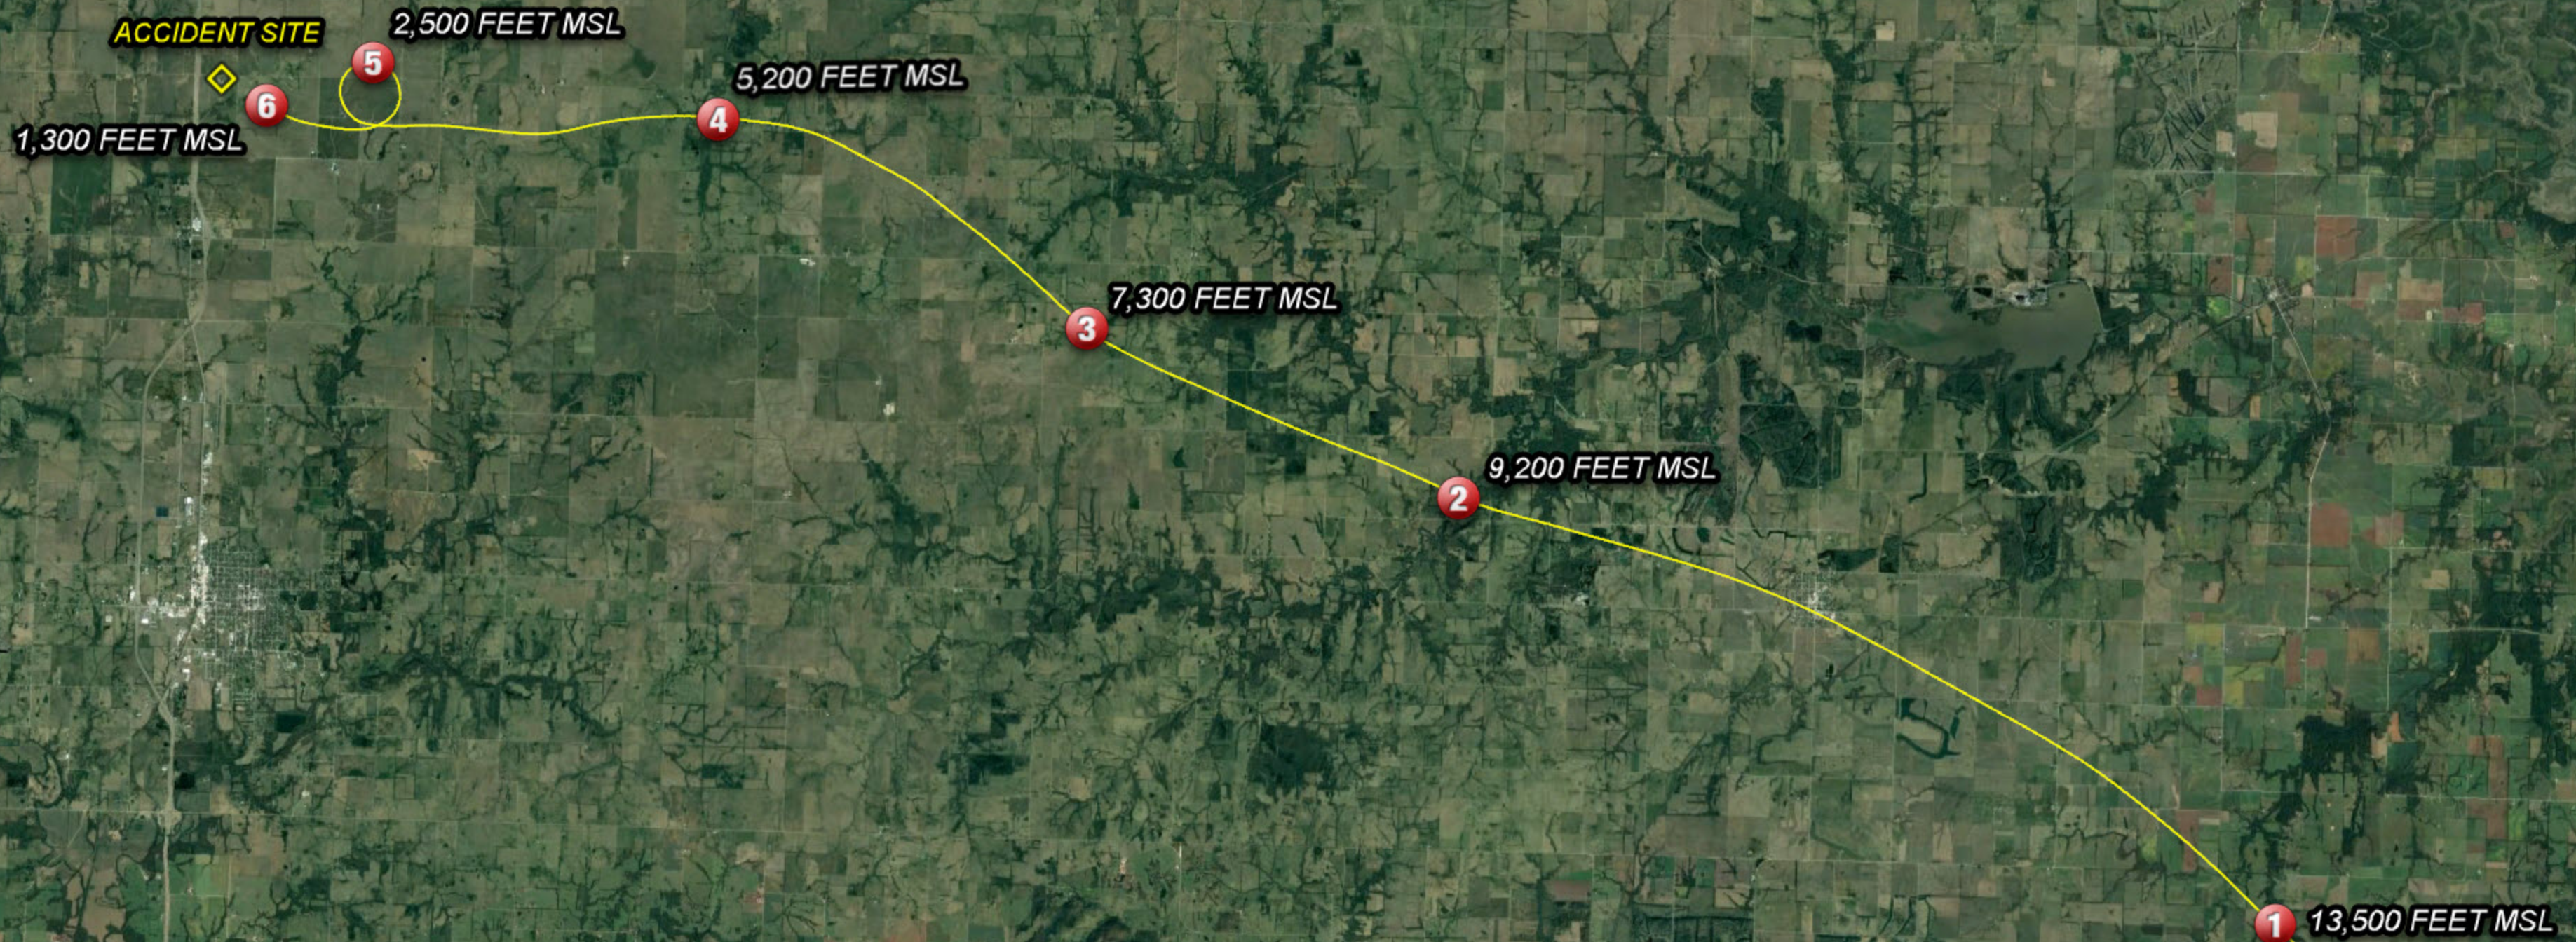
- 1 1009 CDT - PILOT REPORTED HE WOULD HAVE TO SHUT ENGINE DOWN AT FULL POWER
- 2 1012 CDT - PILOT REPORTED HE WAS FLYING ON ONE ENGINE
- 3 1014 CDT - PILOT REQUESTED NEAREST AIRPORT AND WAS PROVIDED BUTLER MEMORIAL AIRPORT (BUM)
- 4 1016 CDT - PILOT ADVISED HE WOULD NEED TO LAND RUNWAY 18 AND REPORTED AIRPORT IN SIGHT
- 5 1018 CDT - PILOT ADVISED HE WAS TRYING TO GET AIRPLANE UNDER CONTROL AND WAS CLEARED VISUAL APPROACH
- 6 1019 CDT - PILOT ADVISED THE AIRCRAFT WAS GOING DOWN
