**NATIONAL TRANSPORTATION SAFETY BOARD
OFFICE OF AVIATION SAFETY
WASHINGTON, D.C. 20594**

**POWERPLANTS GROUP CHAIRMAN'S FACTUAL REPORT
NTSB ID: CEN19MA190**

Location: Addison, Texas
Date: June 30, 2019
Time: 0911 Central Daylight Time (CDT)
Aircraft: Textron Aviation B300, N534FF, operated by EE Operations LLC

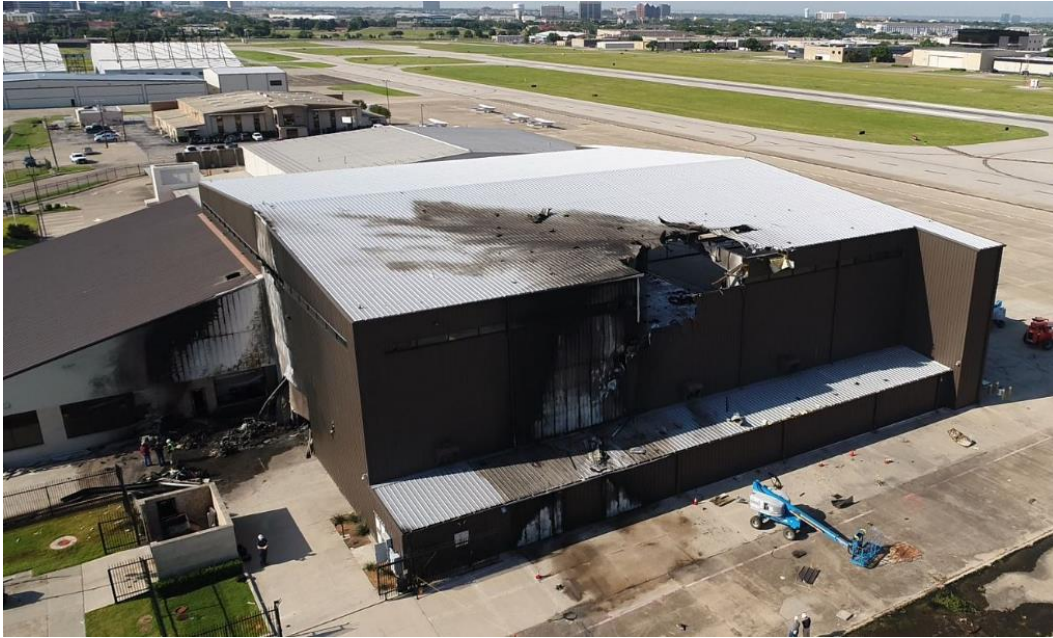
Figure 1. Sky B&B hangar, Addison Airport

The powerplants group documented the wreckage July 1-4, 2019. An initial point of impact was evident on the north wall of the Sky B&B hangar, a steel beam and sheet metal structure. See Figure 1.

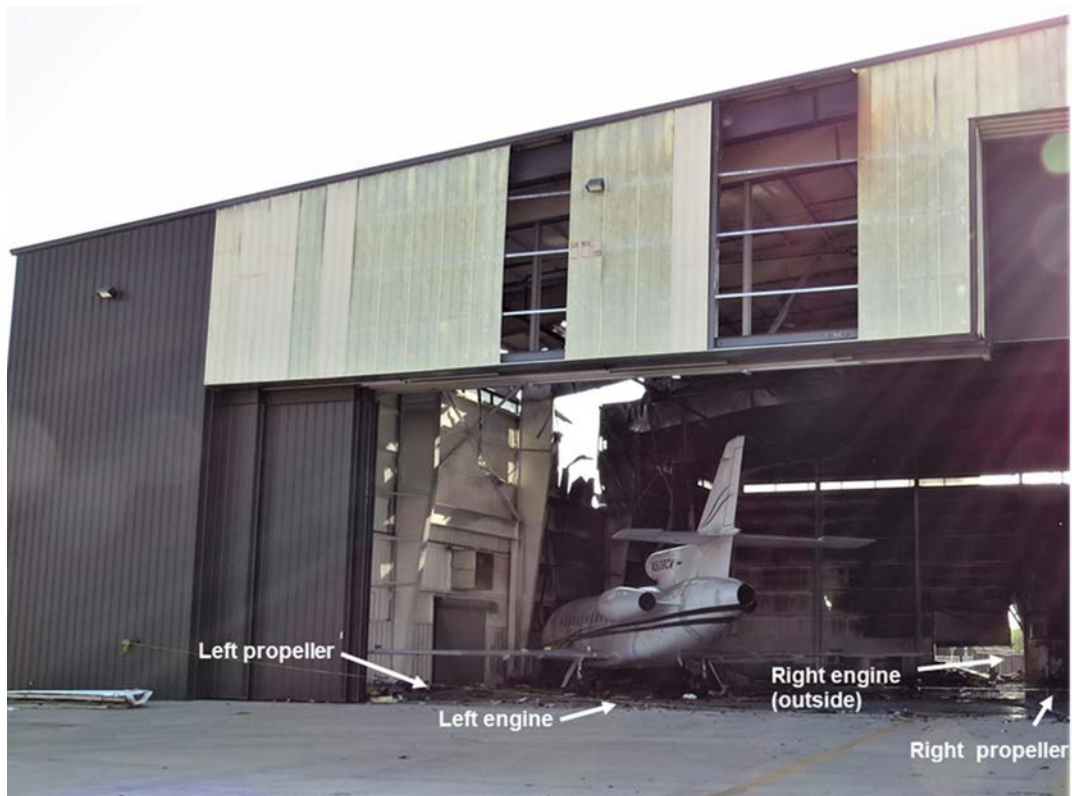
Figure 2. General locations of powerplant components as found

The left engine and propeller assembly were found inside the hangar near the impact hole. The right propeller was found inside the hangar to the right of the rollup door in the east wall. The right engine was found outside the east wall, with the fuselage. See Figure 2.
