NATIONAL TRANSPORTATION SAFETY BOARD
Office of Research and Engineering
Washington, D.C. 20594

Video Study

**NTSB Case Number:
CEN19MA190**

Location: Addison Airport (KADS), Addison, Texas
Date: June 30, 2019
Time: 0911 central daylight time (CDT)
Aircraft: Textron Aviation B300

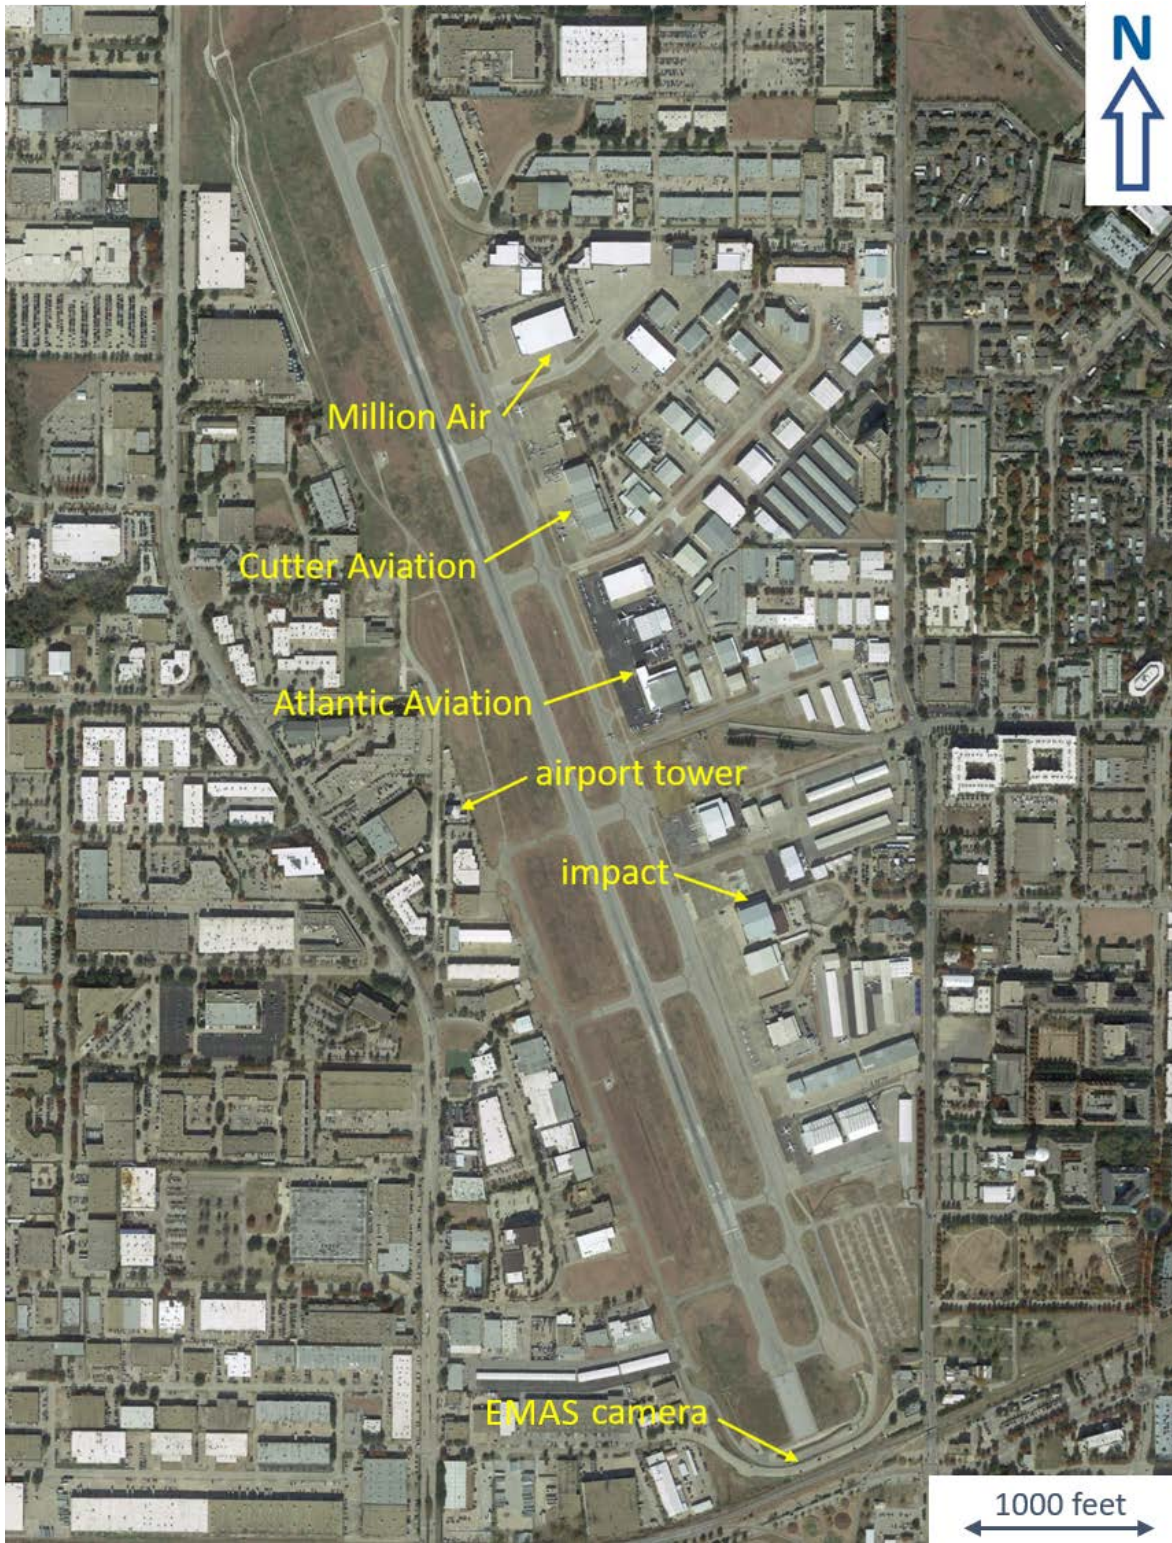
Figure 1. Aerial Image of the Airport

The goal of this investigation was estimating the ground track, altitude, speed, roll angle, pitch angle, angle of attack and sideslip angle of the airplane during its short flight that ended in ground impact. Analysis was based primarily on a video recorded by a camera installed south of the Engineered Material Arresting System (EMAS) section at the southern end of the runway, on the west side of the runway (EMAS camera). The EMAS camera video had 2592x1944 resolution and frame rate of 13.33 fps. A video recorded by a camera installed on the Atlantic Aviation building at the airport provided supporting information. Figure 1 displays an aerial image of the airport with labeled locations that were relevant to the analysis of the EMAS video.

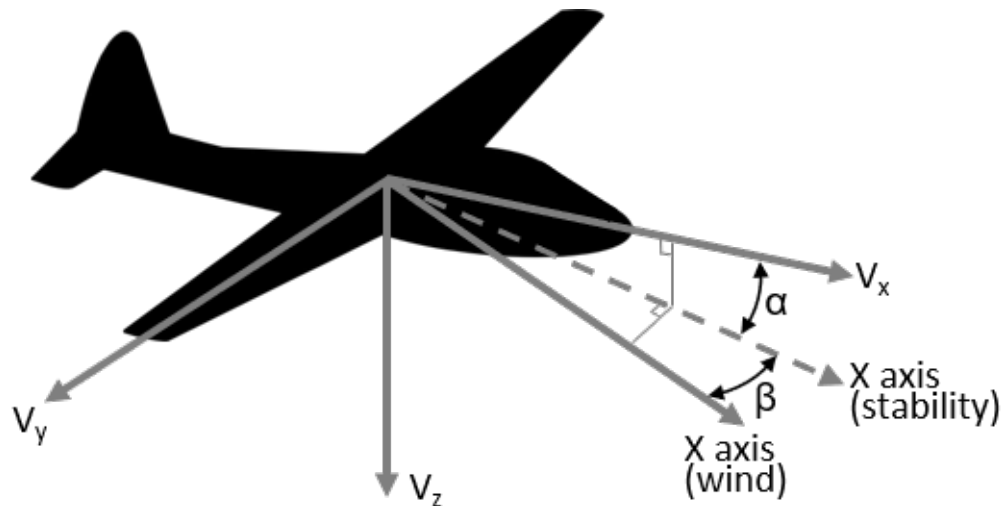
Figure 9. Illustration of the Stability and Wind Coordinate Systems

Estimation of the angle of attack and sideslip angle of the airplane involved transformation of coordinates between the body axes and the stability and wind axes. Figure 9 shows the relationships between these coordinate systems. The equations in [1], pages 9-11, were used for the transformations. In the figure, α is the angle of attack and β is the sideslip angle.
