National Transportation Safety Board

CEN21FA130

VEHICLE PERFORMANCE

Location: Janesville, Wisconsin
Date: February 16, 2021
Time: 0917 CST
1517 GMT
Airplane: Velocity V-Twin, N13VT

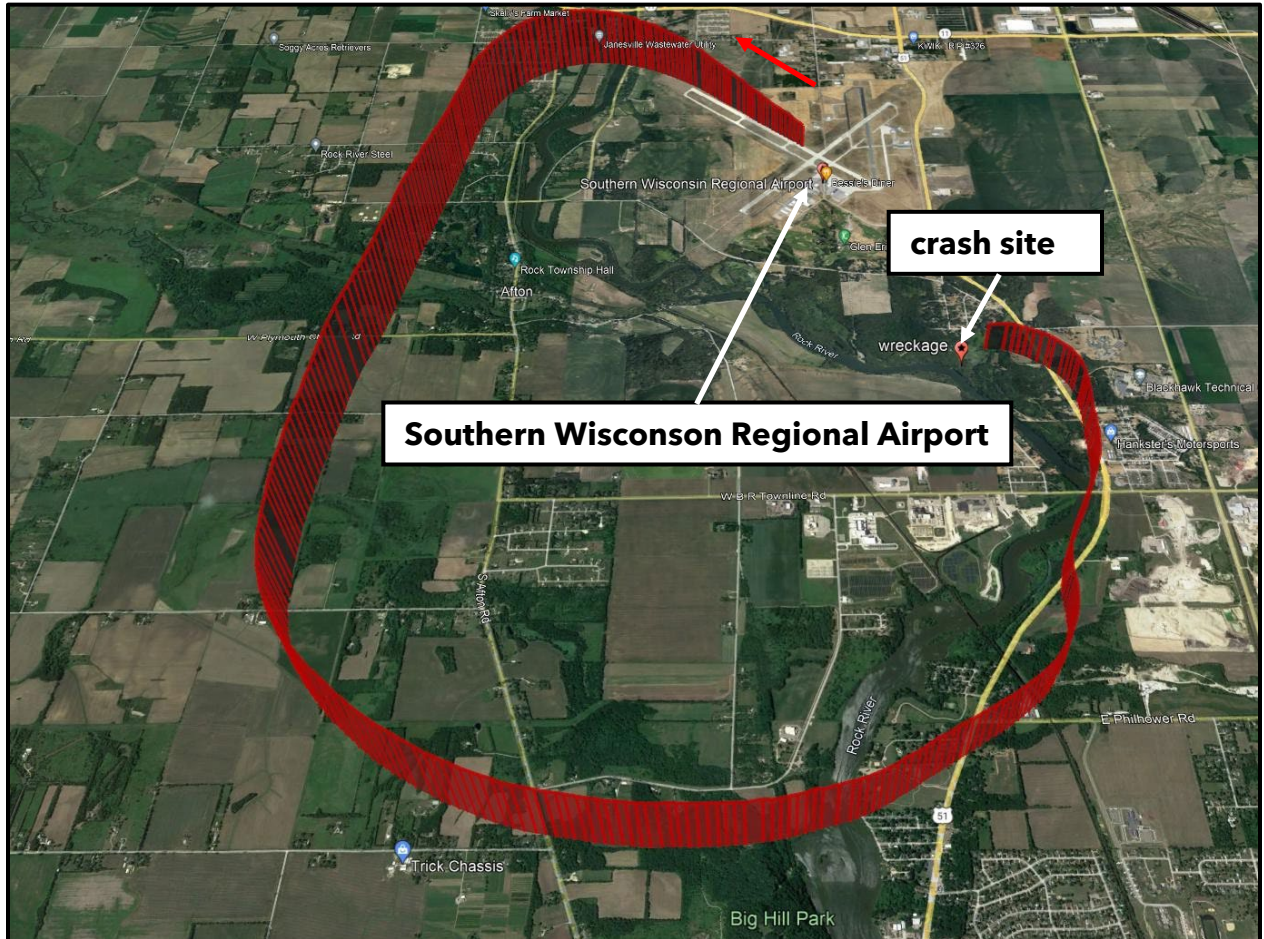
About 0917, the airplane impacted trees and came to rest inverted in a 3 ft-deep tributary of the Rock River about 1 mile south of JVL and sustained substantial damage to both wings, both canards, and the fuselage. Both fuel tanks were breached and a strong odor, consistent with 100LL aviation fuel, was present at the accident site. See Figure 1 for an overview of the take-off.

Figure 1: The Five-and-a-Half-Minute Flight Departed JVL with Sebastian, FL, as the Ultimate Destination

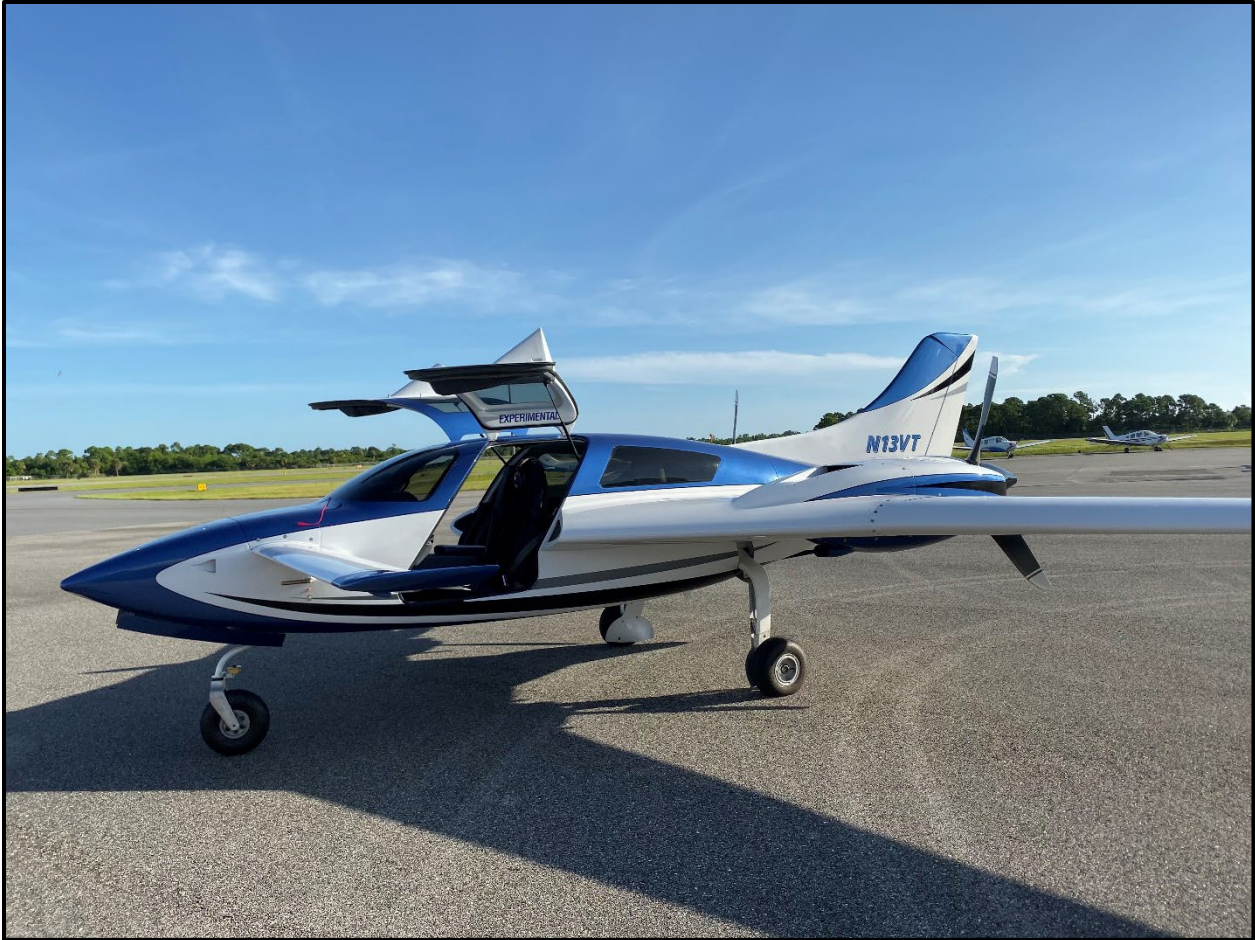
A picture of the accident airplane, an experimental, amateur-built, Velocity V-Twin, is shown in Figure 2. The kit airplane was built in 2020 and is registered to N13VT, LLC.

Figure 2: Accident Airplane, N13VT, an Experimental, Amateur-Built, Velocity V-Twin

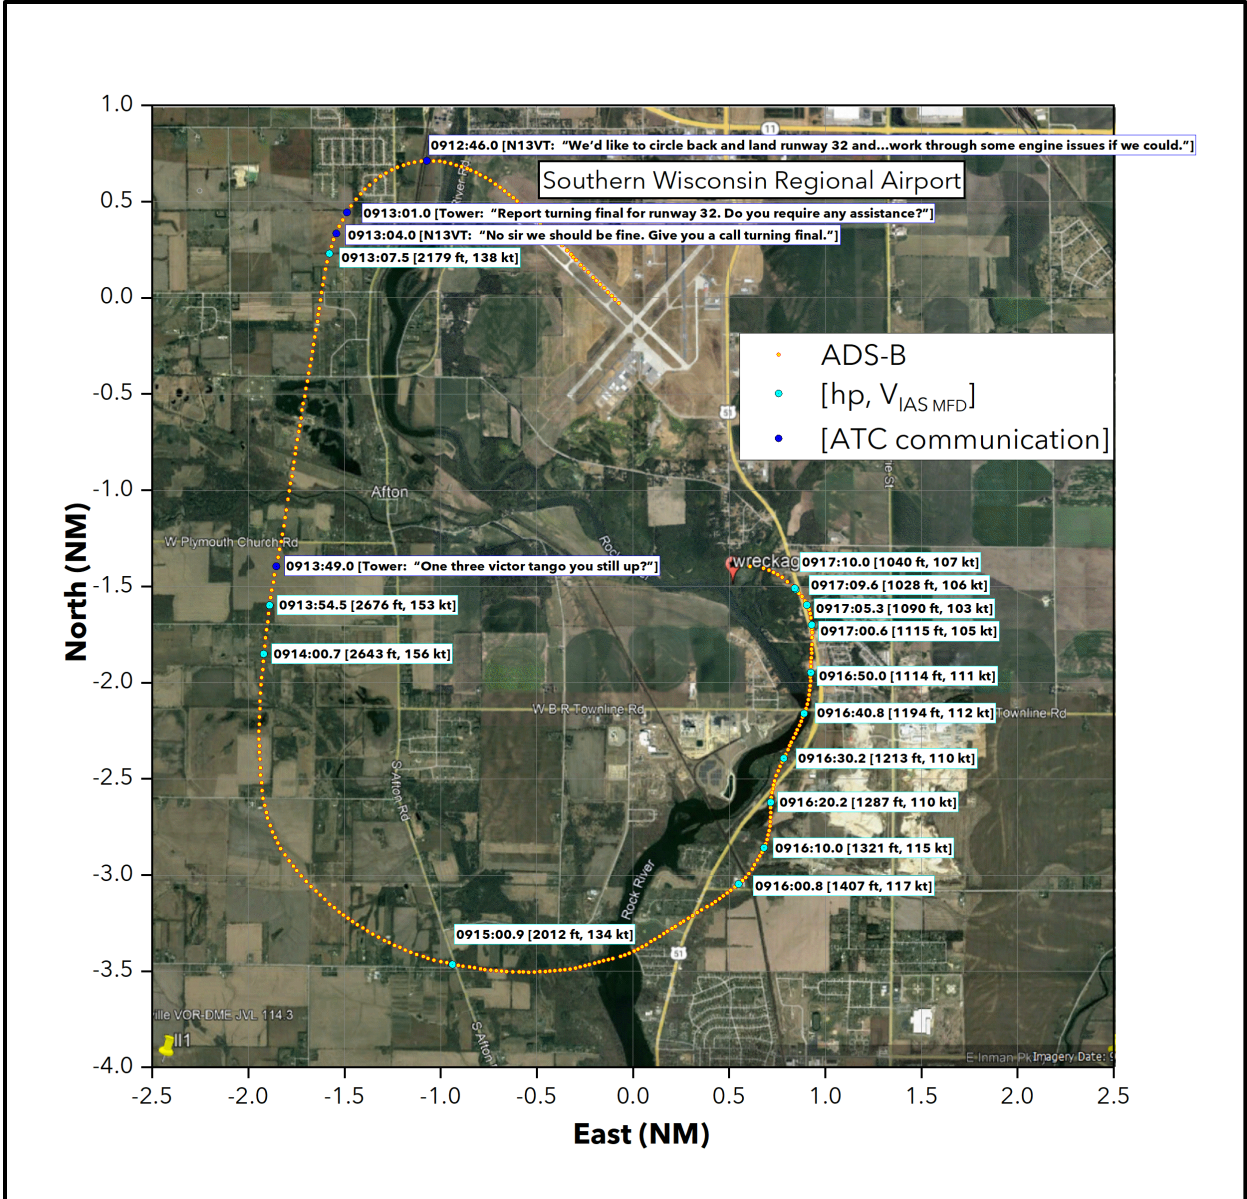
Figure 3 shows the ADS-B position data and MFD altitude¹ and airspeed for the five-and-a-half-minute flight in an overhead view. Communications between N13VT and the control tower are denoted in blue. Figure 4 shows the same parameters as well as the estimated rate-of-climb (ROC) in a time history format.

Figure 3: Position, Altitude and Airspeed for the Accident Flight

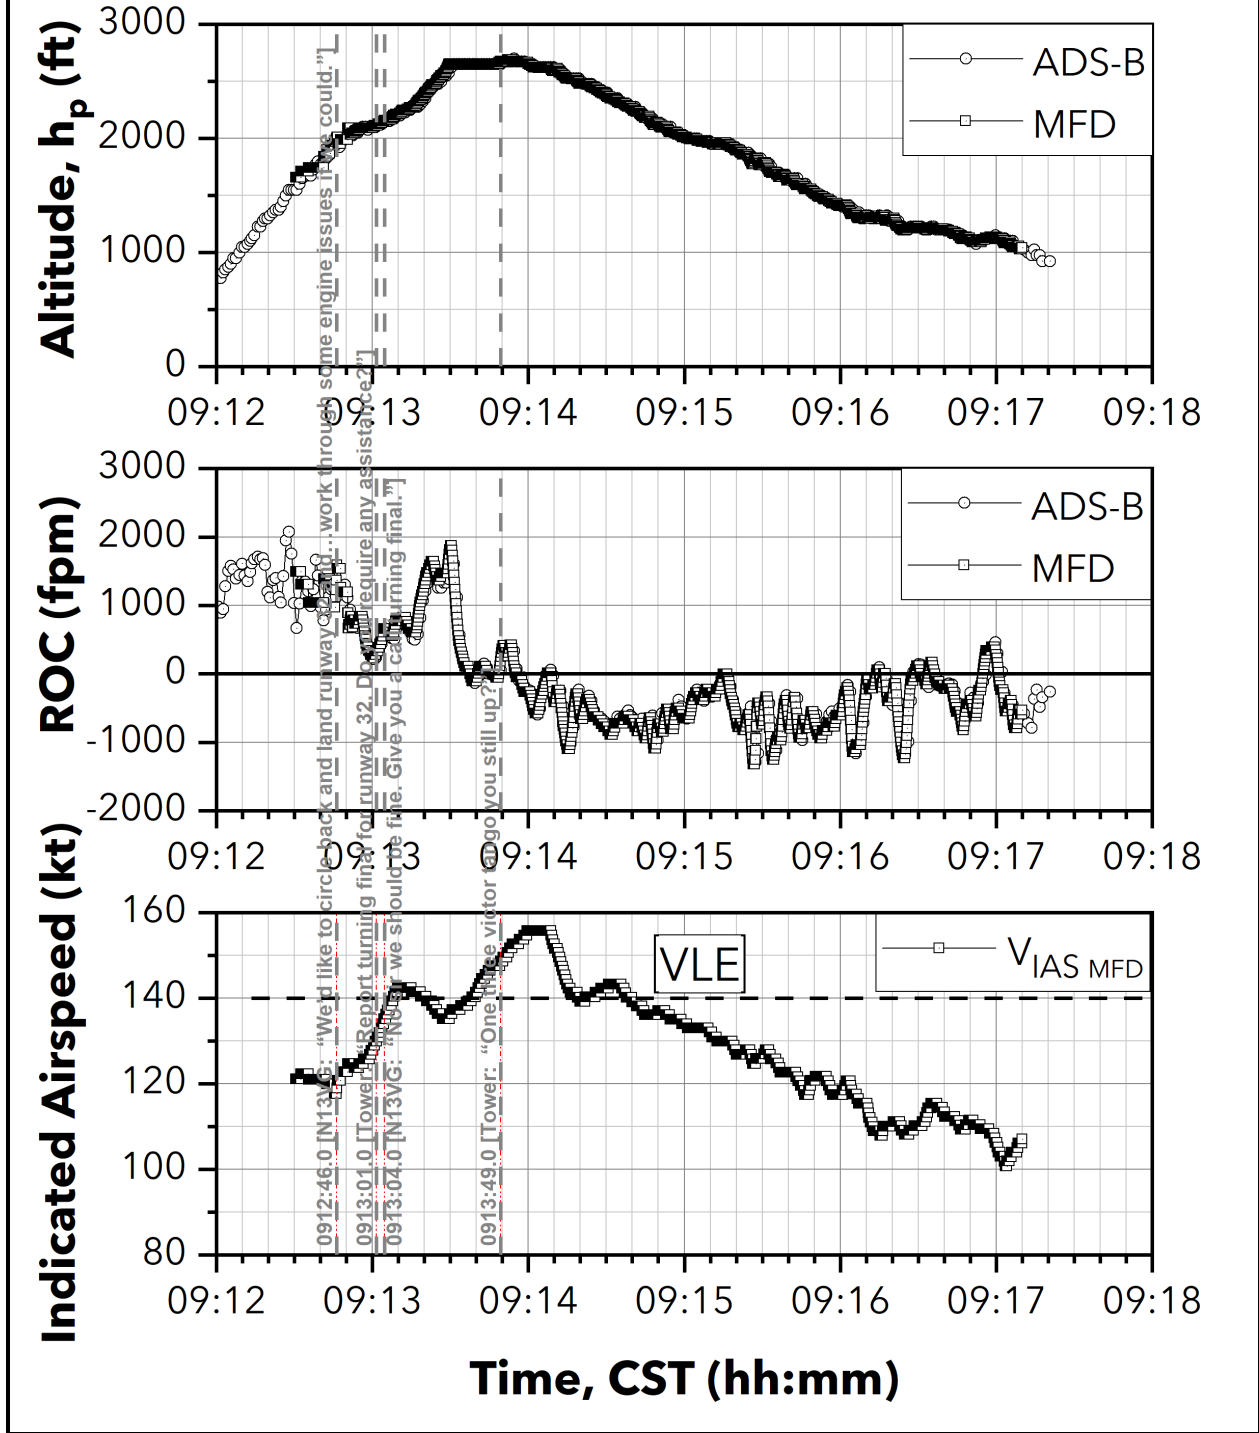
Figure 4: Altitude, ROC, and Airspeed for Accident Flight
