Non-destructive testing of a Garmin memory module, case CEN21FA150

Summary and Conclusions

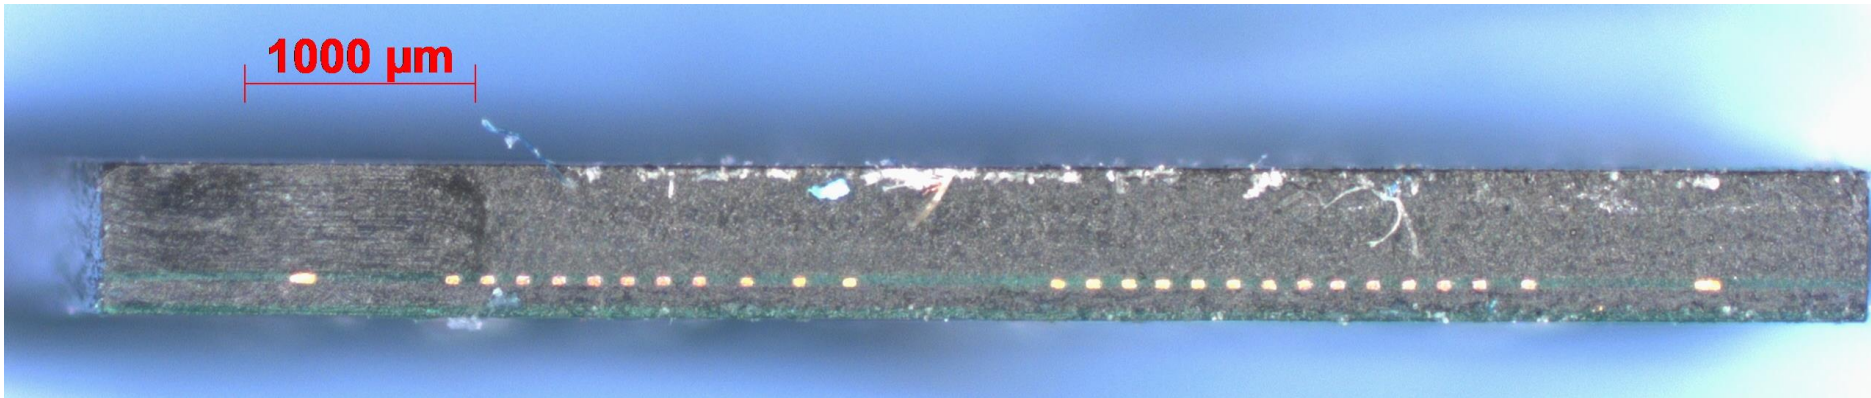
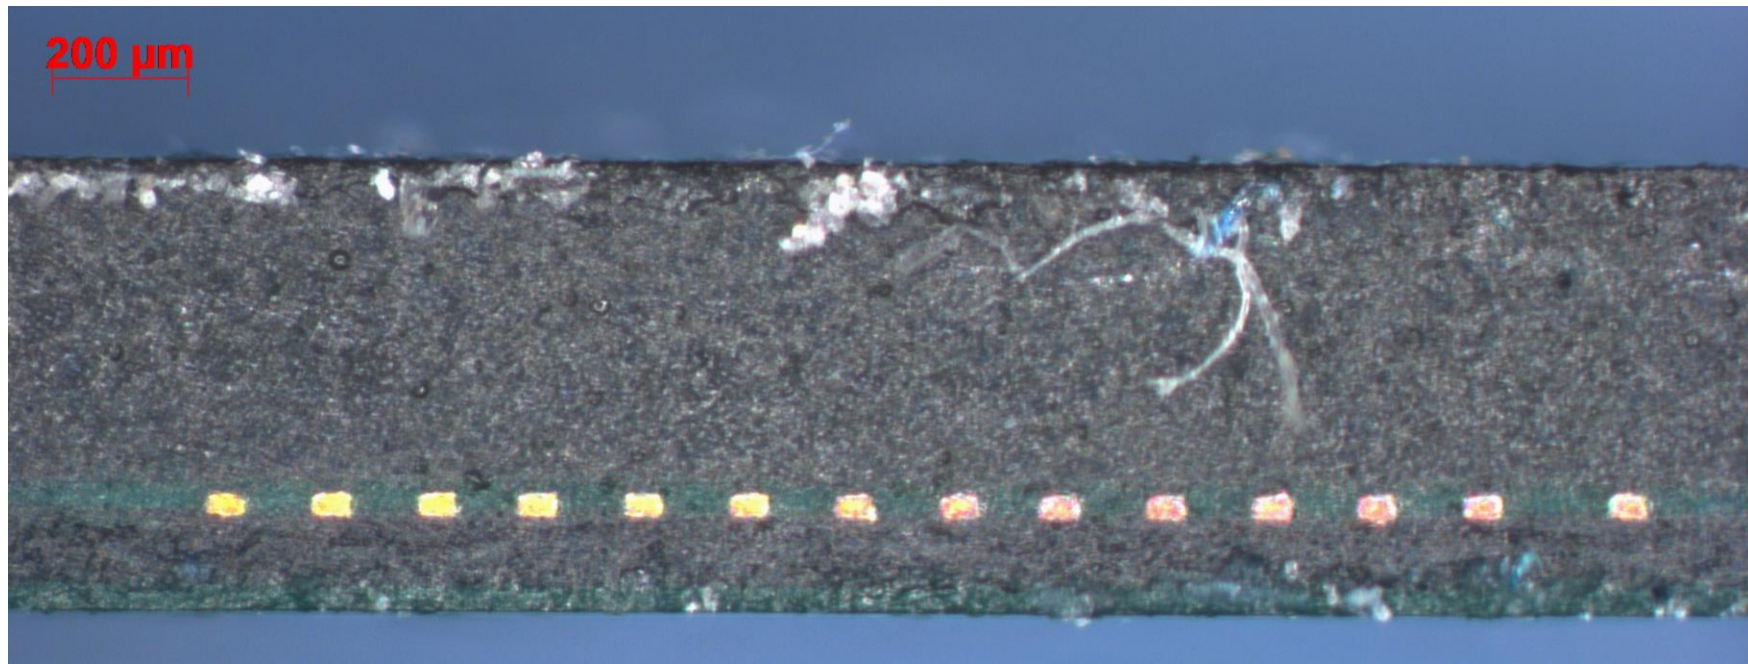
Side view of the package: side 3

Undamaged side of the package

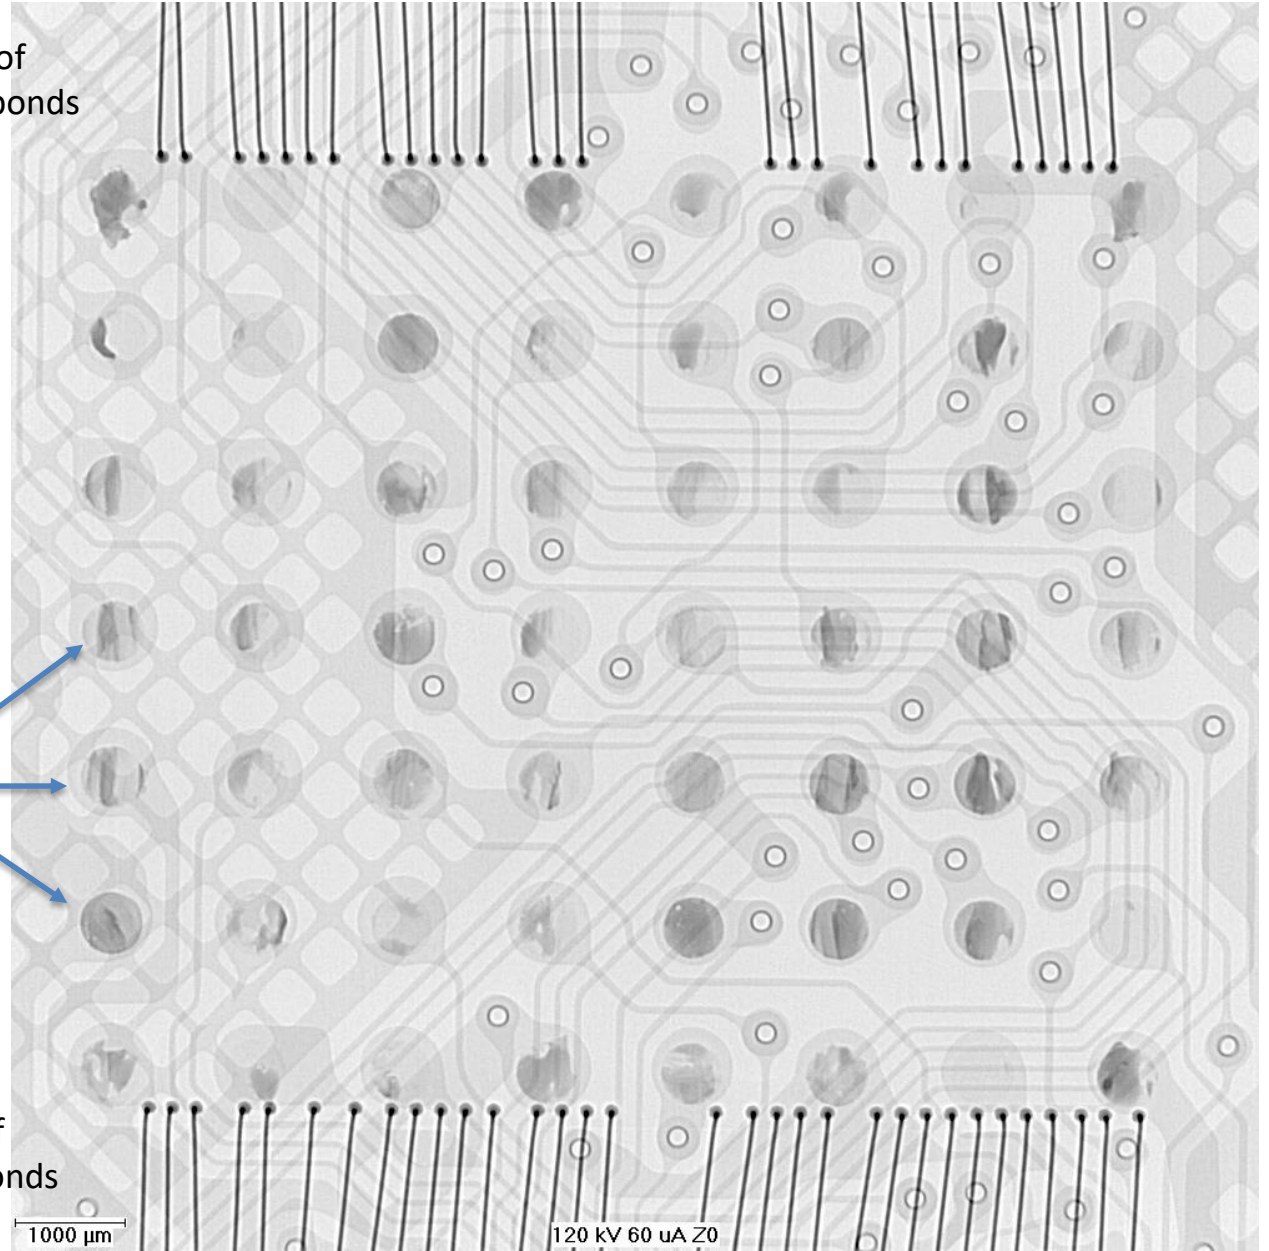
X-ray image of the die with wirebonds

Row of wirebonds

The memory package has a single die with wirebonds on two sides

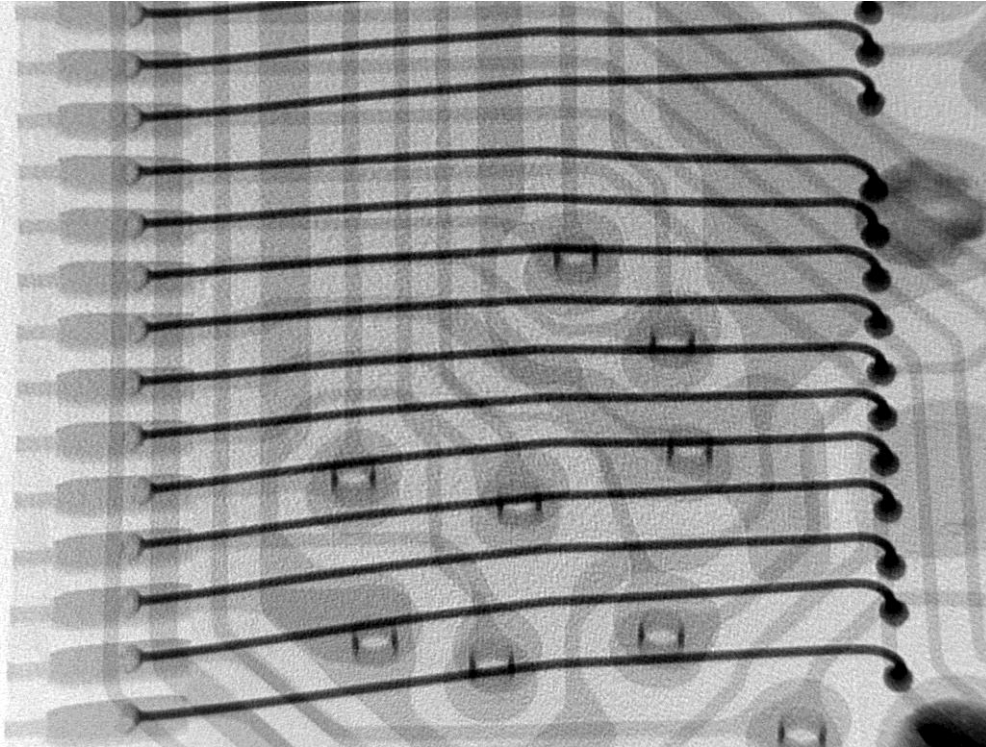
X-ray images of the wire-bonds: Oblique view

No broken wires seen

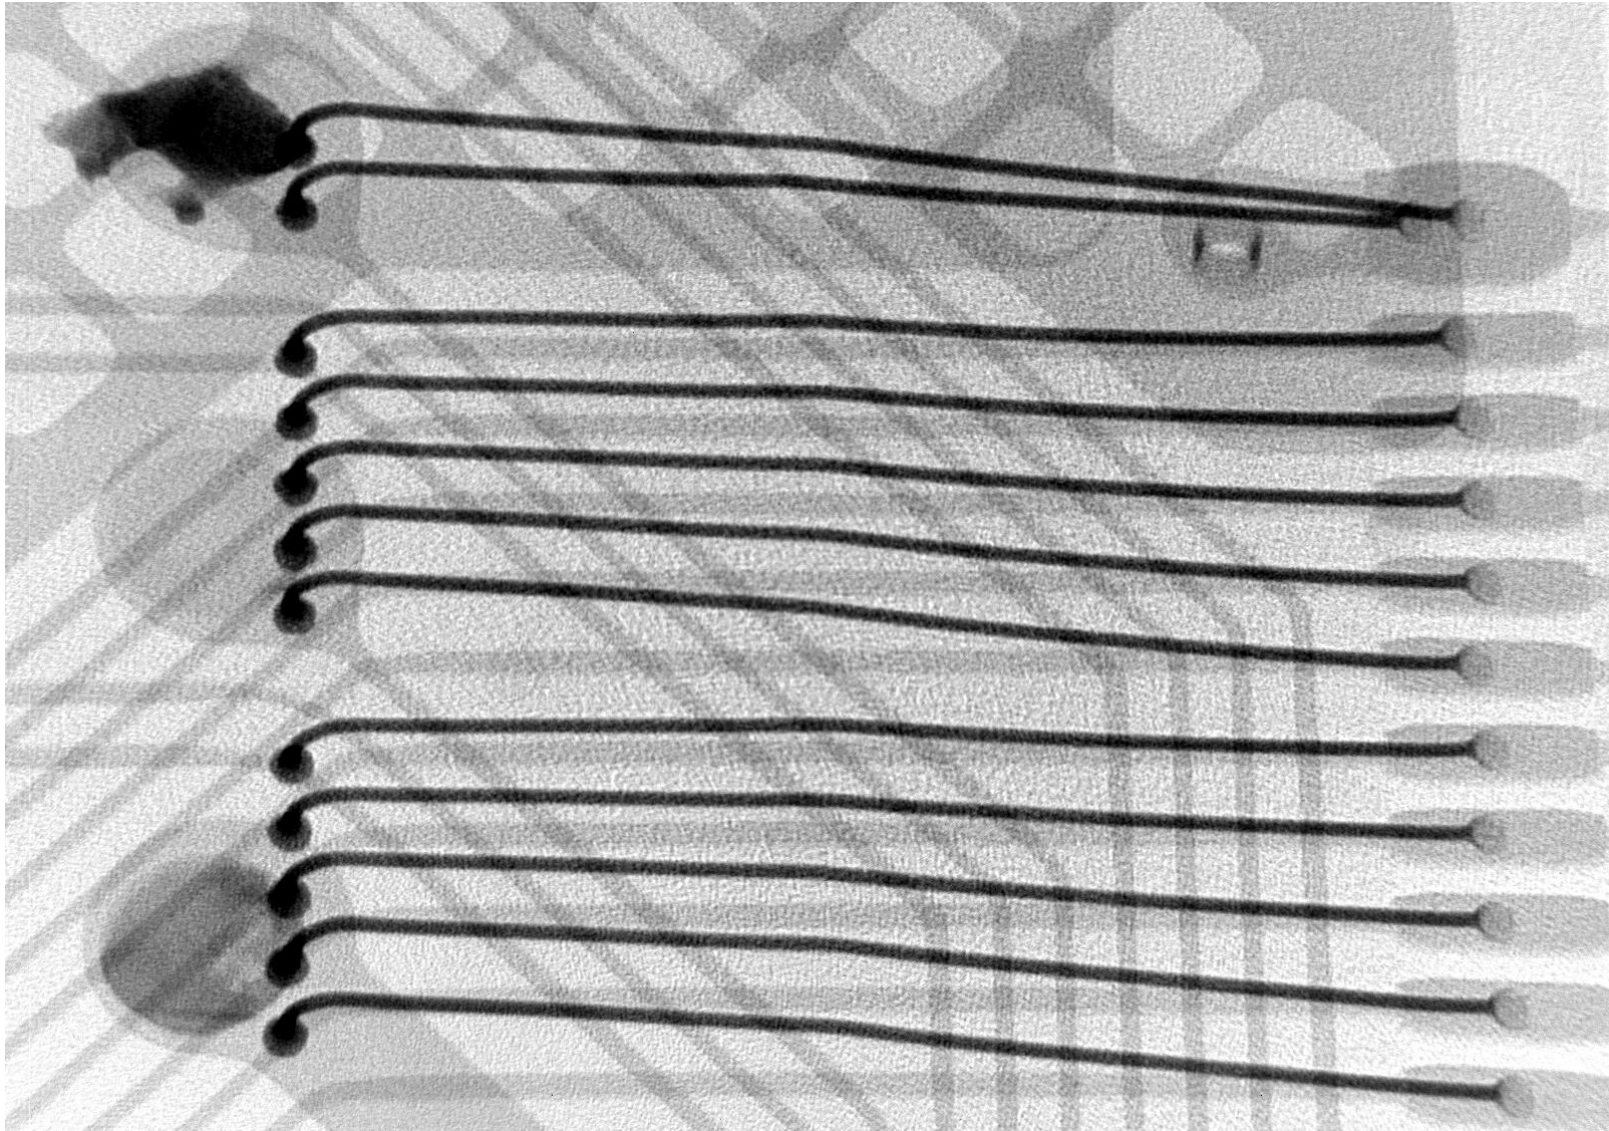
X-ray image of the wire-bonds: Oblique view

No broken wires seen

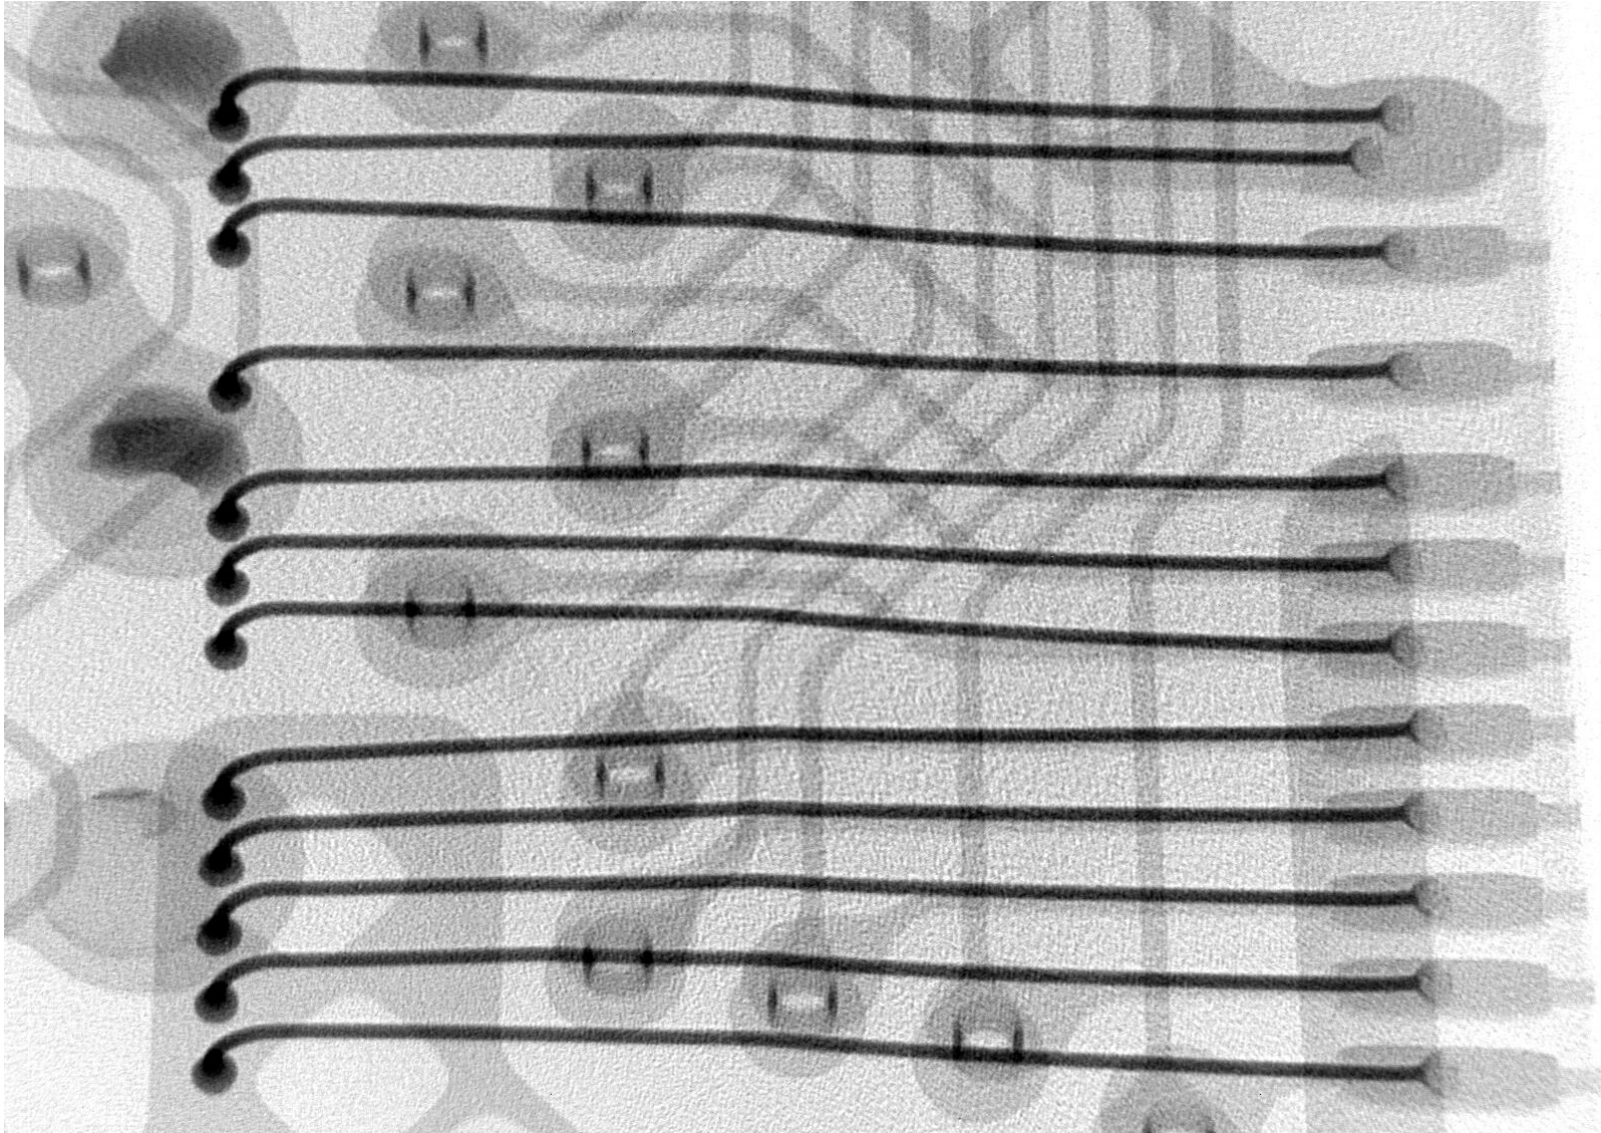
X-ray image of the wire-bonds: Oblique view

No broken wires seen

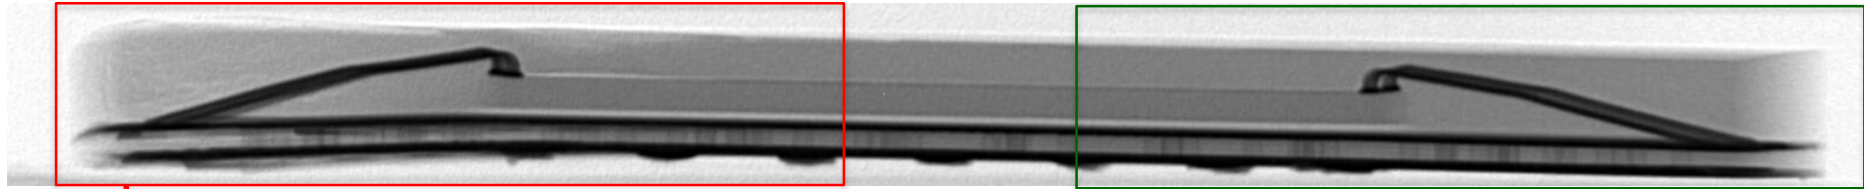
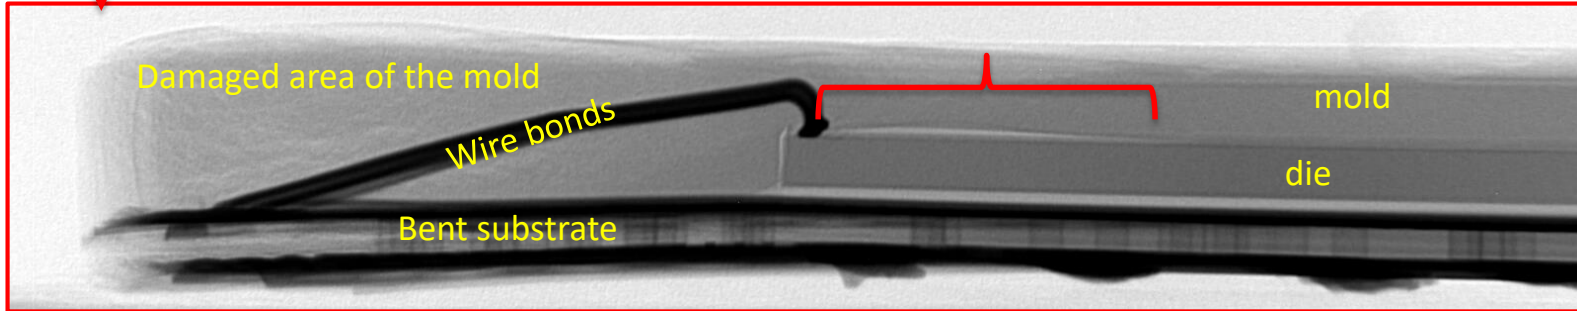
X-ray image of the side of the package

There is separation between the mold and the die which extends to the edge where wire-bonds are located. Wire-bonds are likely lifted off the bond pads.

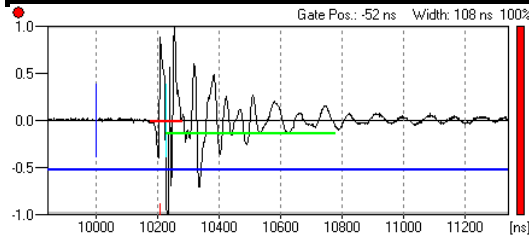
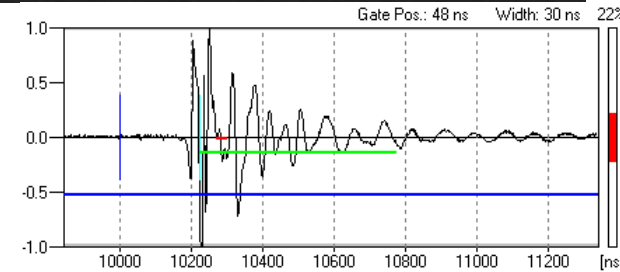
Image from within the mold compound

Acoustic imaging shows that there is a lot of sound attenuation/ scattering/ reflection from the mold compound in bottom 1/3 area of the package. This area exhibited voiding/cracks/ degradation in the mold material.

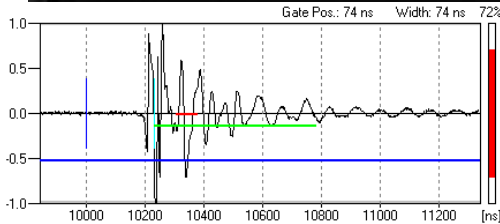
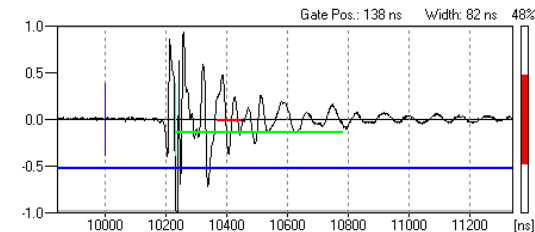
Acoustic images of the memory package

- Acoustic imaging confirms separation of the mold from the die (brightest areas due to high sound reflection)
- Because of the damaged mold in the bottom area of the package, sound is scattered/ reflected/attenuated and can not travel beyond the mold thickness.

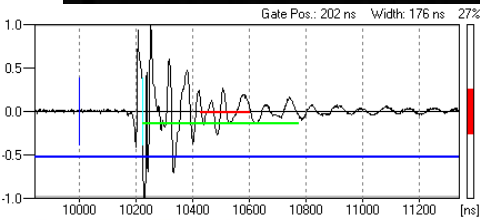
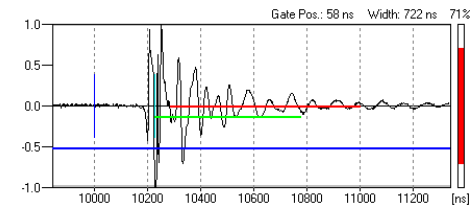
Composite image

- Because of the damaged mold in the bottom area of the package, sound is severely attenuated and can not travel beyond the mold thickness.
