Repair of Memory Module from Incident CEN21FA198

S.R. Cain, A. Sharma, M. Alhendi, B. Chan

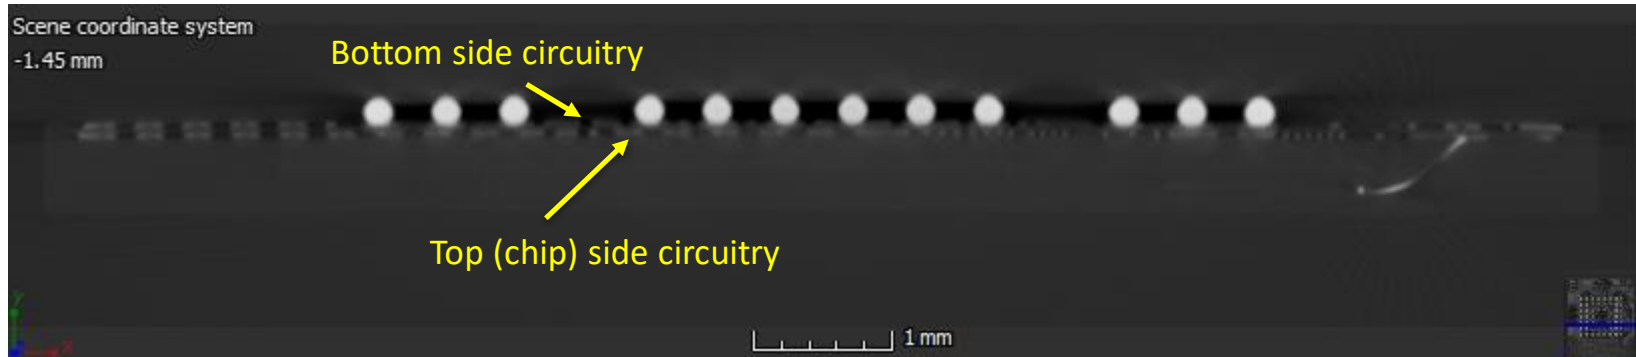
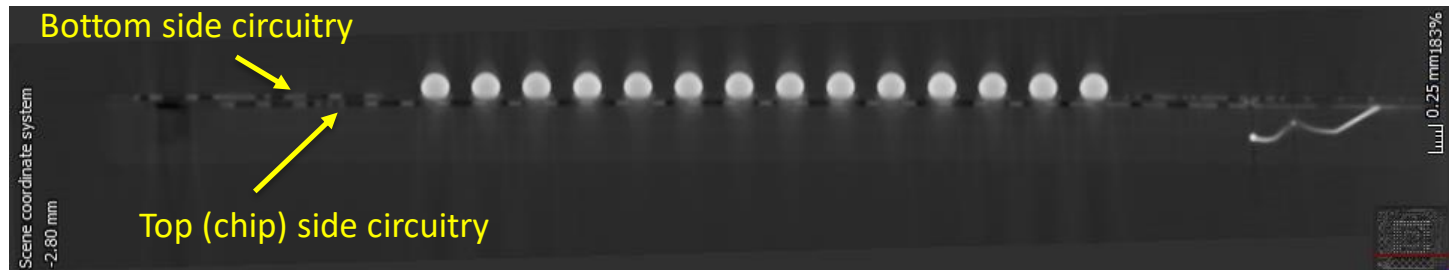
Two Cross Sectional Views of the Memory Module

Note: These views have the module inverted – the chip is on the bottom
The package has only two layers of circuitry

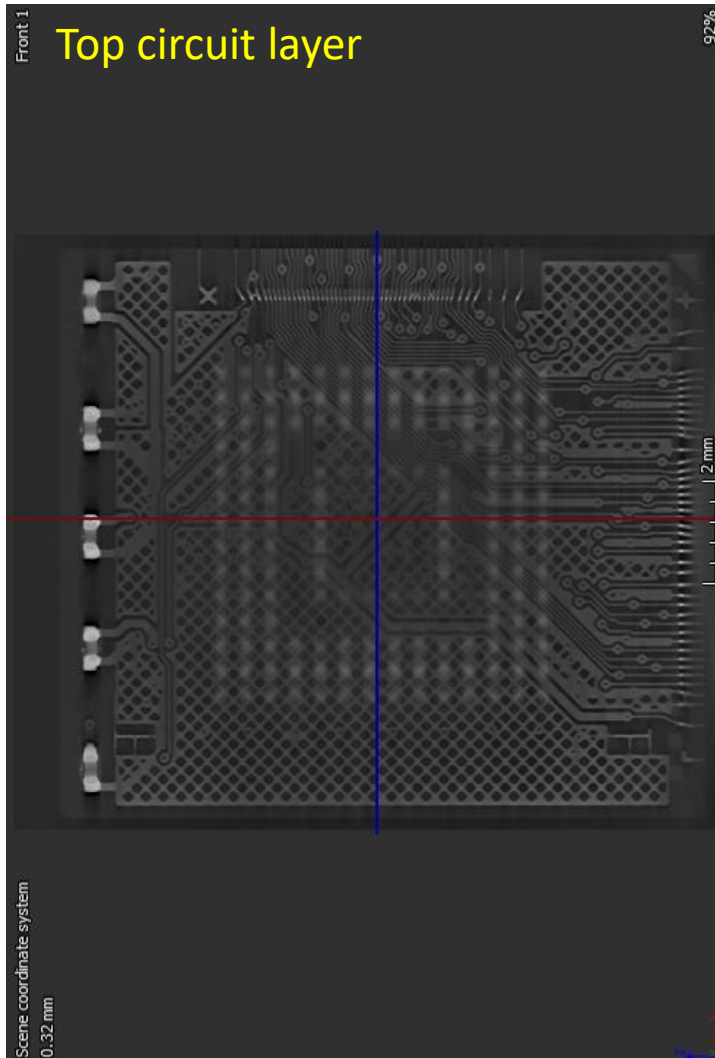
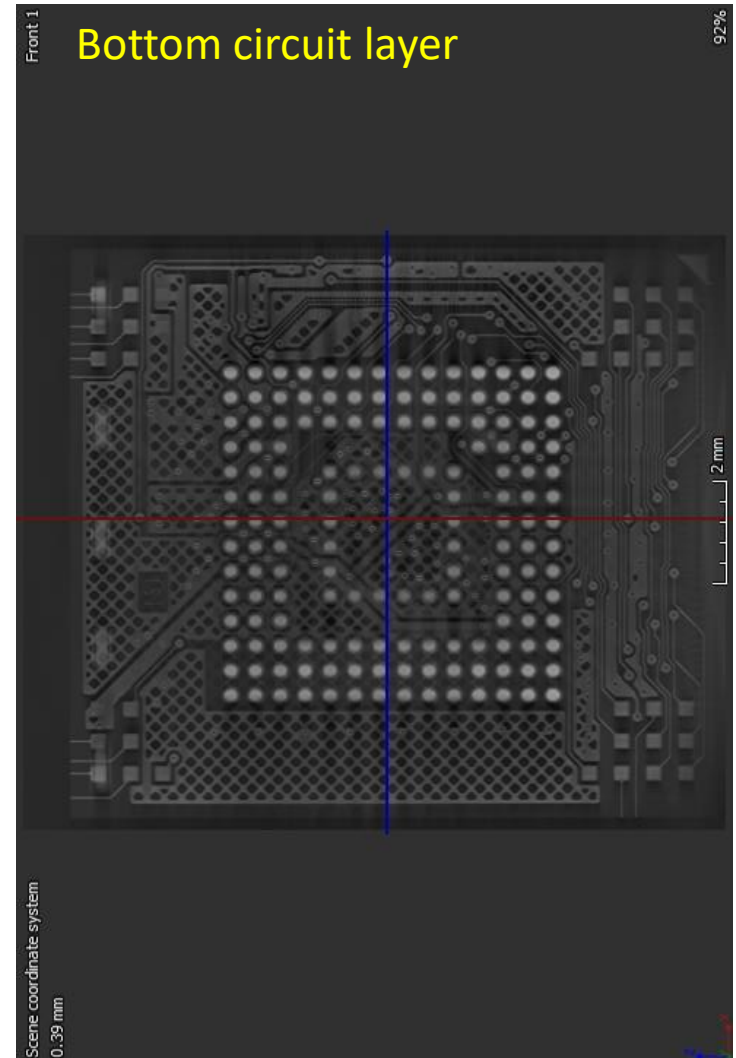
The Two Layers of Circuitry Found in an Undamaged Sample of the Same Part Number

Two layers of circuitry were found in the package. Of these, only the bottom layer is of interest for the repair

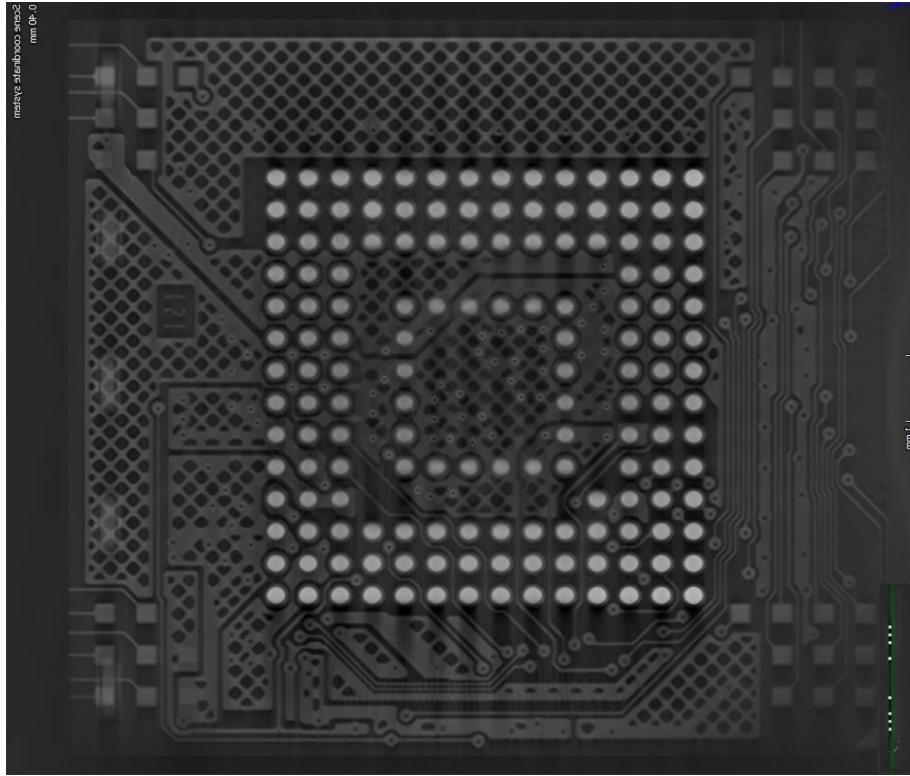
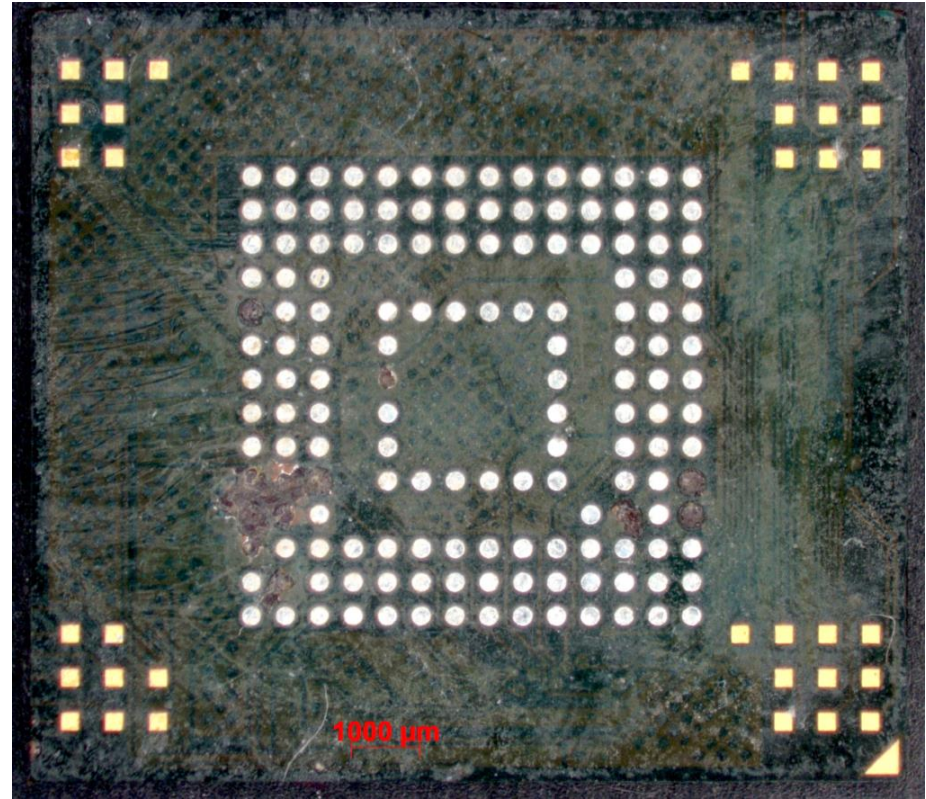
Comparison of the 3D X-ray with the Photograph (Bottom Layer of Circuitry)

X-ray image was reoriented to match the view of the photograph
