NATIONAL TRANSPORTATION SAFETY BOARD

Specialist Factual Report

OPERATIONAL FACTORS

CEN21FA199

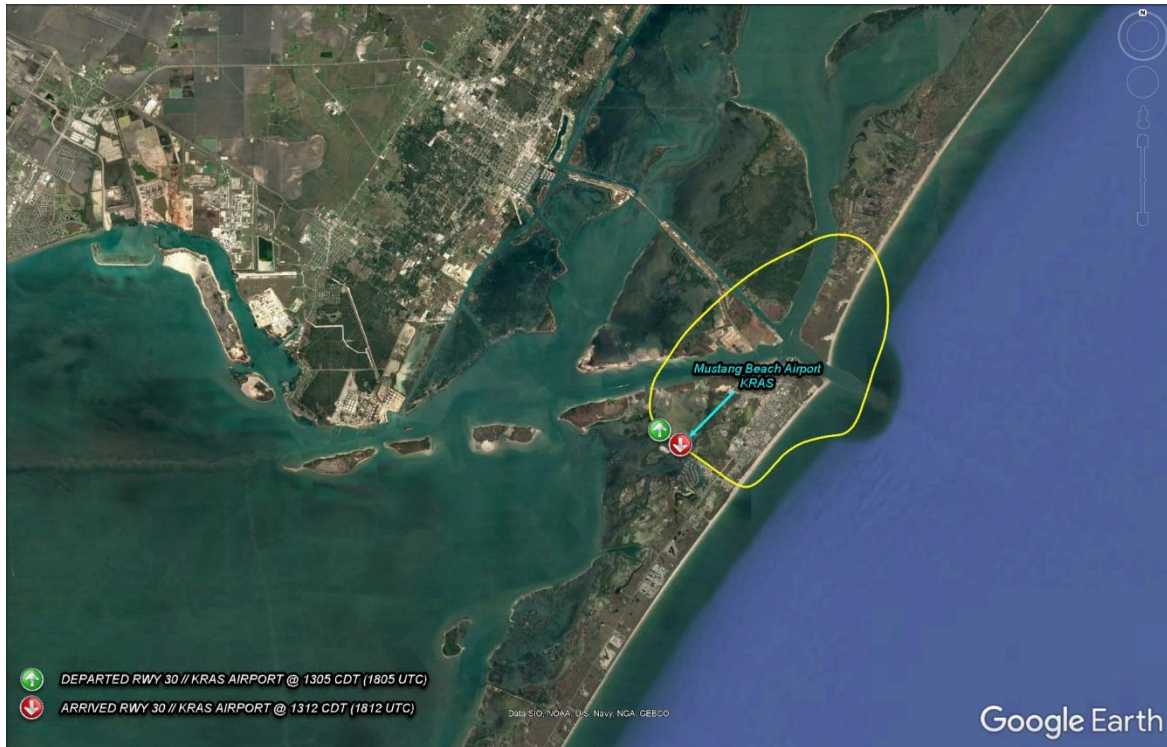
Figure 3: Radar ground track of N587CD’s second Young Eagles flight on April 24, 2021 (accident flight).⁹

Witnesses stated that the flight appeared low on the approach to the runway 30, and almost touched down short of the runway. Witnesses told the NTSB that they observed the pilot’s left-side door was opened out about a foot prior to landing.¹⁰

Prior to touching down on runway 30, the pilot appeared to execute a go-around. At 1312 CDT (1812Z) witnesses observed the N587CD pitch up sharply, then rolled off to the left and impact the ground inverted in front of a row of hangers at KRAS. Witnesses also reported that the Cirrus Airframe Parachute System (CAPS) system deployed on impact.¹² The pilot was fatally injured, and the father and his son were severely injured.

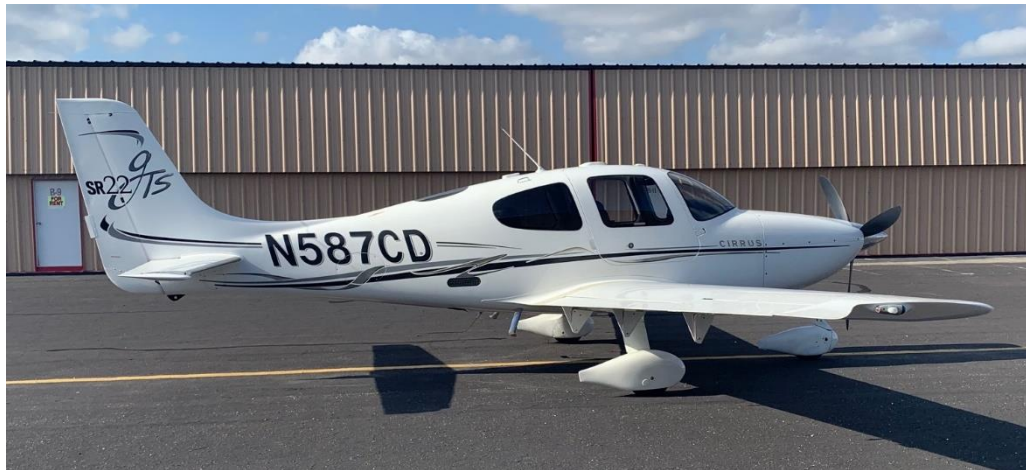
Photo 1: Accident airplane (N587CD).¹⁸
