Title of Investigation: MV Spirit of Norfolk - Fire Investigation (Assist: USCG & NTSB)	Investigation Number: 768026-22-0024	Report Number: 2
--	---	---------------------

Fire Scene Examination: Origin and Cause Investigation of a fire that damaged the Spirit of Norfolk, a cruising vessel based in Norfolk, Virginia.

**Statement of Certified Fire Investigator**

**Type of Exam:** ORIGIN and CAUSE REPORT

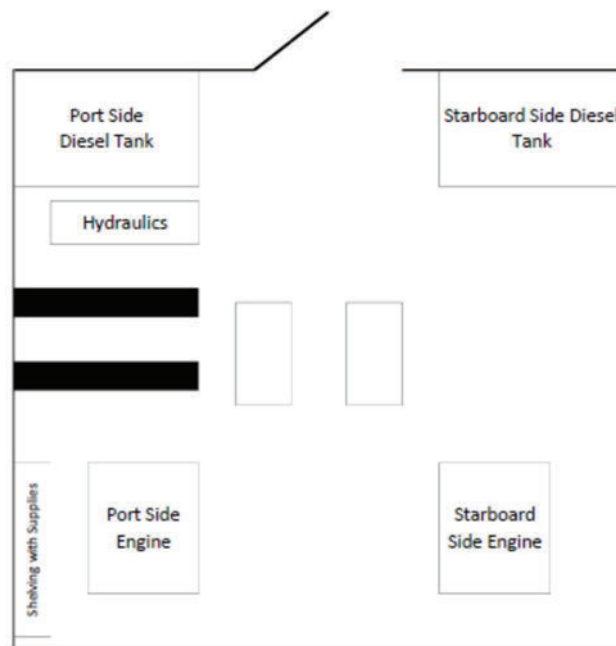
**General Layout (Not to Scale)**

39. Engine Room – The engine room was accessed by a door on the stern side of the galley and adjacent to dishwashing equipment. The engine room had the following layout:

40. The engine room was extensively damaged. The damage was more pronounced high in the room as water build up protected the lower portion of the engine room during the suppression operation. In the early stages of this event, the fire burned and quickly filled the engine room with smoke. Due to limited ventilation to from the intake and outtake ventilation on the Starboard and Port sides of the vessel, the oxygen level was limited, but significant enough to allow the fire to continue to burn and to build up heat in this room. At some point during the event, enough heat was produced to cause the starboard side fuel tank to split open, releasing diesel fuel through the engine room.
