Continental Motors

ENGINE EXAMINATION REPORT LEFT

ENGINE MODEL	IO520C (15B)
ENGINE SERIAL NUMBER	287461-R
AIRCRAFT MAKE & MODEL	Beechcraft D55 Baron
AIRCRAFT SERIAL NUMBER	TE-616
AIRCRAFT REGISTRATION	N533Q
FILE NUMBER	18-366

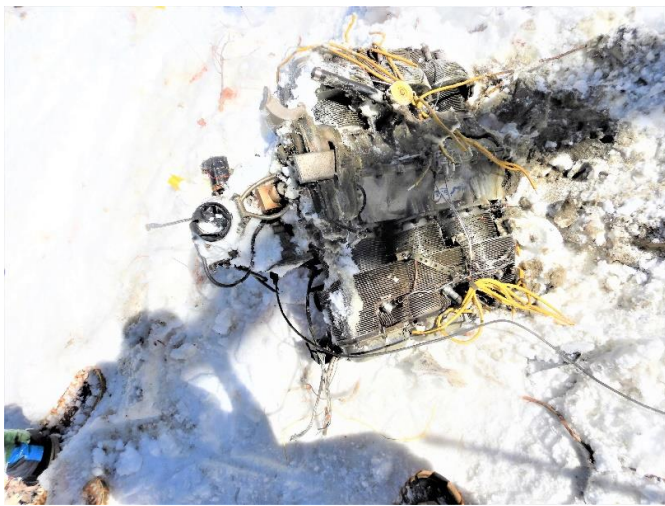
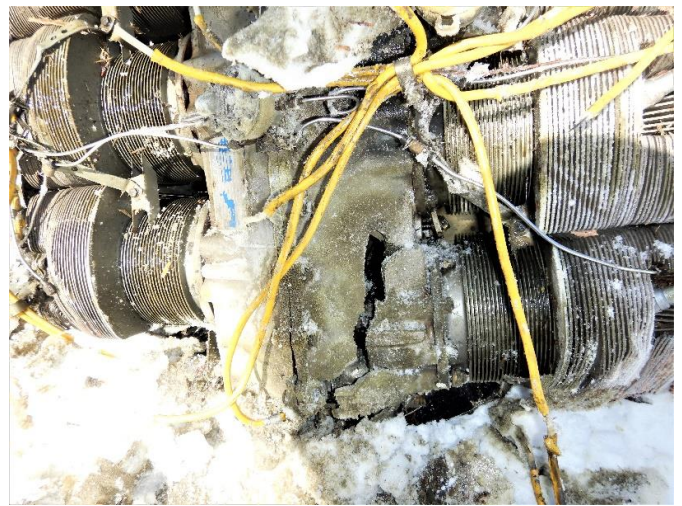
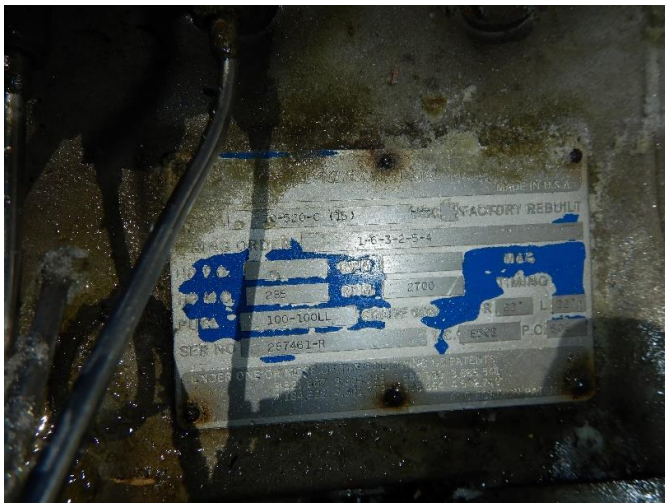
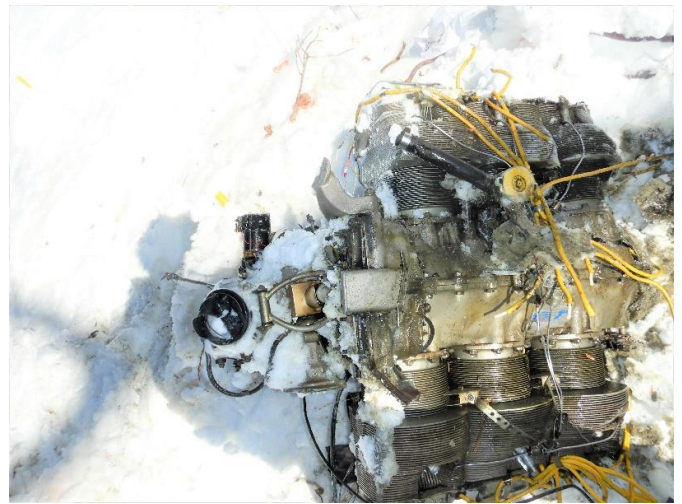
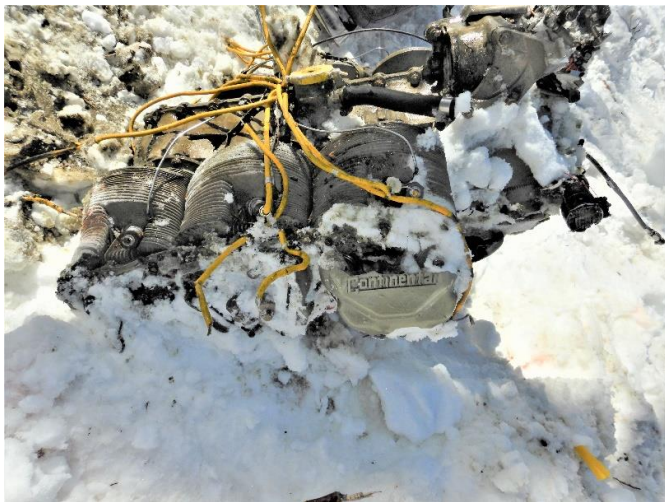
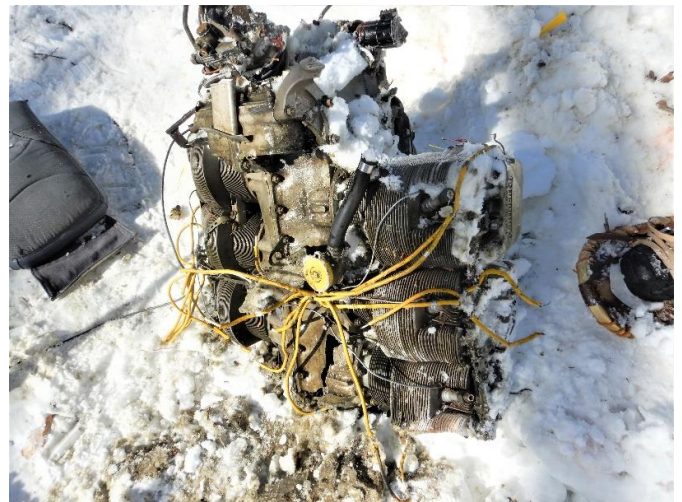
The engine separated from its nacelle and was found forward of the main wreckage in the snow. The engine was inverted, and the engine oil sump exhibited impact damage. The rear portion of the oil sump was crushed upward, and a hole was present. The shape of the puncture was consistent with an undetermined object pushing inward from the outside surface of the sump. The right and left oil drain plugs were present and remained secured with safety wire.

The fuel component-throttle body-mixture control remained attached but exhibited impact damage. The throttle and mixture control arms were intact and properly secured. The throttle control cable and mixture control cable were both attached but were separated at approximate mid-length.

Cylinders 1, 3, and 5 remained attached and exhibited damage to cooling fins and rocker box covers. Cylinders 2, 4, and 6 remained attached but all three rocker covers were impact damaged or missing.

The engine was manually rolled over, right side-up. The left forward crankcase half exhibited heavy impact damage. The right upper crankcase was intact and exhibited an engine data plate identifying the engine as a Continental Motors model IO-520C, serial # 287461-R. The fuel manifold remained attached and the assembly screws were secured. No lead seal was attached.

The left and right magnetos separated and were not recovered. The impact damaged ignition leads exhibited cuts and individual leads were broken with missing ends.
