# ENGINE EXAMINATION REPORT

## RIGHT

<b>ENGINE MODEL</b>	IO520C (15B)
<b>ENGINE SERIAL NUMBER</b>	240456-R
<b>AIRCRAFT MAKE &amp; MODEL</b>	Beechcraft D55 Baron
<b>AIRCRAFT SERIAL NUMBER</b>	TE-616
<b>AIRCRAFT REGISTRATION</b>	N533Q
<b>FILE NUMBER</b>	18-366

EXAMINATION		ACCIDENT DATA	
<b>DATE</b>	2-23-2009	<b>NTSB ACCIDENT #</b>	WPR19FA086
<b>FACILITY</b>	Accident site	<b>NTSB INVESTIGATOR</b>	Jack Vanover
<b>ADDRESS</b>	Cummings Mountain Tehachapi, CA	<b>FAA INVESTIGATOR</b>	NA
		<b>ACCIDENT DATE</b>	2-21-2019
		<b>ACCIDENT LOCATION</b>	Cummings Mountain, Tehachapi, CA

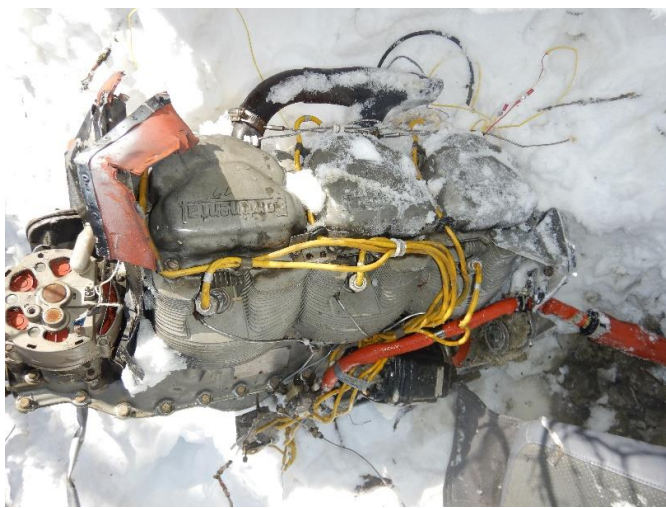
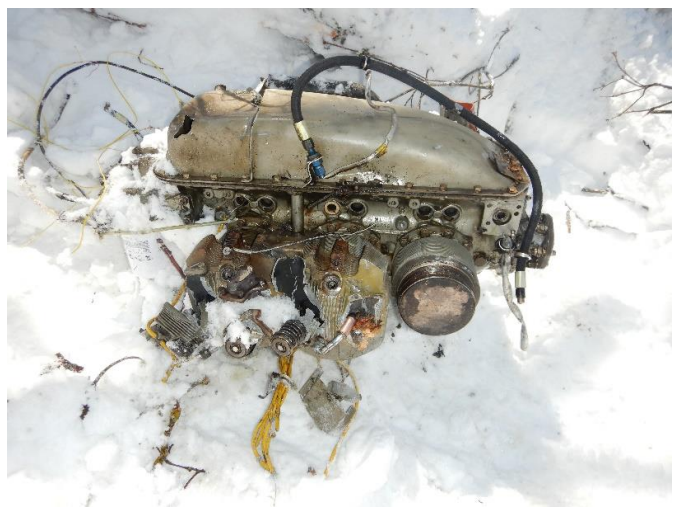
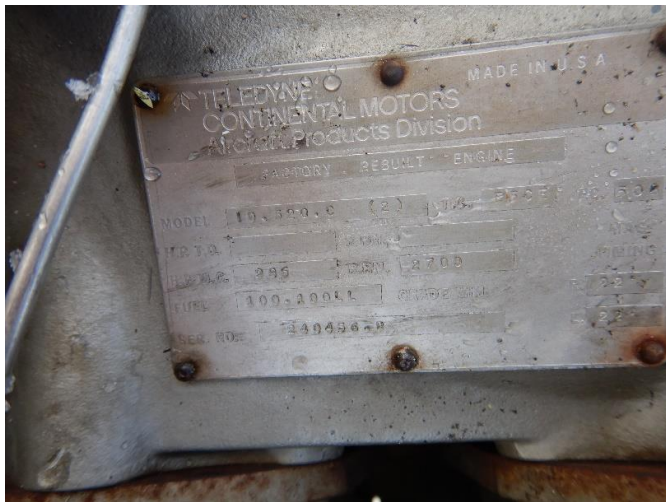
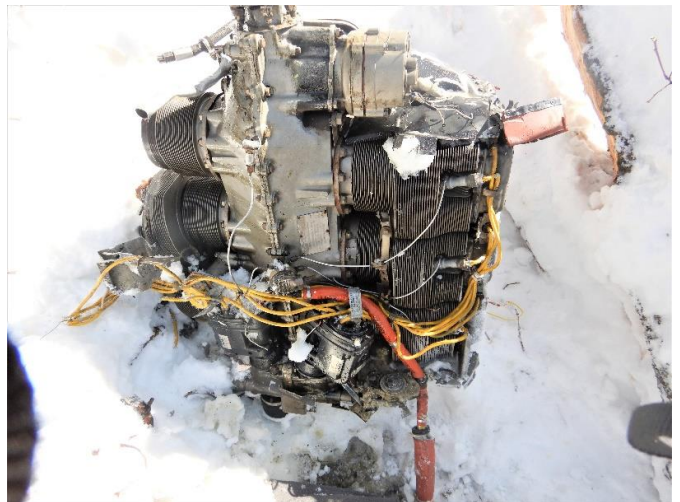
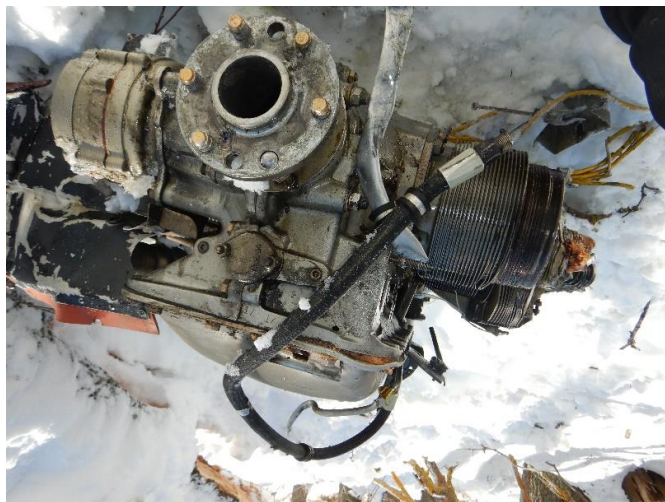
The engine separated from the airframe during the impact sequence and was discovered in an inverted position partially covered in snow. The engine mounts were broken, and the engine exhibited heavy impact damage. Cylinder heads received impact damage and exhaust and induction components separated.

**Condition:** The exhaust collector and risers for cylinders 1, 3, and 5 remained attached but received impact damage. The exhaust collector and riser for cylinders 2, 4, and 6 separated.

**Condition:** The induction elbows and tubes remained attached to the cylinder attach points on cylinders 1, 3, and 5. See photo above. The induction elbows separated from the cylinder attach points on cylinders 2, 4, and 6. The balance tube assembly was impact damaged.
