EVERETT SHIP REPAIR			
  COLUMBIA-SENTINEL ENGINEERS, INC. NAVAL ARCHITECTS & MARINE ENGINEERS SEATTLE, WASHINGTON			
WSF CATHLAMET ABOVE DK DAMAGE			
DRAWN LNZ	APPROVED	APPROVED BY LETTER DATED: OWNER:	A.B.S.:
CHECKED	DATE 19 AUG 22		U.S.C.G.:
DWG NO. 2265-100-01		SHEET 1 OF 10	SCALE: NONE
		REV	D

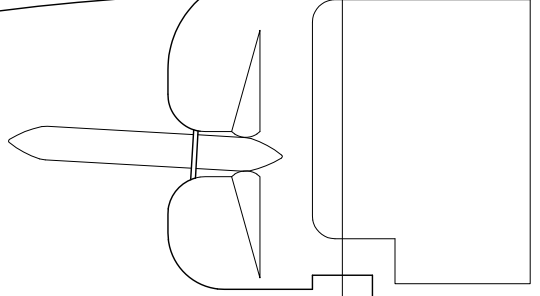
LOOKING OUTBD AT PORT CURTAIN PLATE

1/4" DAMAGED SIDE

LOCALIZED BUCKLED PLATE

CUT CURTAIN PL. ABOUT 6" AFT OF FR 42.

CURB PL UNKNOWN VEHICLE RAMP TO BE PARTIALLY REMOVED. REFER TO LOWER VEH. DECK PLAN VIEW ON SHT 3.
