National Transportation Safety Board

RRD24MR002

SURVIVAL FACTORS- CRASHWORTHINESS INVESTIGATION

Group Chair's Factual Report

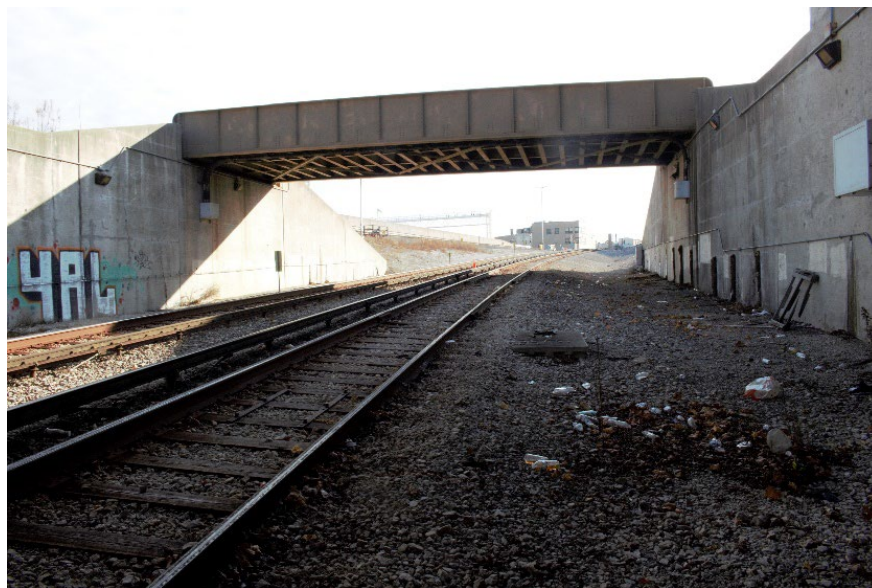
Figure 1 Photograph showing the southbound yellow line track, sloping upward and curving as it enters the Howard Yard. The Chicago Avenue overpass is visible in the foreground. (Source: NTSB)

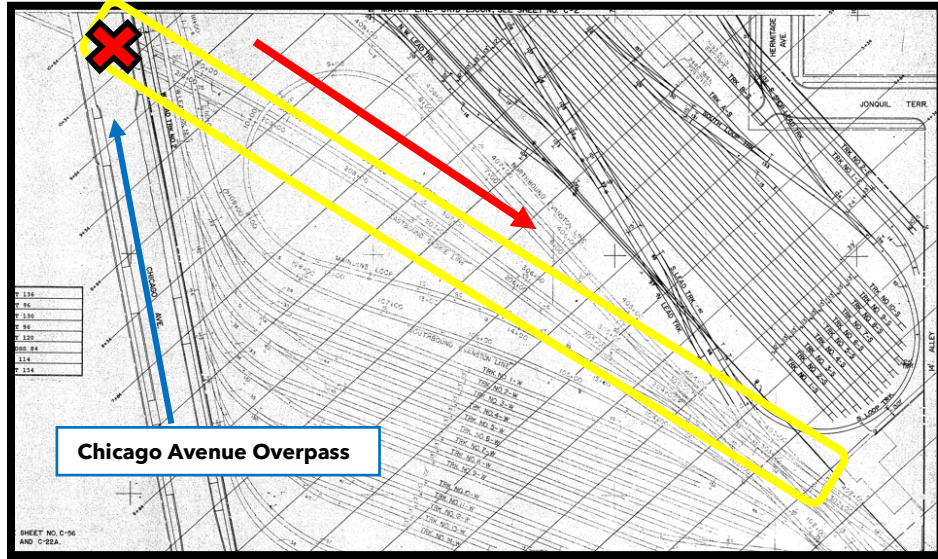
The Howard yard is a large network of intersecting tracks that service the red, purple, and yellow lines and the maintenance facility. **Figure 2** is a yard map showing the Howard yard and the interwoven networks of tracks. The Yellow Line tracks are highlighted in the yellow box with the train's direction of travel noted by the red

arrow and the location of the accident underneath the Chicago Avenue overpass indicated by the red X.

Figure 2 A diagram of the Howard yard showing the interwoven network of tracks and the highlighted yellow line tracks shown in the box. The direction of travel of the accident train is noted by the red arrow and the approximate location of the accident under the Chicago Avenue overpass is indicated by the red X. (Source: CTA)

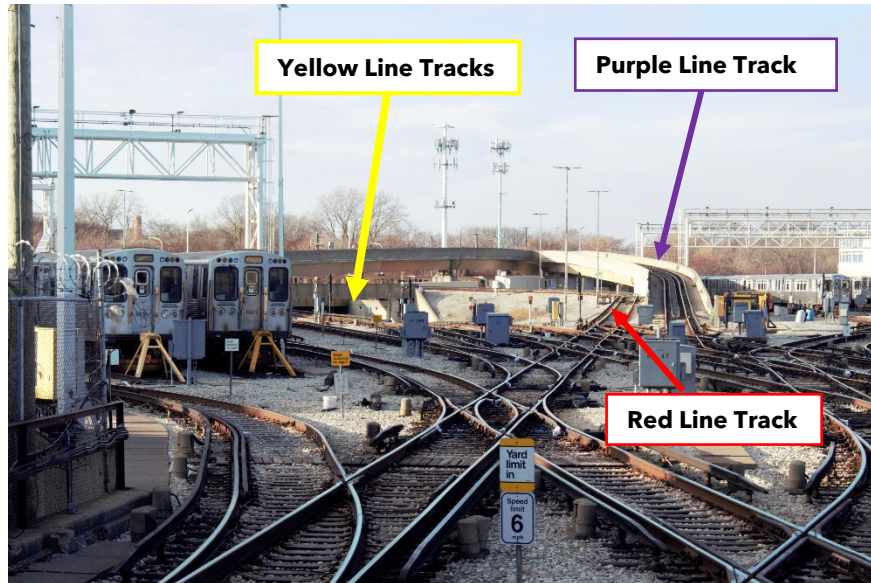
Figure 3 is a photograph taken from the Howard Avenue CTA station platform looking northward towards the Howard yard. The photograph shows the various train lines tracks that traverse through the rail yard.

Figure 3 Photograph taken from the Howard Avenue CTA station platform looking northward into the Howard Yard. The Yellow Line, Red Line and Purple Line tracks are highlighted. (Source: NTSB)

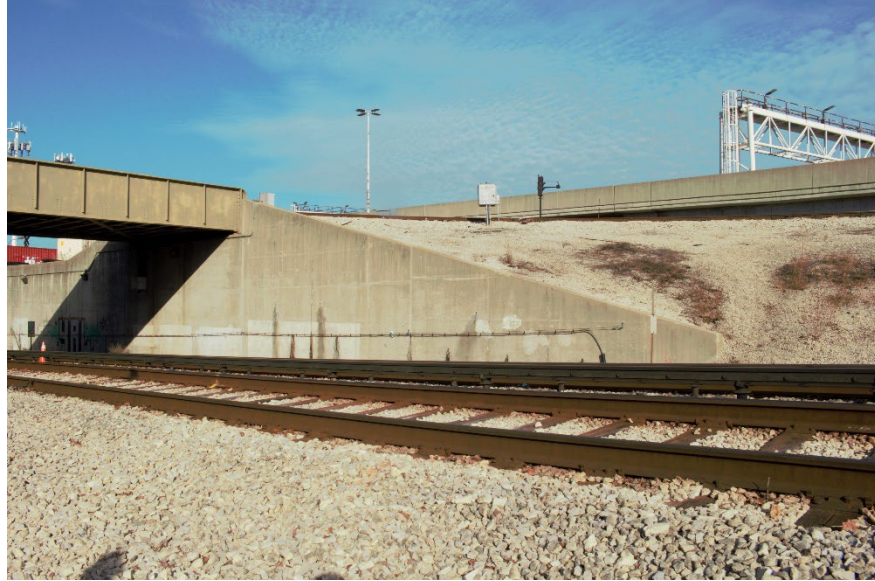
Figure 4 Photograph looking from the accident scene showing the yellow line tracks and the path taken by the emergency responders to access the scene and used by the responders to evacuate the injured. (Source: NTSB)

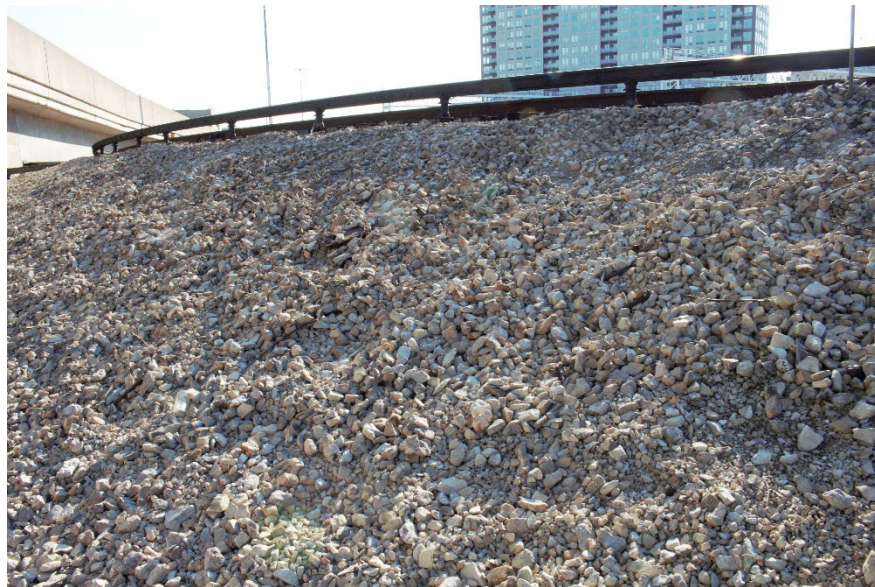
Figure 5 Photograph of the rocky terrain the emergency responders traversed to access the accident scene and the route used to remove the victims. (Source: NTSB)

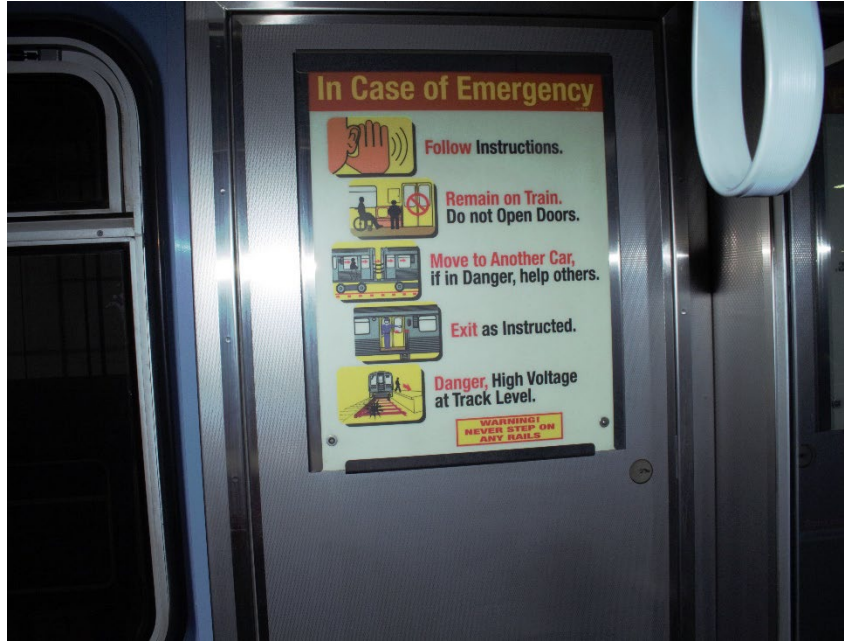
The post-accident inspection of the train cars showed that each car provided the required emergency signage and that it was prominently displayed in several locations within each train car. **Figure 17** is a photograph of the emergency signage found in Car 5600.

Figure 17 Photograph of the emergency signage displayed in train Car 5600.
(Source: NTSB)

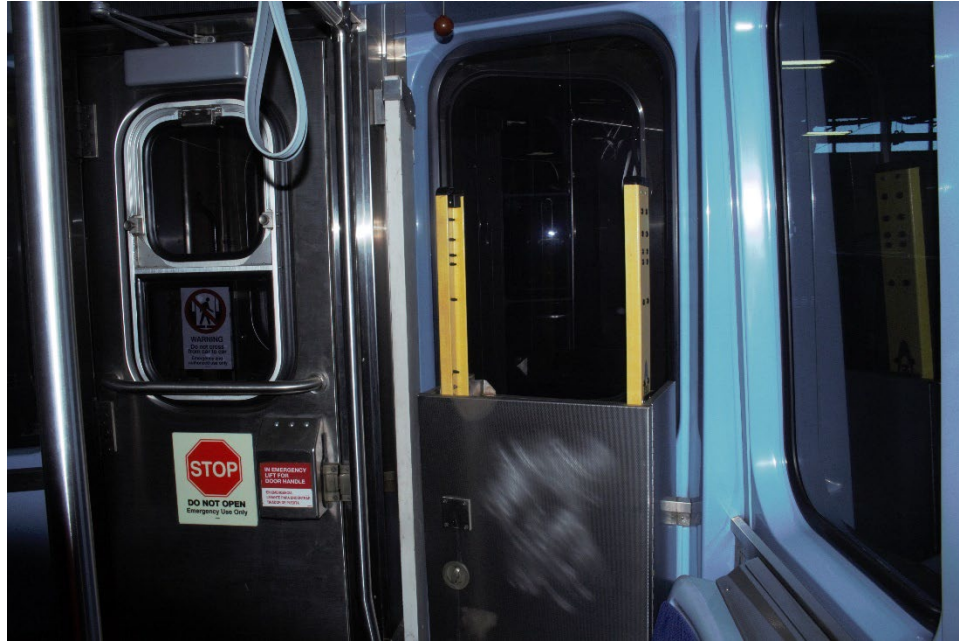
CTA designates the odd number cars as the “A” car of the married pair. In each of the “A” cars, an emergency evacuation ladder and a “gangplank” is available to assist with the emergency evacuation of occupants from the train car. A gangplank is used to move passengers from one train to another by providing a temporary walkway without exposing the individual to the hazards associated with the third rail. **Figure 18** is a photograph of the stowed emergency evacuation ladder in an exemplar “A” car.

Figure 18 Photograph showing the emergency evacuation ladder in the stowed position on an exemplar "A" car. (Source: NTSB)
