Norfolk Southern Railway Train Derailment with Subsequent Hazardous Materials Release and Fires

East Palestine, Ohio
February 3, 2023

Accident Overview

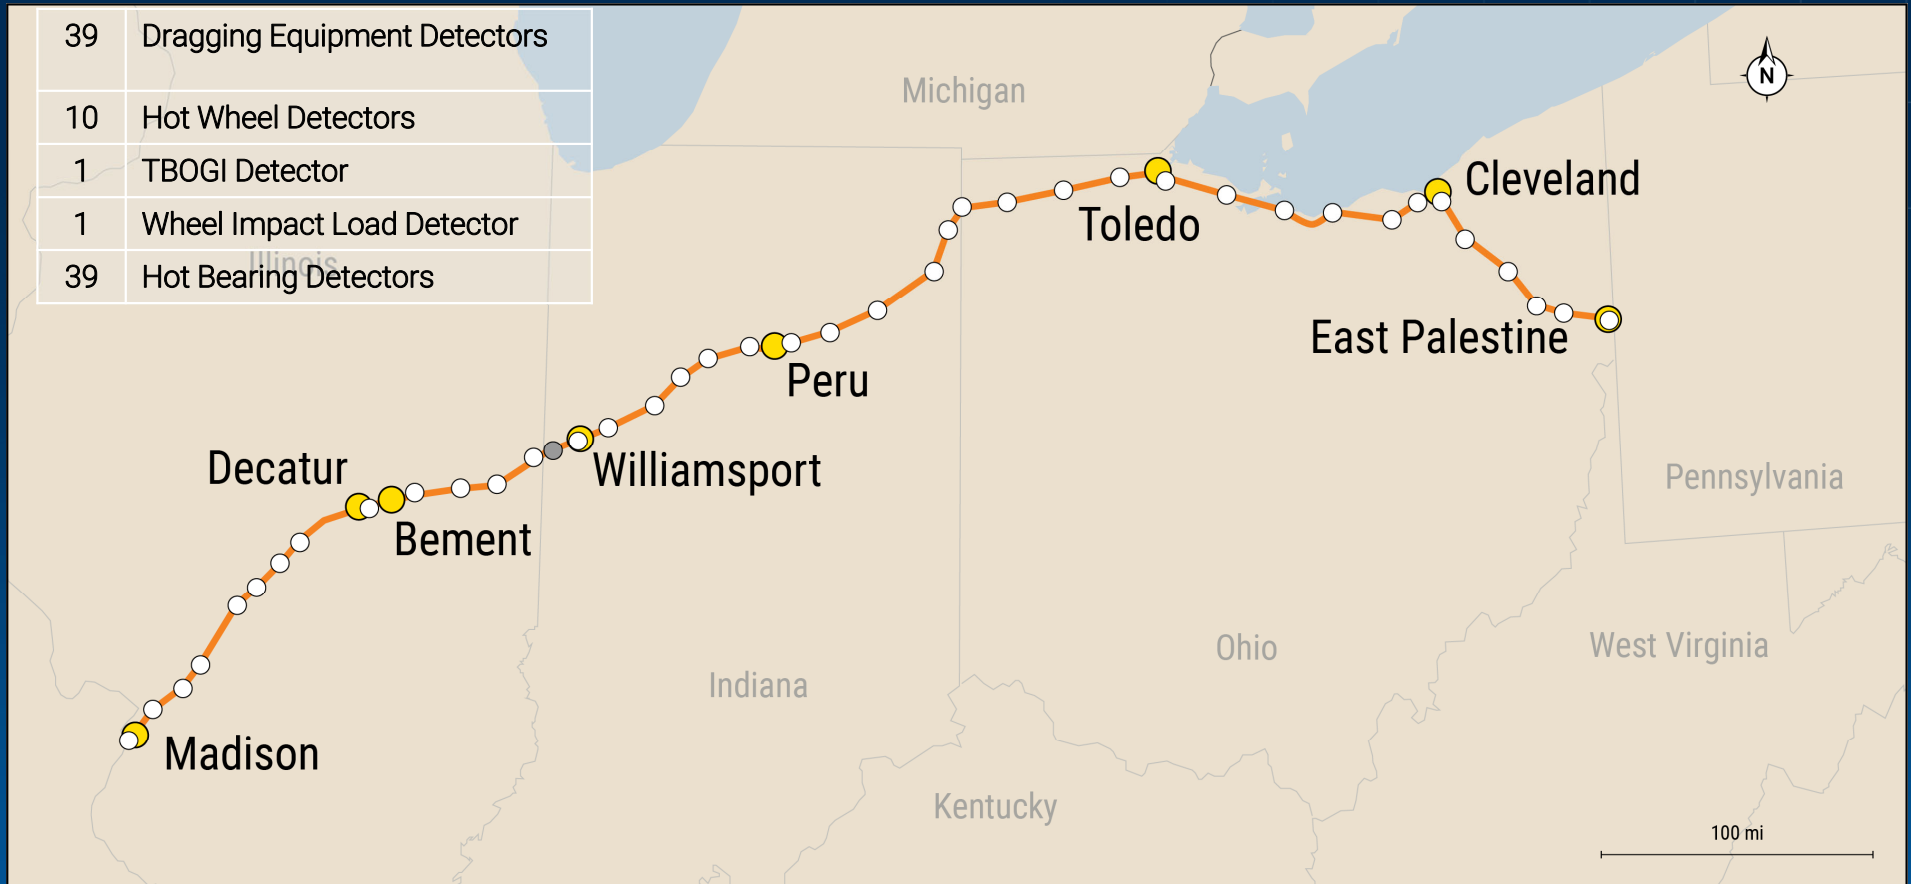
Defect Detector Locations

HBD Sebring	HBD Salem	HBD East Palestine
Distance from Point of Derailment	30 miles	20 miles	0.3 miles
Detector Data (GPLX 75465 Lead Axle Bearing)	L1 Axle Bearing = 38°F R1 Axle Bearing = 18°F	L1 Axle Bearing = 103°F R1 Axle Bearing = 20°F	L1 Axle Bearing = 253°F R1 Axle Bearing = 20°F
Train 32N crew	No radio broadcast	No radio broadcast	Critical Alarm radio broadcast
NS ATC Desk	No alert	Non-Critical Alert	No data

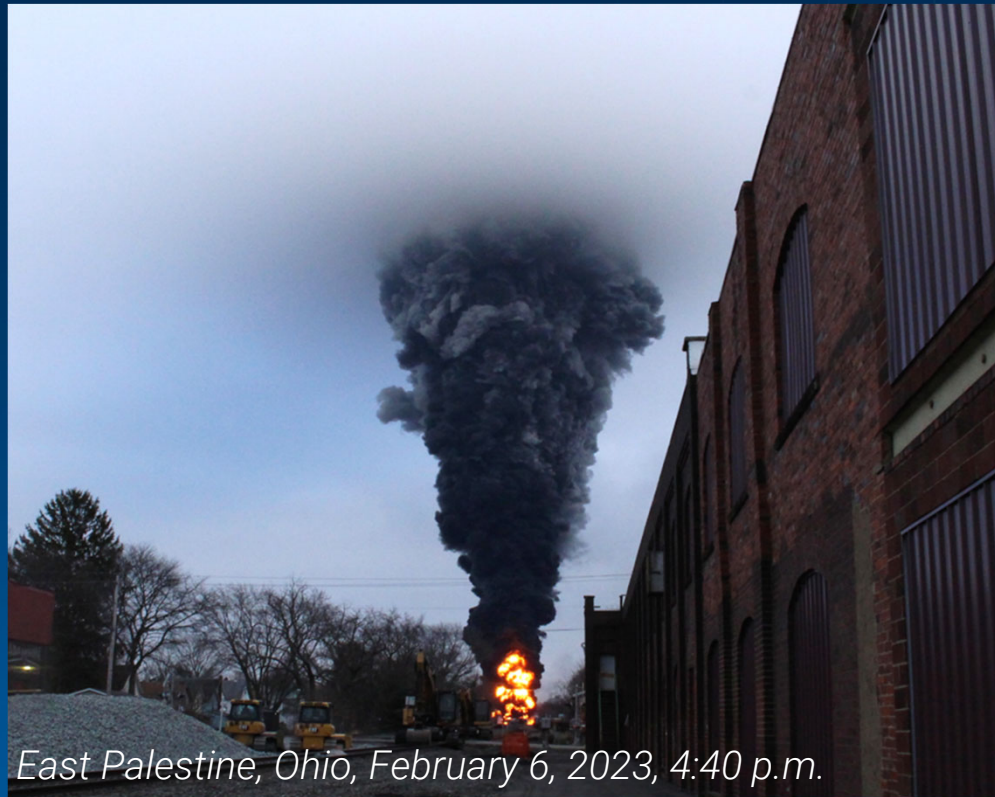
Vent and Burn Actions for 5 Vinyl Chloride Tank Cars

Line #	Car Number	Commodity	Amount Released	Breaching Damage
28	TILX402025	Vinyl Chloride Monomer	Entire Load	*Vent and Burn
29	OCPX80235	Vinyl Chloride Monomer	Entire Load	*Vent and Burn
30	OCPX80179	Vinyl Chloride Monomer	Entire Load	*Vent and Burn
31	GATX95098	Vinyl Chloride Monomer	Entire Load	*Vent and Burn
36	SHPX211226	Ethylene Glycol Monobutyl Ether	Entire Load	Head crack, open bottom outlet valve
38	DOWX73168	Ethylhexyl Acrylate	Partial Load	Head crack and puncture
50	UTLX205907	Butyl Acrylates	Entire Load	Head puncture
55	OCPX80370	Vinyl Chloride Monomer	Entire Load	*Vent and Burn

* Tank cars not breached in the initial derailment
