National Transportation Safety Board

Natural Gas Distribution Pipeline Leak and Resulting Multi-Story Structures Explosion
Harlem, New York

Operations Group Factual Report

DCA-14-MP-002

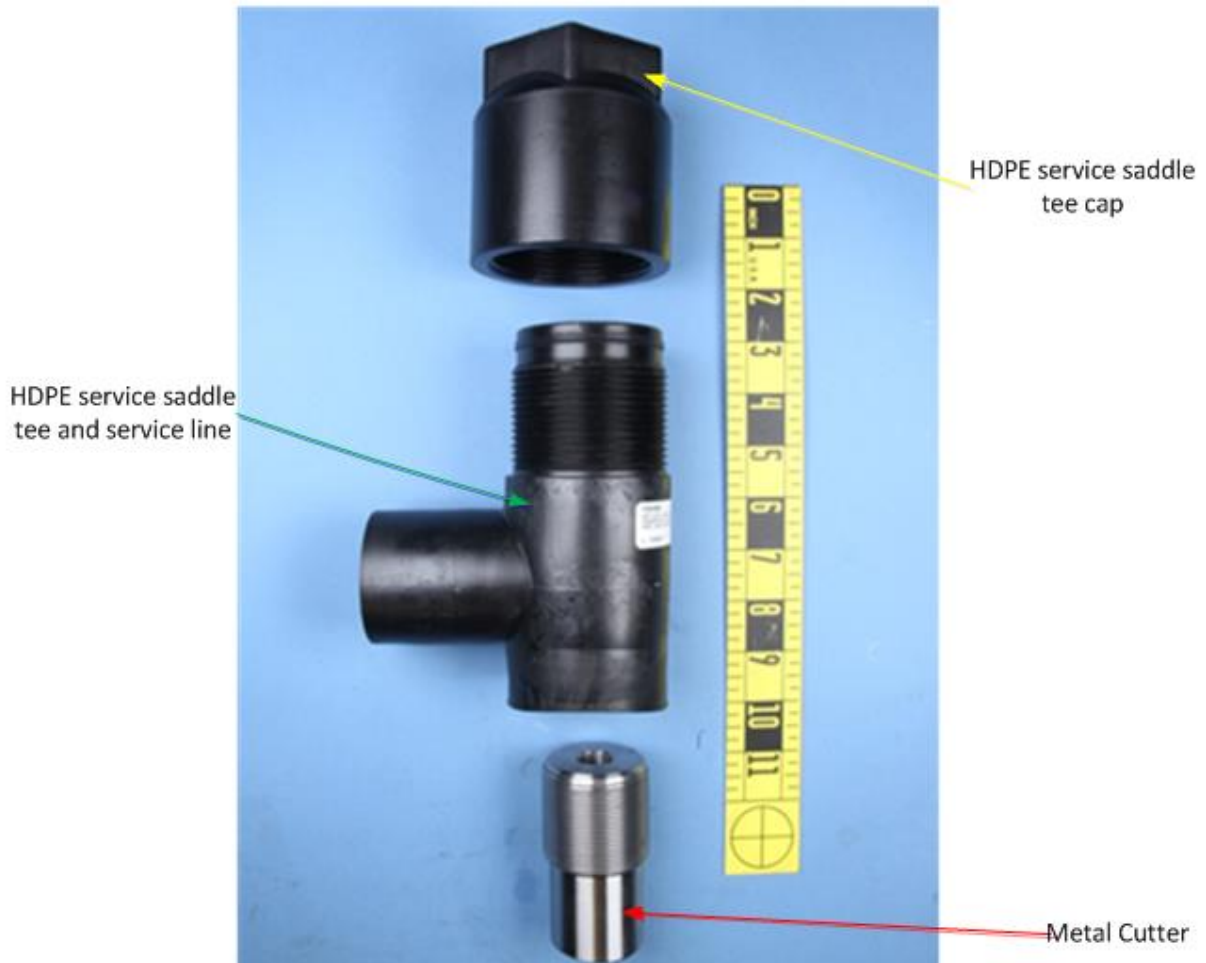
Figure 5: Gas service saddle tee components showing HDPE cap, saddle tee and metal cutter

The installer told investigators the work crew would go inside the property basement and shut the meter service valve. They would then remove the saddle cap and metal cutter and install an adapter on the service tee to attach the air supply line (figure 5). They would pressure test the service line to at least 90 psi, or more to the limit of the pressure gauge, then isolate the line from the pressure source and observe the line pressure for 15 to 20 minutes. If the pressure held, they would release the air from the service line, screw down the metal cutter to cut the hole in the 8-inch HDPE gas main, then retract the cutter and reinstall the cap.
