Continental Motors

ENGINE EXAMINATION REPORT

ENGINE MODEL	TSIO-520-JcNB
ENGINE SERIAL NUMBER	218873-R
AIRCRAFT MAKE & MODEL	Cessna 414A
AIRCRAFT SERIAL NUMBER	414A0821
AIRCRAFT REGISTRATION	N414RS
FILE NUMBER	18-357

EXAMINATION		ACCIDENT DATA	
DATE	03/08/2019	NTSB ACCIDENT #	WPR19FA079
FACILITY	Air Transport	NTSB INVESTIGATOR	Maja Smith
ADDRESS	[REDACTED] Phoenix, Arizona 85009	FAA INVESTIGATOR	Benjamin Harris
		ACCIDENT DATE	02/03/2019
		ACCIDENT LOCATION	Yorba Linda, California

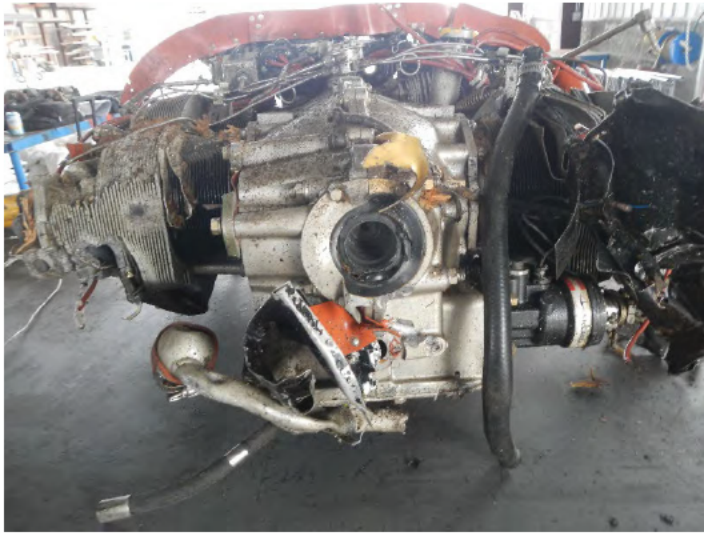
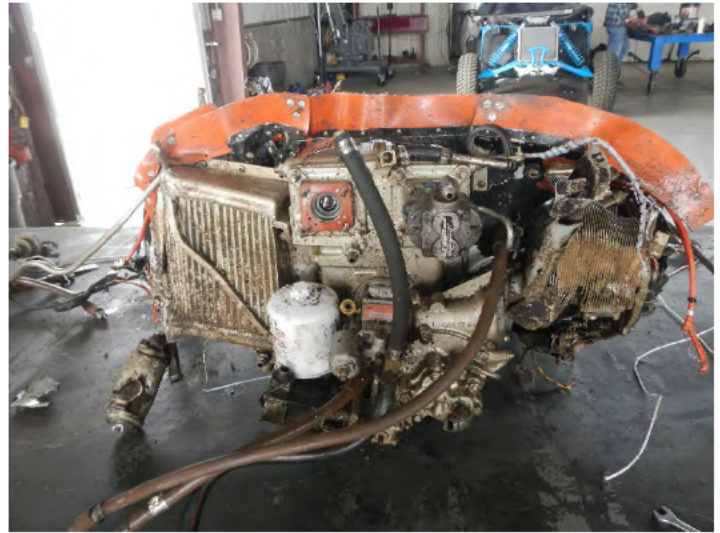
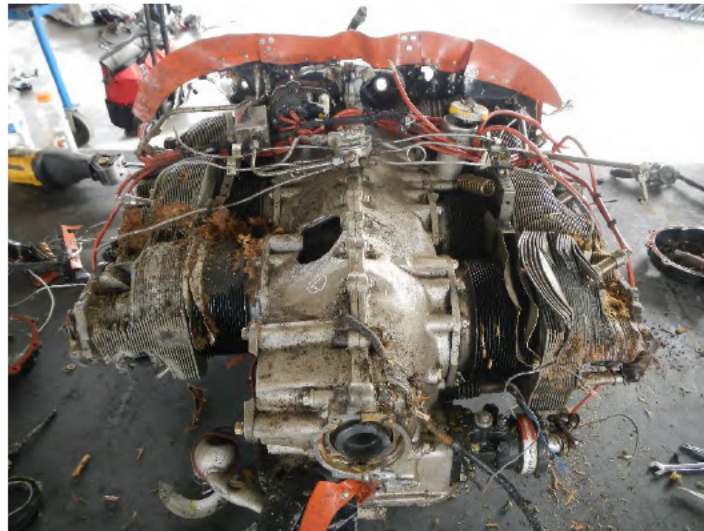
The engine was separated from the nacelle and the propeller, left magneto, alternator, vacuum pump, starter motor, and throttle body were separated from the engine. There was a hole in the crankcase over the #5 connecting rod area, but the fractures appeared as though the case was punctured from the outside-in. Wood debris was observed in the area of the puncture. The oil sump was displaced up around the bottom of the engine. The crankshaft was fractured at the nose seal and the fracture surface was jagged and irregular, consistent with overload. The #2, #5, and #6 cylinders heads were fractured. There was no evidence of lubrication distress on any of exposed components.

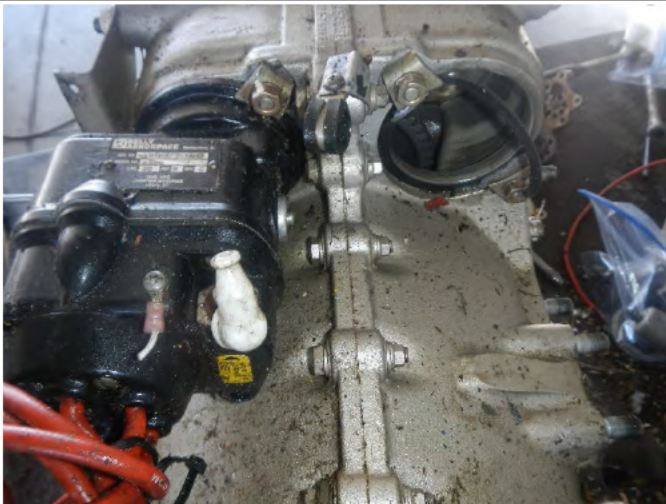
The right magneto remained attached to the engine and manual manipulation of the unit did not result in any slipping. The magneto's ignition harness was cut to remove damaged ends, and a functional test was performed. Rotation of the crankshaft resulted in an audible snap of the impulse coupling as well a spark from each ignition lead in firing order with no pre-accident anomalies noted.

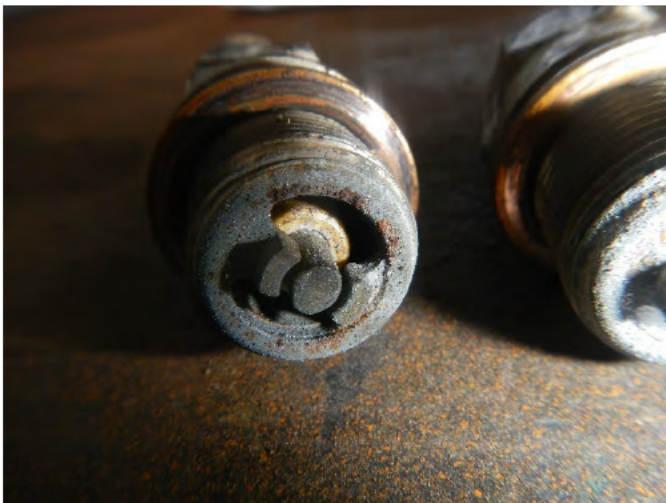
1T

The sparkplugs remained attached to their respective cylinders with the exception of the #5 top sparkplug (only the outer electrodes remained threaded into the cylinder). Examination of the sparkplugs revealed normal wear and combustion deposits with no pre-accident anomalies noted. NOTE: the outer electrodes of the #5 top sparkplug were mechanically damaged by investigators during a borescope examination of the cylinder.

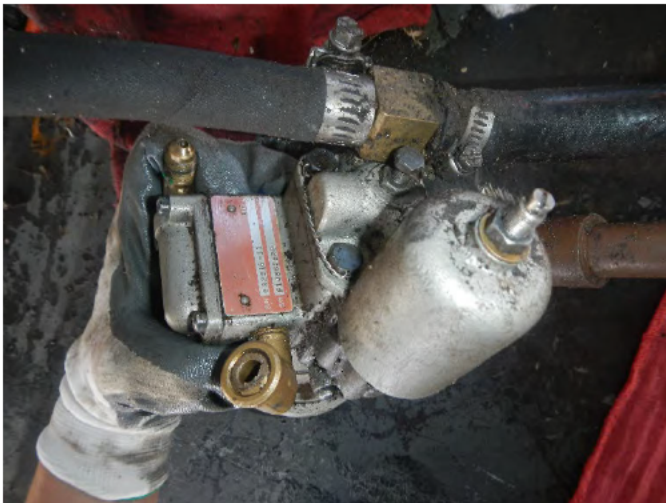
Condition: The engine-driven fuel pump remained attached to the backside of the engine. The inlet fuel line fitting was fractured. The pump was removed and the drive coupling was intact. The drive coupling was manually rotated and the pump shaft rotated freely with no binding noted. The pump was disassembled with no pre-accident anomalies noted.

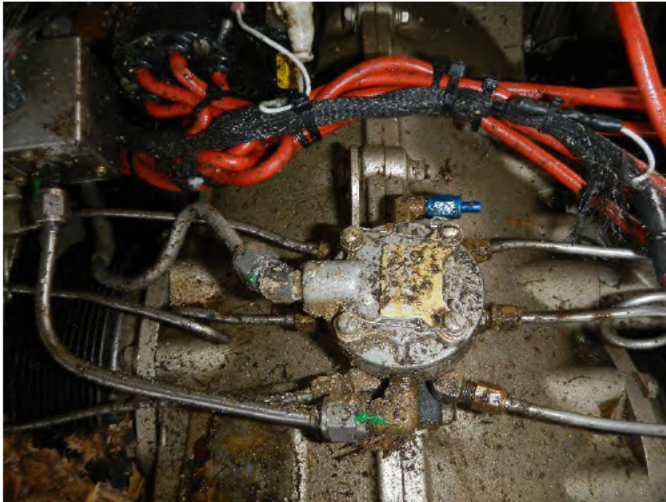
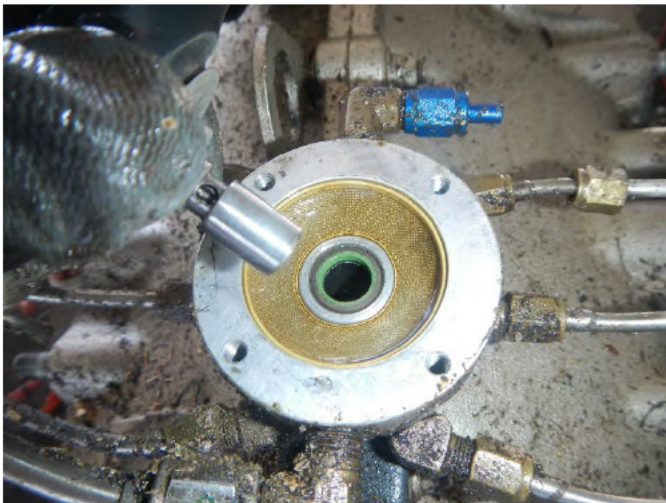
The fuel manifold valve remained secured to the topside of the engine and all fuel lines remained secured in place. The cap was removed and the spring, diaphragm and plunger remained intact. The screen was clear and blue aviation fuel was observed in the housing.

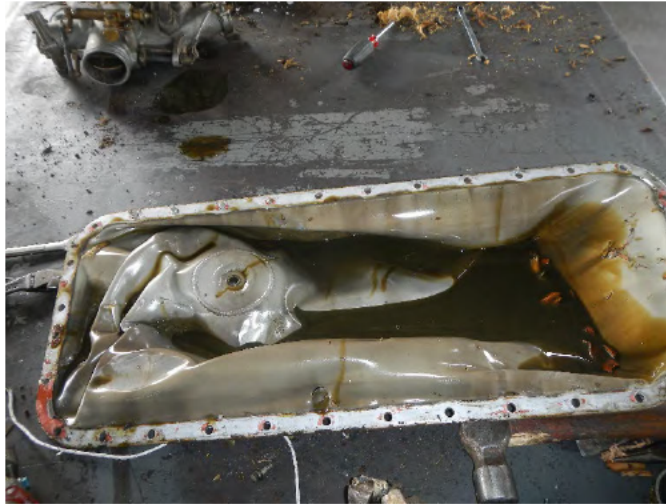
Condition: The oil sump was displaced up around the bottom of the engine. Removal of the sump revealed residual oil in the pan. There was no sign of metallic debris in the sump.

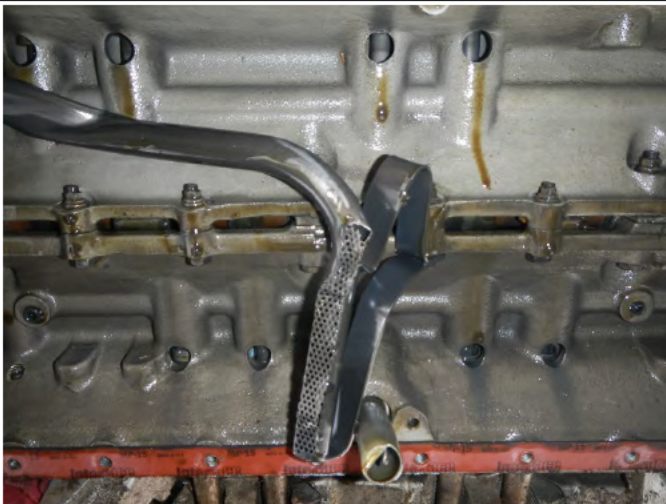
Condition: The pickup tube and screen were deformed and displaced up toward the bottom of the engine. No pre-accident anomalies or blockages were noted.

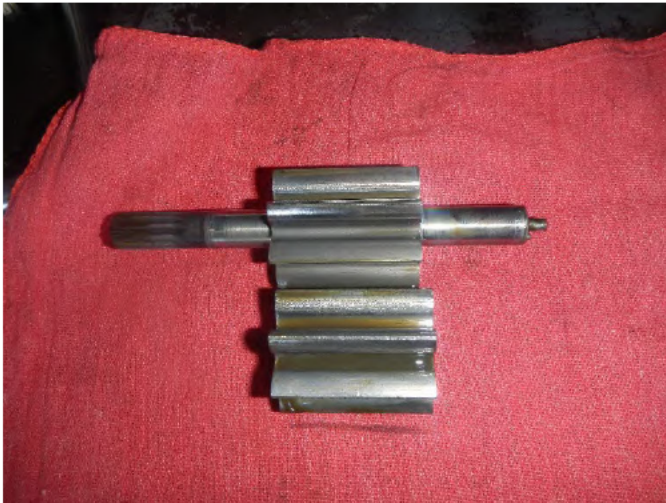
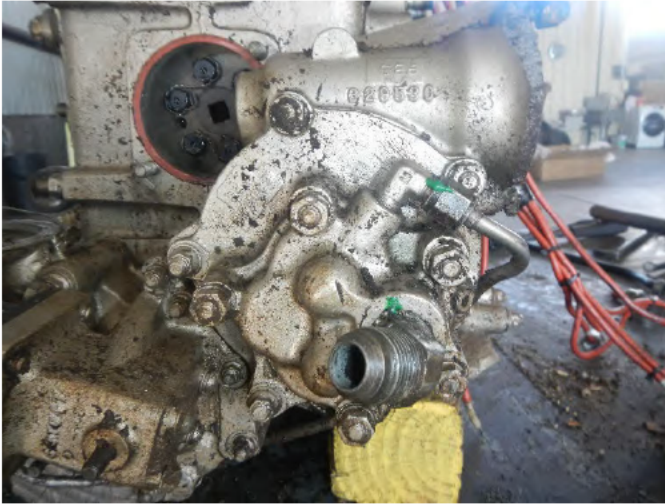
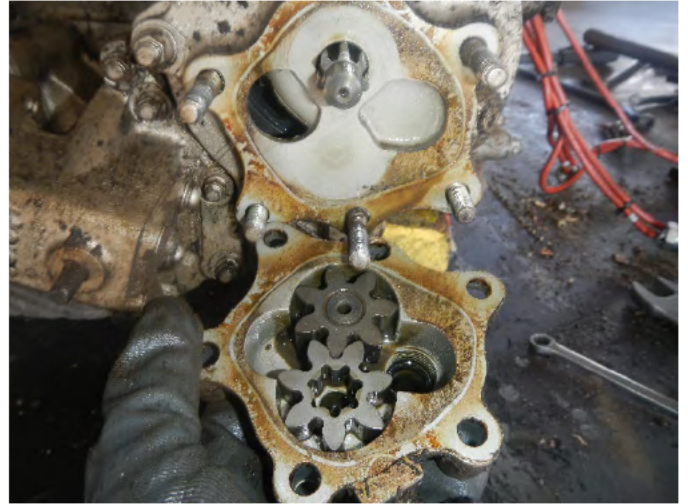
The oil pump remained attached to the crankcase. The pump was disassembled and all components were covered with residual oil. The gears were intact and there was no sign of hard particle passage on the pump walls. Rotational scoring was noted on the pump housing cap.

The scavenge pump remained attached to the back side of the starter adapter. The pump was disassembled and no pre-accident anomalies were noted.

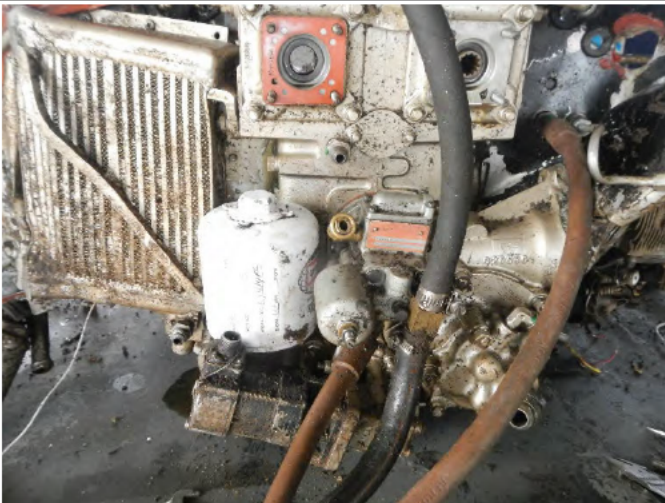
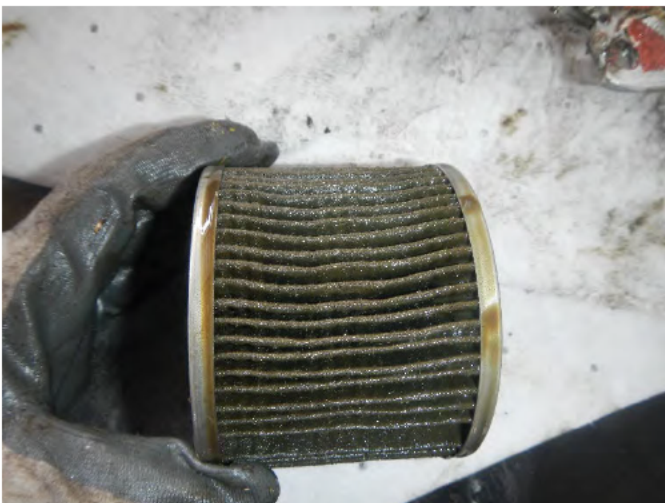
The oil filter remained secured to the oil filter adapter and the safety-wire was intact. The filter was removed and cut open to find relatively clean residual oil and no observable metallic debris between the filter pleats.

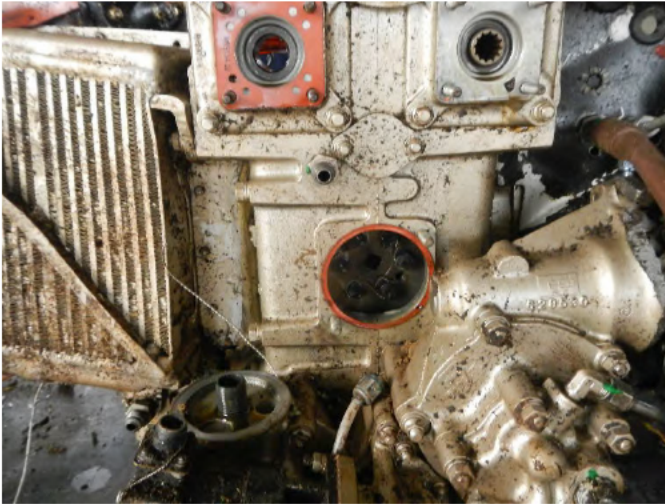
The oil cooler sustained impact-related deformation damage and its mounting bracket was fractured. Removal of the cooler from the engine revealed no pre-accident anomalies.

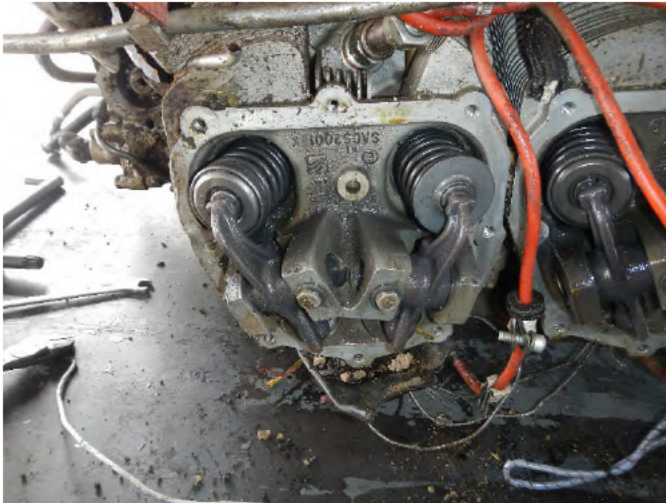
The cylinder remained secured to the crankcase with no external pre-accident anomalies noted. The rocker cover was fractured on the exhaust side. Removal of the remaining cover revealed no pre-accident anomalies with the rockers and valve springs. Removal of the cylinder revealed corrosion on the piston, barrel and cylinder, but no pre-accident anomalies with any of the cylinder components.

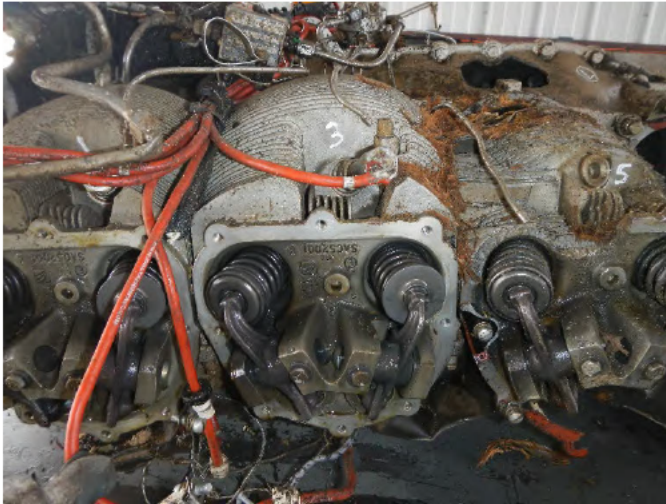
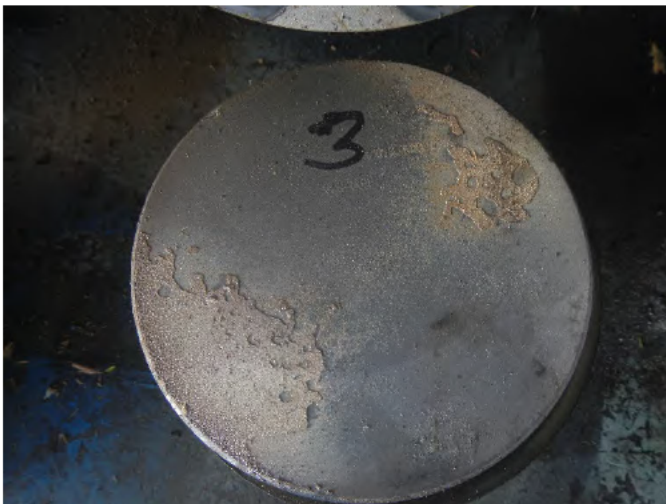
The cylinder remained secured to the crankcase with no external pre-accident anomalies noted. The rocker cover was fractured on the bottom side. Removal of the remaining cover revealed no pre-accident anomalies with the rockers and valve springs. Removal of the cylinder revealed no pre-accident anomalies with the piston, barrel cylinder head, valves, or valve seats.

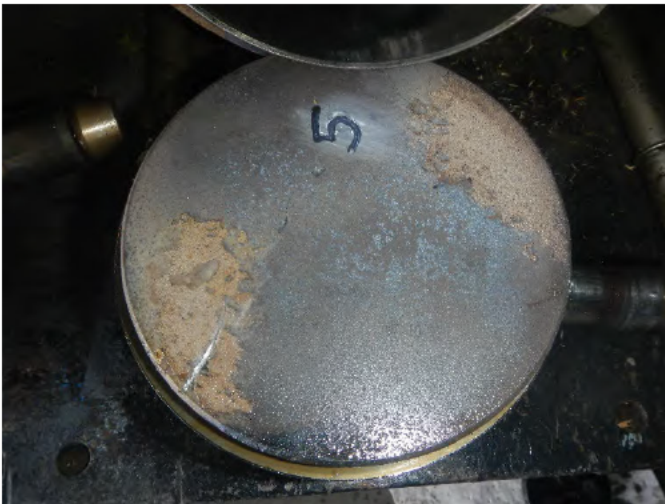
The cylinder remained attached to the crankcase, but numerous cooling fins were fractured as was the bottom area of the cylinder head (in the pushrod area). Wood fragments were embedded in between some fractured cooling fins. There were no pre-accident anomalies noted with the rockers or valve springs. Removal of the cylinder revealed no pre-accident anomalies with the piston, barrel, cylinder head, valves and valve seats.

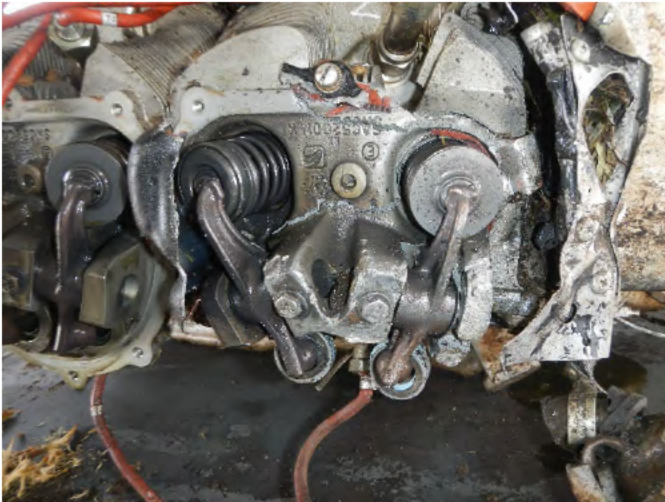
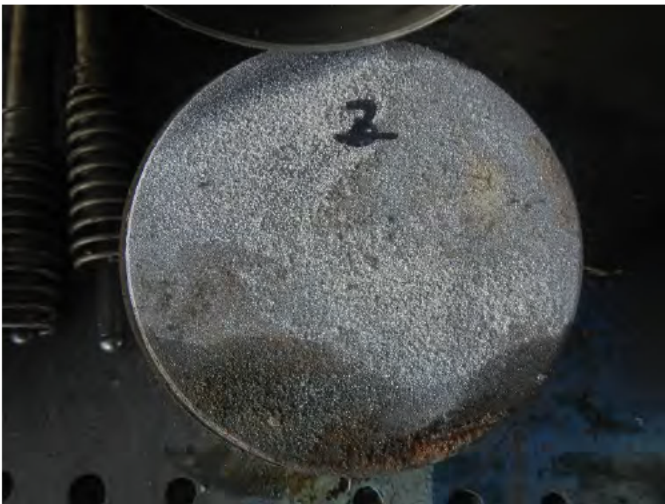
Condition: The cylinder remained secured to the crankcase with no external pre-accident anomalies noted. The rocker cover was fractured as was the bottom of the cylinder head. The cylinder head had another irregular and jagged fracture line that intersected the intake valve area and displaced the intake valve. There were no pre-accident anomalies with the rockers and valve springs. Removal of the cylinder revealed corrosion on the piston, barrel and cylinder, but no pre-accident anomalies with any of the cylinder components.

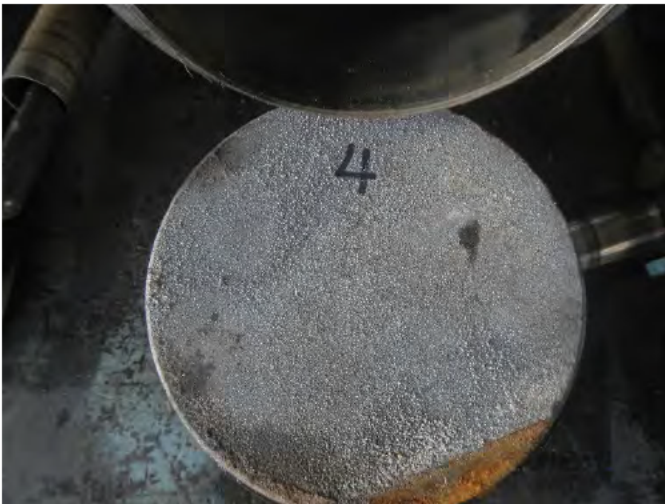
Condition: The cylinder remained secured to the crankcase with no external pre-accident anomalies noted. The rocker cover was fractured. Removal of the remaining cover revealed no pre-accident anomalies with the rockers and valve springs. Removal of the cylinder revealed corrosion on the piston, barrel and cylinder, but no pre-accident anomalies with any of the cylinder components.

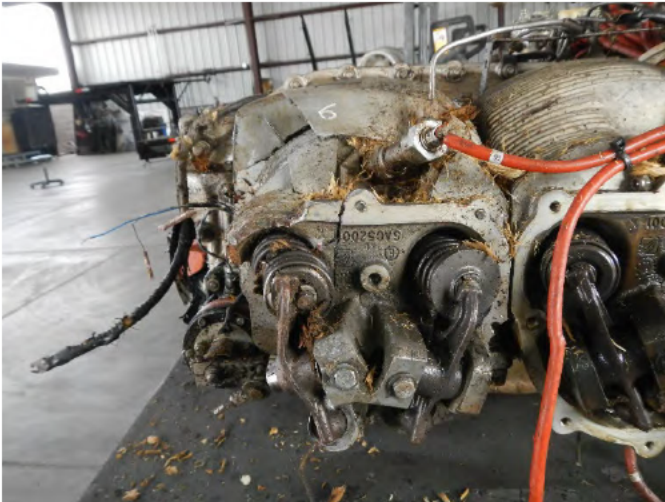
Condition: The cylinder remained attached to the crankcase, but numerous cooling fins were fractured as was the left side of the cylinder head. The exhaust rocker, valve stem, and valve springs were deformed. Wood fragments were embedded in between some fractured cooling fins and around the top sparkplug. There were no pre-accident anomalies noted with the rockers or valve springs. Removal of the cylinder revealed corrosion on the piston, barrel and cylinder, but no pre-accident anomalies with any of the cylinder components.

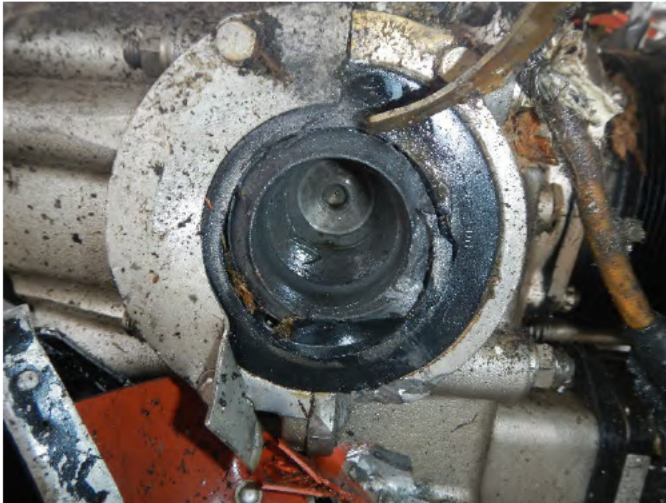
The crankshaft was fractured at the nose seal. The fracture was irregular and jagged consistent with overload. The alternator face gear remained attached to the crankshaft and no pre-accident anomalies were noted with the gear teeth. The crankshaft gear was bolted in place and the safety-wire was intact. The connecting rods remained secured in place and all rotated freely on the crankshaft when they were manually manipulated with no signs of discoloration or thermal distress. Once the wood debris was removed from the front of the crankcase, the crankshaft rotated freely with no binding noted from any of the main bearings.

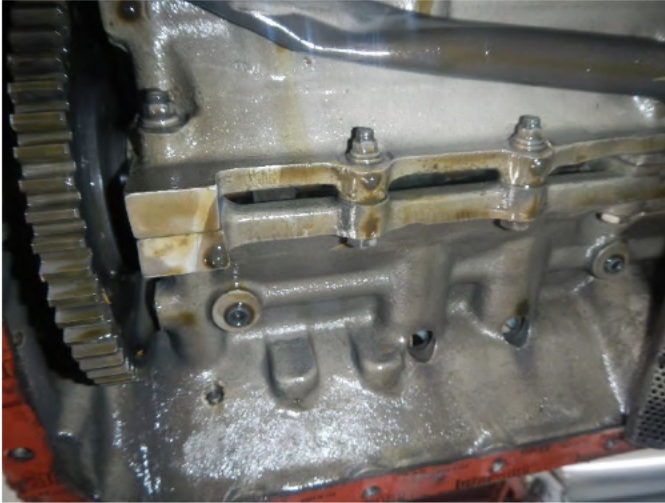
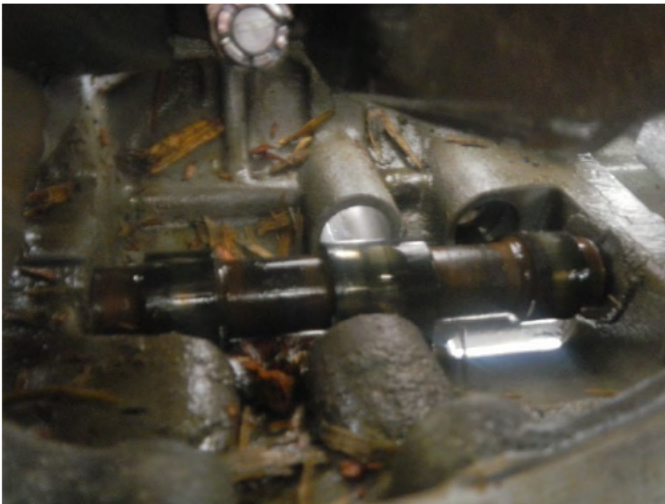
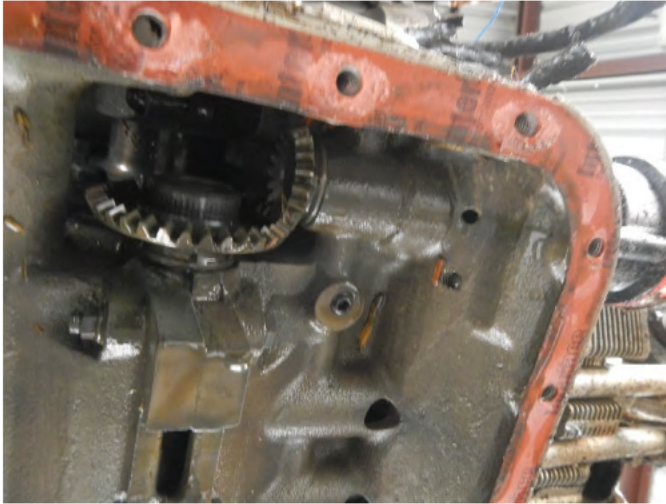
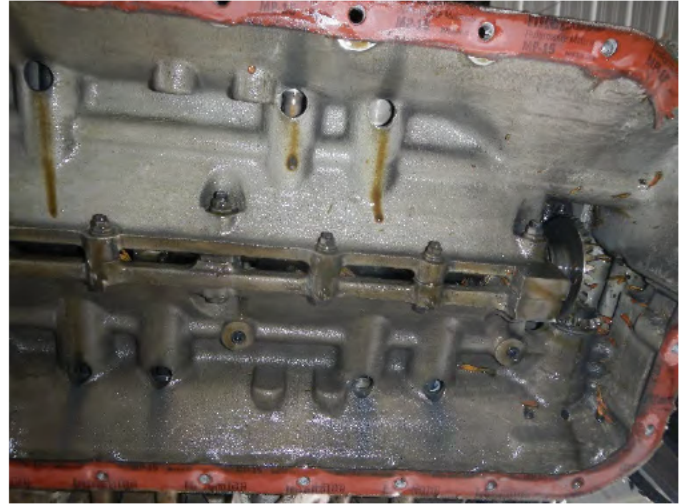
The camshaft remained intact with no pre-accident anomalies noted. Rotation of the crankshaft resulted in a coinciding rotation of the camshaft with no pre-accident anomalies noted on the gear teeth and lobes.

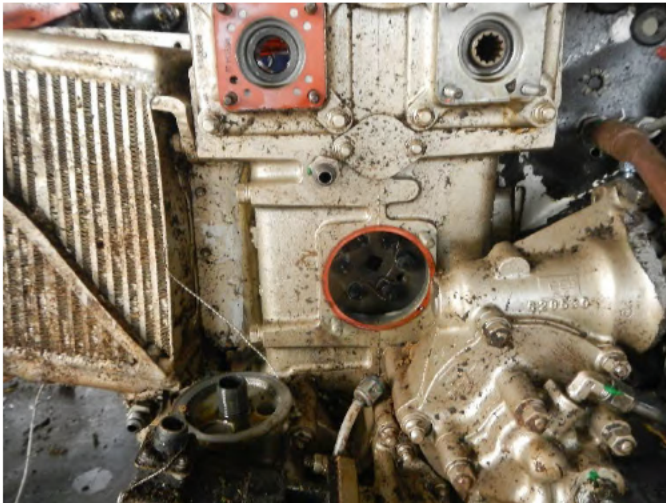
The starter adapter remained secured to the backside of the engine and manual rotation of the crankshaft resulted in rotation of the adapter gear and scavenge pump.

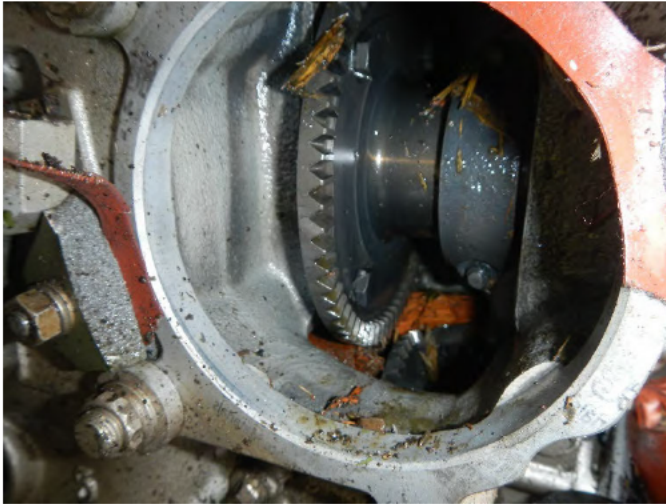
The alternator was separated from the engine and the housing was fractured. There were no pre-accident anomalies noted with the alternator. The drive coupling remained secured in place, though it sustained impact damage to one side that deformed the cup and elastomer.

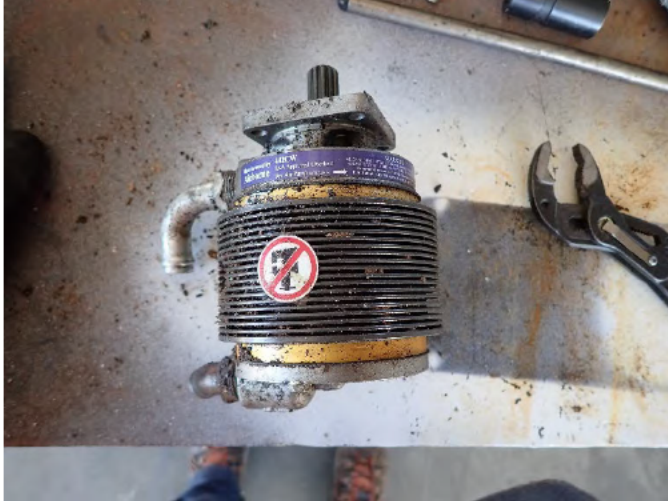
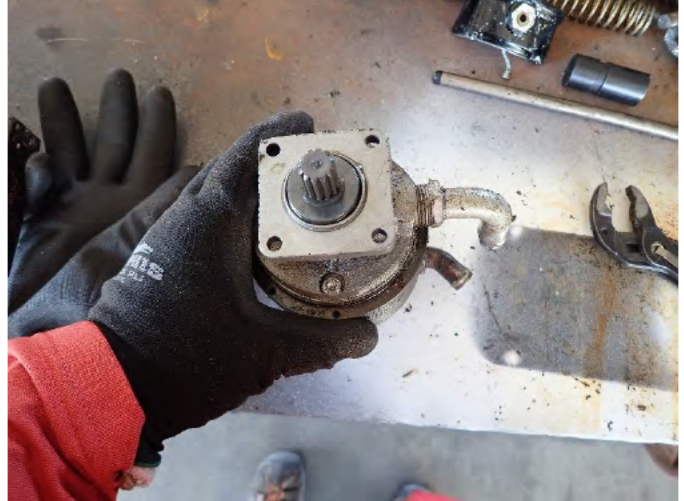
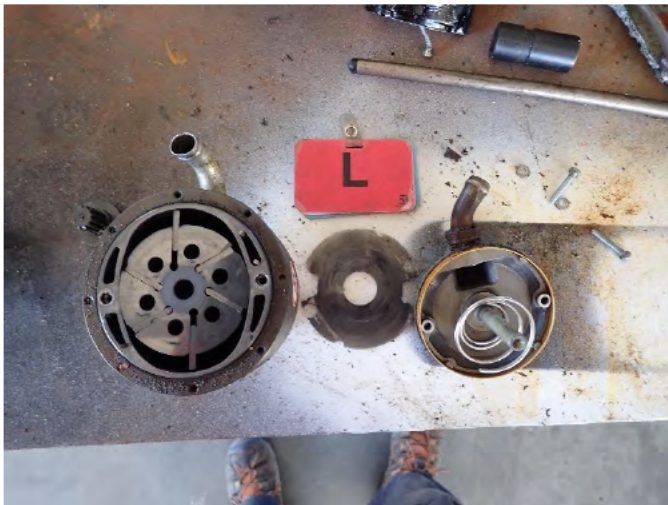
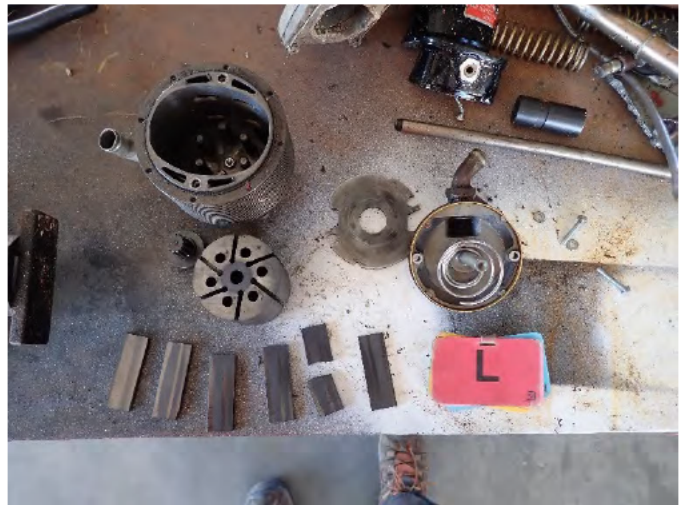
NOTE: the vacuum pump was disassembled at a separate wreckage examination and the photos below are from that examination (courtesy: Textron Aviation).
