ENGINE EXAMINATION REPORT

| ENGINE MODEL | TSIO-520-NB |
| ENGINE SERIAL NUMBER | 244794-R |
| AIRCRAFT MAKE & MODEL | Cessna 414A |

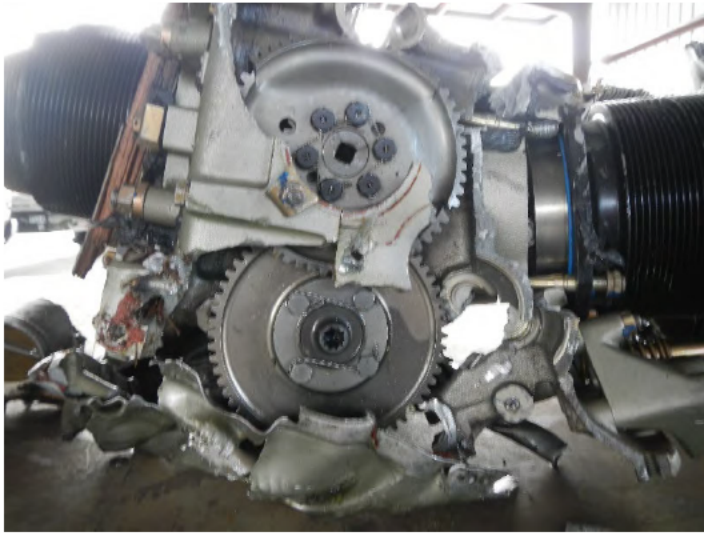
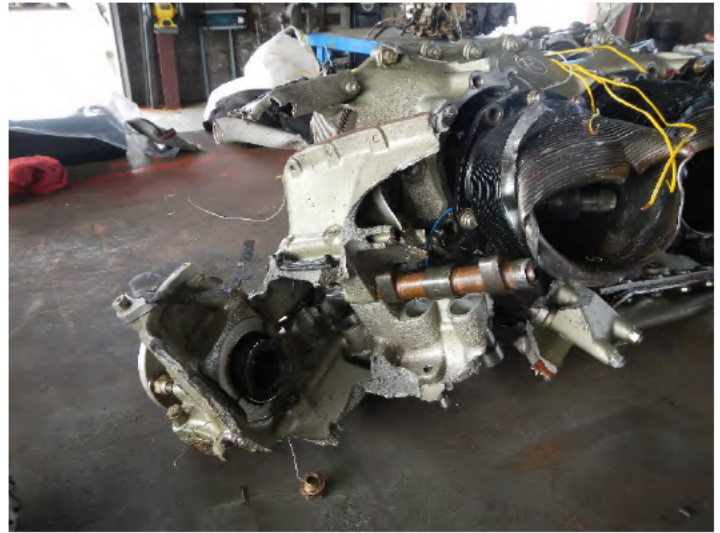
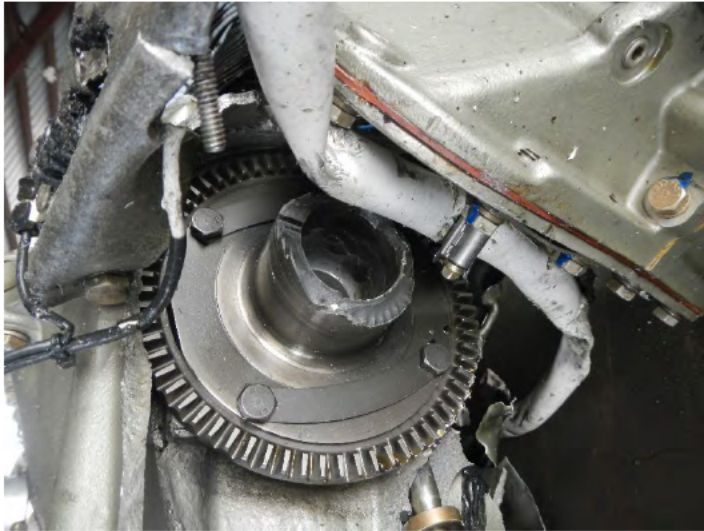
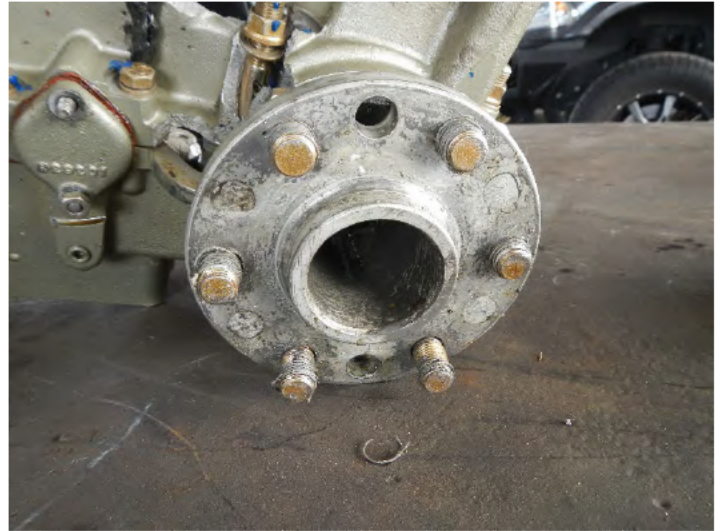
The engine was separated from the nacelle and all systems but the fuel manifold valve housing and oil pump were separated from the engine. The crankcase was fractured in multiple locations and the nose of the case was displaced to the bottom of the oil sump. The crankshaft was fractured in the same area as the crankcase nose fracture (at the oil transfer collar). All fracture surfaces were jagged and irregular, consistent with overload. The #2, #4, and #6 cylinders heads were separated from the barrels and the barrels were deformed down around their respective pistons. There was no evidence of lubrication distress on any of exposed components.

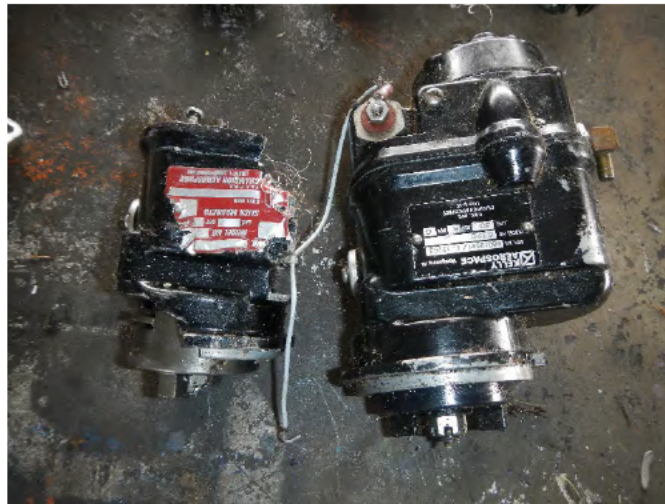
The magneto was separated from the engine. The drive shaft could be manually rotated, and the impulse coupling made an audible snap. A spark was obtained from the distributor towers during manual rotation of the shaft.

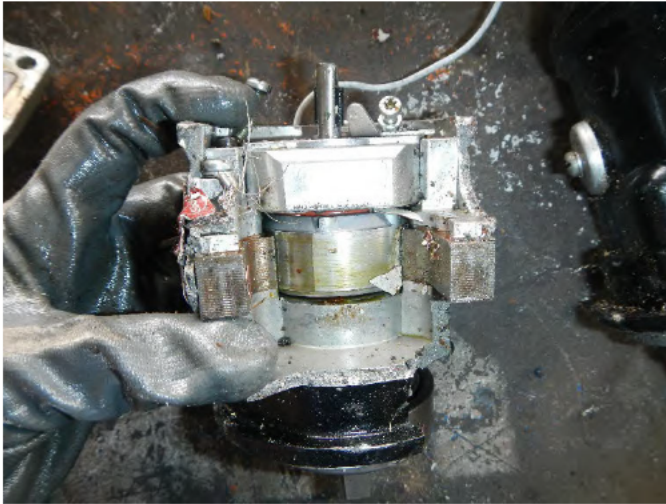
The magneto was separated from the engine and the housing was fragmented with only the drive shaft and magnet observed.

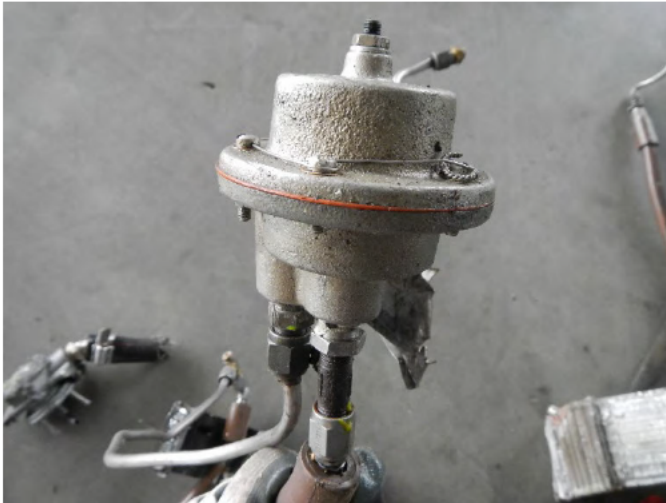
The fuel pressure regulator's reference line fitting was separated. The fuel lines remained secured in place.

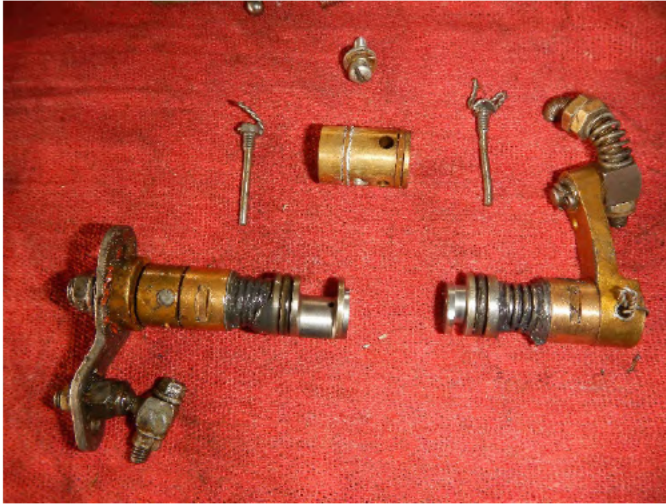
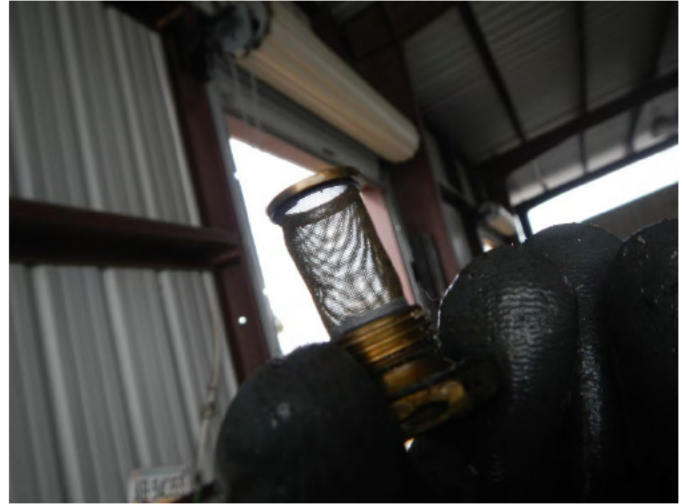
The throttle body was fractured and separated from the engine. The throttle interconnect linkage was fractured and one half of the arm was bent 180 degrees. The unit was disassembled, and no pre-accident anomalies were noted with the throttle and mixture cams, the metering plug, and the inlet fuel screen.

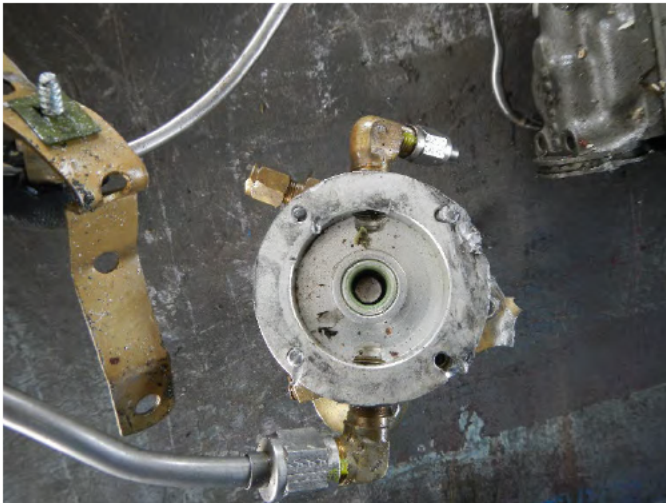
Condition: The fuel manifold housing remained attached to the engine, but the cap, diaphragm, plunger and screen were separated as were all the injector lines.

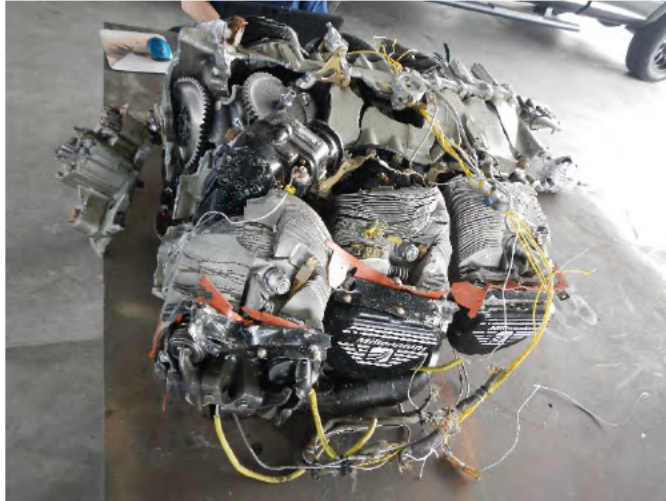
The upper deck reference lines were separated from the engine and were not observed. The nozzles were bent and/or fractured and the lines were separated from the engine, with the exception of the #5.

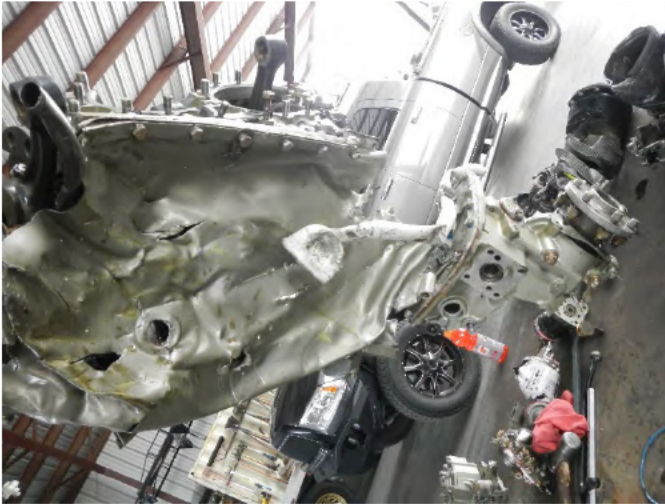
Condition: The oil sump was punctured, torn, and bent in half at the large crankcase fracture near the nose.

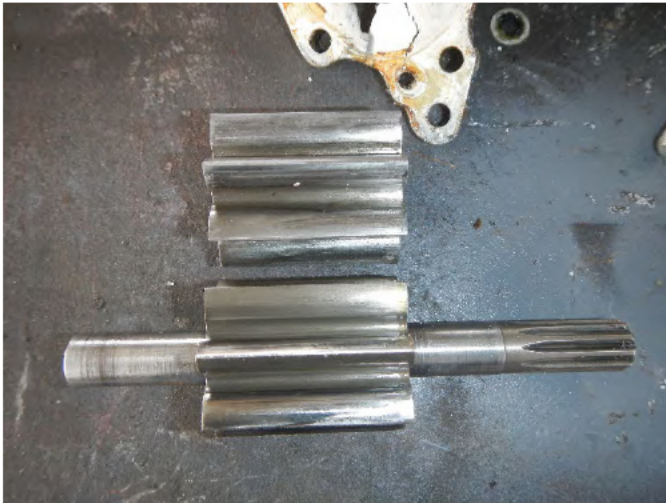
Condition: The oil pump remained attached to a fractured segment of the crankcase. The pump was disassembled and all components were covered with residual oil. The gears were intact and there was no sign of hard particle passage on the pump walls.

The scavenge pump remained attached to the separated starter adapter. The pump was disassembled and no pre-accident anomalies were noted.

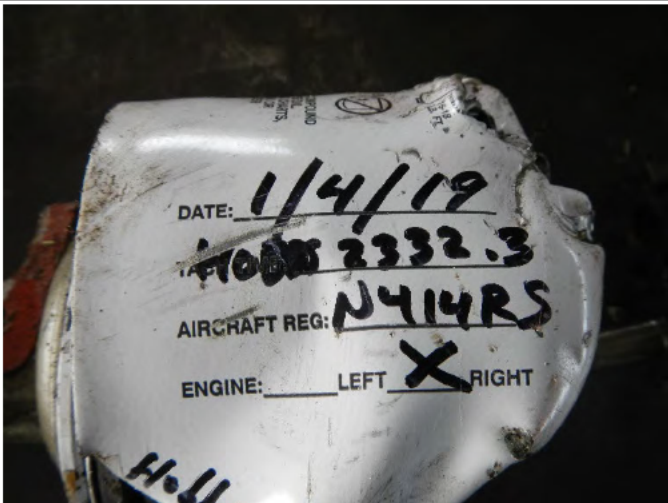
| Condition: | The oil filter remained attached to its separated adapter. The filter was torn open exposing the filter element. No pre-accident anomalies were noted. A date of January 4, 2019 and a Hobbs time of 2,332.3 hours were hand written on the filter. |

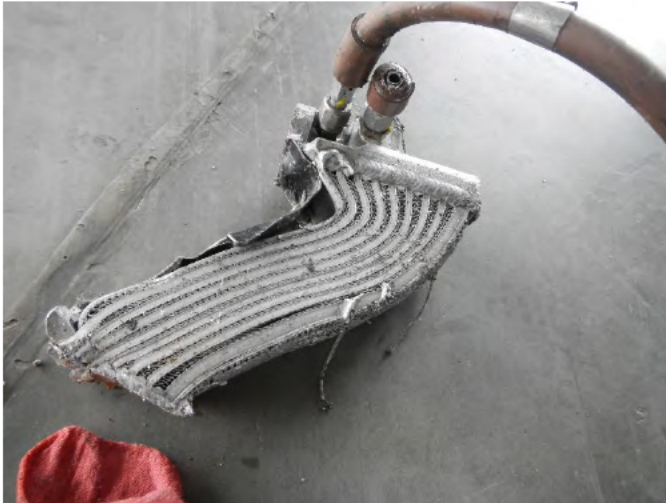
The oil cooler was separated and deformed with the top and bottom casings separated.

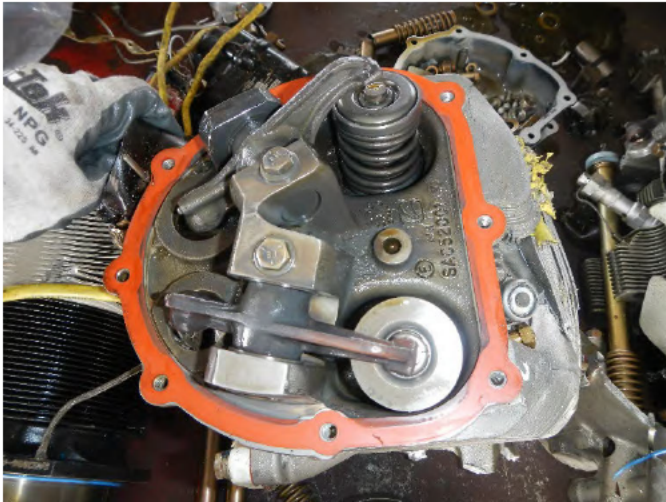
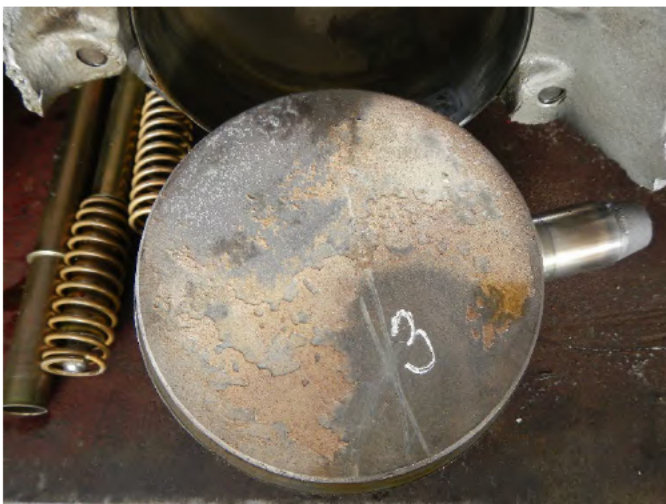
CYLINDER #3

Condition: The #3 cylinder sustained impact damage that fractured numerous cooling fins, the top sparkplug barrel, and the fuel injector nozzle. Removal of the rocker cover revealed no pre-accident anomalies with the rockers and valve springs. Some of the attaching hardware was displaced due to the fractured crankcase, but the top studs retained their torque putty. The cylinder was removed and no pre-accident anomalies were noted with the sparkplugs, piston, barrel, valves or valve seats. One side of the piston skirt was fractured as was the oil control ring in that area.

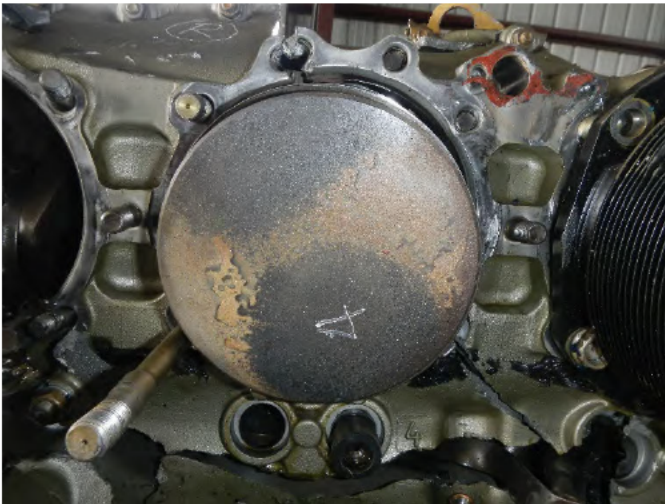
CYLINDER #4

Condition: The #4 cylinder remained partially attached to the fractured crankcase. Only one of the top attaching studs remained intact. The barrel was bent down over the piston and the top cooling fins displayed deformation damage. The cylinder head was separated and found in the debris. The remnants of the cylinder head revealed no pre-accident anomalies with the rockers, valves, valve seats, and valve springs. The barrel and piston revealed no pre-accident anomalies.

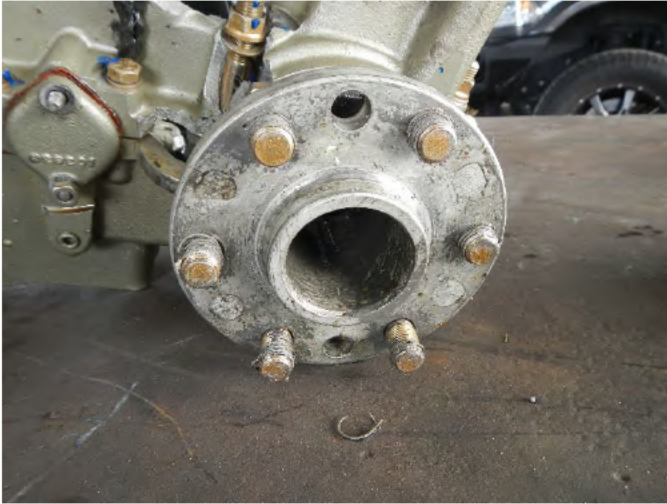
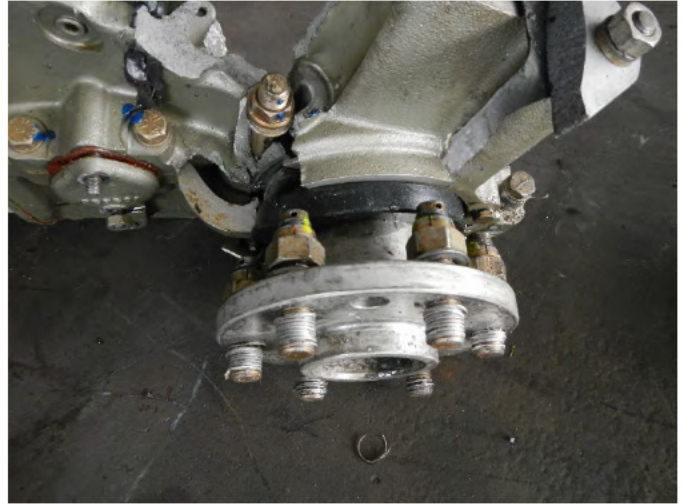
The crankshaft was fractured at the oil transfer collar area. The fracture was irregular and jagged and appeared to be displaced toward one side. The alternator face gear remained attached to the crankshaft and no pre-accident anomalies were noted with the gear teeth. The crankshaft gear was bolted in place and the safety-wire was intact, but the gear was bent forward on the topside. There were no pre-accident anomalies noted with the gear teeth. The connecting rods remained secured in place and all rotated freely on the crankshaft when they were manually manipulated (with the exception of the #2) with no signs of discoloration or thermal distress.

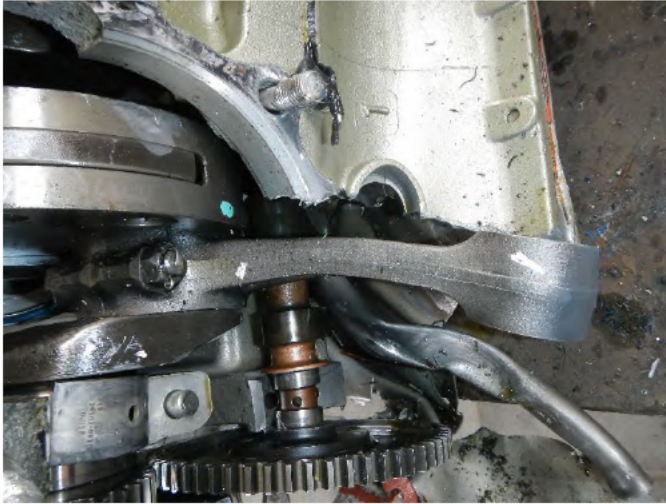
The connecting rod remained attached to the crankshaft and the piston pin. It was bent aft with no sign of thermal discoloration. Manual manipulation of the connecting rod revealed no binding of the connecting rod bearing.

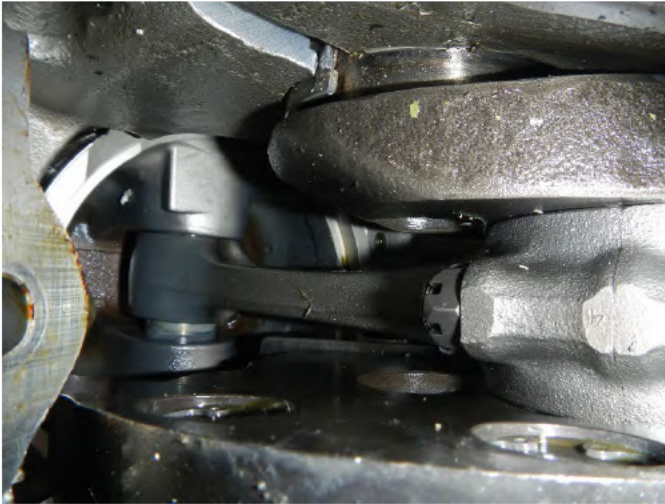
The connecting rod remained attached to the crankshaft and the piston pin. The connecting rod was bent slightly, but there was no sign of thermal discoloration. Manual manipulation of the connecting rod revealed no binding of the connecting rod bearing.

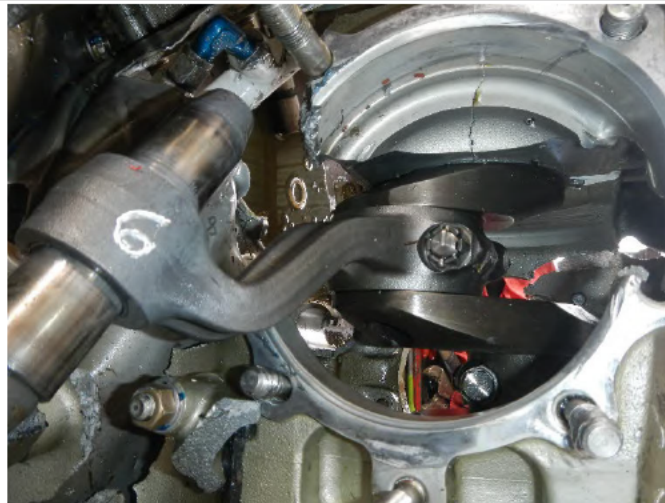
#6 CONNECTING ROD

The connecting rod remained attached to the crankshaft and the piston pin. The connecting rod displayed s-bending with no sign of thermal discoloration. Manual manipulation of the connecting rod revealed no binding of the connecting rod bearing.

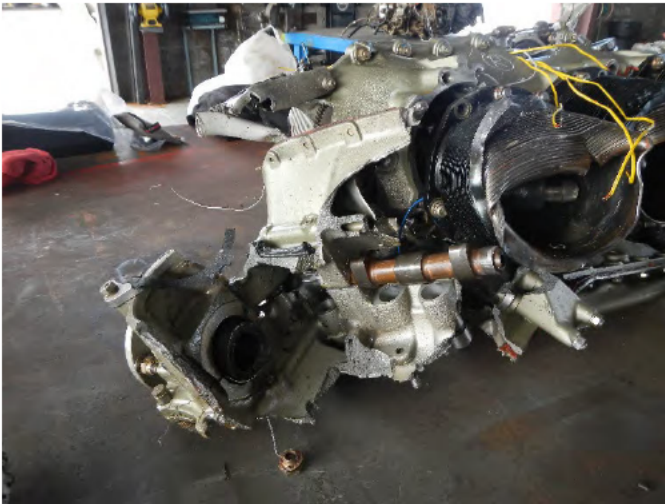
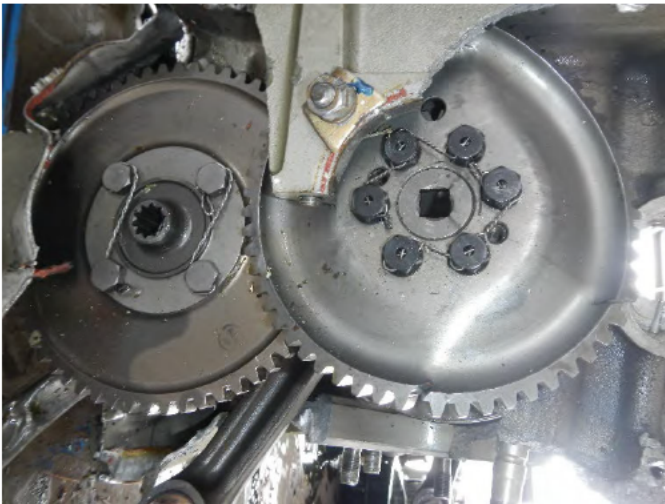
Condition: The camshaft was fractured and bent in numerous locations. The camshaft gear remained attached and the safety-wire was intact. There were no pre-accident anomalies noted with the lobes.

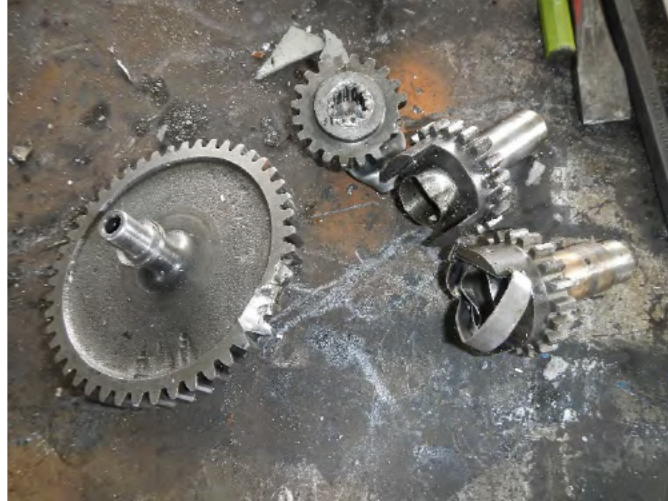
The accessory gears sustained impact-related damage with the idler gear being separated from the crankcase. There were no pre-accident anomalies noted.

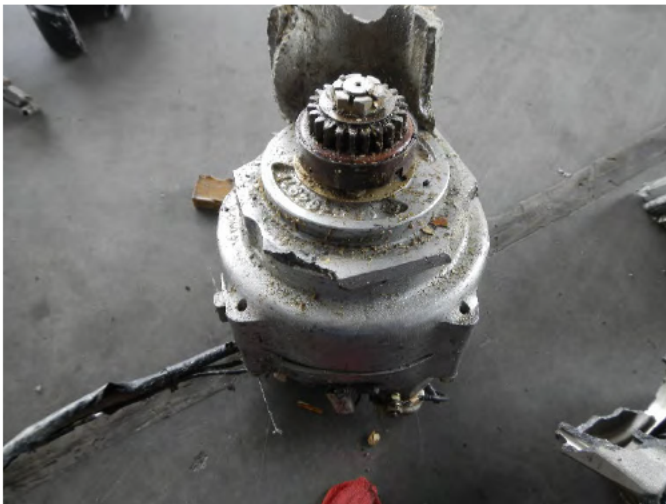
| ALT/GEN #1 | Manufacturer: Unknown | P/N: Unknown | S/N: Unknown |

| Condition: | The alternator was separated from the engine and a portion of the crankcase remained attached. The unit sustained impact damage. There were no external pre-accident anomalies noted with the alternator. The drive coupling remained secured in place. | | |

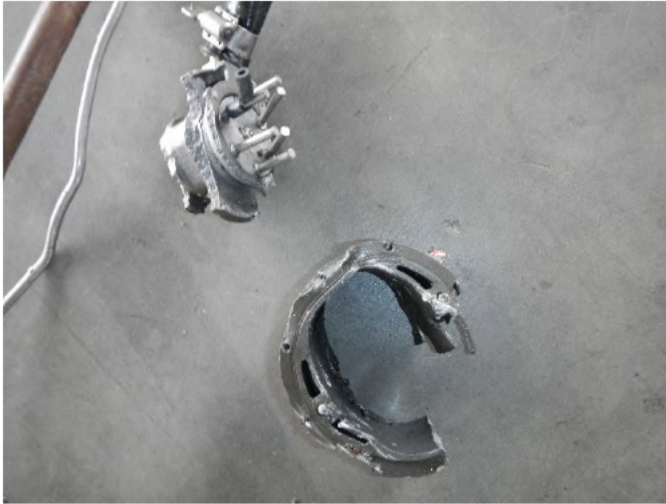
The vacuum pump was separated from the accessory end of the engine and it sustained significant impact deformation damage that fractured the housing and separated the drive mechanism. The drive coupling remained intact
