Examination at Messier-Bugatti Dowty, Ajax, Ontario, Canada, November 2013:

C. SUMMARY

D. DETAILS OF INVESTIGATION

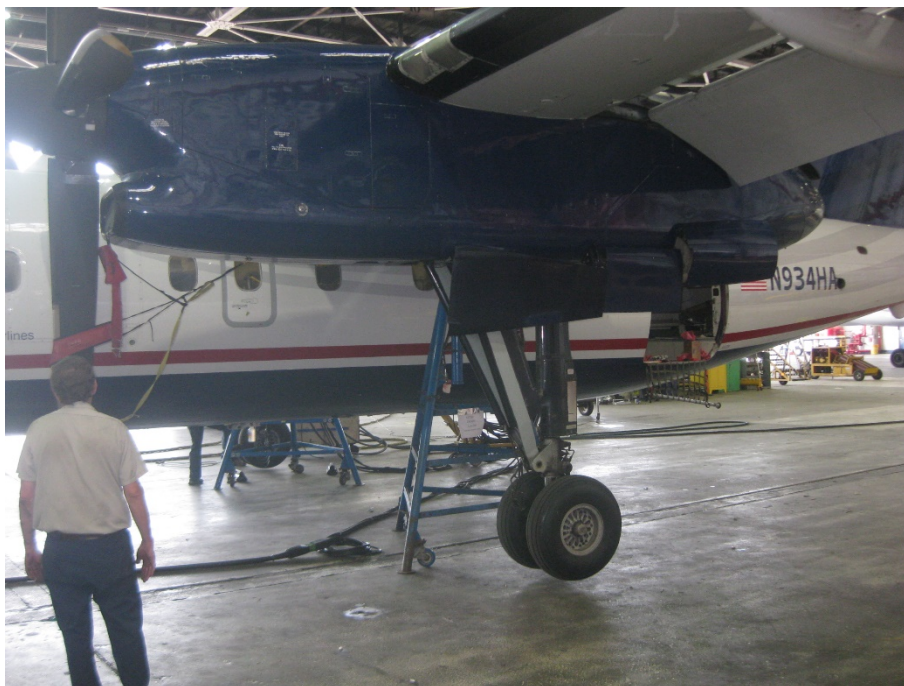
Figure 3 - The Left Main Landing Gear of the accident airplane, on jacks, after removal from the runway. The gear moves aft and up during the gear retraction sequence.

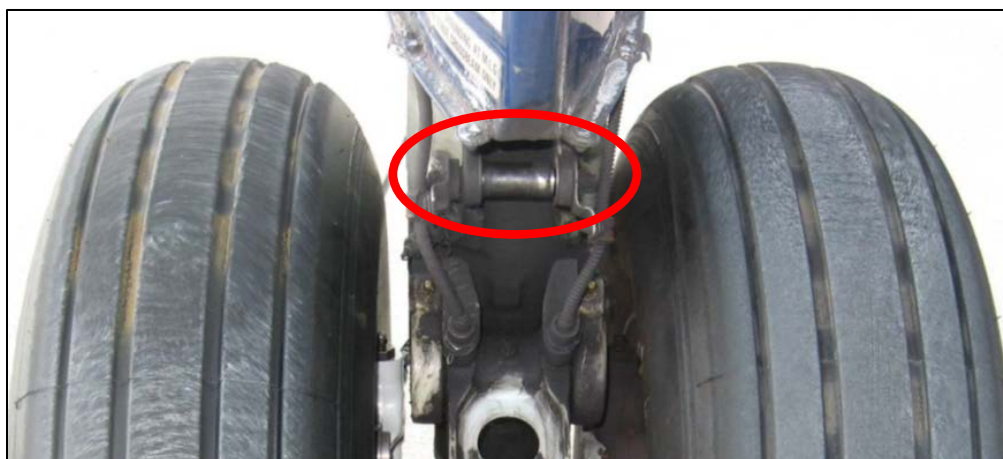
On the left and right gear strut, the main landing gear uplock roller sits on the uplock latch such that, when the alternate system is activated, the latch unhooks from the rotating roller and the gear “falls” away. See Figure 6.

Figure 6 - Main Gear with Uplock Roller Circled in Red. Note: Airplane in figure is not the accident airplane. (Photograph Courtesy of Piedmont)

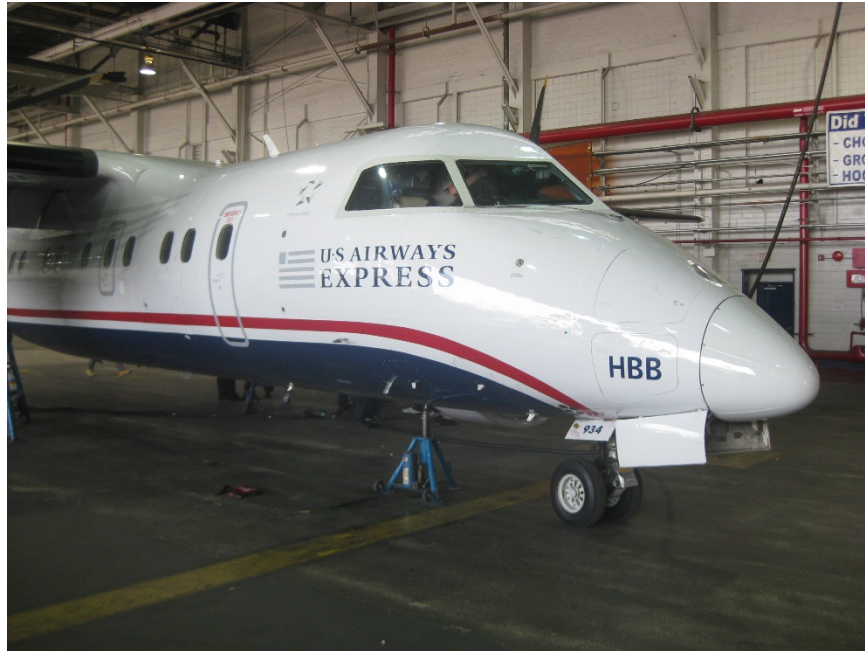
Figure 7 - The accident airplane in the hangar.

The airplane exhibited substantial damage to underside of aircraft, including fuselage skin abraded in several areas, consistent with damage incurred during the accident sequence.

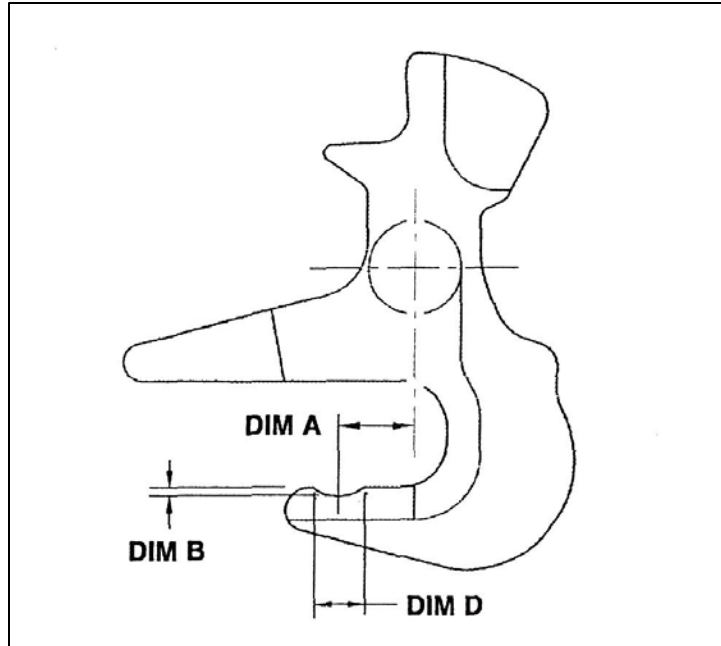
Figure 13 - Uplock Latch Wear Dimensions, From Messier-Dowty Uplock Assembly CMM, Figure 802.
(Figure courtesy of Messier-Dowty)

- Using Figure 802, dimension “D”, the width of the worn groove, was measured as 0.38”.
- Using Figure 802, dimension “A” (the gear pin offset) was measured on the uplock latch as 0.6565”.
- Using Figure 802 (Latch Working Surface - Wear Allowances) and Dimension “D”, Dimension “B” was determined to be 0.044”.
- Using Dimension “A” as the input to Figure 803 (Latch Working Surface-Wear Allowance Graph), the resultant permitted Maximum Indent Depth (Dimension C) was determined as 0.035”.
- Using Paragraph C.1 (page 8009), Dimension “B” was greater than Dimension “C”. Therefore, the uplock latch was determined to be beyond limits by 0.009”.
