National Transportation Safety Board

Performance Study

Specialist Report

Location:	Memphis, Tennessee
Date:	February 5, 2014
Time:	0015 CST, 0615 UTC
Airplane:	EMB145, N802HK
NTSB Number:	DCA14FA058

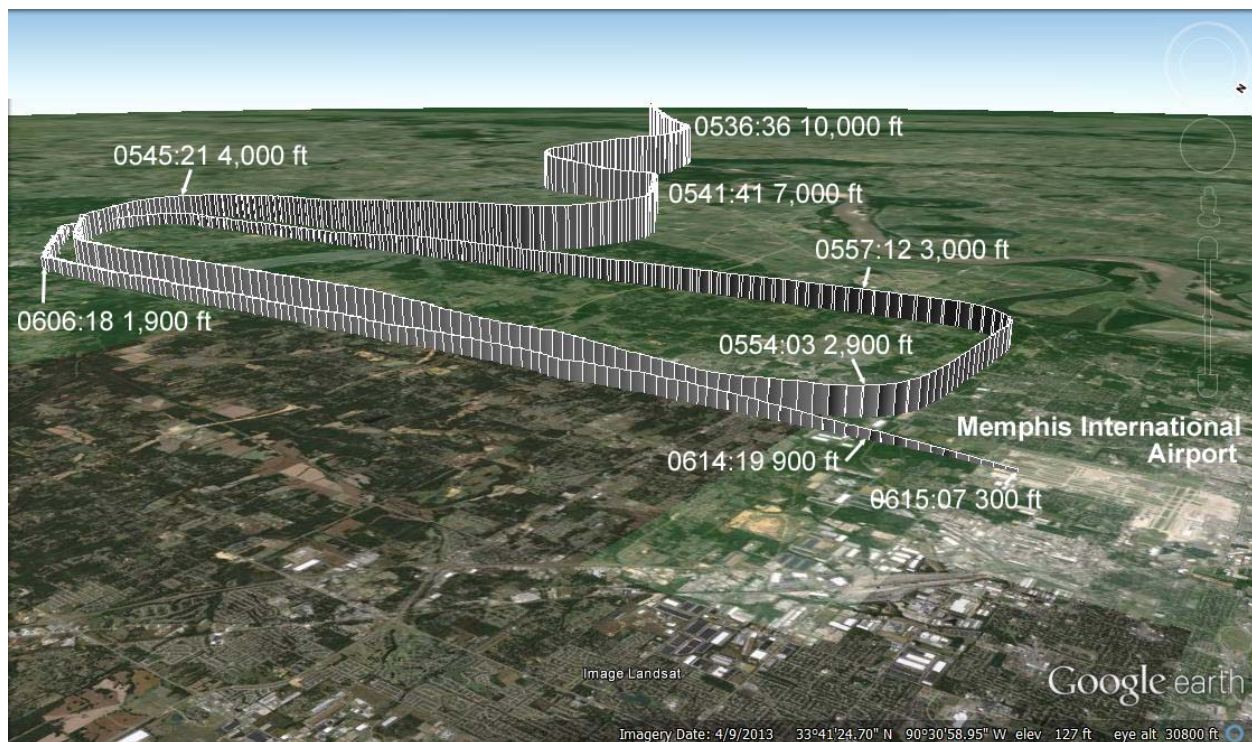
The aircraft first approached Memphis International Airport at approximately 0550 UTC before abandoning the landing attempt and executing a go-around. At 0606 UTC, the aircraft turned again onto final for runway 36R at MEM. One second before touchdown (marked as weight on wheels) the aircraft experienced a sudden roll that resulted in the right wing impacting the ground. The aircraft's flight path during the first approach, go-around, and final approach are shown in Figure 1.

Figure 1. Aircraft radar track with selected times and altitudes marked.

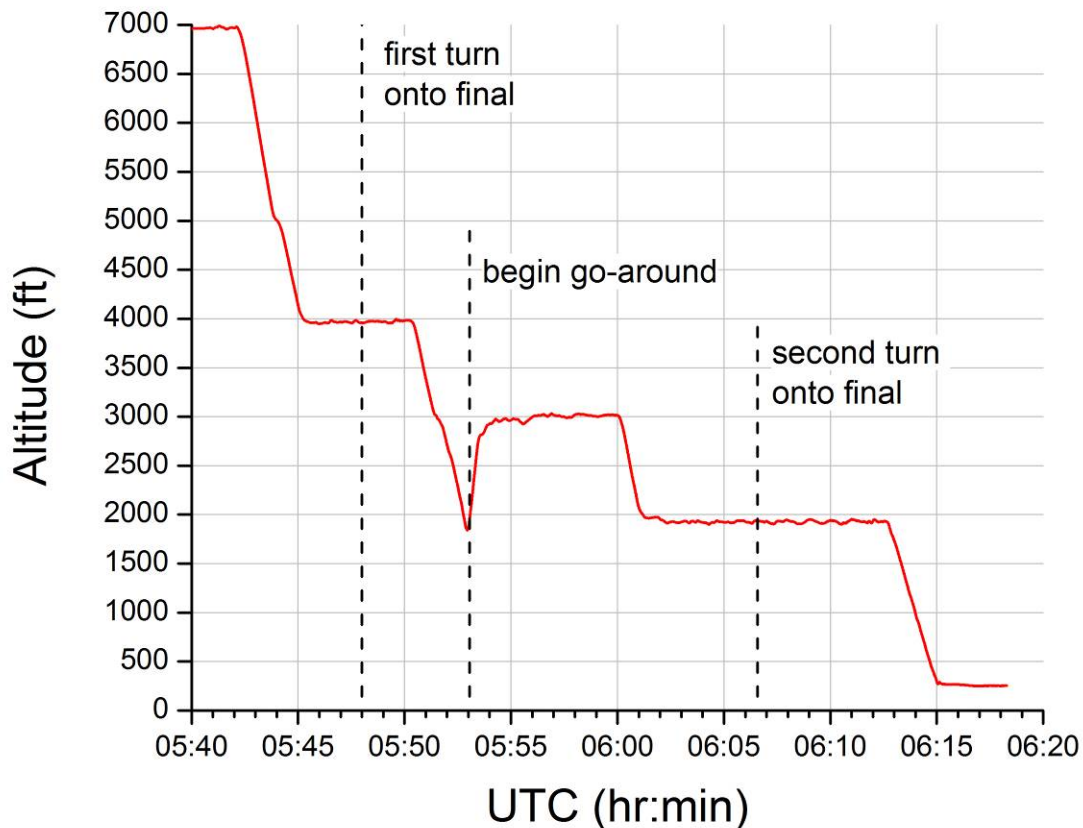
At about 0545 UTC, the aircraft descended from 7,000 to 4,000 ft mean sea level (MSL), as shown in Figure 2. At 0553 when the go-around was initiated, the aircraft was at an altitude of about 2000 ft (runway 36R is at an elevation of 250 ft MSL). The aircraft climbed to 3,000 ft during the go-around before returning to 2,000 ft and maintaining that altitude for approximately 12 minutes.

Figure 2. Aircraft altitude (MSL) with the times for the initial turn onto final, the go-around, and the second turn onto final marked.
