**NATIONAL TRANSPORTATION SAFETY BOARD**

**UAS Aerial Imagery Factual Report**

**A. ACCIDENT                    DCA17FR011**

Location:                    Hyndman, PA  
Date:                         August 2, 2017  
Time:                         0500 Local Time (EDT)  
Event:                        CSX train derailment

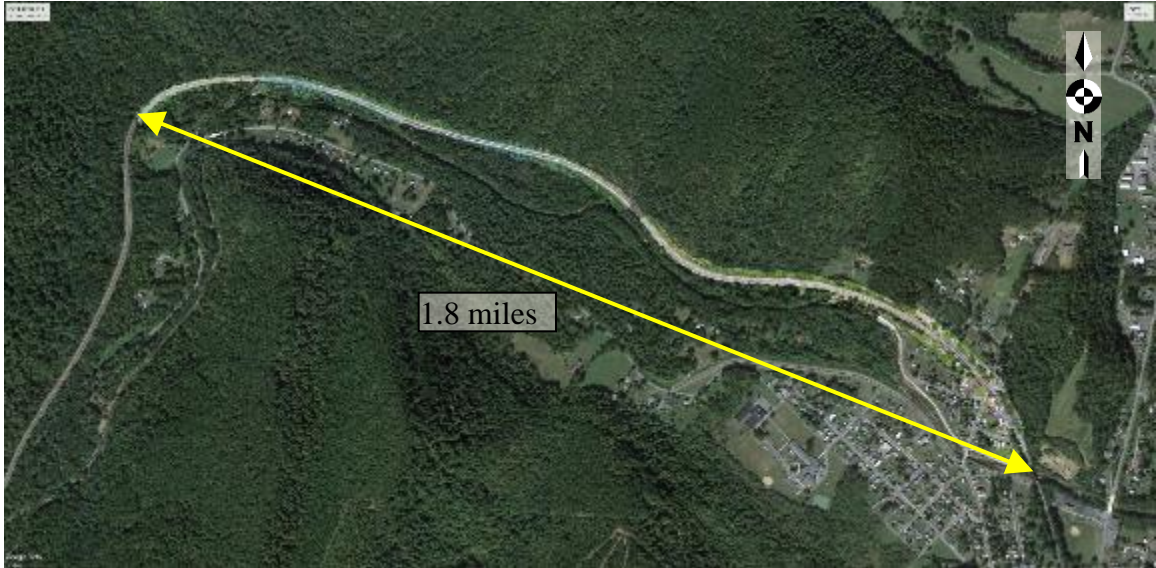
Figure 1 – Overview of entire area

Approximately 1300 high resolution photos and videos were gathered. Still photos, videos, and initial low-resolution maps and 3D models were provided to the IIC and investigative team on scene. Select images are included below and in the docket for this accident. Full resolution maps and exported models are included in the docket. Figure 1 is an overview of the entire coverage area.

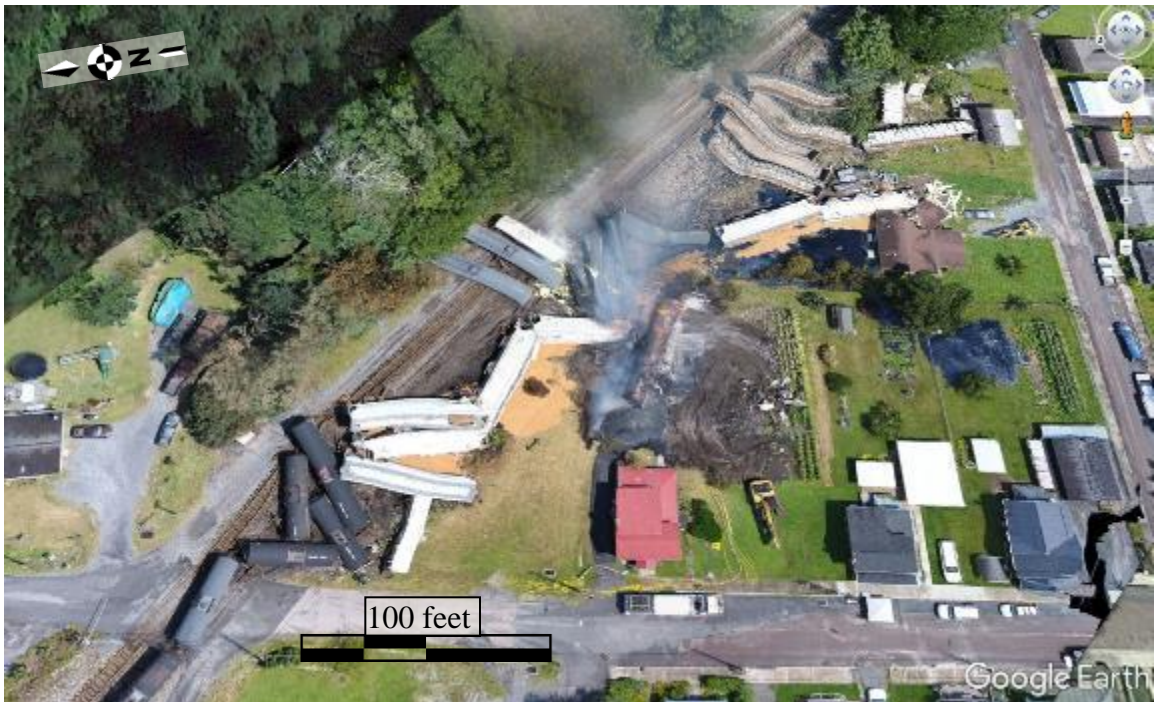
Figure 2 – Snapshot of Wreckage Day 1 Orthomosaic Export

An orthomosaic map of the main wreckage site on Aug 3, was developed and exported in Google Earth kmz format. Figure 2 is a sample snapshot of the map, attachment 1 is a full resolution kmz export.

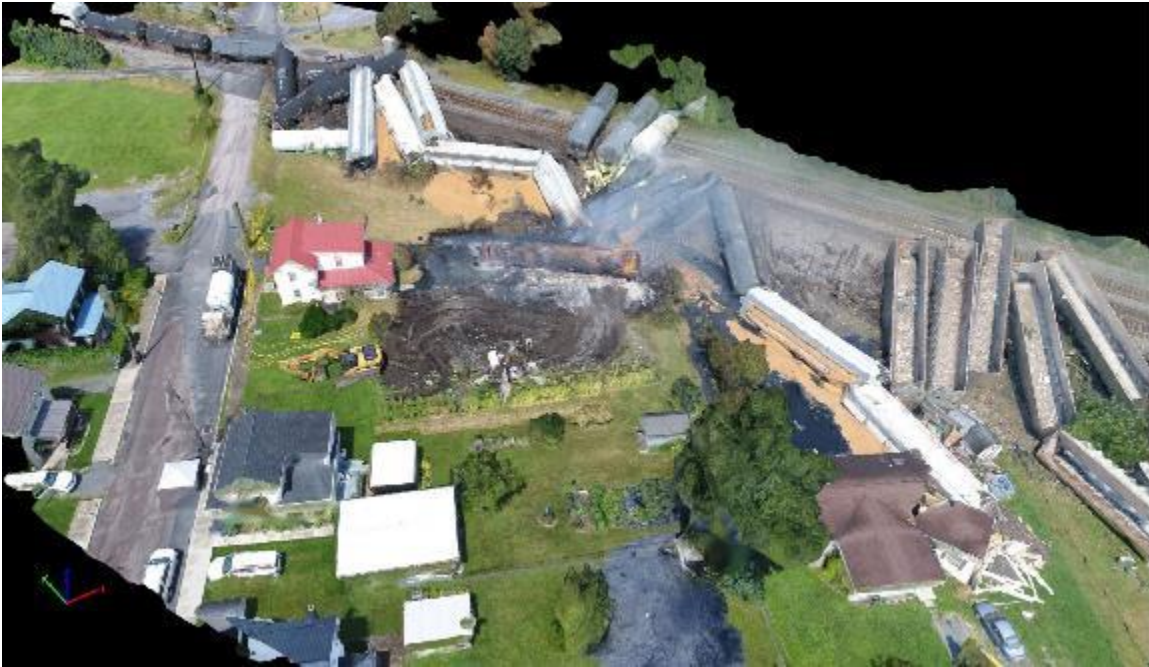
**Figure 3 – Snapshot of Wreckage Day 1 3D Model**

Figure 3 is a sample snapshot of the 3D model of the main wreckage site on day 1.

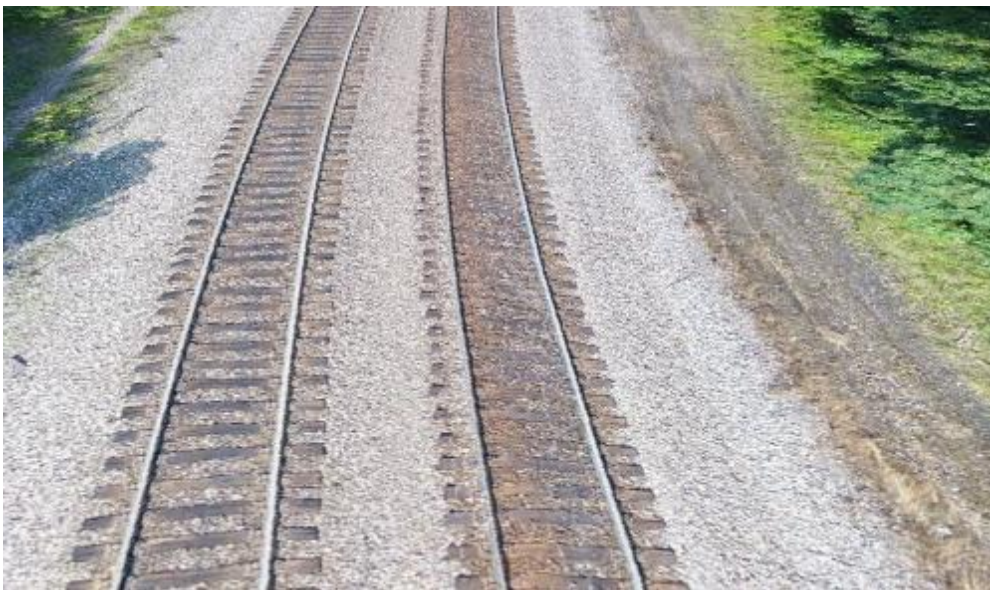
**Figure 6 – Snapshot of Rail Day 1 Orthomosaic Export**

The Track Group Chairman accompanied the UAS team to document the section of rail leading up to the main wreckage. The initial point of derailment was approximately 1.8 miles northwest of the main site. Multiple sorties were flown over two days (weather required flights to stop near the end of day 1) and processed into orthomosaic maps of the rail. Figure 6 is a snapshot of a portion of the orthomosaic showing the initial point and witness marks. Figure 7 is a sample source photo showing the marks and initial point.

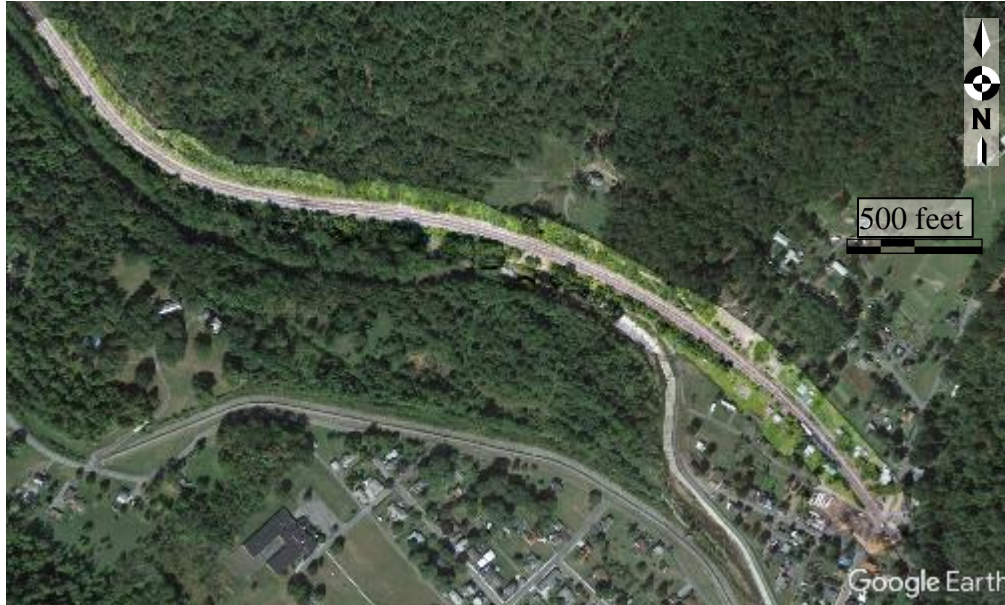
Figure 9 – Overview of rail map day 2

On the second day, the remainder of the rail section leading to the grade crossing and main wreckage area was documented. Figure 9 is an overview of the rail map, and figure 10 is an excerpt in the area of the grade crossing. Attachment 10 is the orthomosaic export in kmz format.

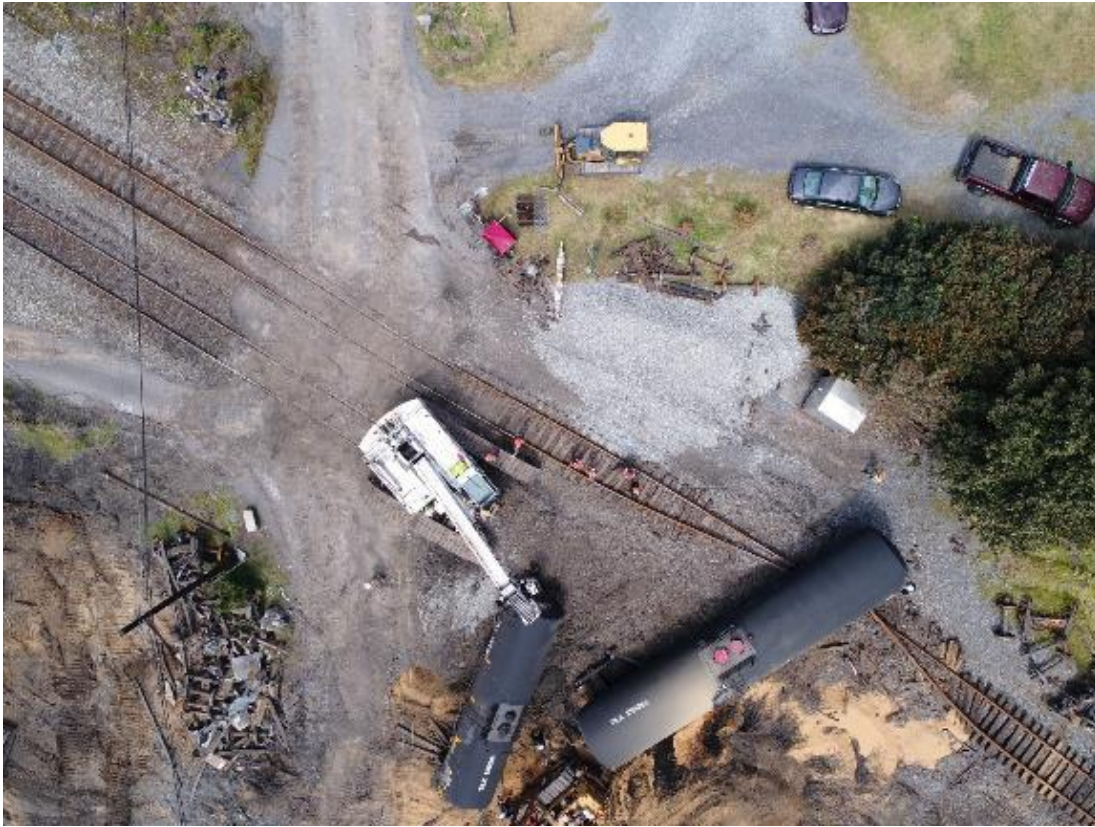
**Figure 11 – Source photo in area of grade crossing**

Figure 11 and attachment 11 are a sample source photo in the area of the grade crossing.
