**National Transportation Safety Board**  
Office of Research and Engineering  
Washington, D.C. 20594

**Airplane Performance Study**

**Location:** Presque Isle, Maine  
**Date:** March 4, 2019  
**Time:** 1629 GMT (1129 EST)  
**Airplane:** EMB-145XR, N14171  
**NTSB Number:** DCA19FA089

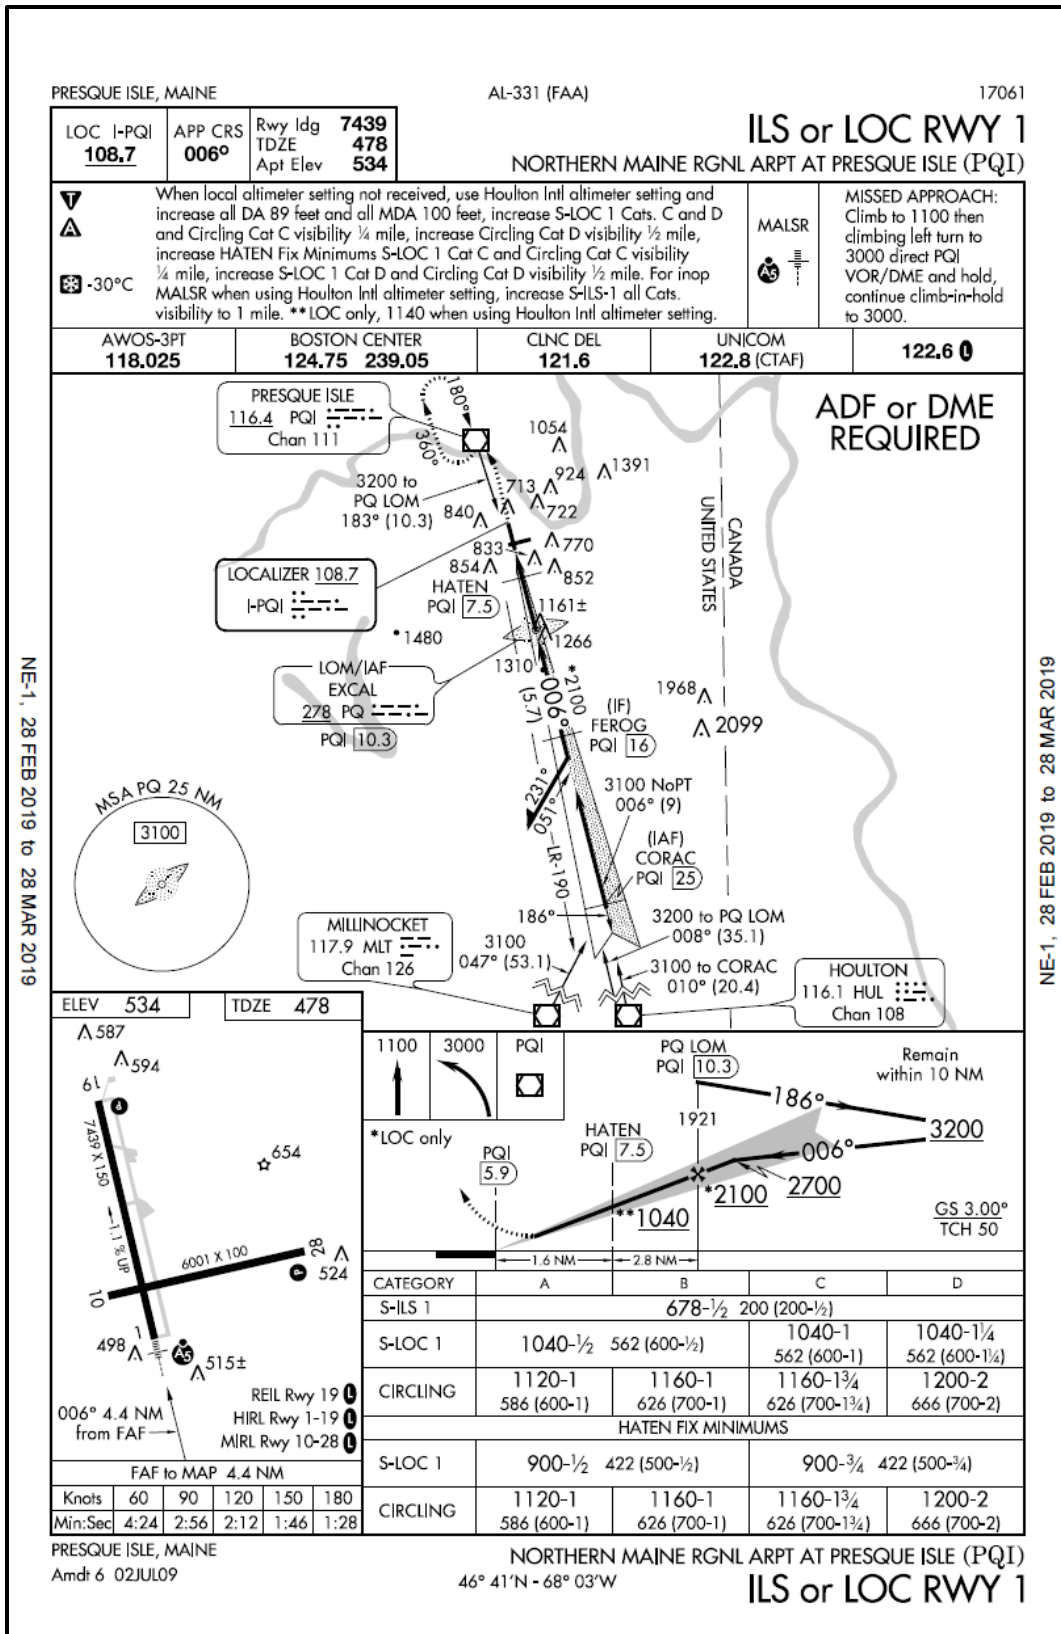
**Figure 3: KPQI ILS Runway 01 Approach Plate**

Figure 3 is the approach plate for the ILS 01 at KPQI. Figure 4 is an overview of the airplane's ground track in the vicinity of Presque Isle Airport and captures the initial approach and second landing attempt on KPQI's runway 1. (Note the 17° magnetic variation between the approach course of 6° and the true course of 349° to runway 1 depicted in the figure.)

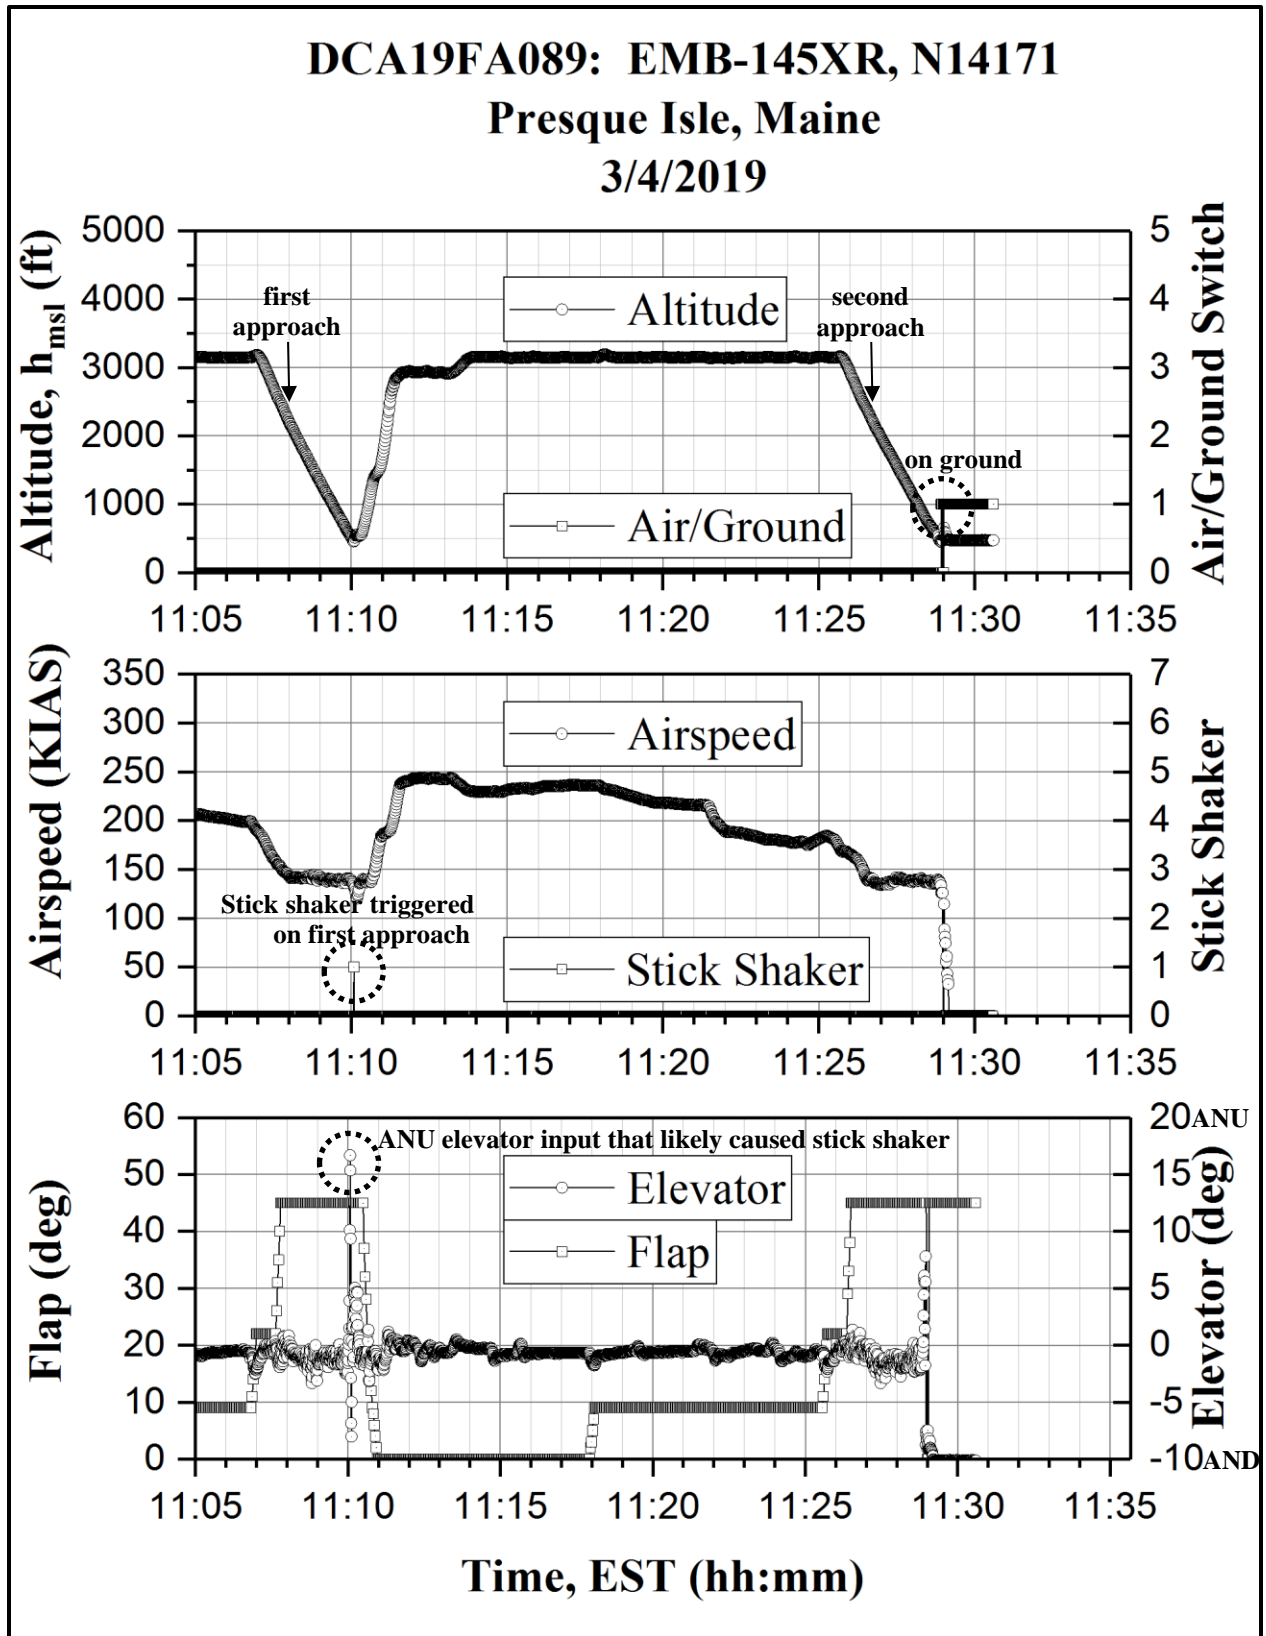
Figure 8: Altitude and Speed for Final 30 Minutes Based on FDR Data

Figure 8 focuses on the final 30 minutes of the flight for more detail.

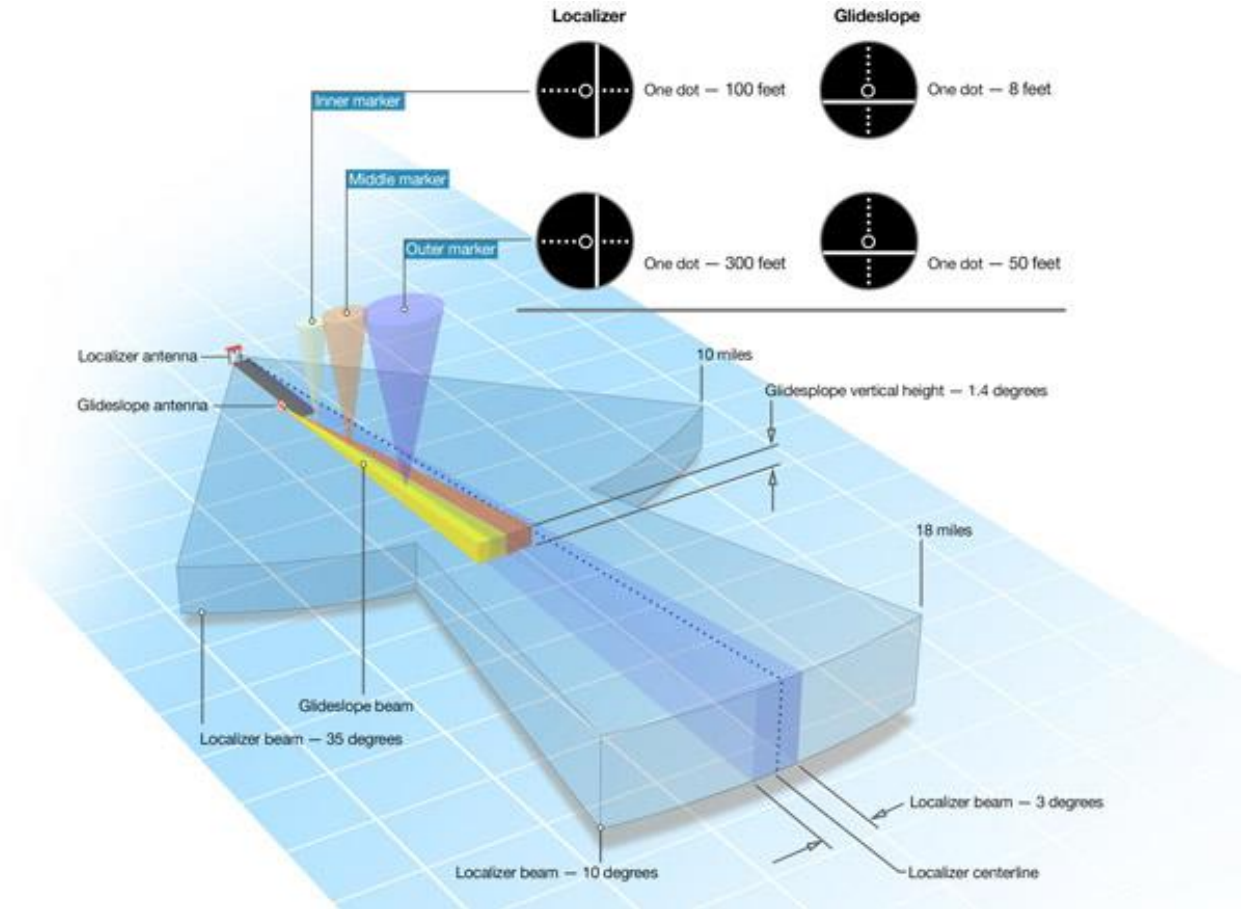
**Figure 12: Typical ILS Coverage (source: AOPA Pilot)**

<sup>3</sup> At the final approach fix, each dot is worth about 300 feet; a mile from touchdown, each dot counts for 100 feet. See Figure 12.
