Boeing Commercial Airplanes Equipment Quality Analysis Report

Examination of Control Stand Thrust Lever Assembly

MODEL NUMBER: 767-300BCF

SUBJECT: *Examination of Control Stand Thrust Lever Assembly*

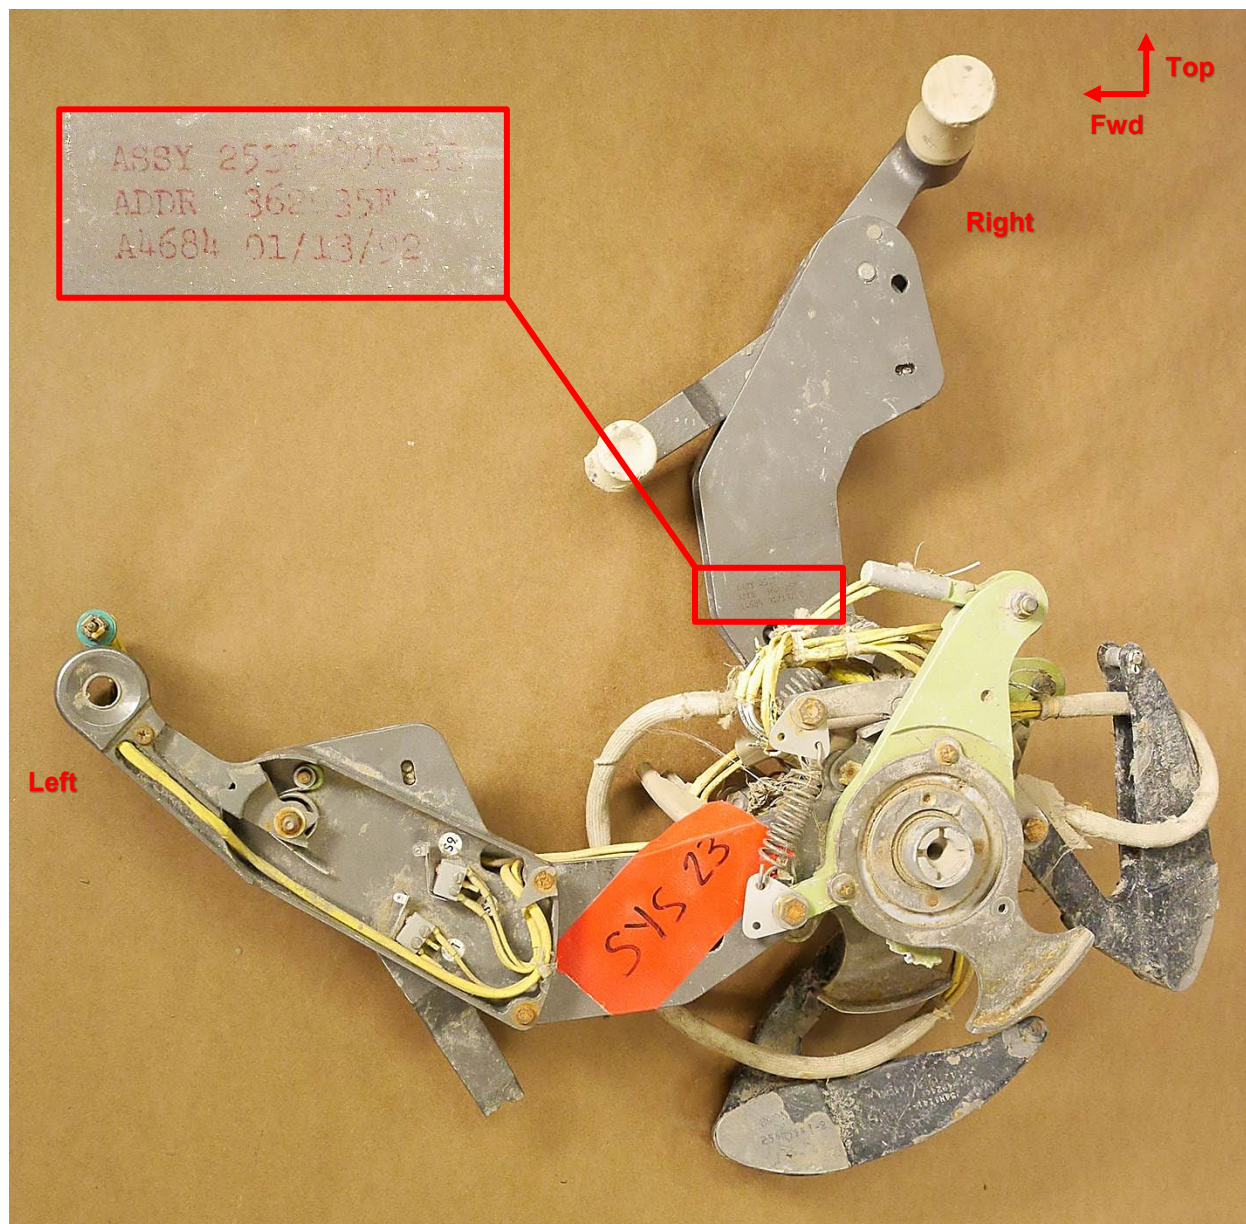
Figure 4 – TLA view from the left side

The TLA was unwrapped and photo documented prior to X-ray examination, as seen in Figure 4 and Figure 5. EQA was informed by Boeing ASI that the SYS 23 label on the left throttle lever was placed by on-site accident investigation teams for organizational purposes, and has no direct correlation to Boeing systems or part numbers.

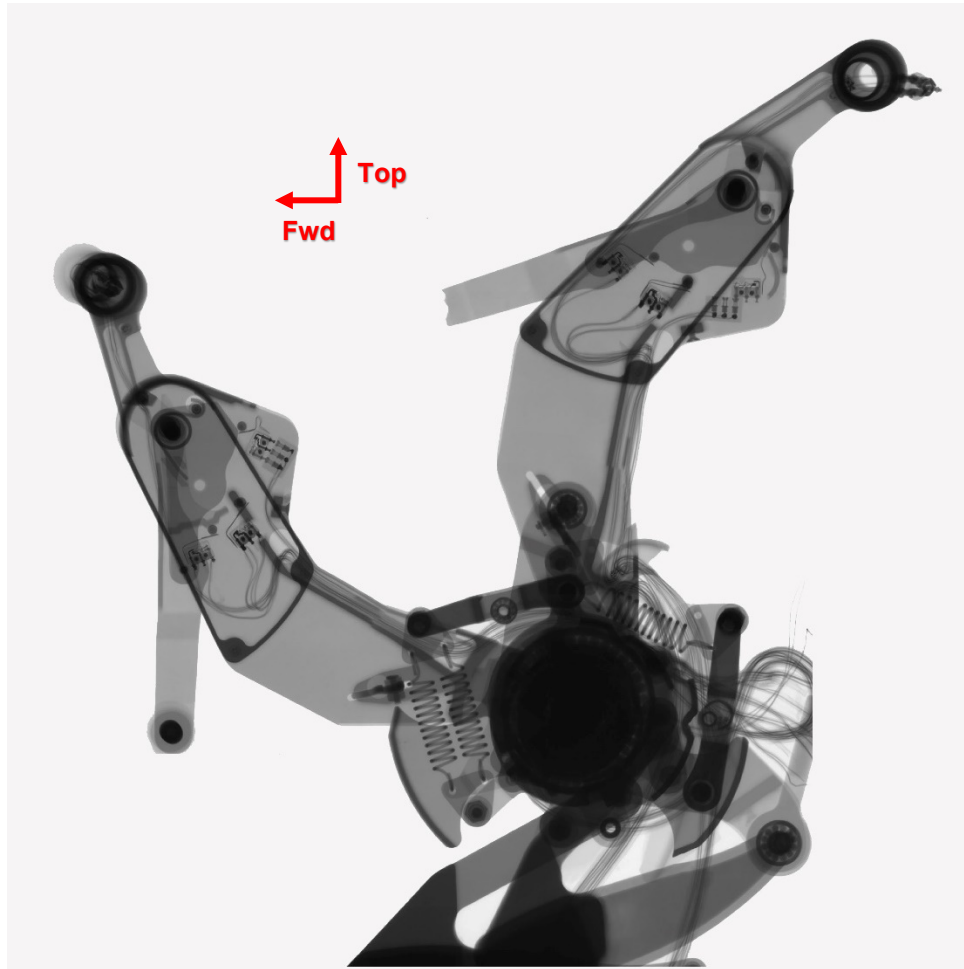
Figure 6 – DR composite image of TLA

The TLA was examined using digital radiography (DR) X-ray imagery. A composite of three DR images of the TLA is shown in Figure 6.

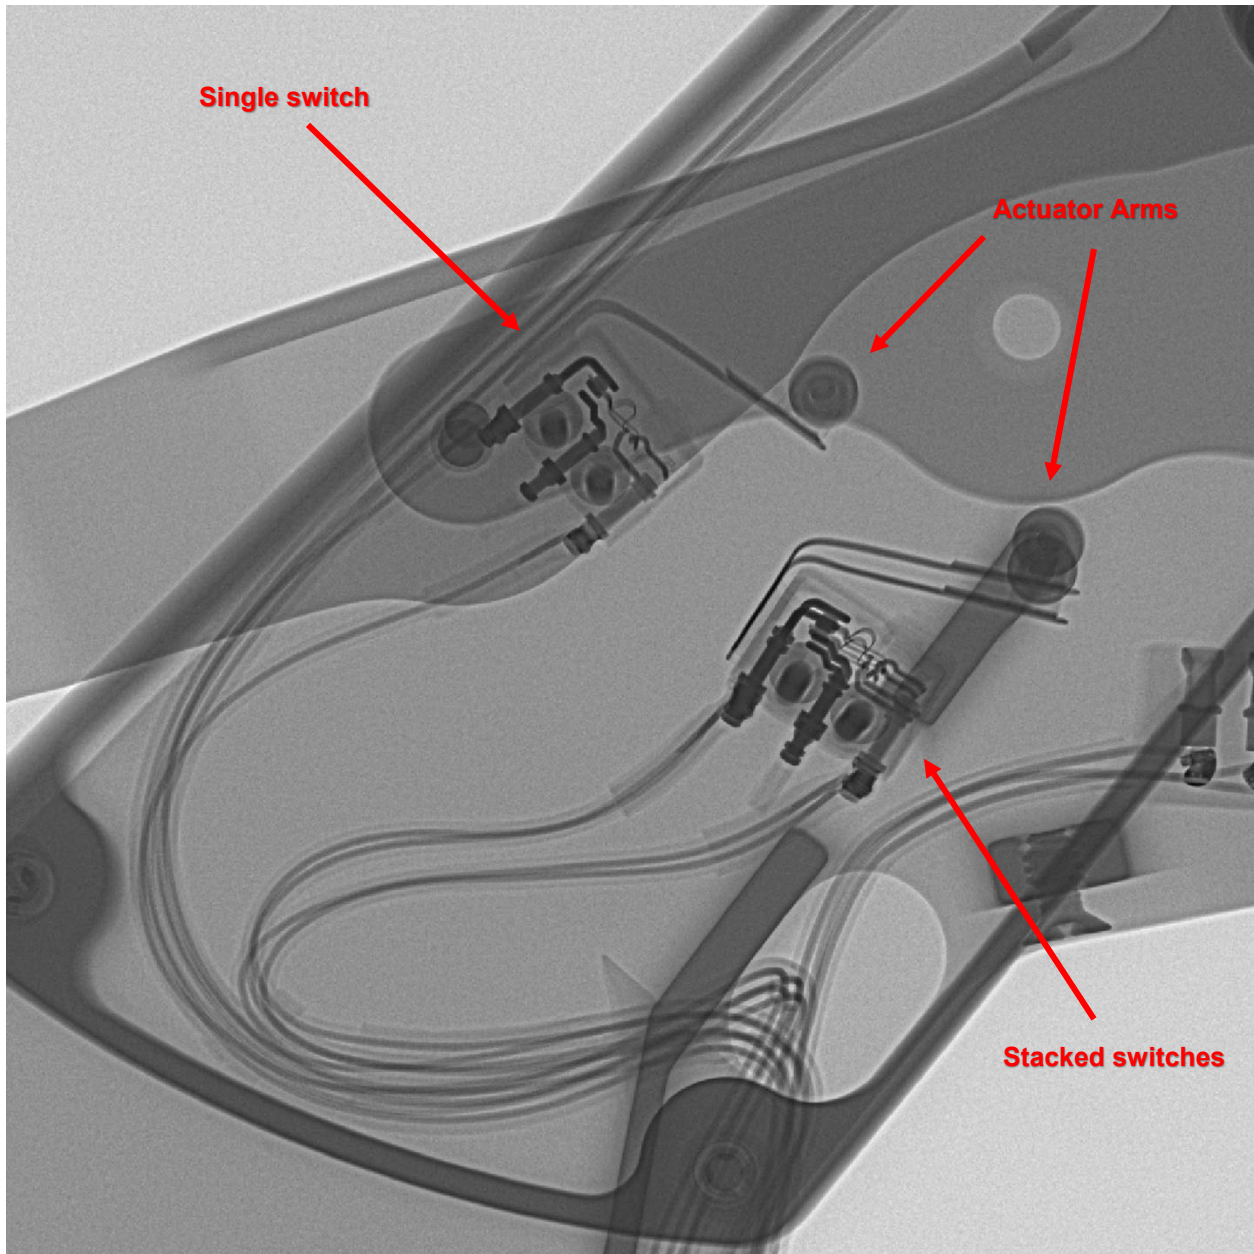
Figure 10 - Left throttle lever

The primary focus of the DR examination was on the go-around switches in each throttle lever and the associated wiring, as seen in Figure 7 through Figure 13. It was noted that the actuator arm on the right throttle single switch was depressed, depressing the associated switch, as seen in Figure 7. There was also high density material noted in the right throttle where the wiring leaves the switch cavity of the handle, shown in Figure 12. No other anomalies were observed during examination of the go-around switches and switch wiring.

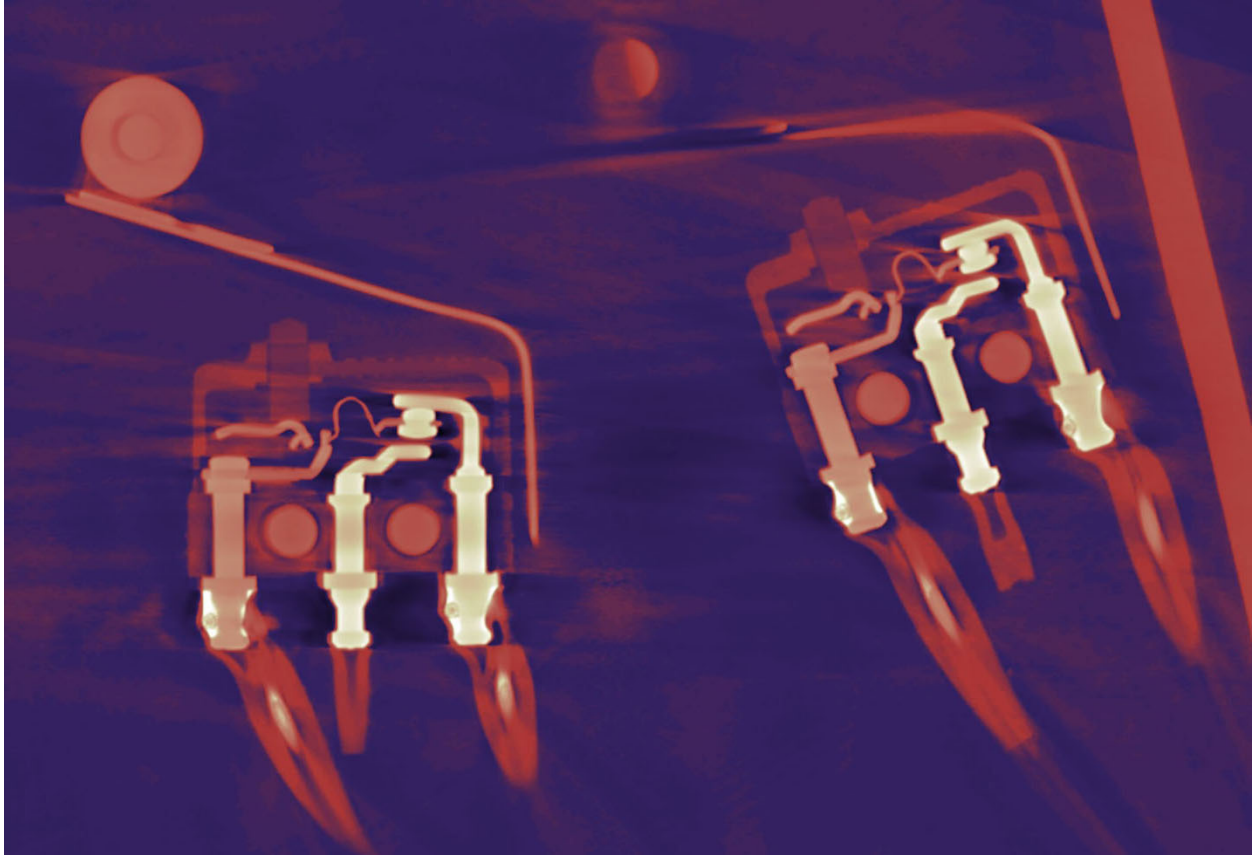
Figure 16 – CT cross section of left go-around switches

Computed Tomography (CT) scans were captured of the go-around switch areas of the left and right throttles, shown in Figure 14 through Figure 20. No anomalies were observed concerning the switch bodies, solder joints, and associated wiring, as shown in Figure 14 and Figure 18. CT cross sections of the switch assemblies, Figure 16, Figure 17, Figure 19, and Figure 20, revealed no anomalies or discrepancies. The depressed actuator arm, shown in Figure 7, was depressing the single switch, Figure 19, actuating the internal components and closing the normally open contacts.

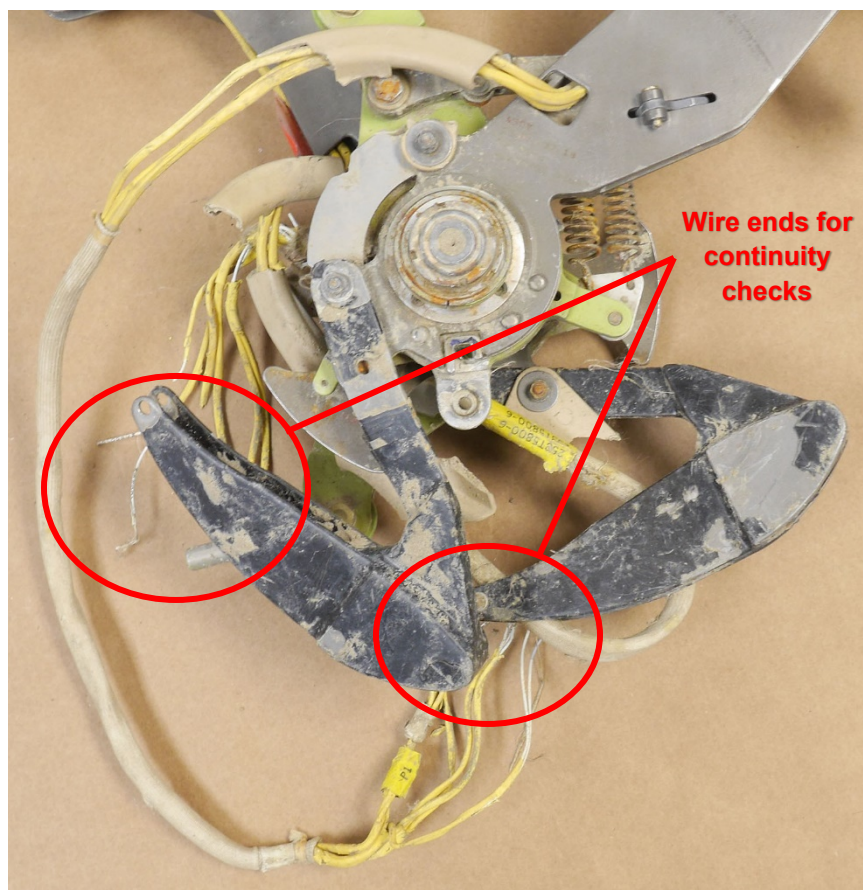
Figure 27 – TLA with wire ties removed

A continuity check of the six go-around switches was accomplished using a Fluke® Model 289 digital multimeter and reference (c) as a guide. The continuity of each switch was checked at the base of the switch and at the end of the switch's wires, at the end of their respective runs at the base of the throttle levers where the wires were severed, shown in Figure 27. For each check, the switch was actuated by pressing the actuator arm onto the switch plunger. Results of the continuity checks are shown in Table 1 and Table 2.

A continuity check of the left and right autothrottle disconnect switch wires was accomplished using a Fluke® Model 289 digital multimeter and reference (c) as a guide. The continuity of the wires was checked from the switch ring terminal to switch's wires at the end of their respective runs at the base of the throttle levers where the wires were severed, see Figure 27. The resultant values are shown in Table 3.

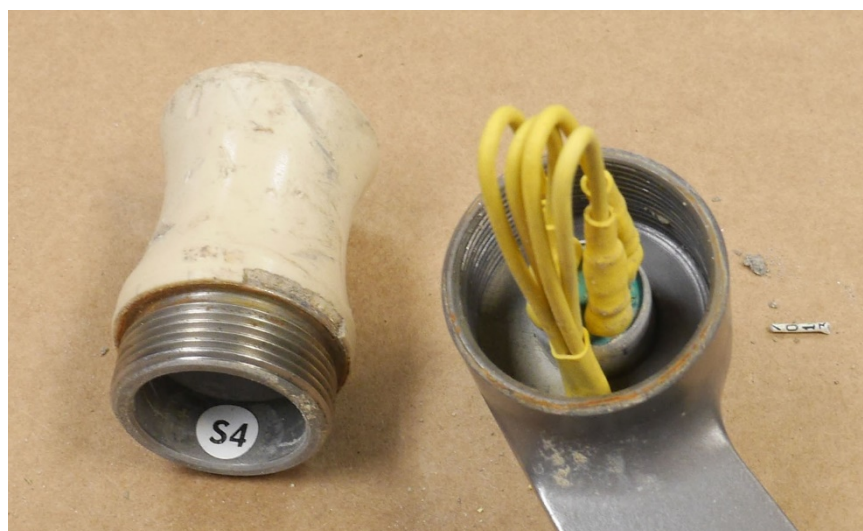
Figure 28 – Right throttle lever with knob removed for switch access

The knob was removed from the right throttle lever under direction of the NTSB, see Figure 28. Continuity checks of the right autothrottle disconnect switch at the ring terminals were performed, but no continuity in either switch position (normal or actuated) was observed.
