**NATIONAL TRANSPORTATION SAFETY BOARD**  
Office of Aviation Safety  
Washington, D.C. 20594

**Systems Group Chairman's Factual Report**

**A.    ACCIDENT            **DCA19MA086****

Location:            Trinity Bay, Texas  
Date:                February 23, 2019  
Time:                1239 central standard time  
Aircraft:            Atlas Air flight 3591, a Boeing 767-375BCF, registration N1217A

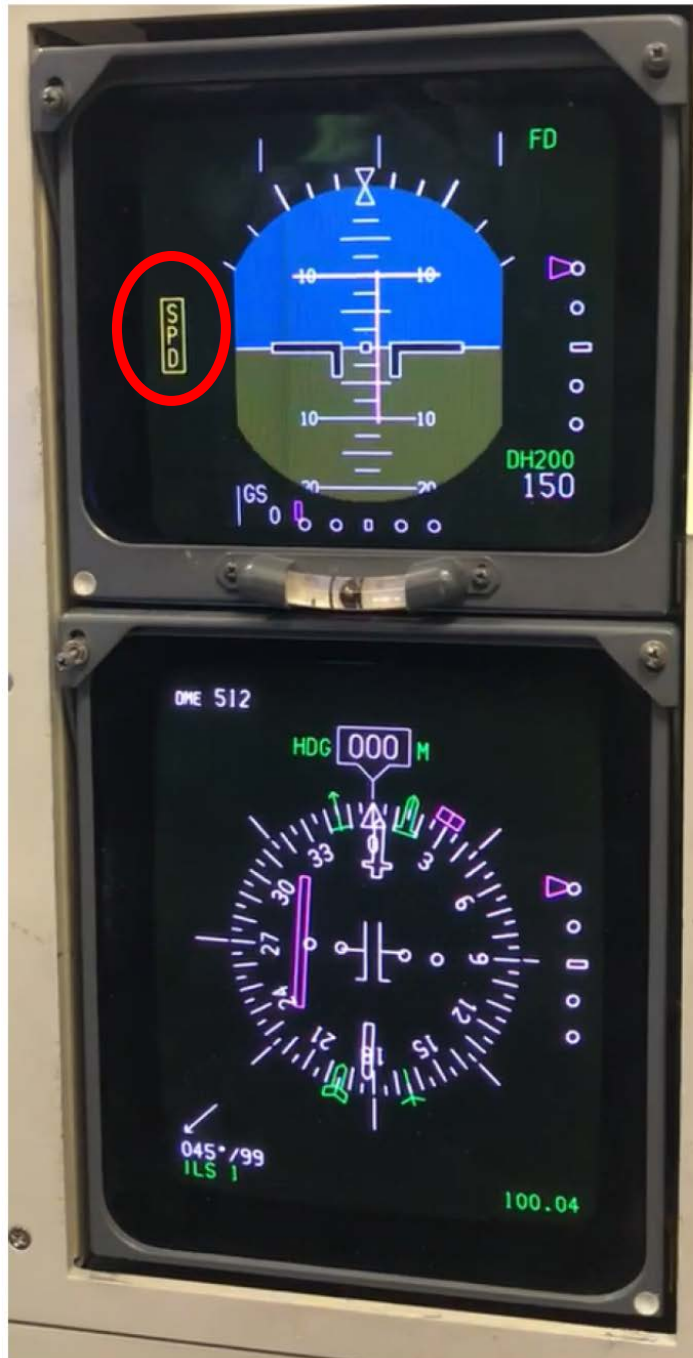
Finally, Collins Aerospace provided a picture of an EADI in a failed condition. The failure condition depicted was a failed airspeed bus source that provided airspeed information to the selected symbol generator. If the failure were due to a failure of the air data system, then the Mach/airspeed indicator would also show a failure flag. See Figure 19.

Figure 19 - EFIS Displays with Airspeed Flagged. The Airspeed Flag is circled in red.
