## **NATIONAL TRANSPORTATION SAFETY BOARD**

# **STRUCTURES**

**DCA19MA143**

**SUBJECT:**      ***Right Main Landing Gear Wire and Grease Samples***

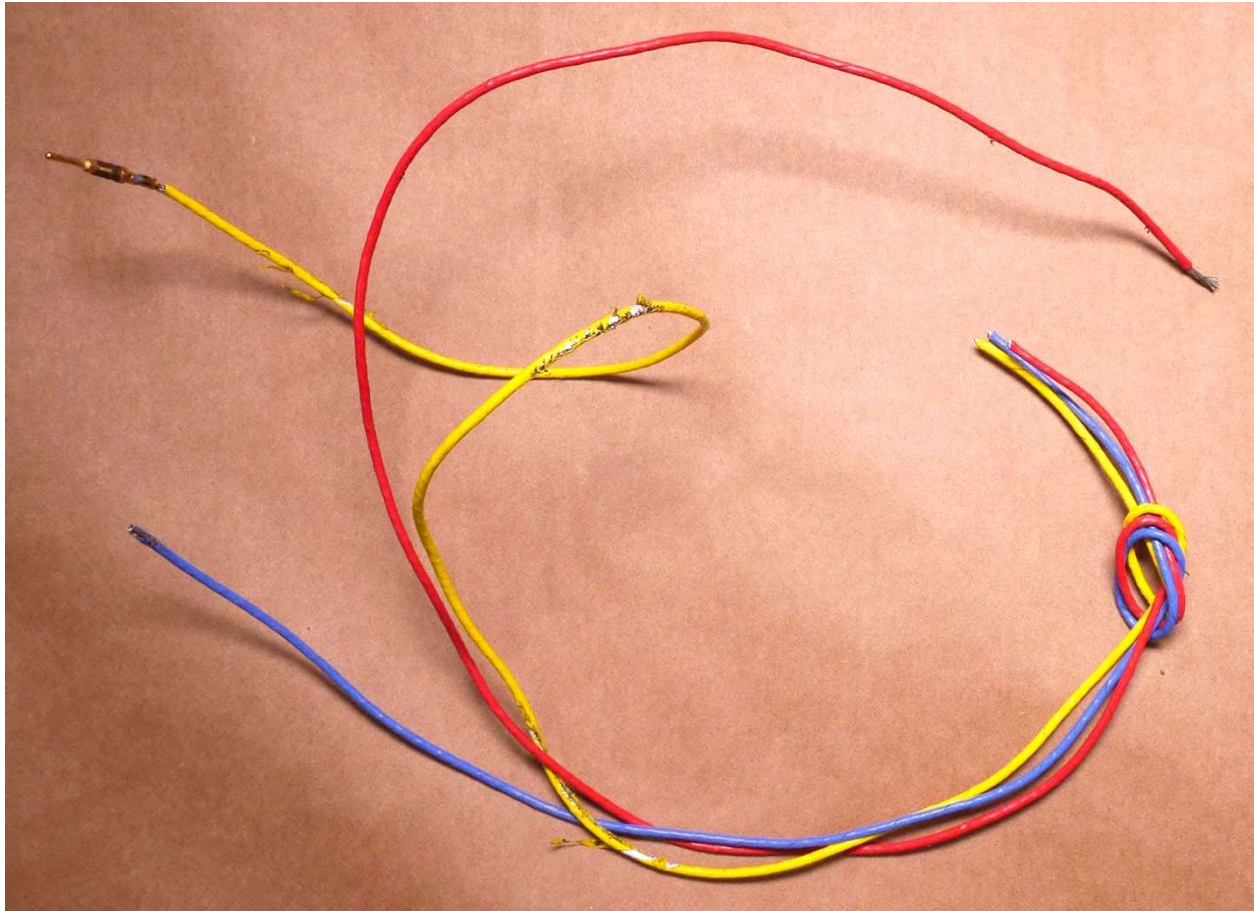
**Figure 5 – RMLG harness**

The RMLG harness was removed from the packaging for examination, Figure 5.

The RMLG wire harness had been cut for removal from the gear by on site investigators, as described by the NTSB and Boeing ASI. The cut ends of the wires are shown in Figure 6 through Figure 8.

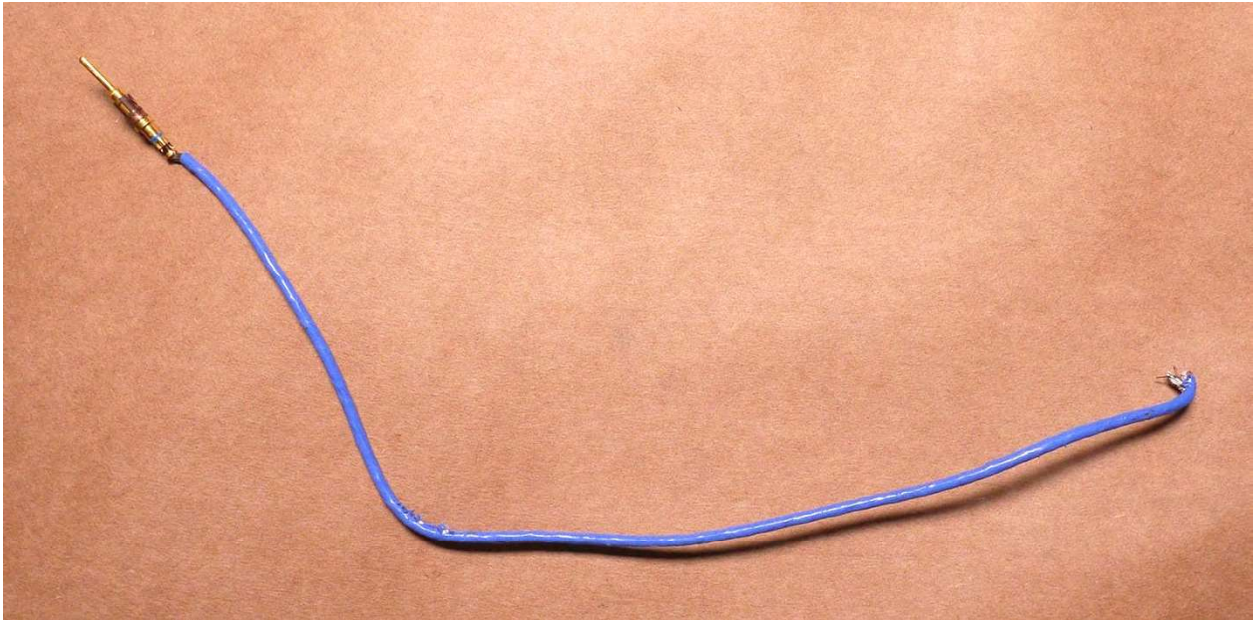
**Figure 21** – Wire section 44

Wire section 44 was removed from the packaging for examination, shown in Figure 21.

Wire section 44 was noted to have a pin contact on one end, Figure 22, with the opposite end fractured and bent to approximately ninety degrees, Figure 23. The wire was measured at 9.875 inches from the bent fracture end to the end of the pin contact, approximately 10 inches with the fractured end straightened. Two areas of damage to the wire jacket were noted.

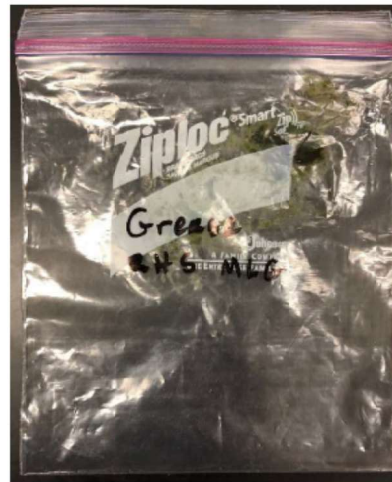
Grease RHS MLG

Both grease samples were very similar in overall chemistry; there was slight differences in the ratio of the base oil to thickener components between the two samples.

Both greases are consistent with BMS3-33.
