NATIONAL TRANSPORTATION SAFETY BOARD

Factual Report

METEOROLOGY

DCA19MA143

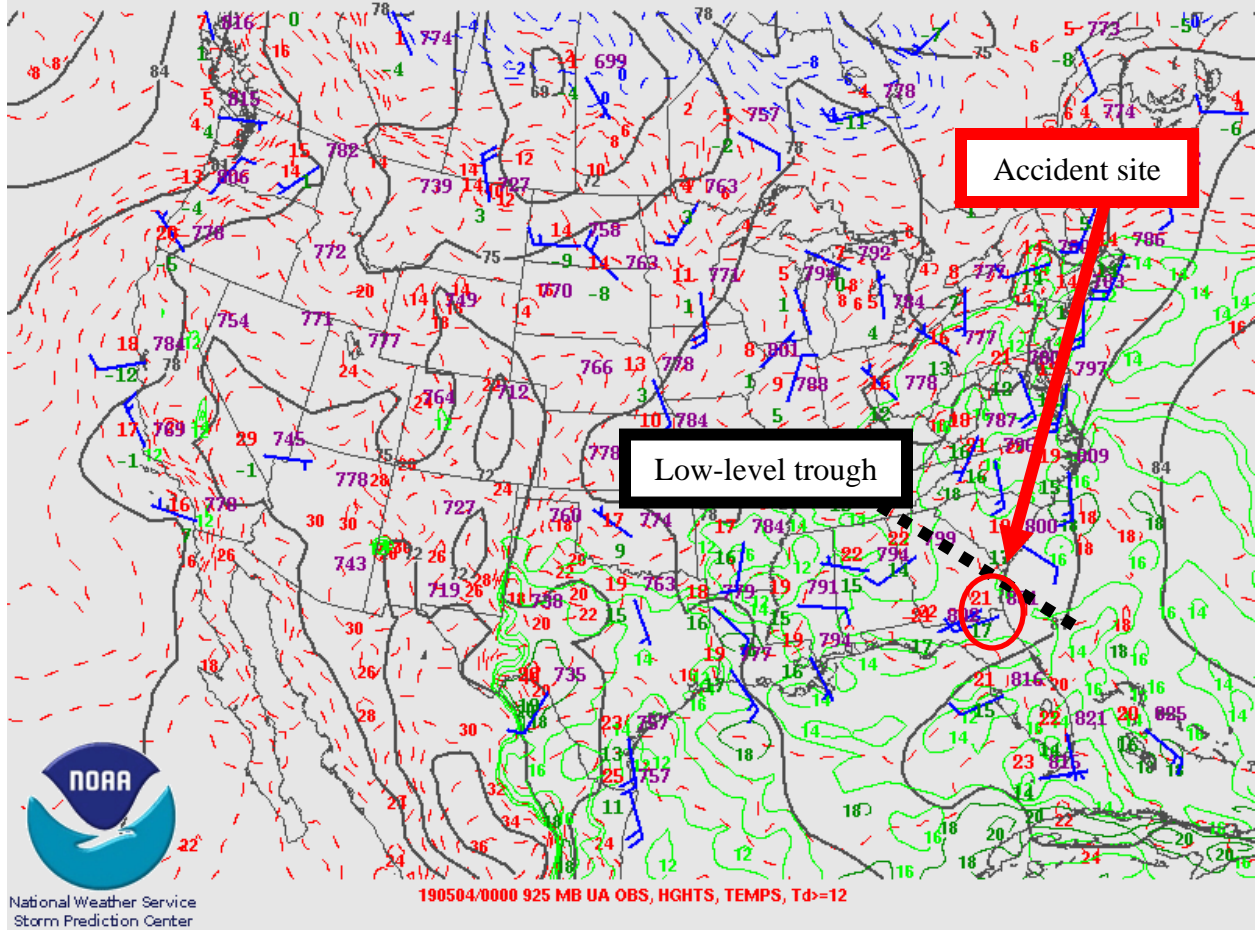
Figure 2 – 925-hPa Constant Pressure Chart for 2000 EDT

The NWS Storm Prediction Center (SPC) Constant Pressure Charts for 2000 EDT at 925-, 850-, 700-, 500-, and 300-hPa are presented in figures 2 through 6. There were low- and mid-level troughs located above and just northeast of the accident site from 925- through 500-hPa. These low- and mid-level troughs were associated with the surface trough in southern Georgia (figure 1). There was a west wind of 10 knots at 925-hPa above the accident site with the wind becoming northwesterly by 700-hPa (figure 4) with the wind speed at 10 knots. By 300-hPa, the wind above the accident site was from the south and the wind speed increased to 30 knots (figure 6).

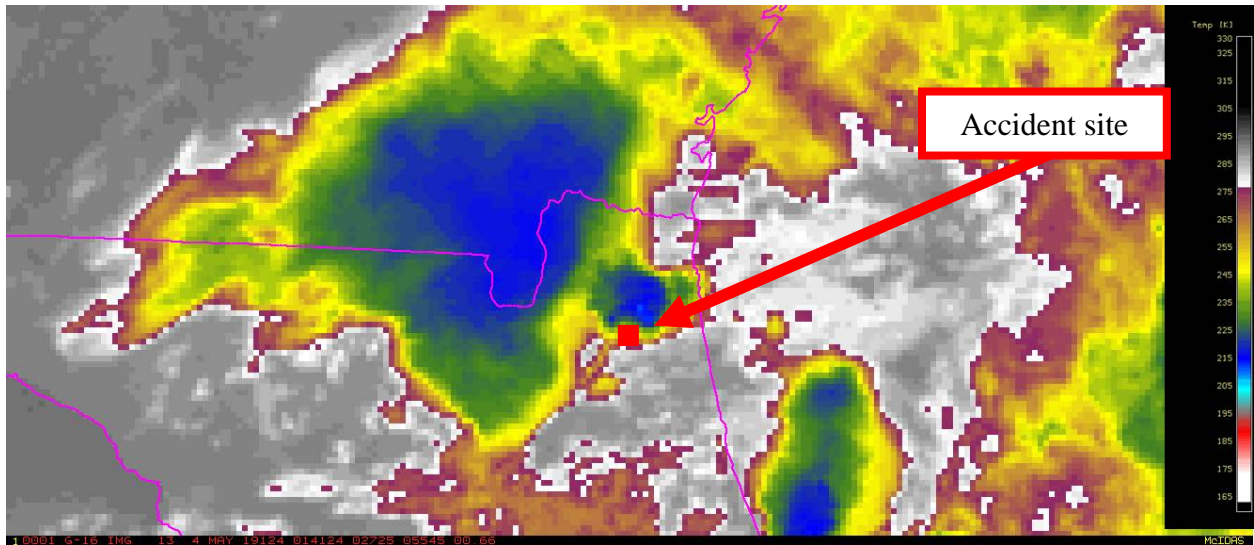
Figure 15 – GOES-16 infrared image at 2141 EDT

Figures 15, 16, and 17 present the GOES-16 infrared imagery from 2141 and 2146 EDT at 6X magnification with the accident site highlighted with a red square (red circle in figure 17). Inspection of the infrared imagery indicated cloud cover over the accident site. The lower brightness temperatures (blue and green colors; higher cloud tops) were located above and to the northeast and northwest of the accident site. There was a rapid increase in geostationary lightning mapper (GLM)¹⁵ targets after 2100 EDT above the accident site with GLM indicated lightning flashes at the accident site at the accident time (attachment 5). The cloud cover was continuing to expand with time after 2100 EDT and the higher cloud tops were moving from southwest to northeast (attachment 5). Based on the brightness temperatures above the accident site and the vertical temperature profile provided by the 2000 EDT KJAX sounding, the approximate cloud-

top heights over the accident site were 24,000 ft at 2146 EDT (253° Kelvin). It should be noted these figures have not been corrected for any parallax error.

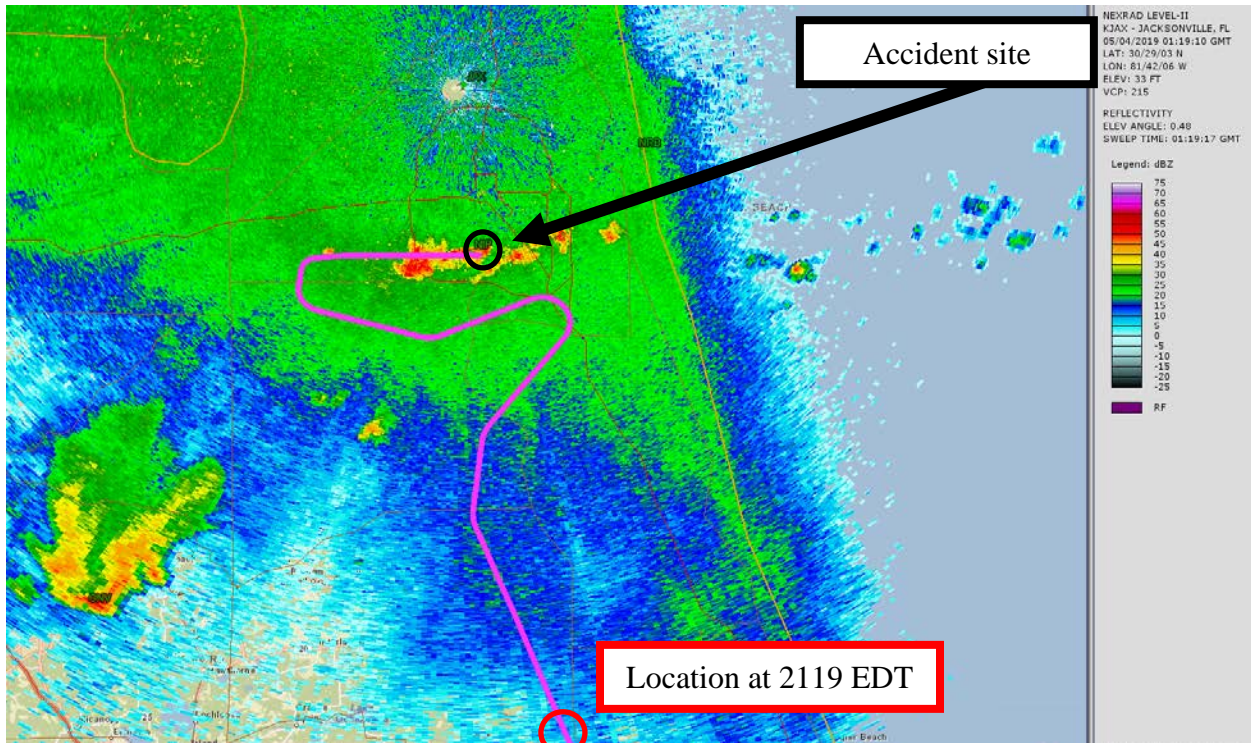
Figures 19, 20, 21, 22, and 23 present the KJAX WSR-88D base reflectivity images for the 0.5° elevation scans initiated at 2119:17, 2125:15, 2131:27, 2137:33, and 2143:17 EDT, respectively, with a resolution of 0.5° X 250 m, with the flight track overlaid. Reflectivity values between 40 and 55 dBZ were located above the accident site at the accident time. Reflectivity values above 40 dBZ were located above KNIP as early as 2055 EDT (attachment 7). The reflectivity bands were moving from west to east (attachments 7). The radial velocity data indicated velocity targets heading away from KJAX and KNIP at the accident time with increasing strength to the east and southeast of KNIP after the accident time (attachment 8).

Figure 19 – KJAX WSR-88D reflectivity for the 0.5° elevation scan initiated at 2119:17 EDT with the accident site marked with black circle and the accident flight track in pink

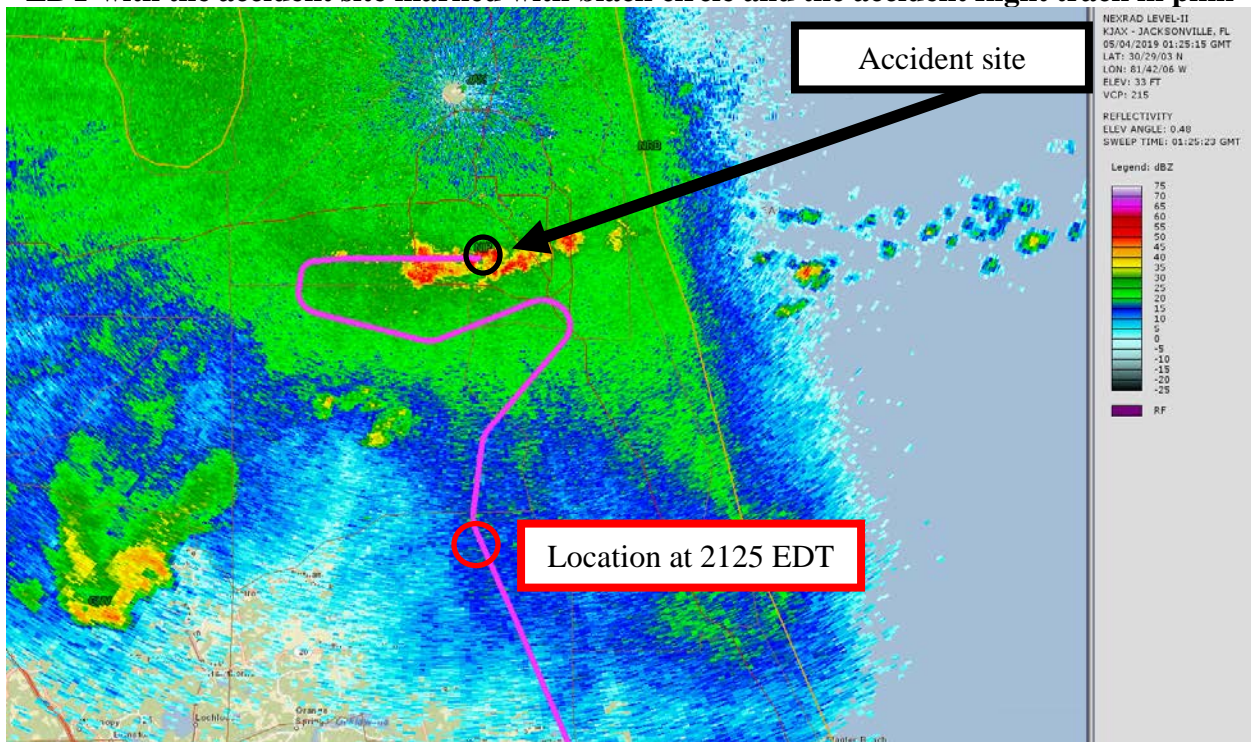
Figure 20 – KJAX WSR-88D reflectivity for the 0.5° elevation scan initiated at 2125:15 EDT with the accident site marked with black circle and the accident flight track in pink

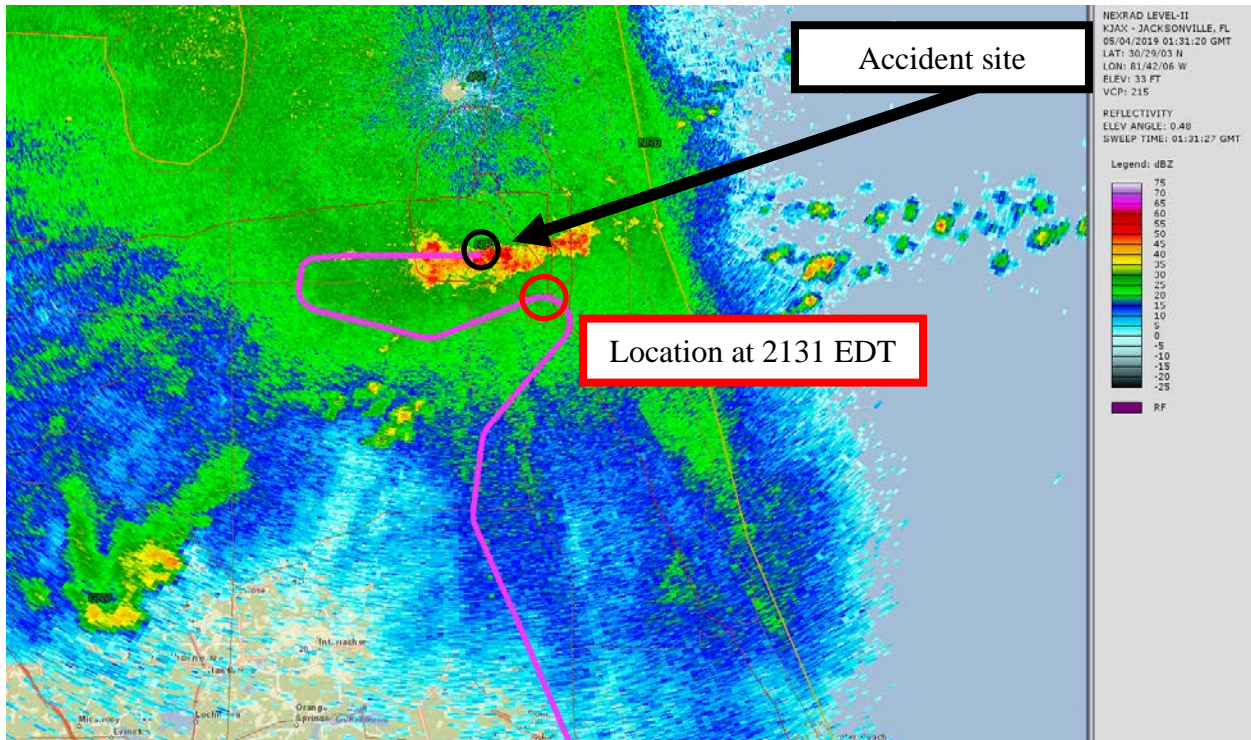
Figure 21 – KJAX WSR-88D reflectivity for the 0.5° elevation scan initiated at 2131:27 EDT with the accident site marked with black circle and the accident flight track in pink

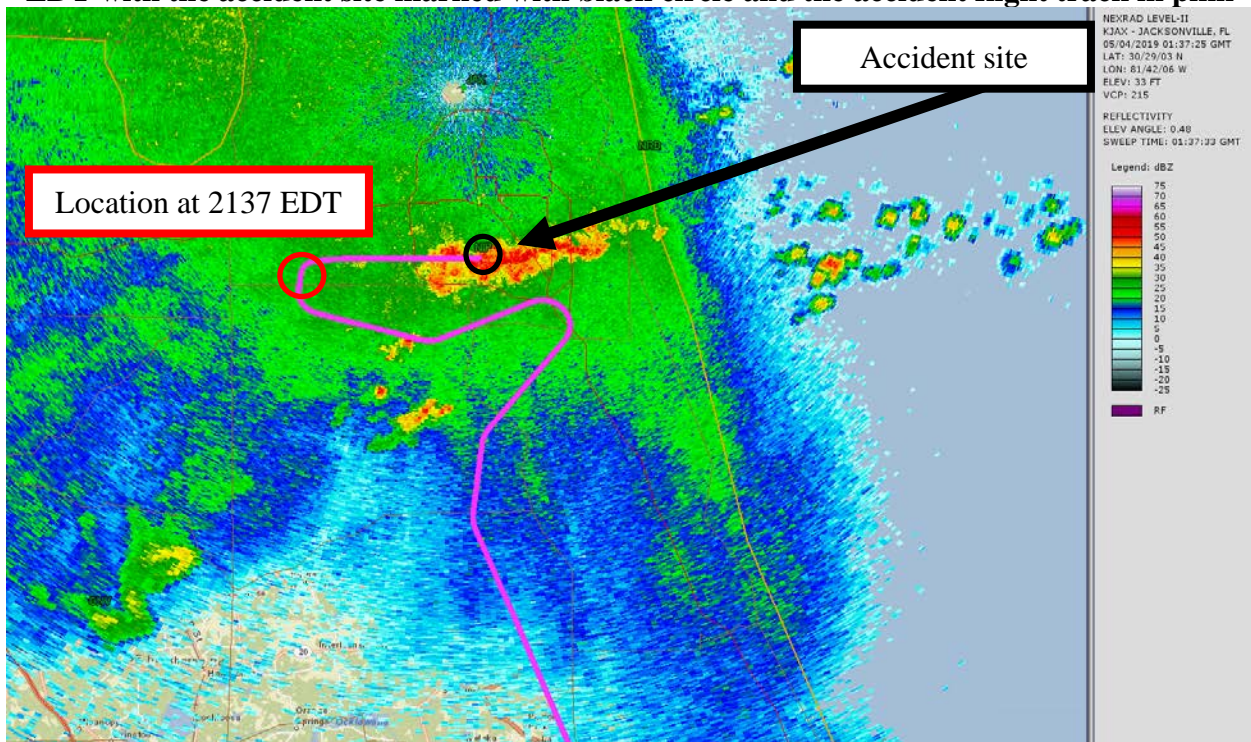
Figure 22 – KJAX WSR-88D reflectivity for the 0.5° elevation scan initiated at 2137:33 EDT with the accident site marked with black circle and the accident flight track in pink

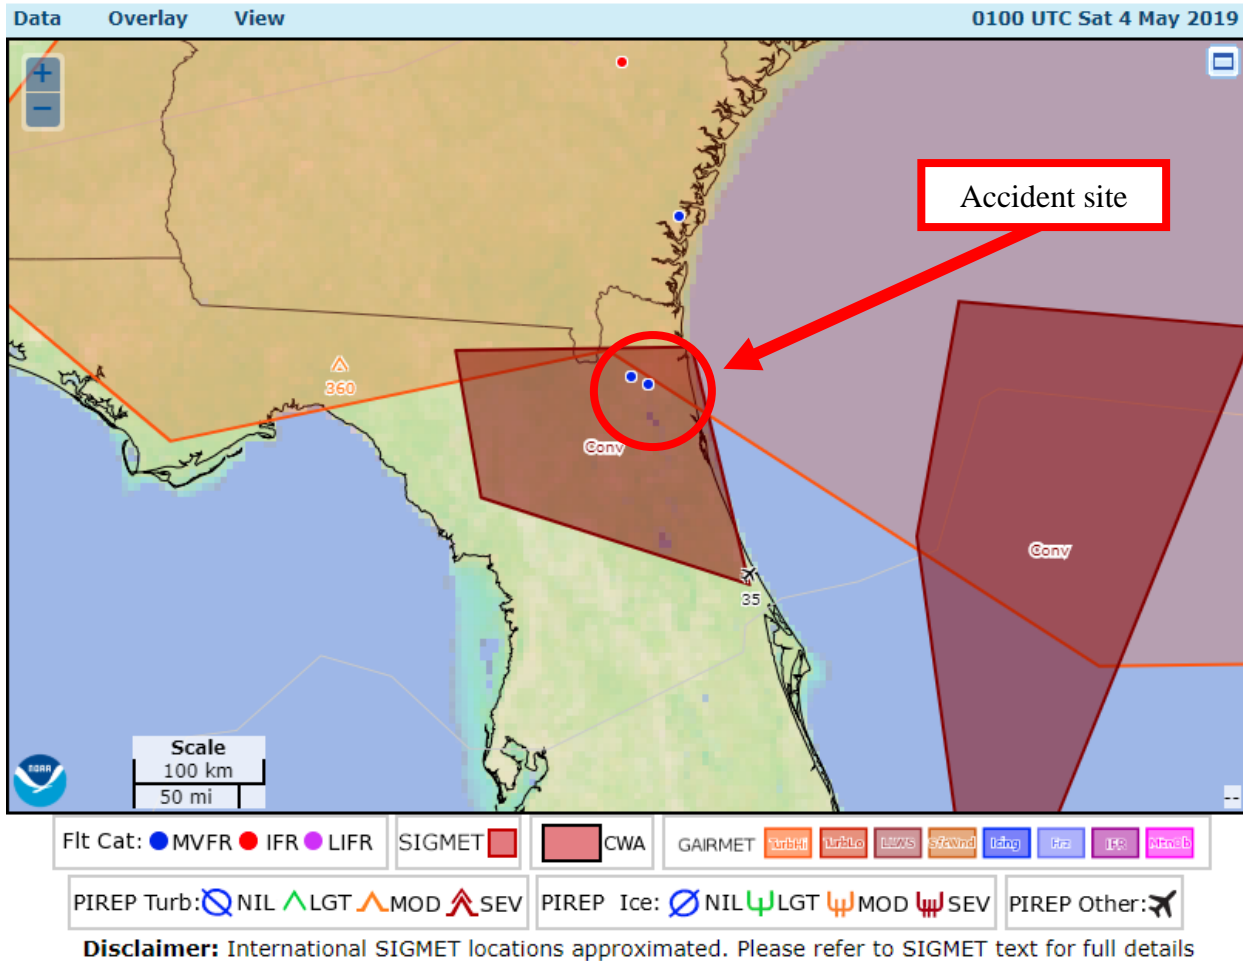
Figure 25 – SIGMETs, AIRMETs, and CWAs valid at 2100 EDT through the accident time

There were several Convective Significant Meteorological Information (SIGMET) advisories issued surrounding the period of the accident.. Convective SIGMET 25E was issued at 1955 EDT and valid through 2155 EDT and it warned of an area of thunderstorms with tops to FL450 with the area movement from 250° at 10 knots. The advisory was updated by Convective SIGMET 3E at 2055 EDT, which was current at the time of the accident and valid through 2255 EDT and it warned of an area of thunderstorms moving little with tops above FL450 (figure 25).²⁶:

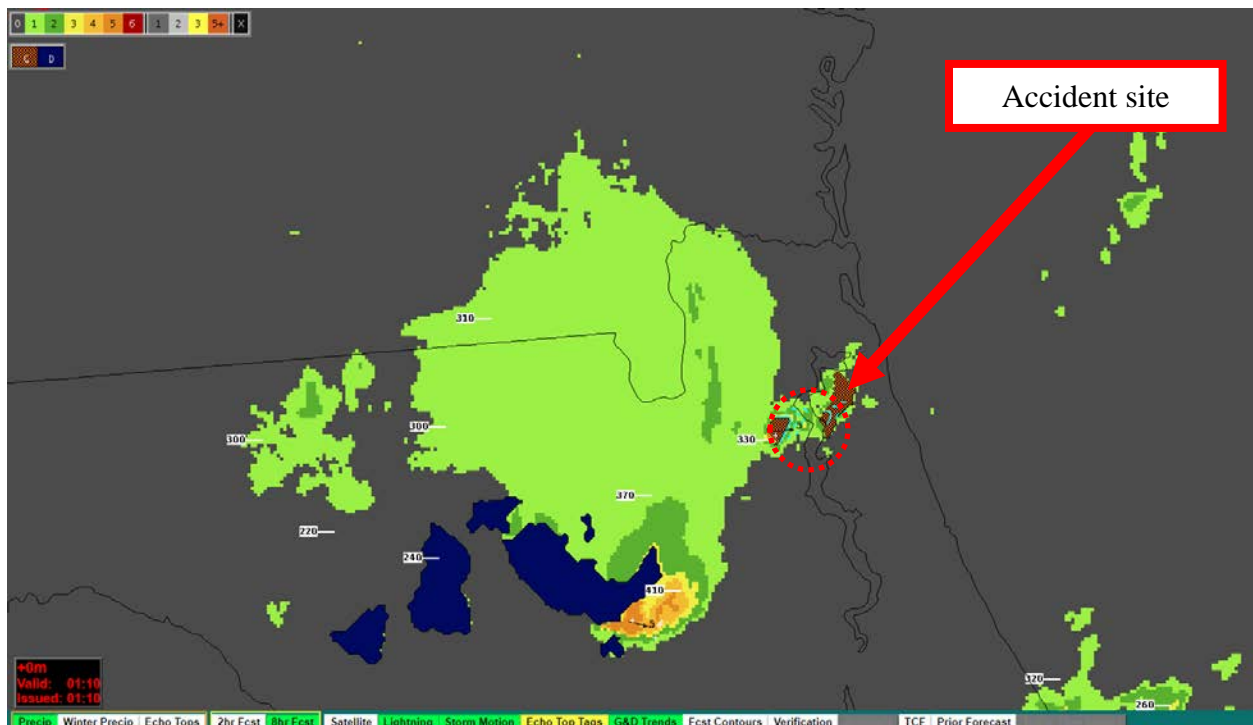
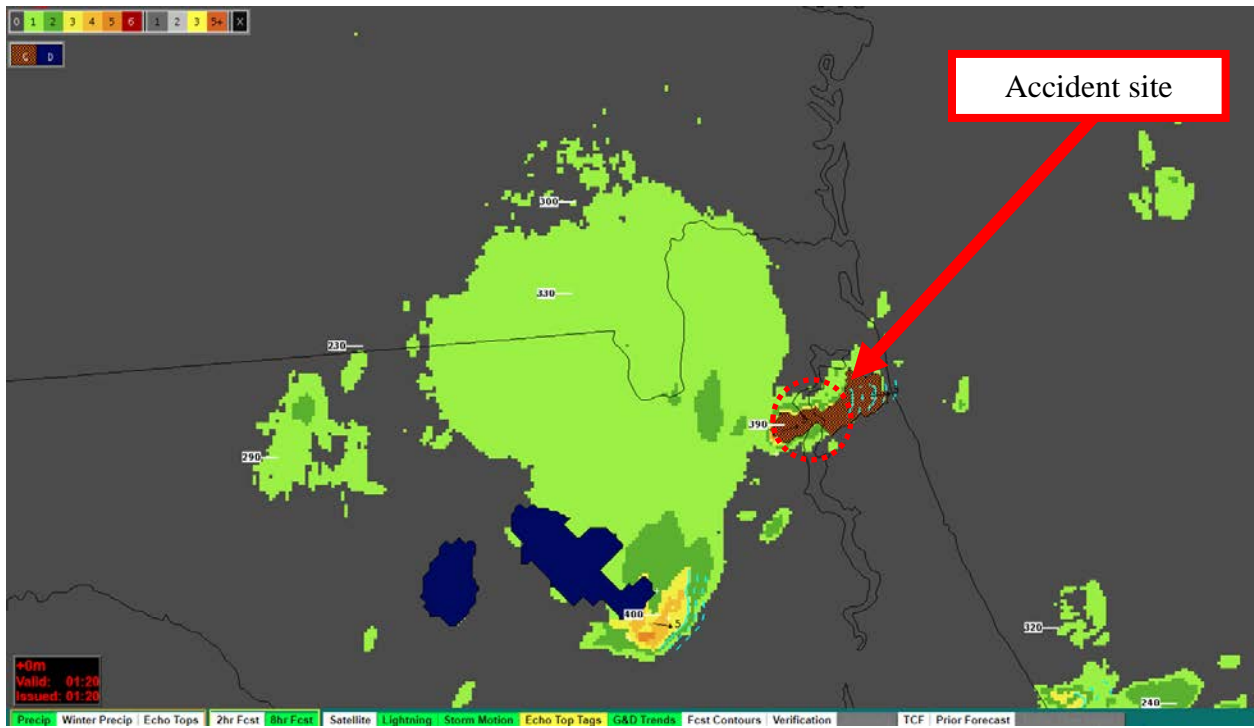
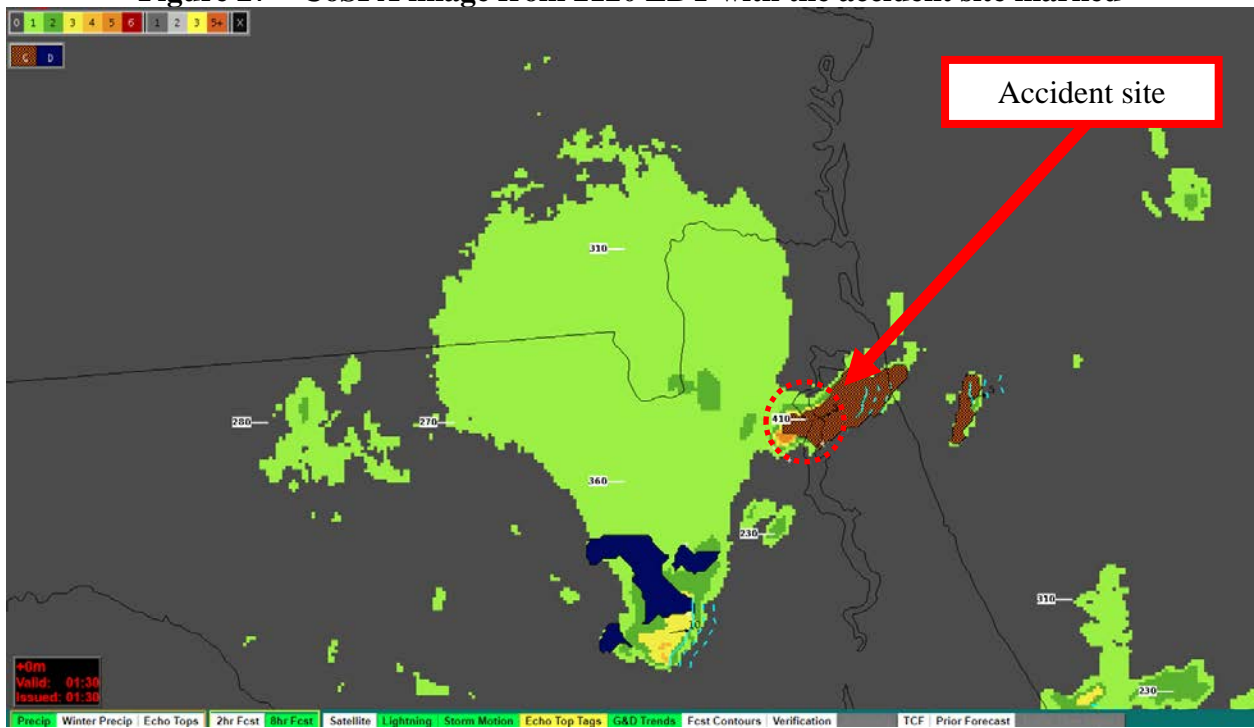
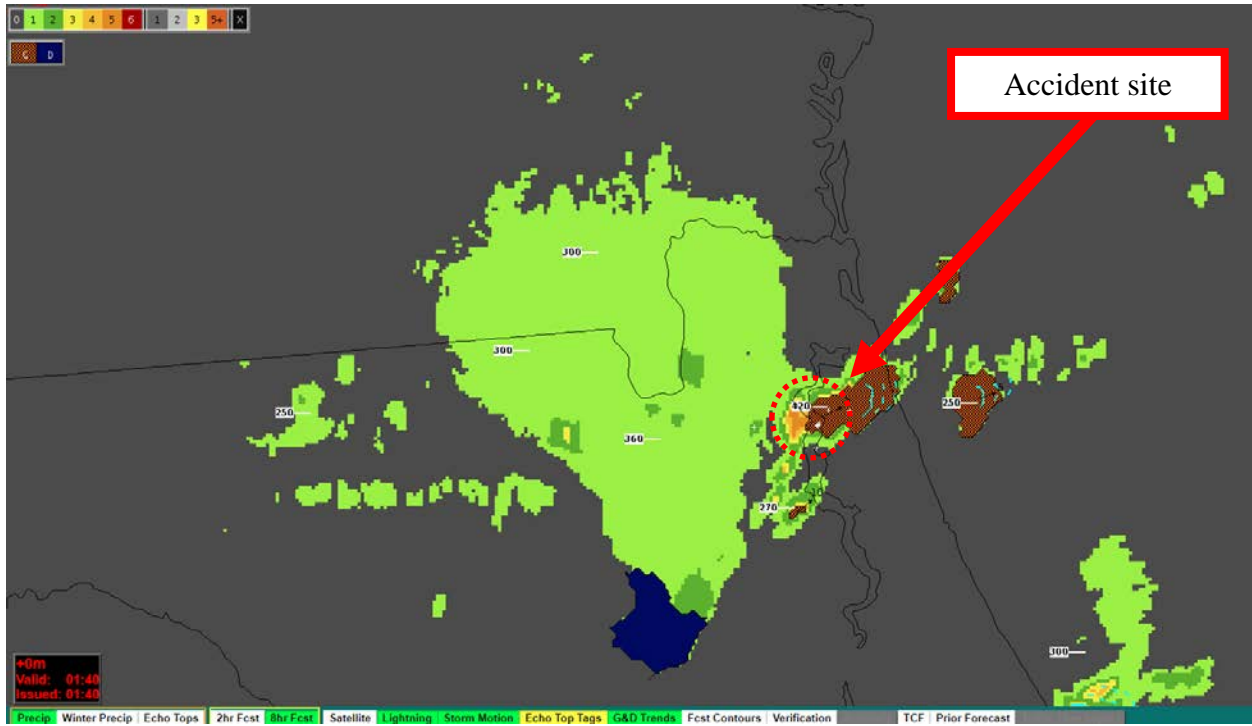
The FAA Air Route traffic Control Centers (ARTCC) managers and CWSU use the Consolidated Storm Prediction for Aviation (CoSPA) to display WSR-88D imagery, with lightning data, echo tops, movement, and growth and decay predictions in one display system. The CoSPA images were retrieved for 2110, 2120, 2130, and 2140 EDT and provided in figures 26 through 29 with the accident site marked. The CoSPA, along with depicting NWS weather radar VIP levels, lightning data, weather satellite, and storm motion, forecast areas of likely rain shower or thunderstorm growth (orange hatched areas) and areas of likely rain shower or thunderstorm dissipation (blue hatched areas). The thunderstorm and rain shower activity was moving from west to east around 5 knots with CoSPA forecast areas of rain shower or thunderstorm growth over the accident site from 2110 EDT onward (orange hatched areas). The accident site located in an area of VIP level values of 4 to 5 (section 7.3) and CoSPA cloud top values indicated to FL420.

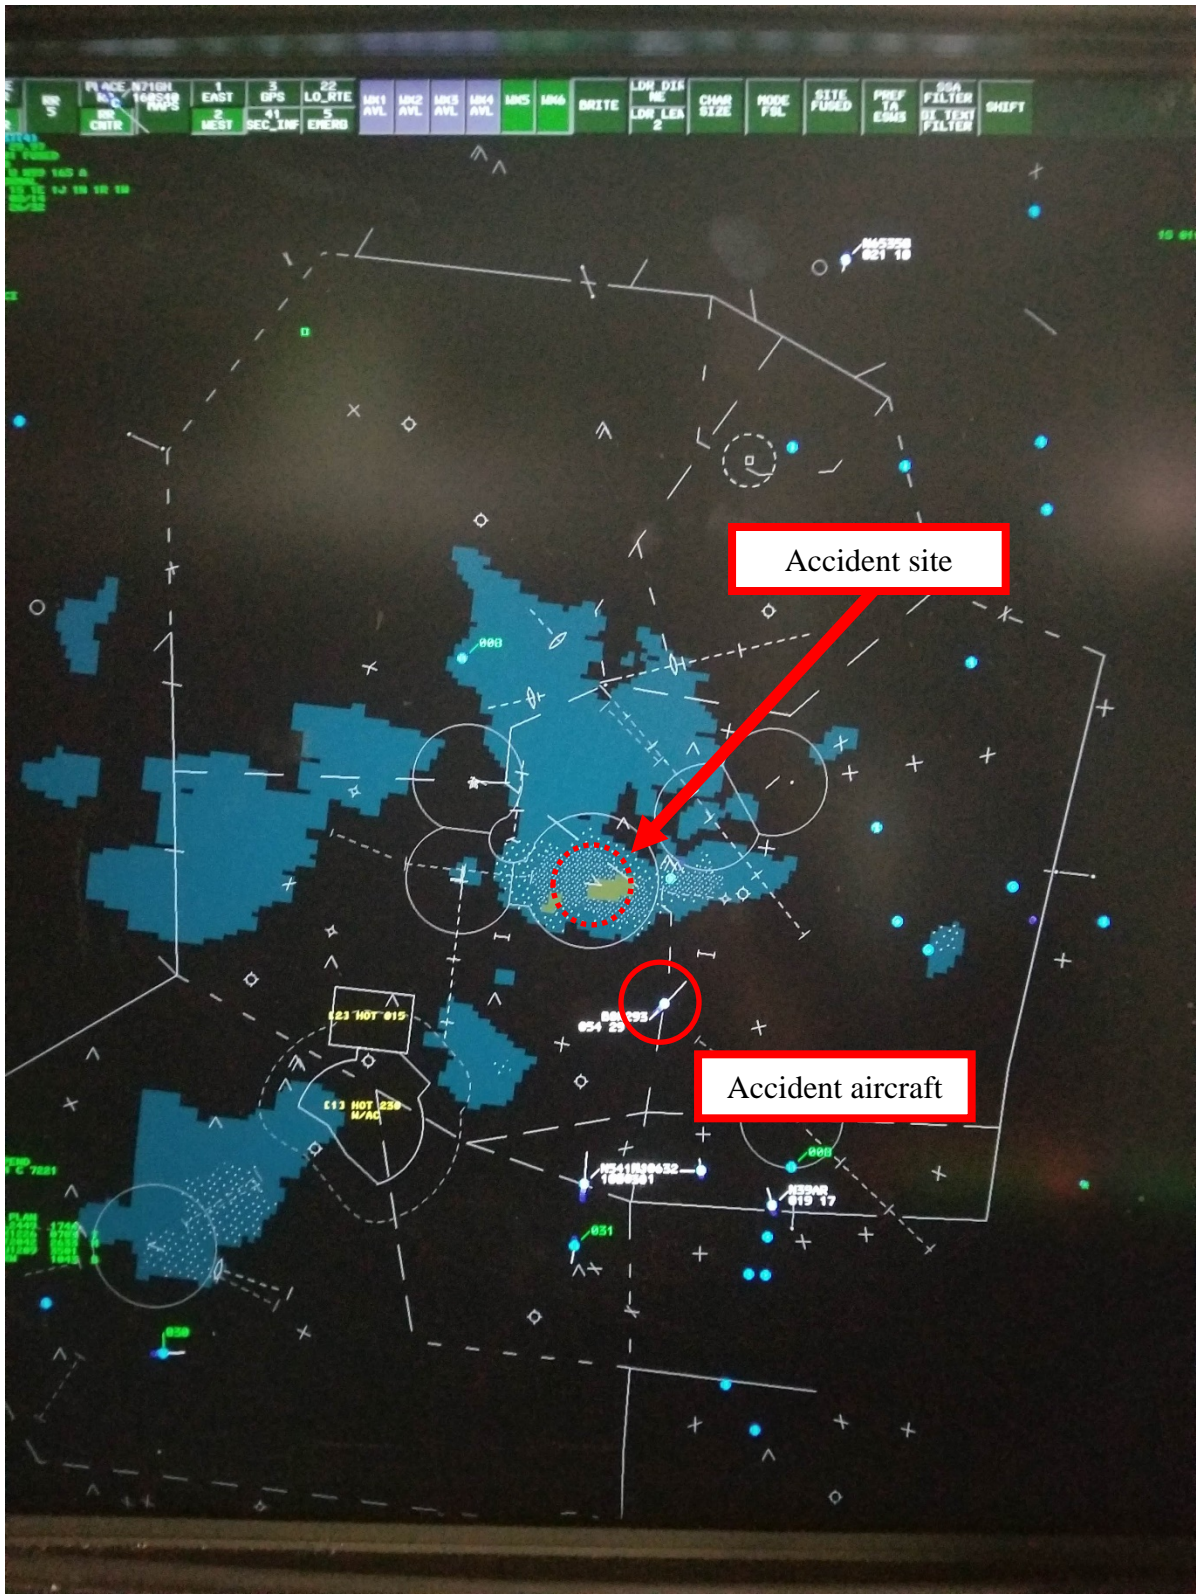
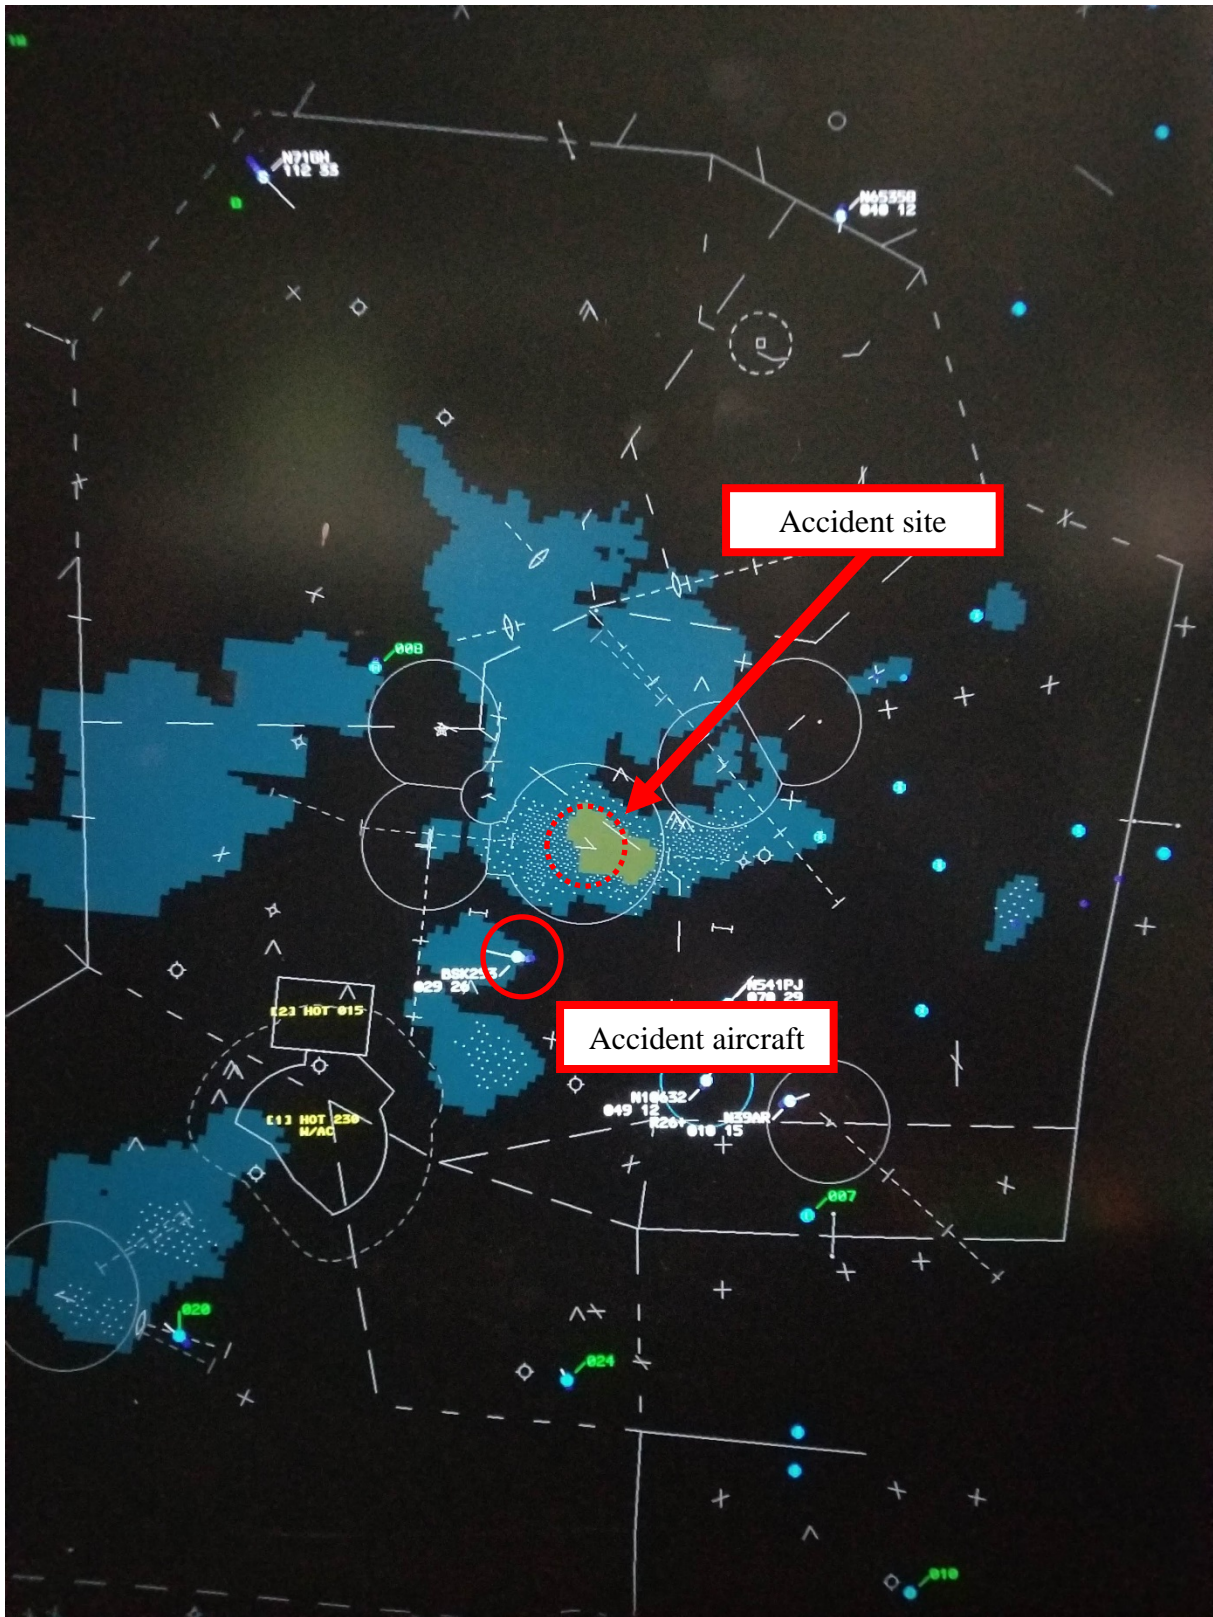
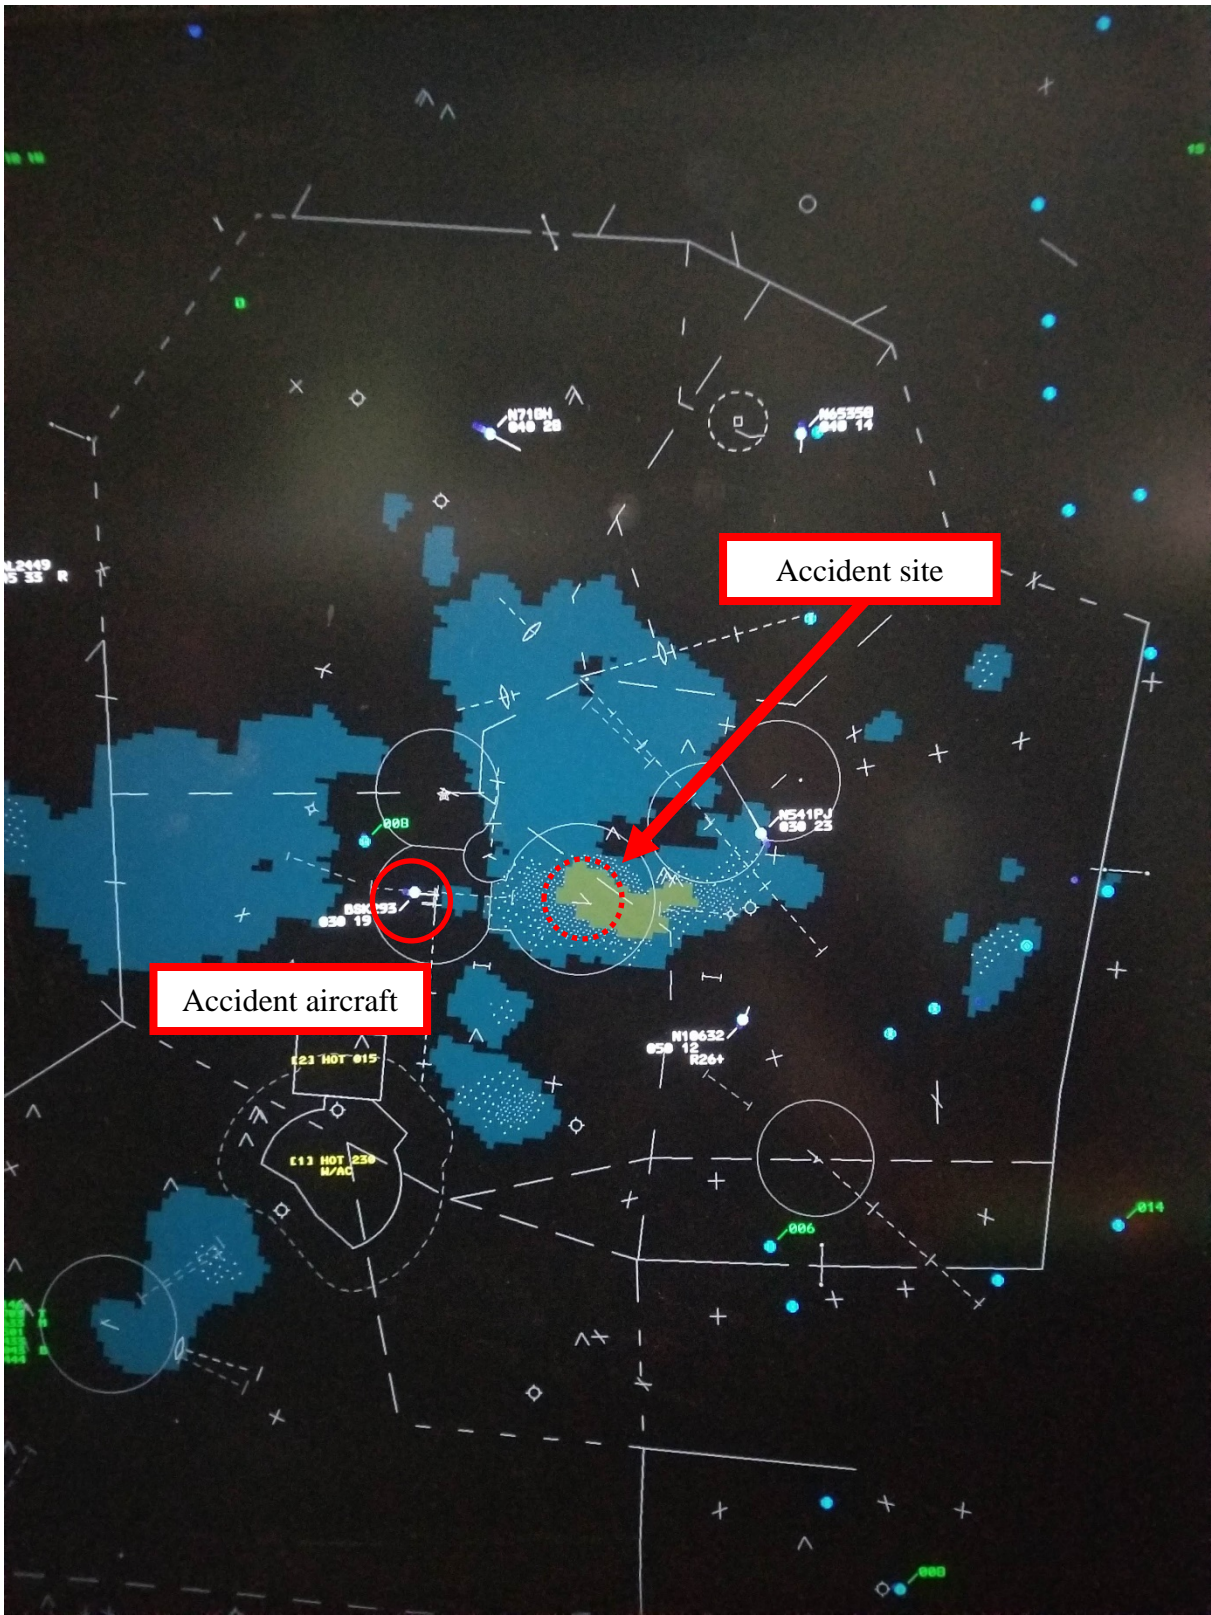
Figure 30 provides an exemplar view of what precipitation levels 1 through 6 look like on STARS display of precipitation. Figures 31 through 34 show the STARS display of precipitation used and seen by Jacksonville TRACON ATC at 2130, 2134, 2138, and 2142 EDT. Between 2130 and 2142 EDT level 3 and 4 precipitation (moderate to heavy precipitation) was indicated over KNIP. For more data please see attachment 12.
