NATIONAL TRANSPORTATION SAFETY BOARD

Factual Report

METEOROLOGY

DCA19MA143

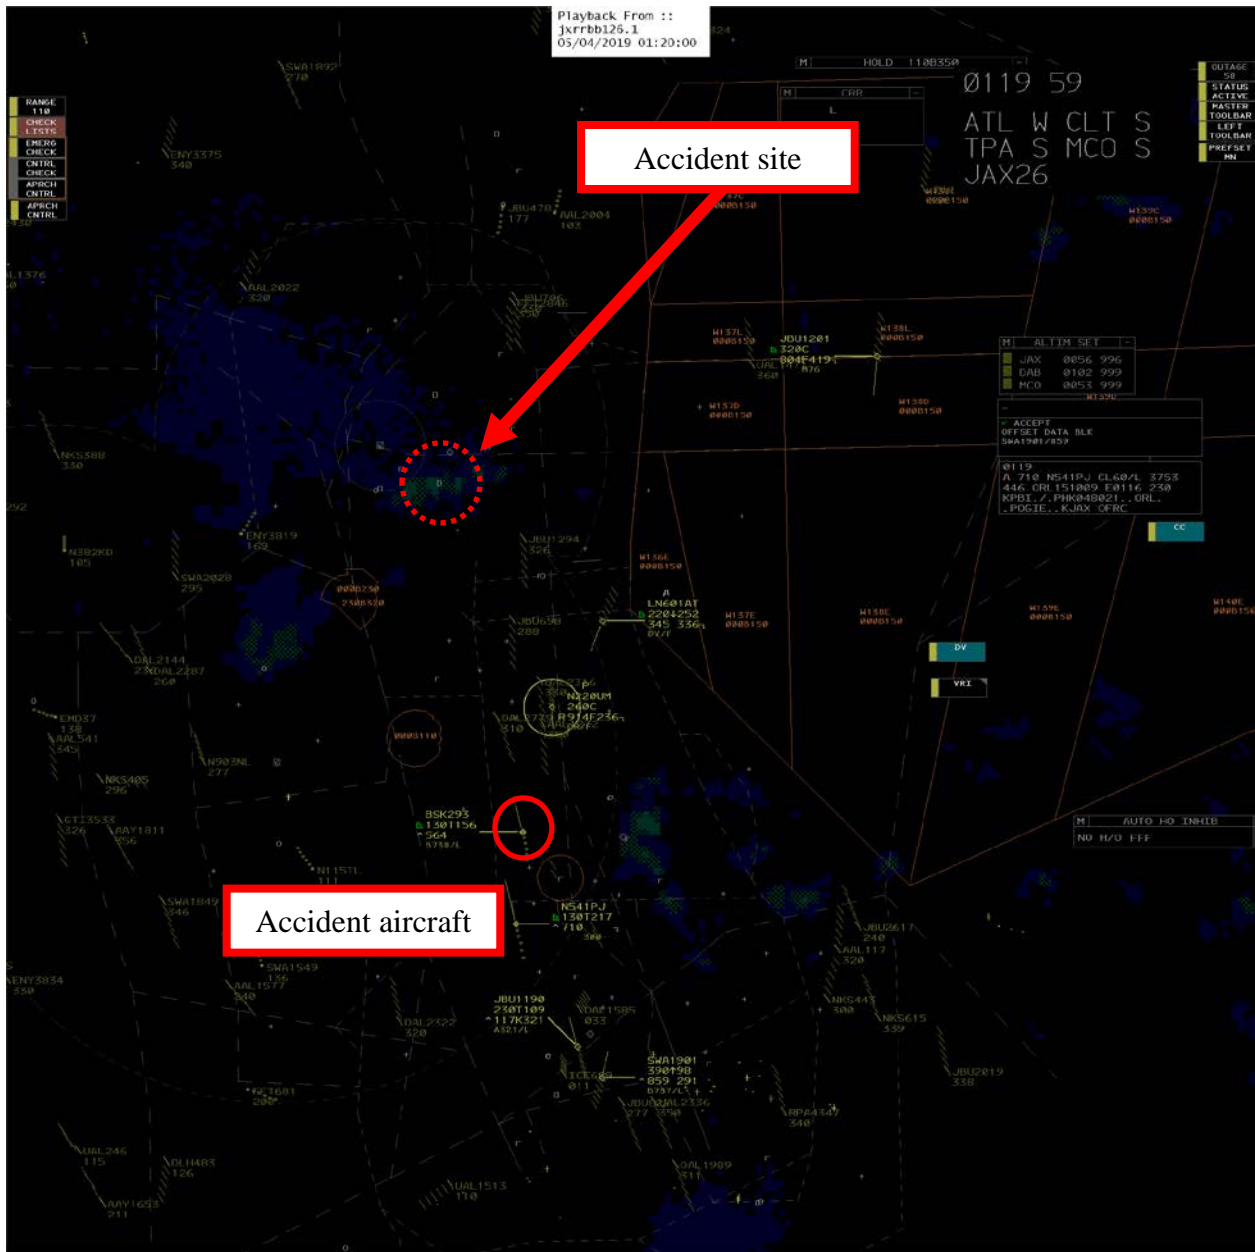
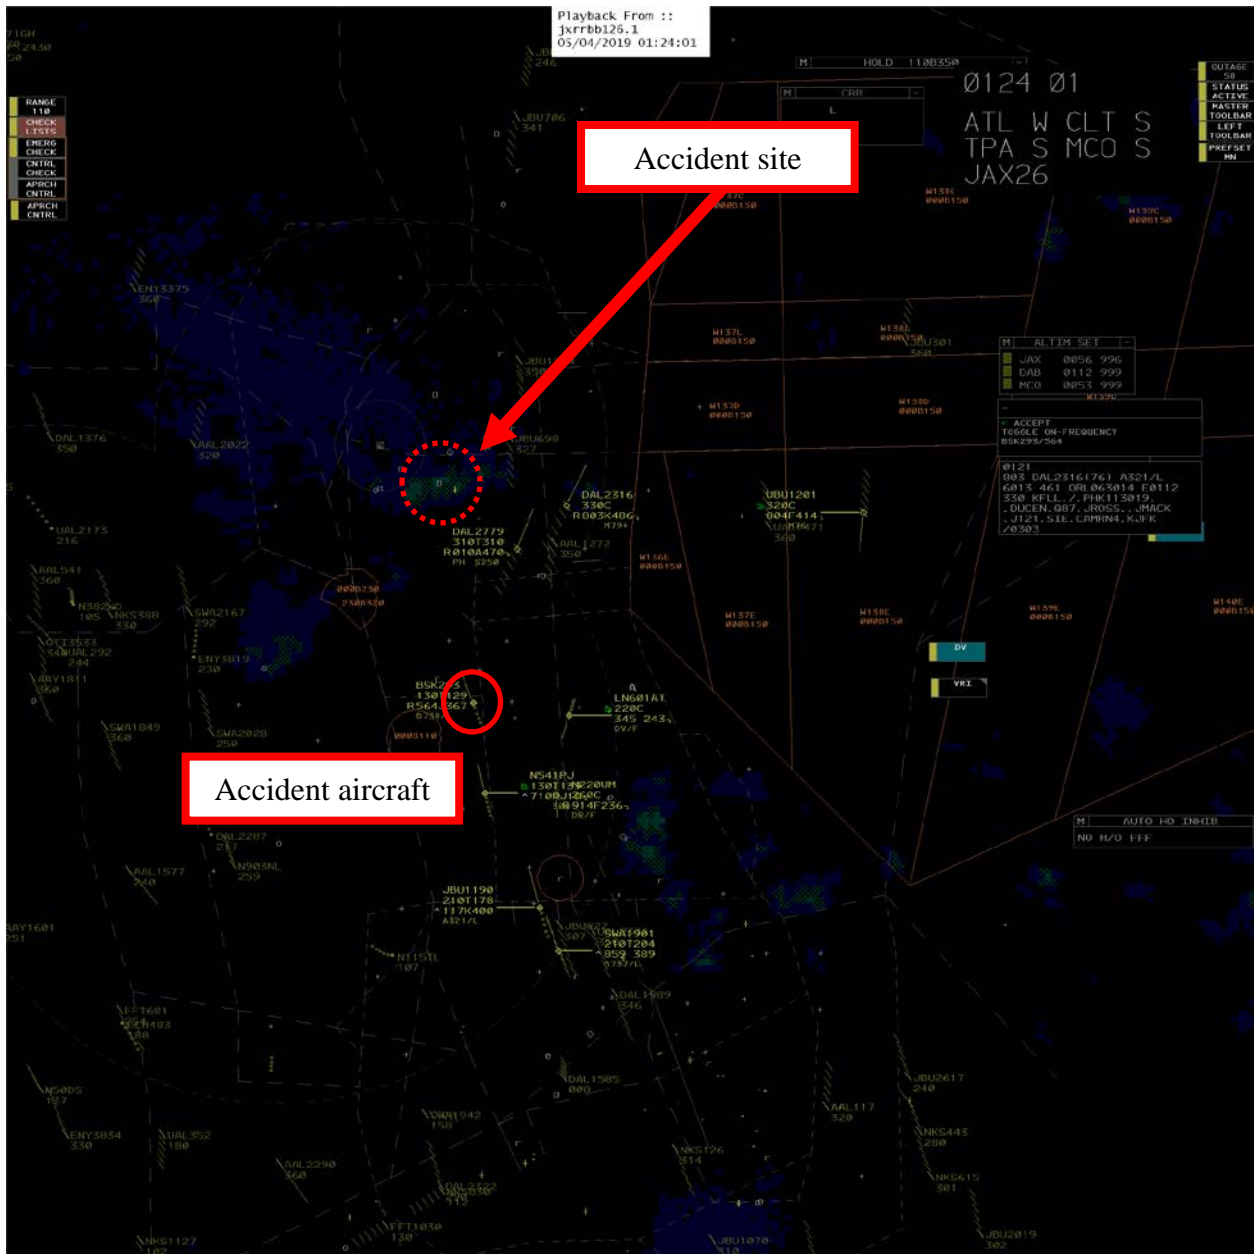
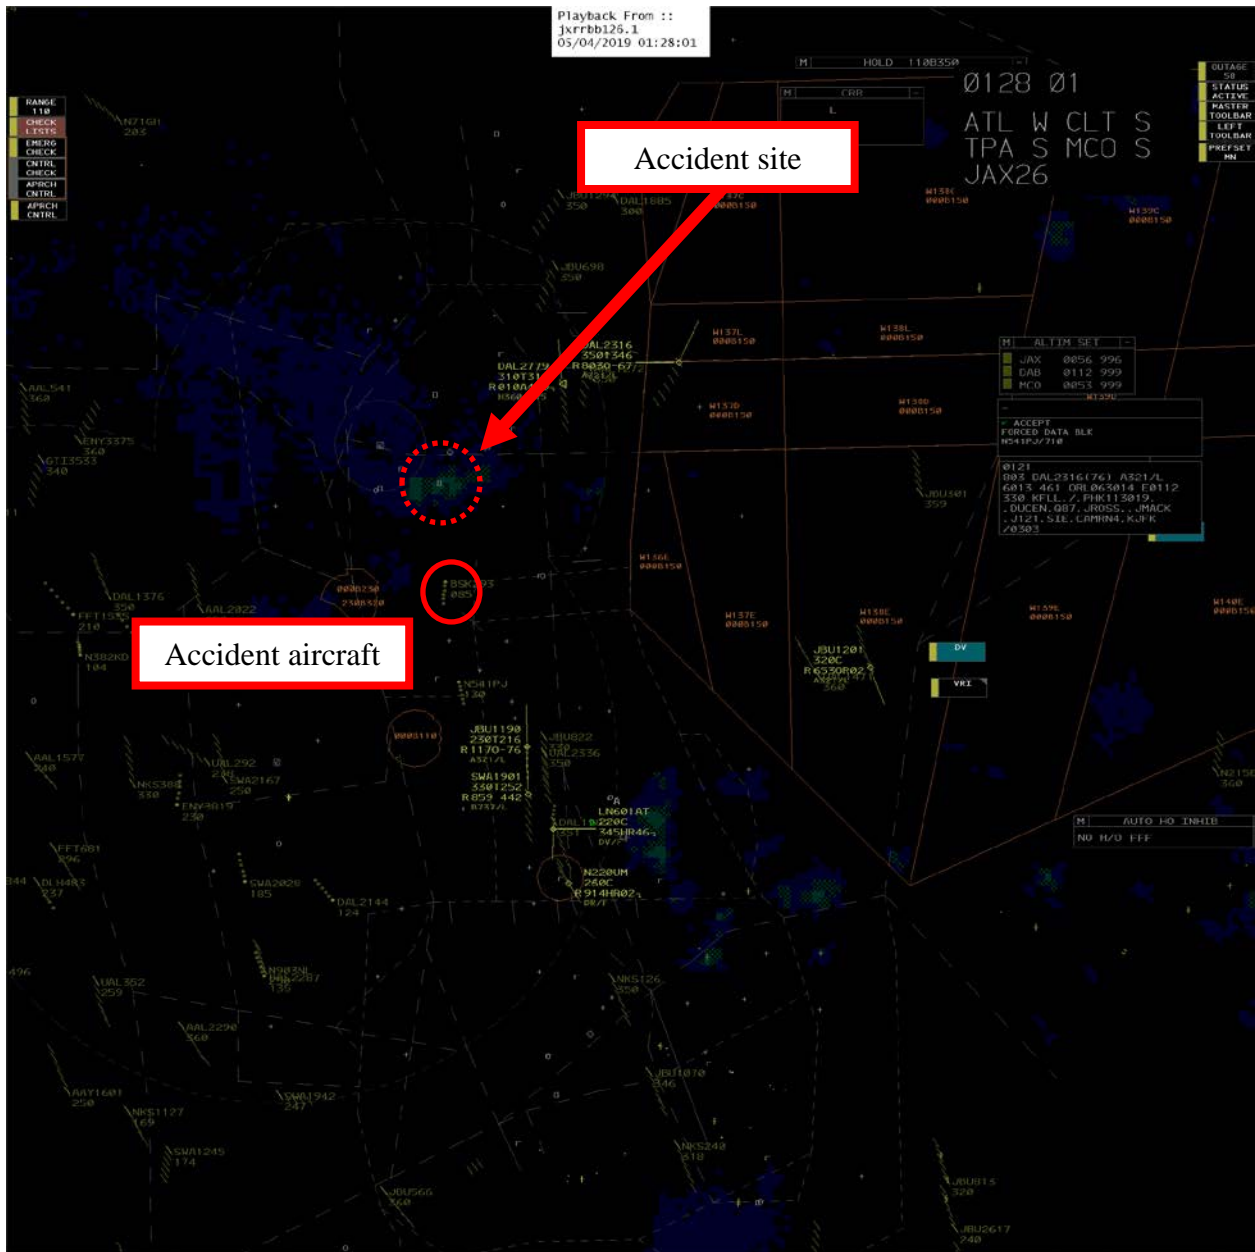
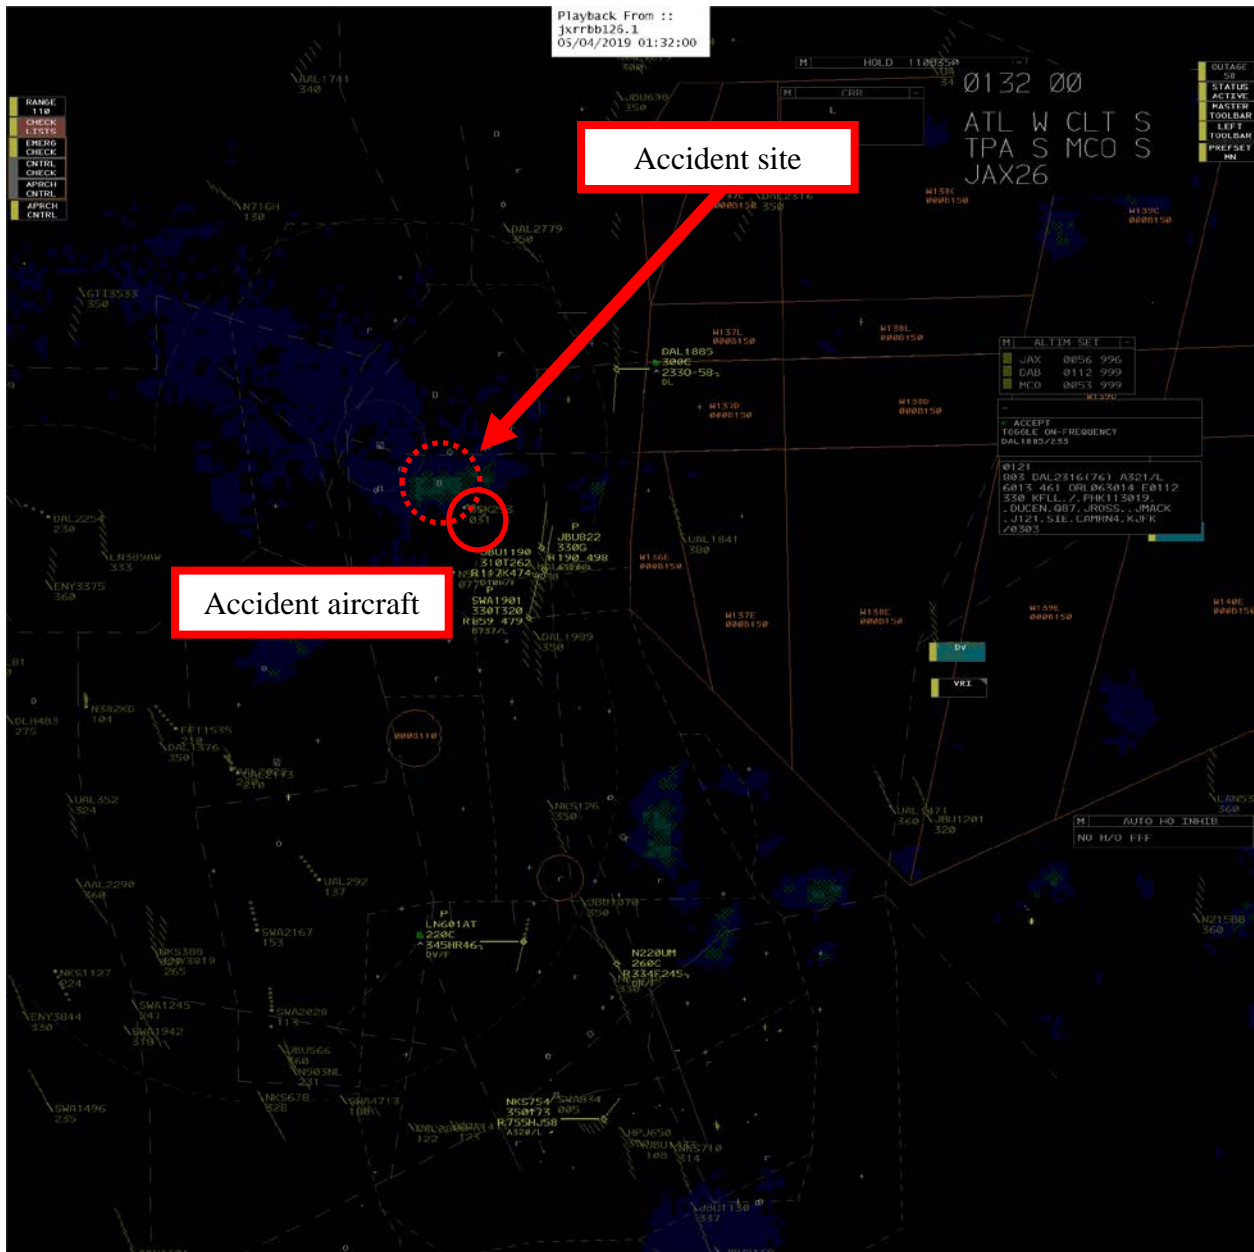
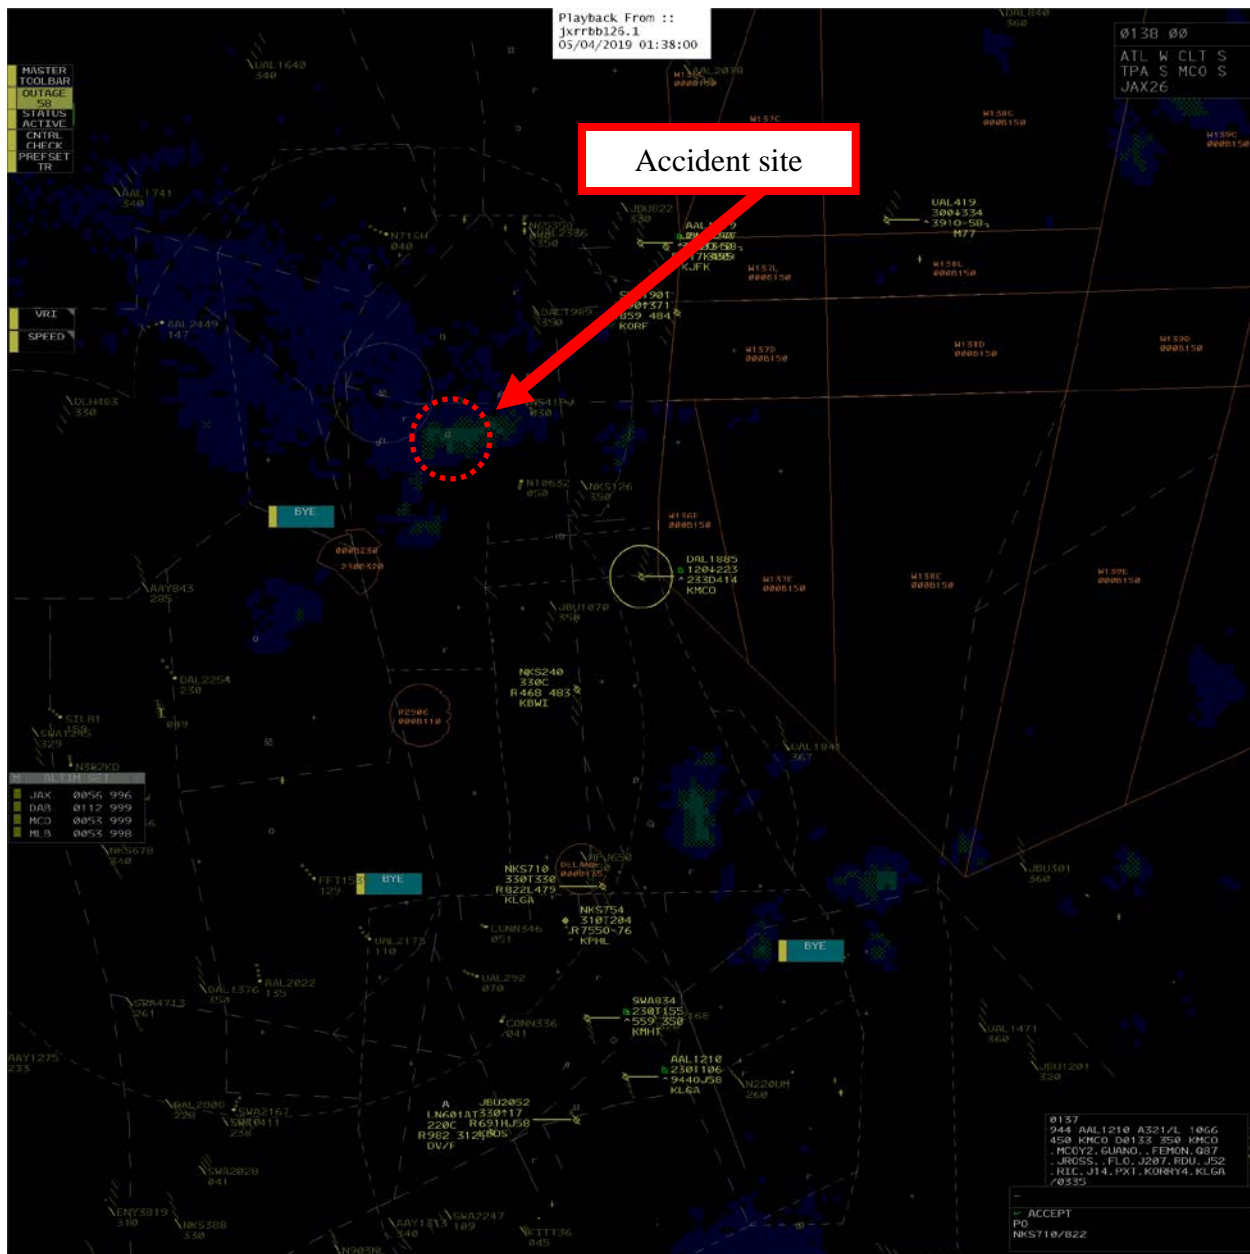
The ZJX ATC's radar display of Weather and Radar Processor (WARP)³⁰ weather derived imagery, weather radar representation, settings, and aircraft movement of the accident aircraft is provided in figures 36 through 41 with images from 2120, 2124, 2128, 2132, 2138, and 2141:31 EDT, respectively. Each minute screen capture of WARP weather imagery is displayed in attachment 13. An exemplar image of WARP weather derived imagery precipitation levels is provided as figure 35. The ZJX radar display of WARP weather derived imagery indicated heavy to extreme precipitation above KNIP and the accident site at 2120 EDT (figure 36) with the area of extreme precipitation continuing to grow in areal coverage through 2142 EDT (figure 41) and remaining above the accident site and KNIP (attachment 13). For more WARP imagery please see attachment 13. The STARS display of weather and precipitation levels at the accident site did not match the WARP display of weather and precipitation levels, with WARP display of weather and precipitation indicating extreme precipitation above the accident site and KNIP as early as 2120 EDT.
