**NATIONAL TRANSPORTATION SAFETY BOARD
OFFICE OF AVIATION SAFETY
WASHINGTON, D.C. 20594**

Systems and Structures Group Chairman's Factual Report

DCA20MA002

Operator: PenAir
Aircraft: Saab 2000
Location: Dutch Harbor, AK
Date: October 17, 2019
Time: 1740 ADT

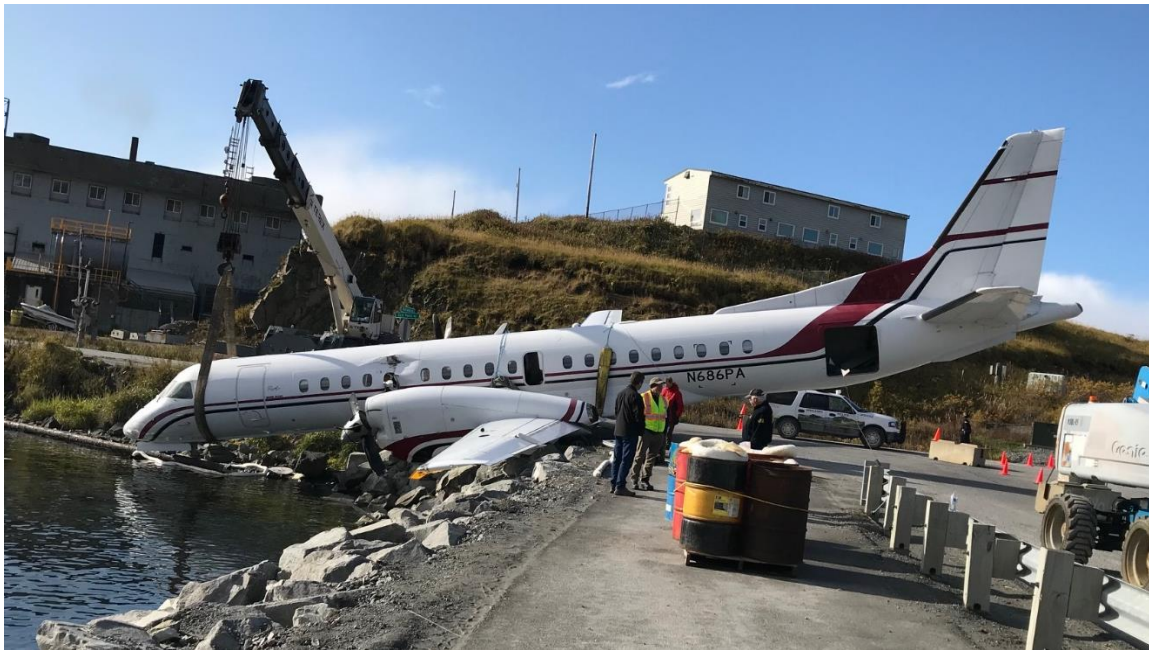
Figure 1 Final position of airplane, secured by crane.

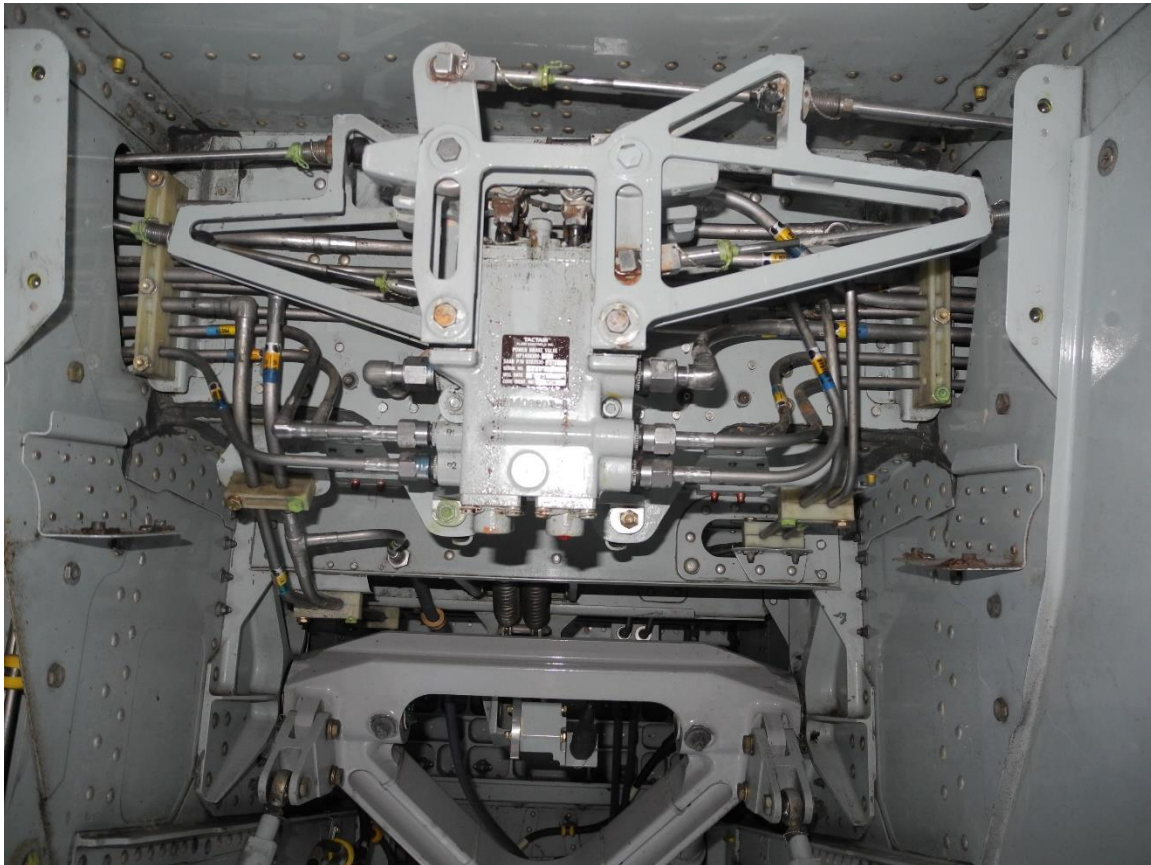
Figure 11 Power Brake Valve

Between February 12-13, 2020 representatives from the team, including NTSB, PenAir, SHK, and Saab convened at the Tactair facility in Liverpool, NY to examine the PBV. Tactair advised that the unit had no repair history, and it not been returned for servicing during its life. The unit was tested according to the production Acceptance Test Procedure 1408300, Rev D. All tests passed except there were slight exceedances in three of the four brake pressure versus plunger test near full displacement (approximately 0.025 inches from full travel). On each, the exceedance occurred during the return from full travel or decreasing pressure. There was also substantial corrosion of the clevis pins which attached the captains input cables to the mechanism. Neither of these conditions were considered to be significant in the operation of the PBV.

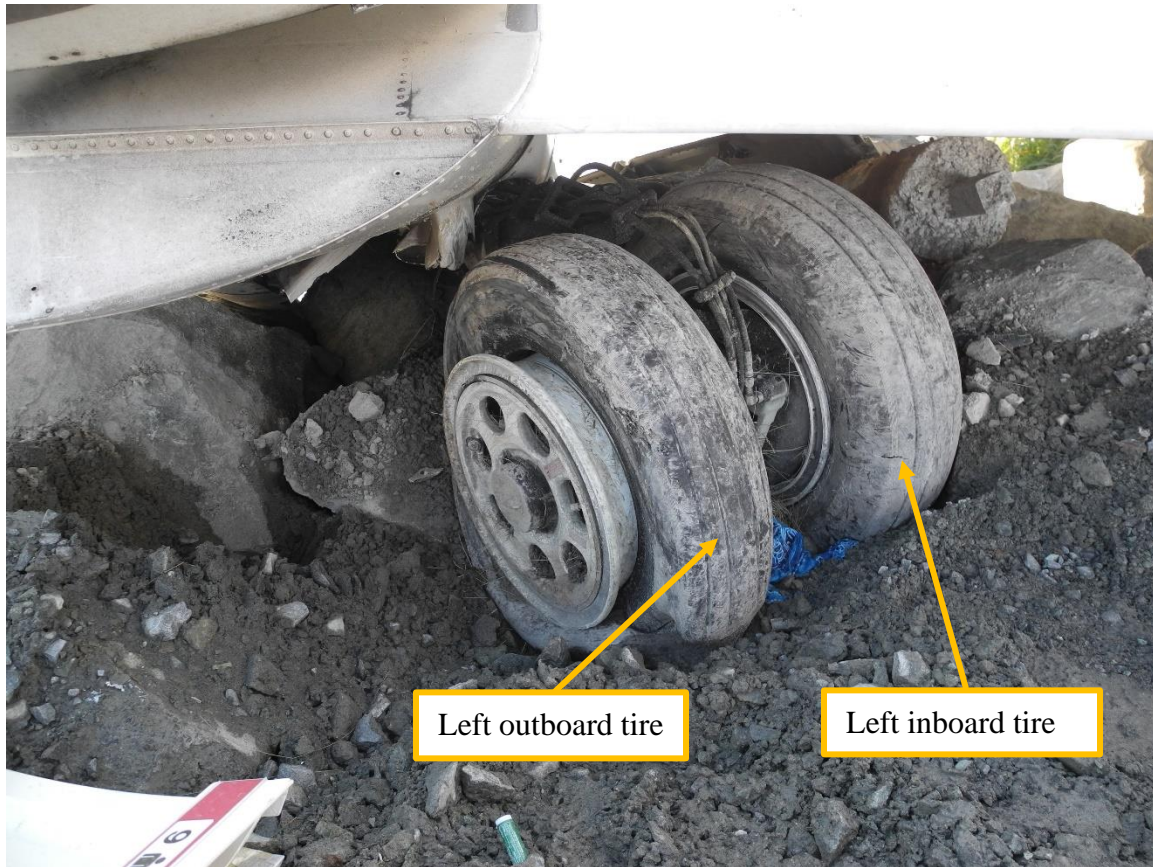
The #1 tire was found to be deflated and had an area approximately 11 inches in length which was ground flat all the way through the tire, Figures 12-13. There was a hole in the sidewall of the tire near the flat spot, and an oval shaped worn area approximately 180 degrees from the ground flat area, Figure 14. The runway was inspected and there was a long skid mark on the left side of the runway past the touchdown area.

Figure 12 Left main gear tires

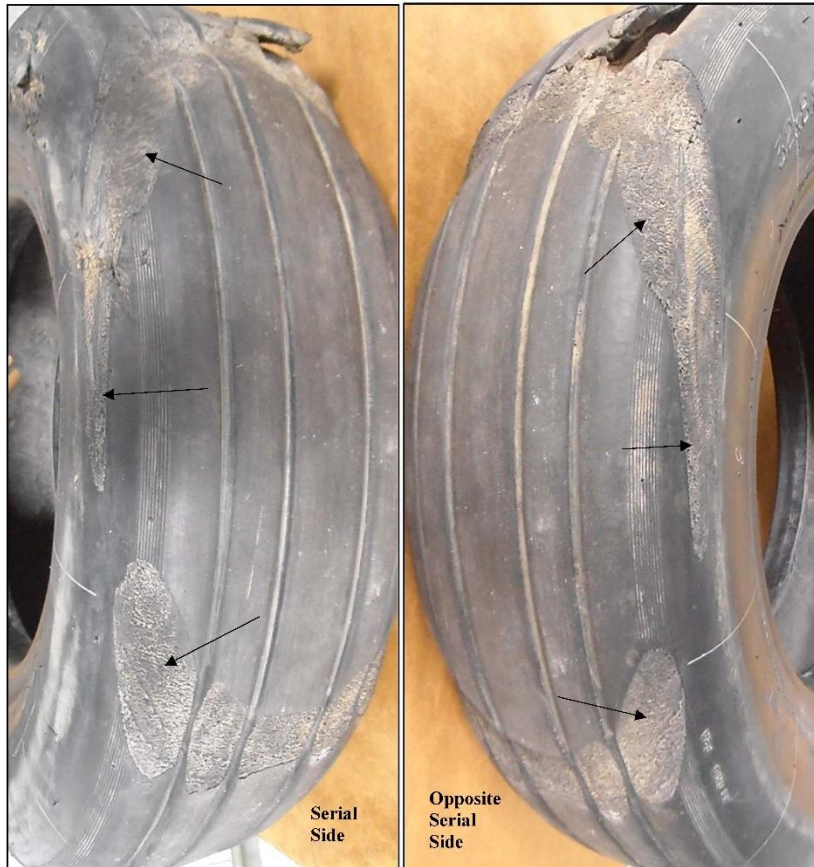
RGA 020-001 Photo G

- After complete pressure loss, the skid pattern showed the tire skid footprint increased to include the sidewall damage in that area of the tire. This was the result of the tire collapsing and skidding on both of the sidewalls, Figure 17.

Skid pattern extends into the sidewall area.

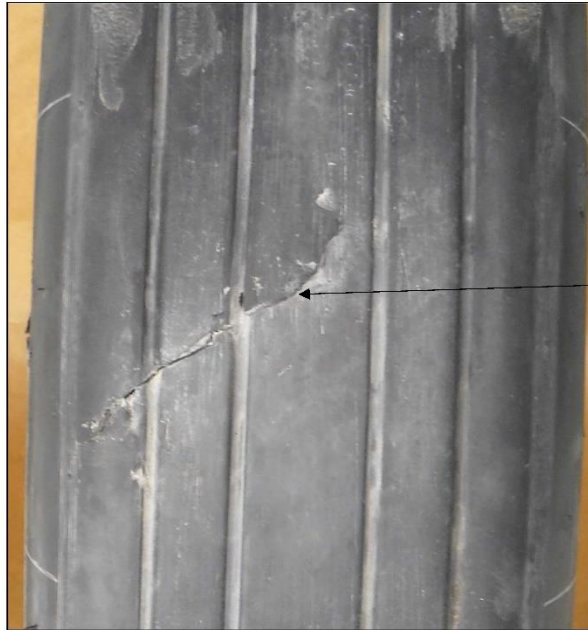
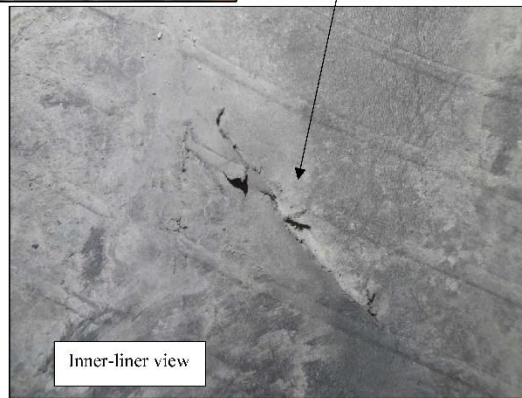
RGA 020-001 Photo I

- The large cut / damage on the tread that extended through the casing and inner-liner appeared to have occurred after the pressure loss, Figure 19. If this was the initial cause of the pressure loss, there would be no tapered and oval shaped skid pattern at the flat spot. Also, if this was the initial pressure loss, there most likely would be a bias, or X-type rupture of the casing – pressurized blow-out. The debris found in this cut / damage appears to be gravel, pieces of rock, concrete, etc.

Cut on the tread extends through the casing and inner-liner.

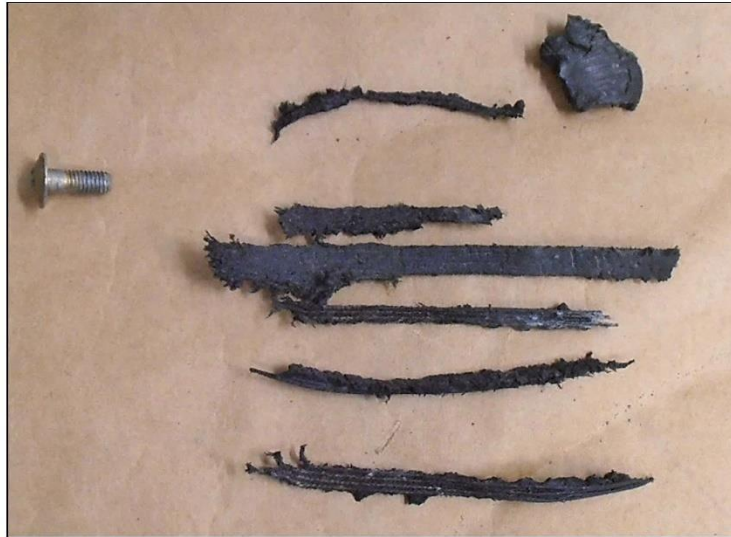
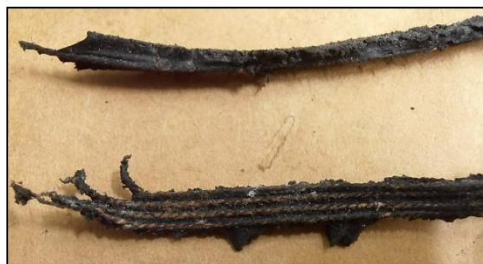
RGA 020-001 Photo N

- The small amount of fragments appear to be from the area of the initial skid, Figure 20. The small screw was not part of the tire.
- With regard to the flat spot prior to dispatch, if there were no reinforcing plies visible the tire was serviceable in that condition.

Additional fragments returned with the tire

Figure 20 Tire fragments and screw

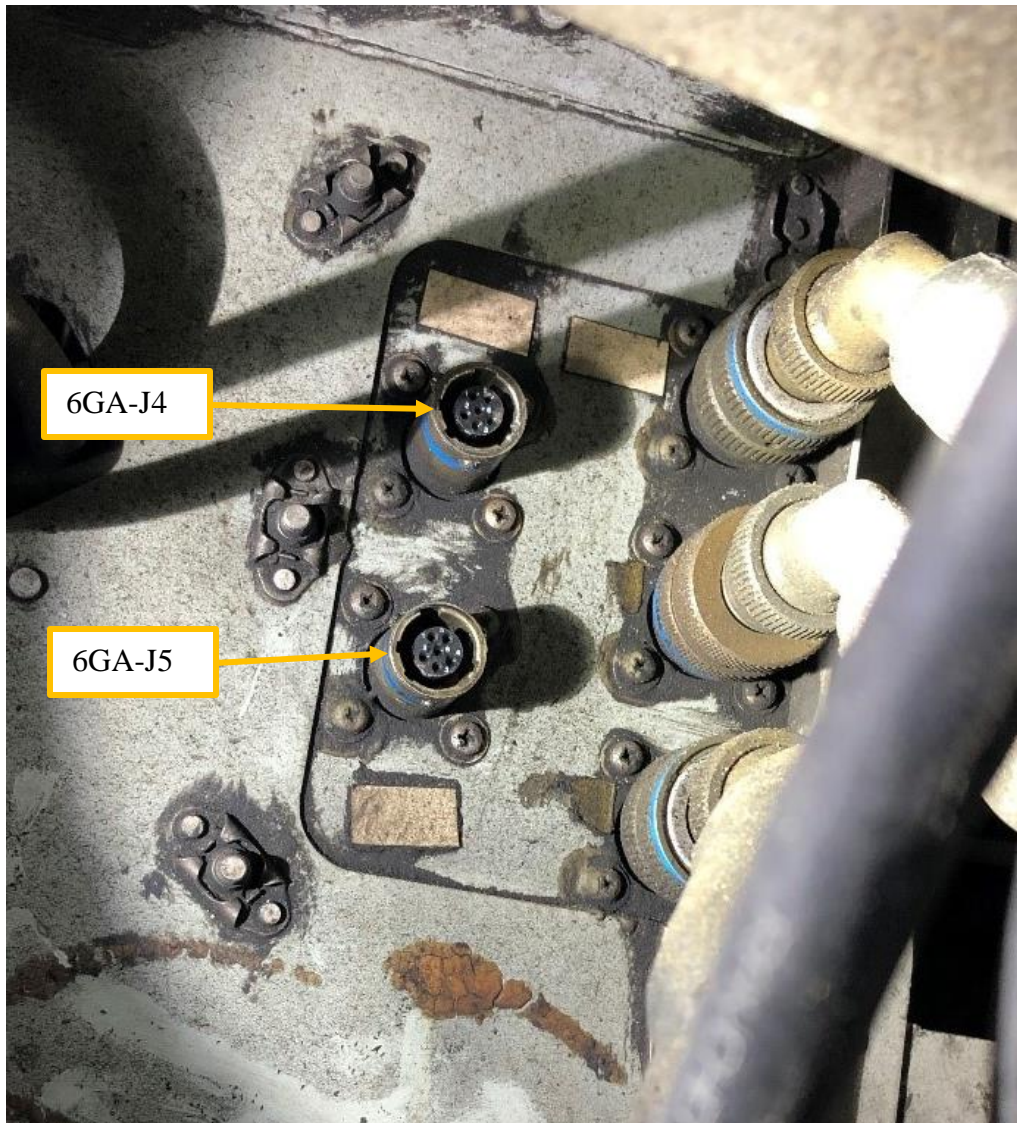
Figure 25 Accident airplane right main gear wheel well, wheel speed transducer bulkhead fittings

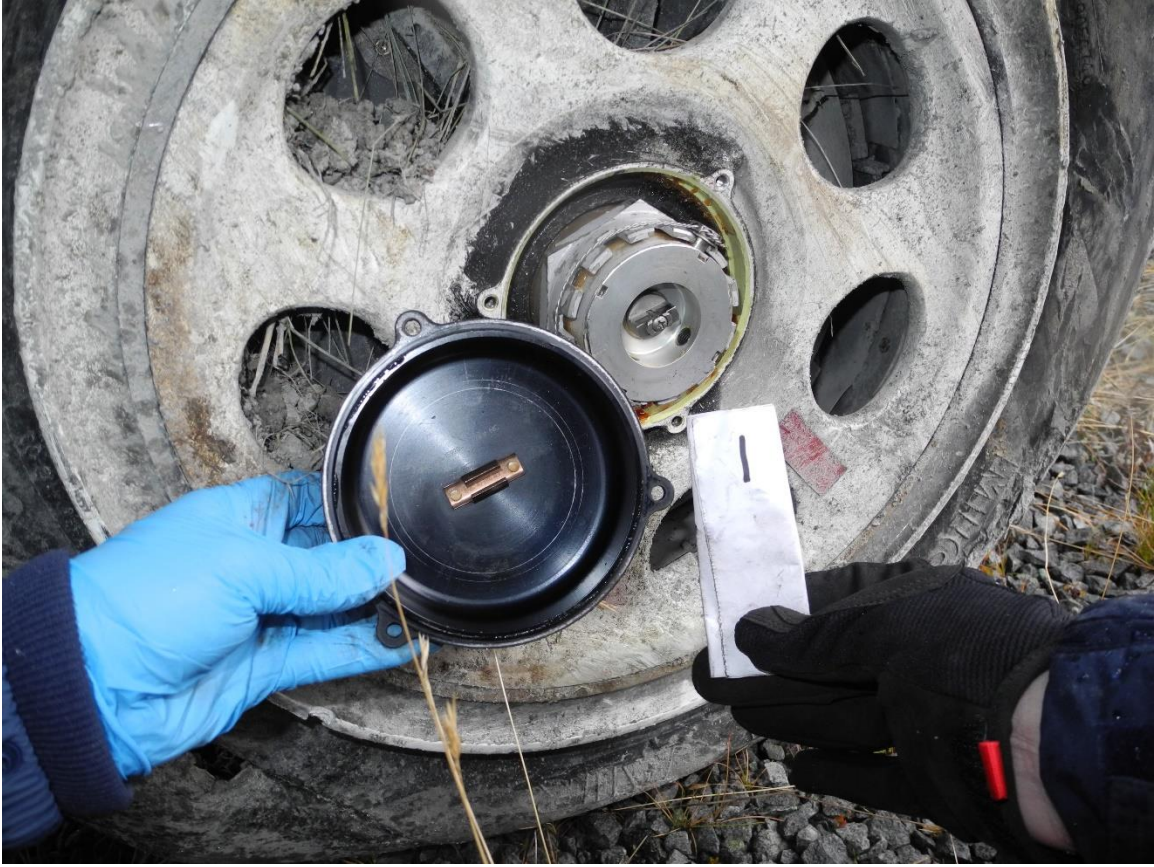
The hubcaps were removed to expose the wheel speed transducers, Figure 28. It was observed, by the feel of a light force required to remove the caps, that each of the sensors were still attached to the clip in the cap. All clips were in excellent condition.

Figure 28 #1 wheel hubcap with transducer clip

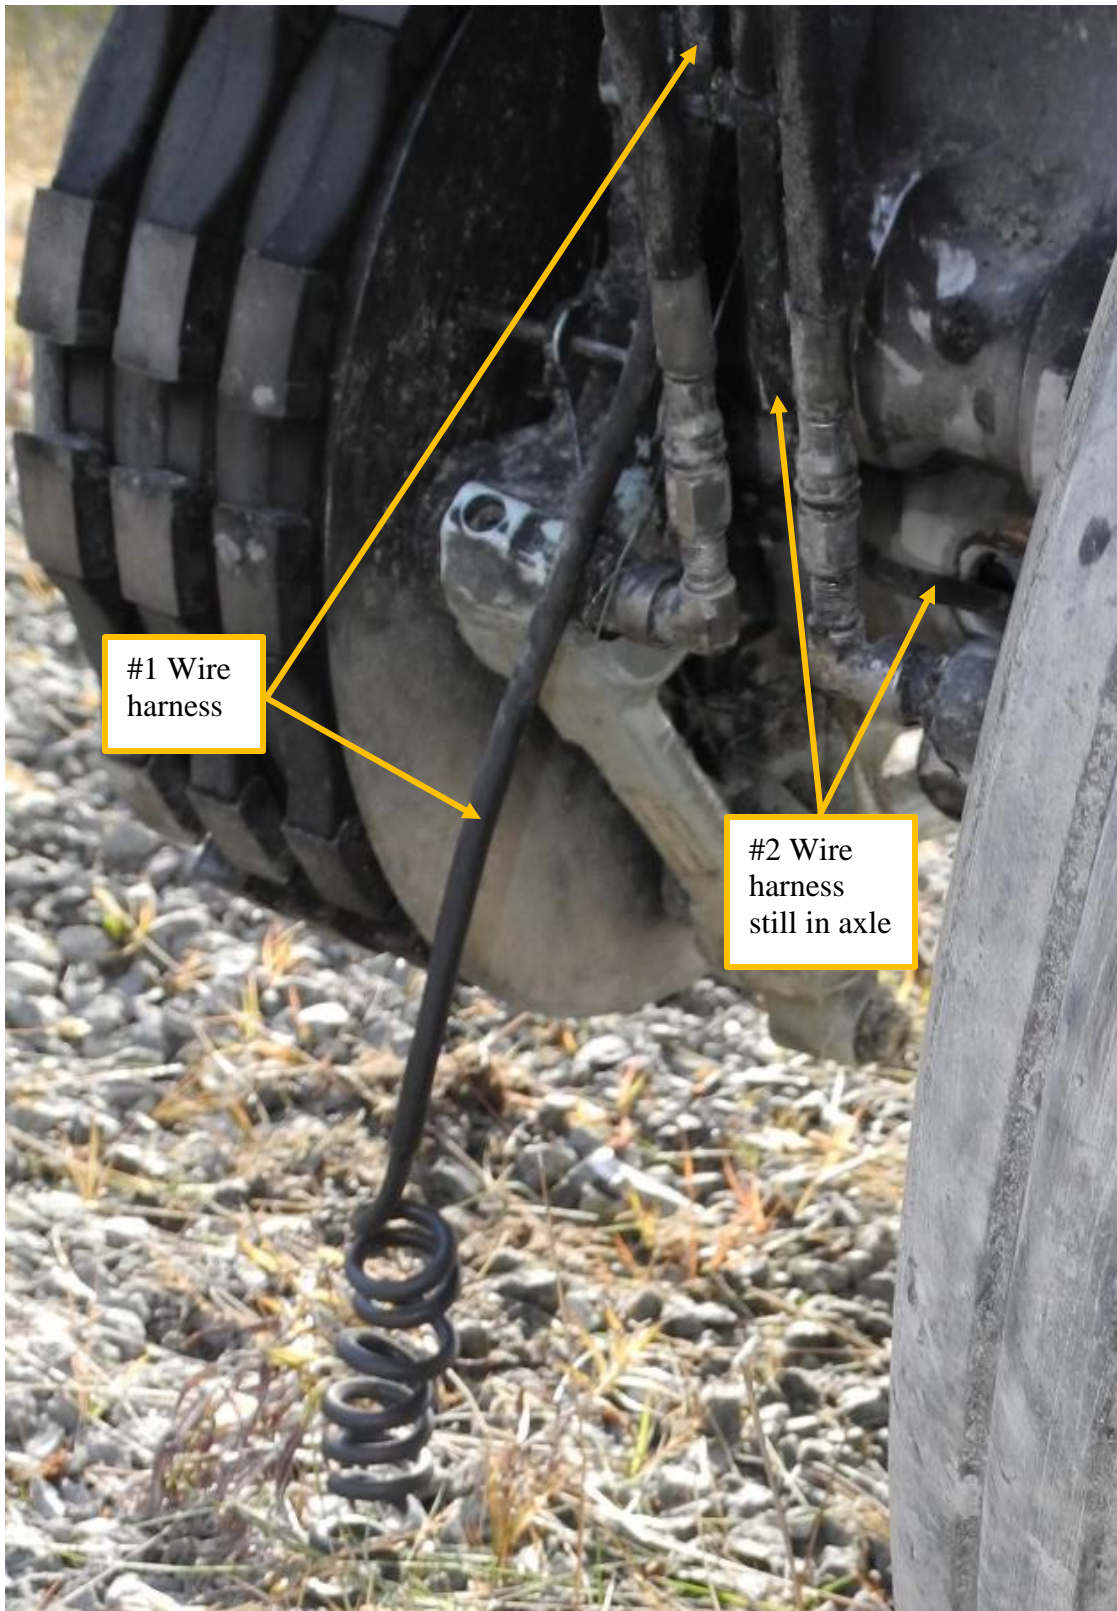
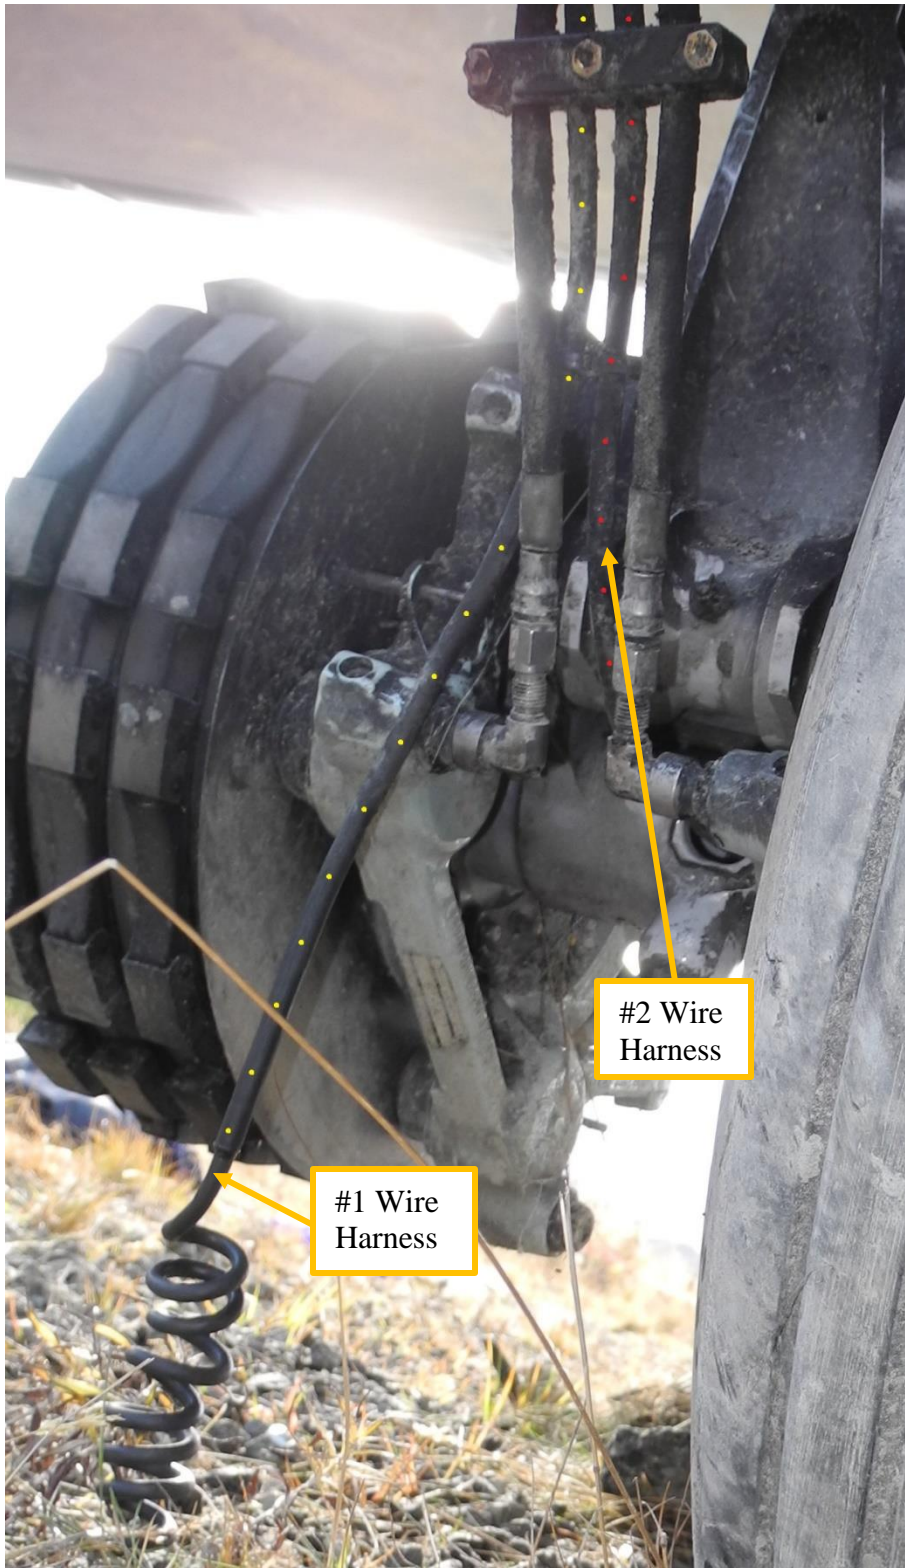
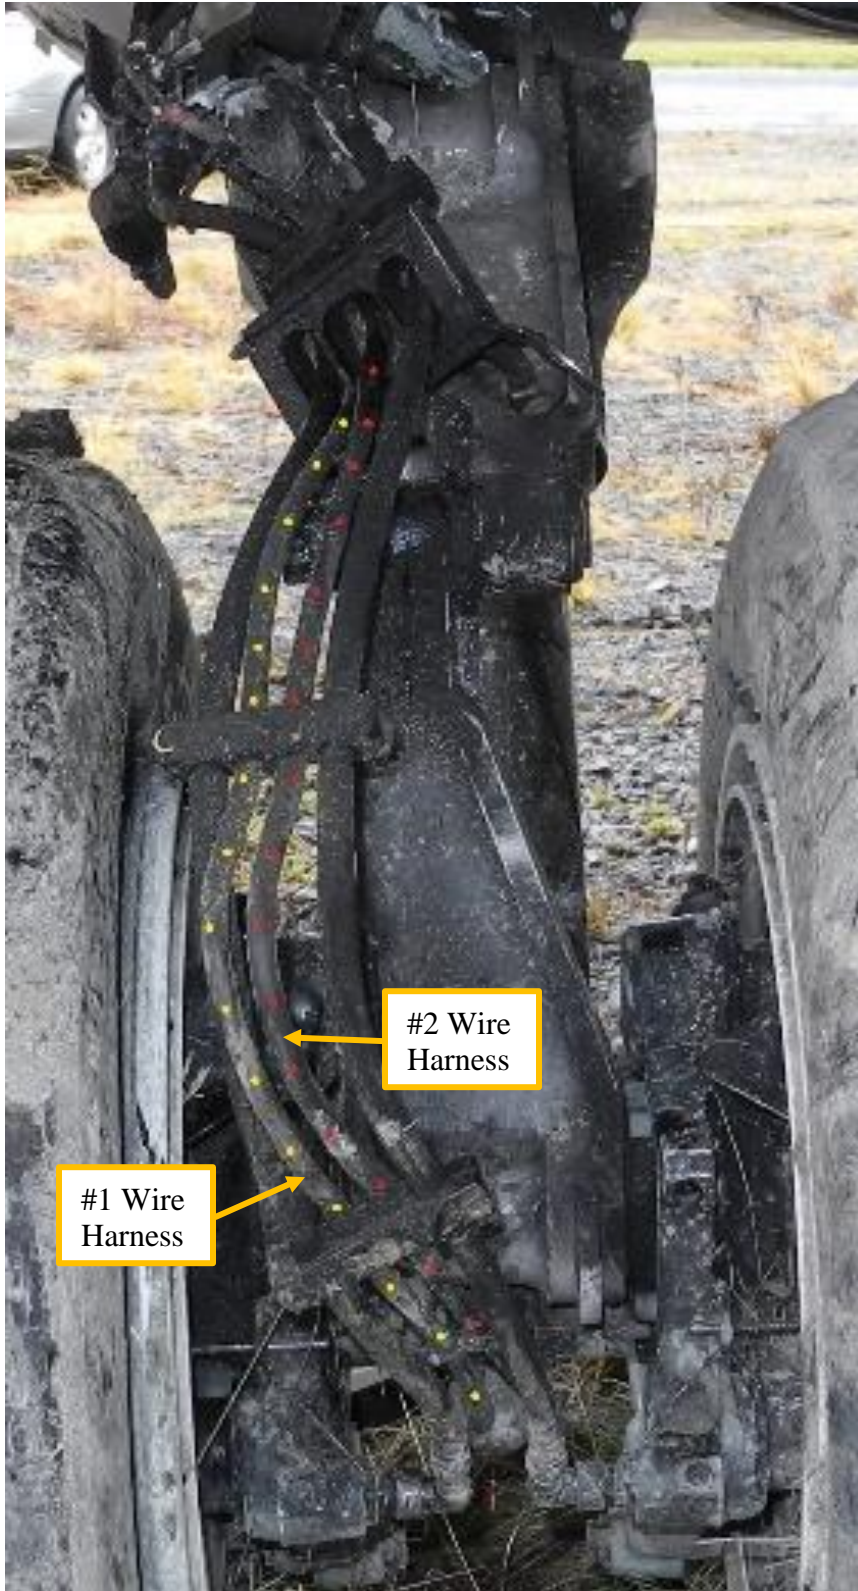
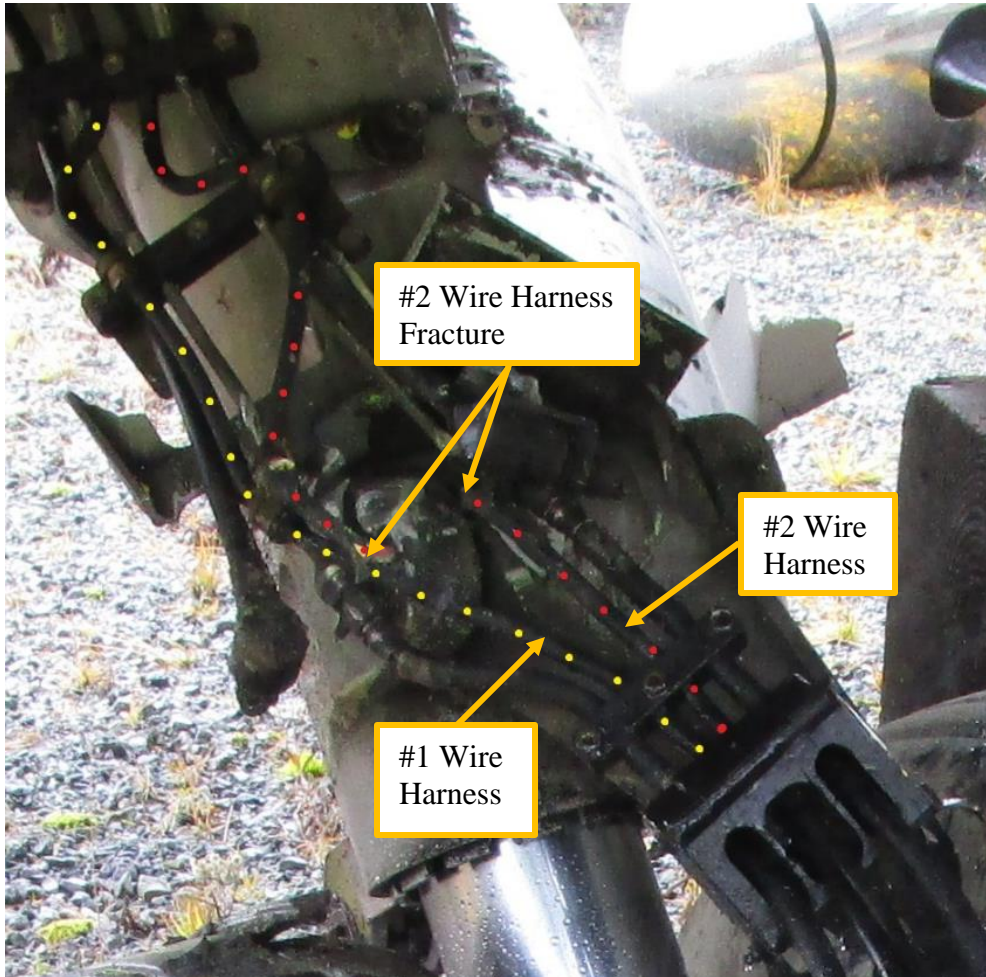
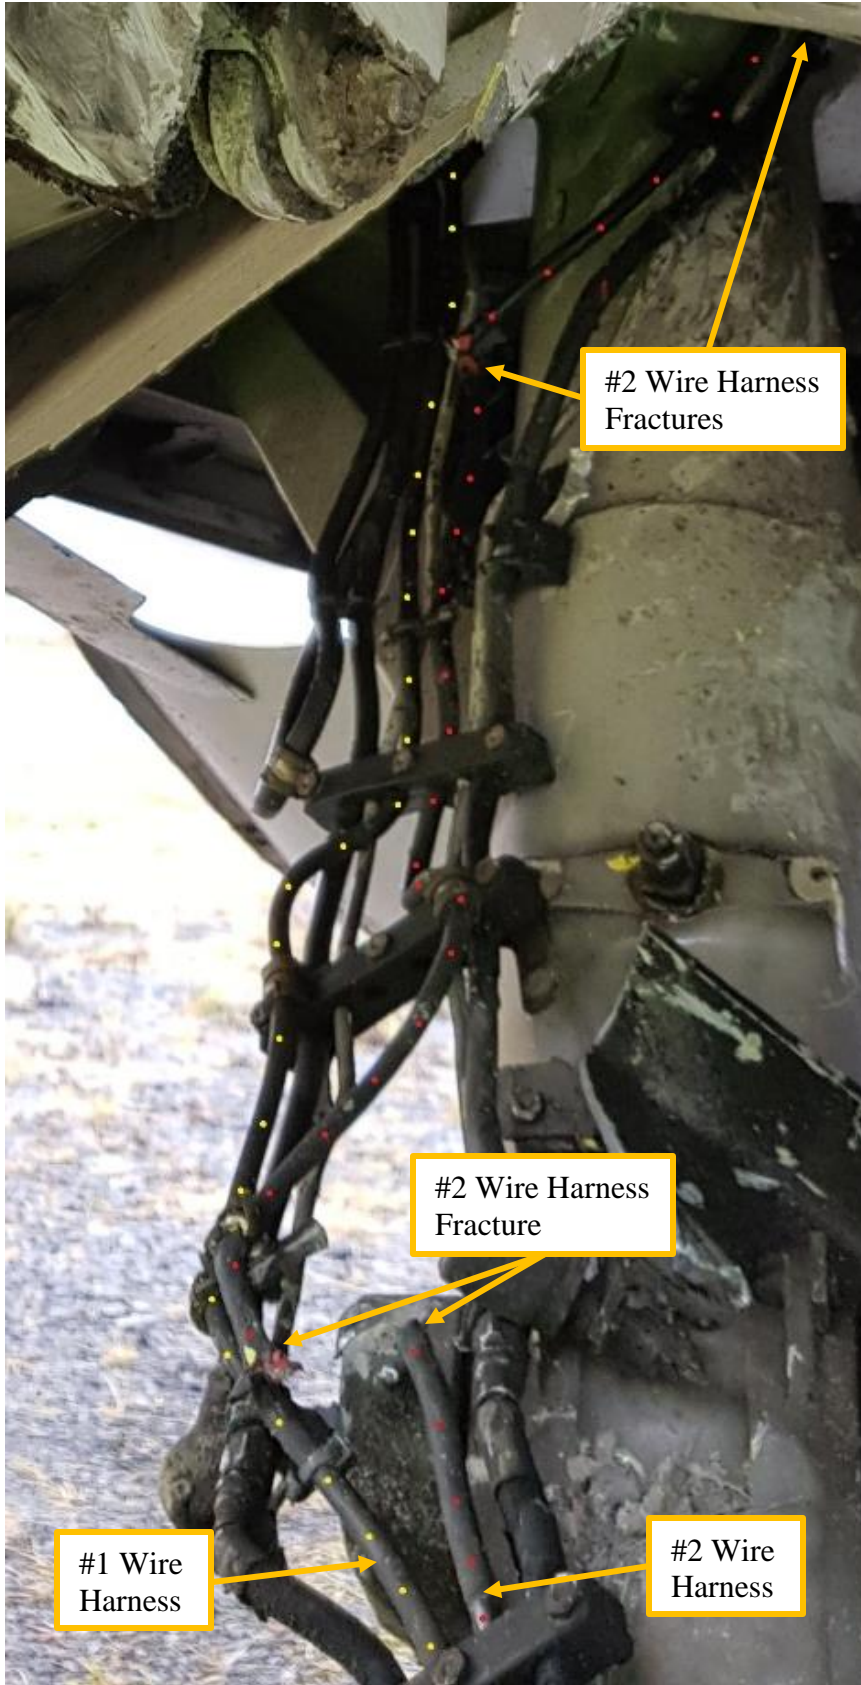
Photos of the left main gear wheel speed transducer wiring, Figures 30 – 35 showed the harness was routed according to the manufacturer's instructions from the axles to the top of the strut (the harness from the left wheel was routed on the left side of the strut). The routing from the top of the strut to the bulkhead fittings was not known because of the damage.

Figure 30 Left gear wheel speed transducer harness routing

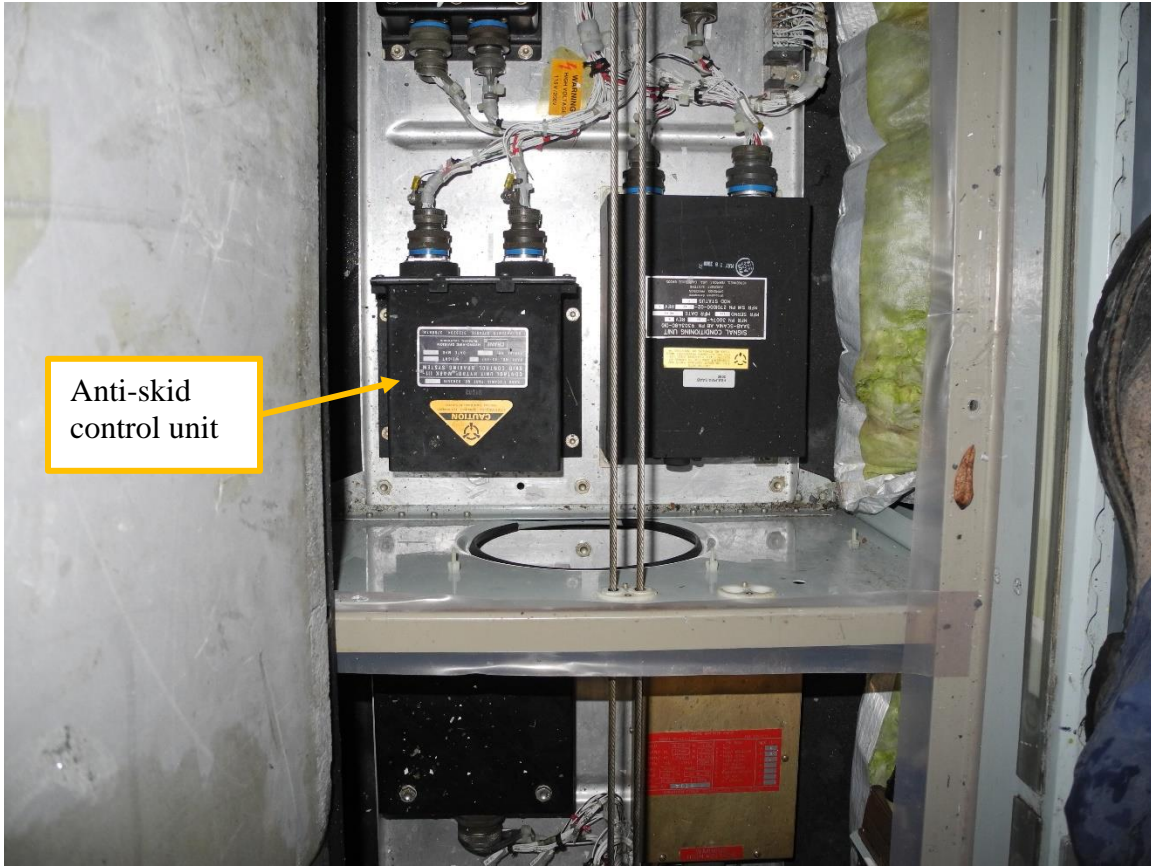
The anti-skid control unit was installed under the floor panels in the forward cabin. The carpet and panels were removed. The control unit was in good condition with no observable damage to the area Figure 36. The electrical connectors were left in place and the wiring was cut to remove the component. The component data plate showed it was a Crane Hydro-Aire P/N 42-897-1, S/N 150, MFG 02-94. The unit was retained for examination.

Figure 36 Antiskid control unit (left side of image)

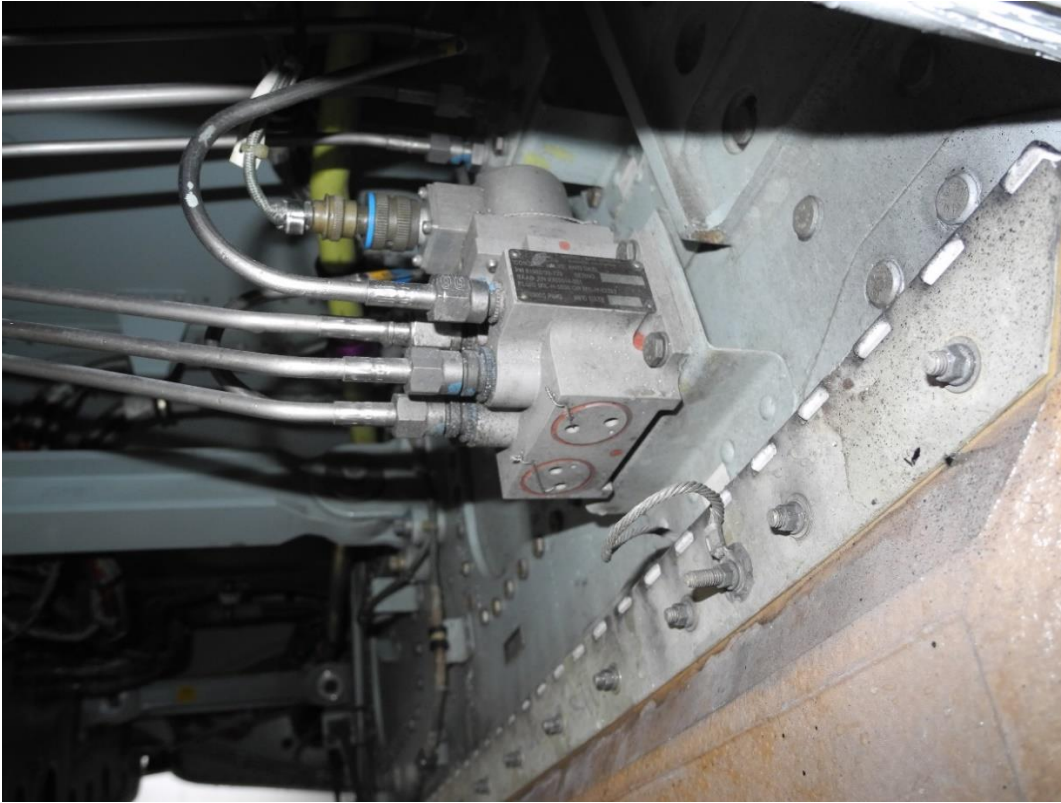
The access panel was opened for the antiskid control valves. The components were observed to be in good condition with no damage to the area, Figures 37 - 38.

Figure 37 Outboard anti-skid control valve

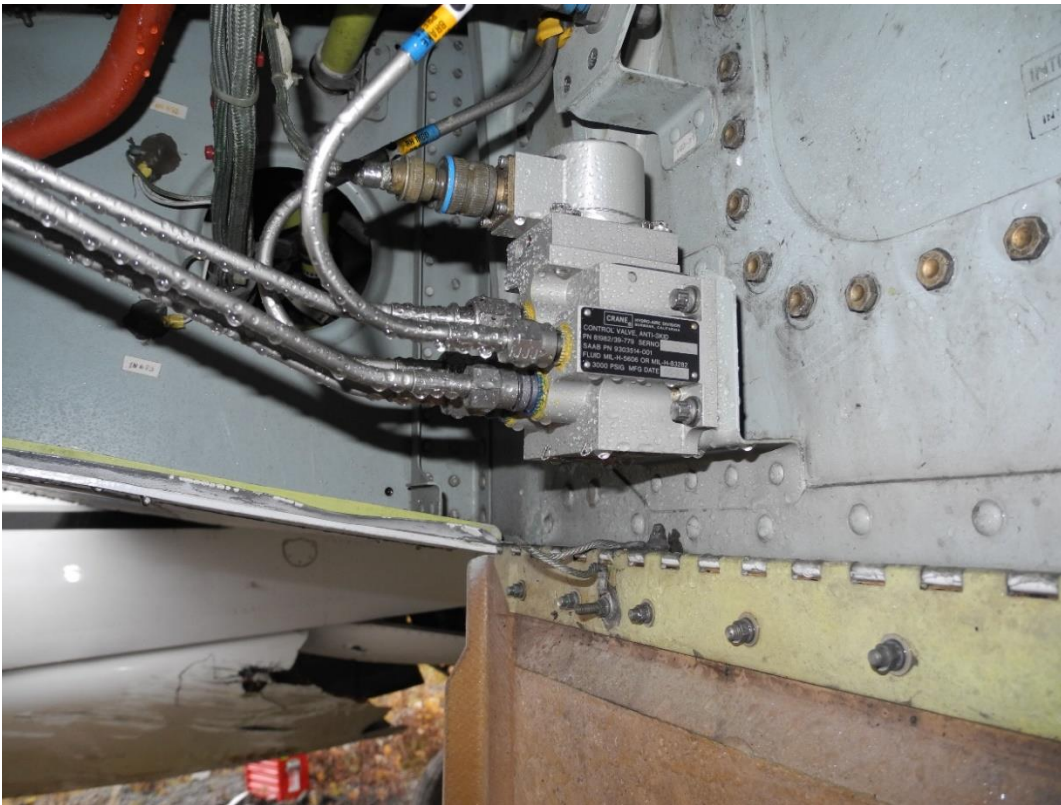
Figure 38 Inboard antiskid valve

All tests passed except for 6.3.2 internal leakage with 5mA command. The result was 170 cc/min, and the allowable for a new or overhauled part was 40 cc/min.

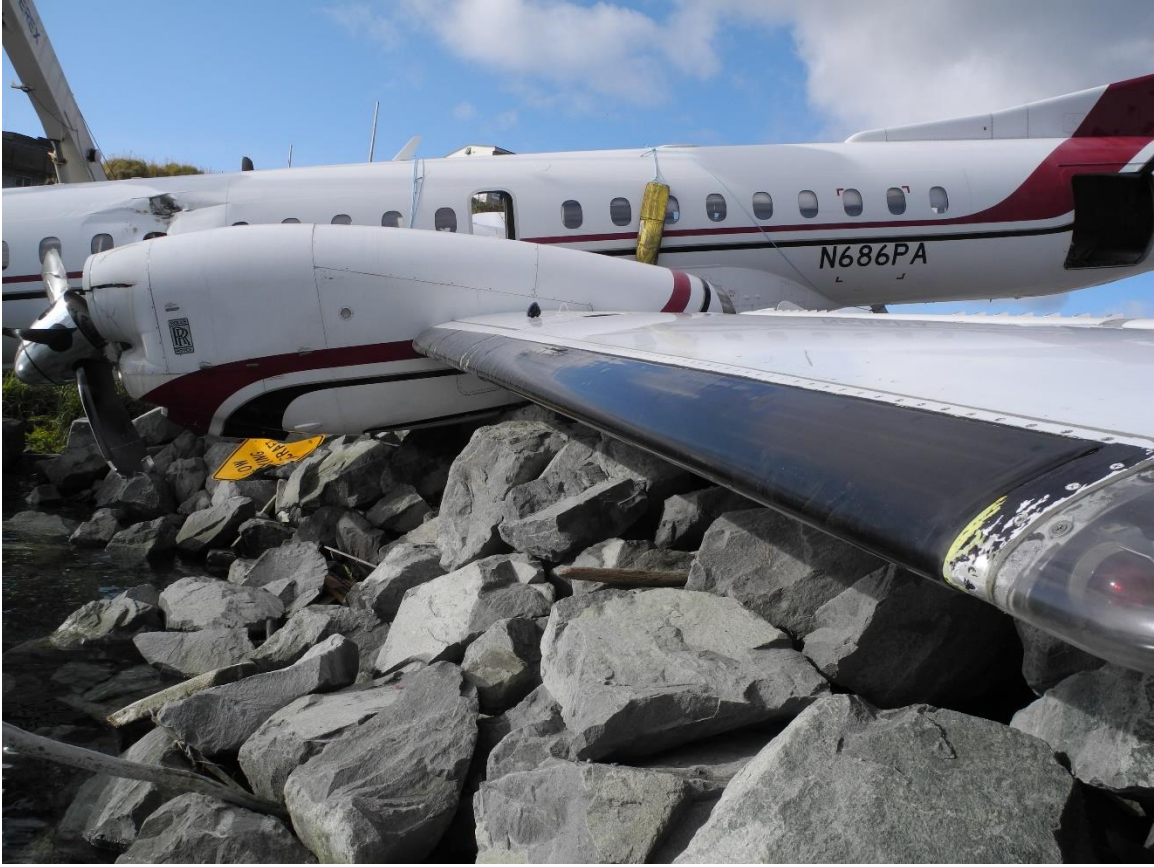
The wing was intact and had only minor impact marks on the leading edge, Figure 40. There was no damage to the wing tip. During recovery the tip impacted a telephone pole which caused scrapes and damage to the static wick. The aileron and aileron trim surfaces were intact, Figure 41. The flaps were intact and partially extended to a similar position as the right flap, Figure 42. There was an impact mark on the bottom inboard portion of the flap, Figure 43, which extended through to the top.

Figure 40 Left wing leading edge

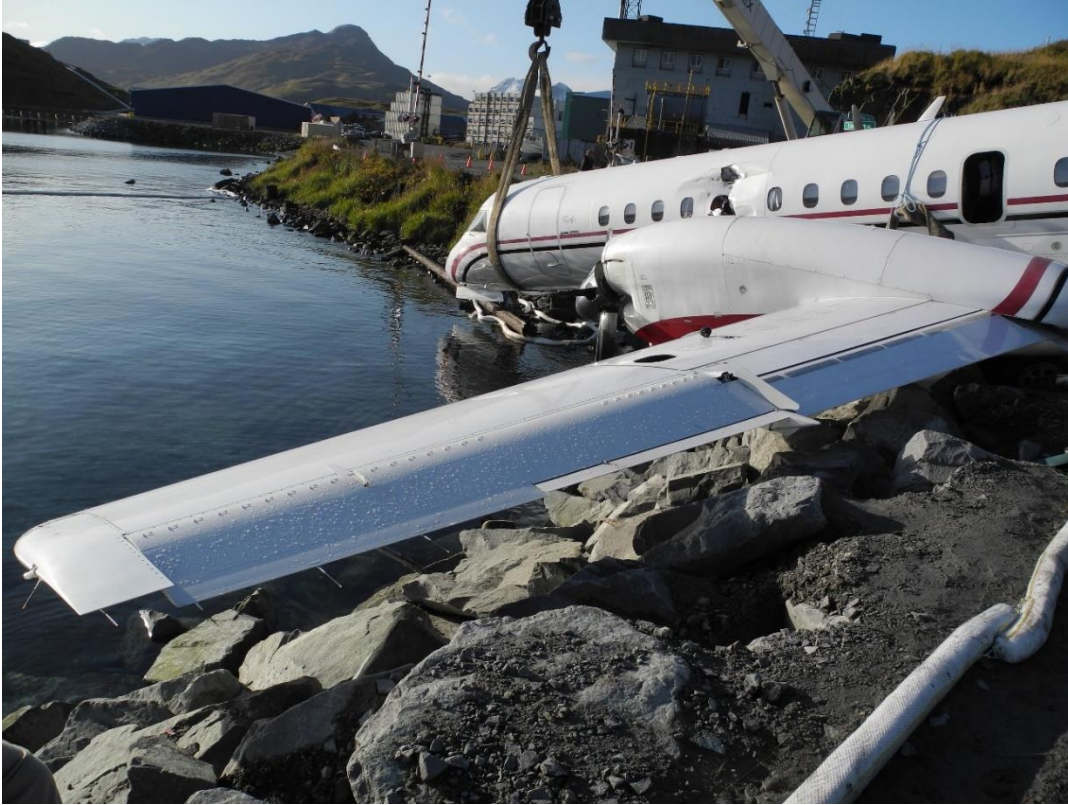
Figure 41 Aileron and tab

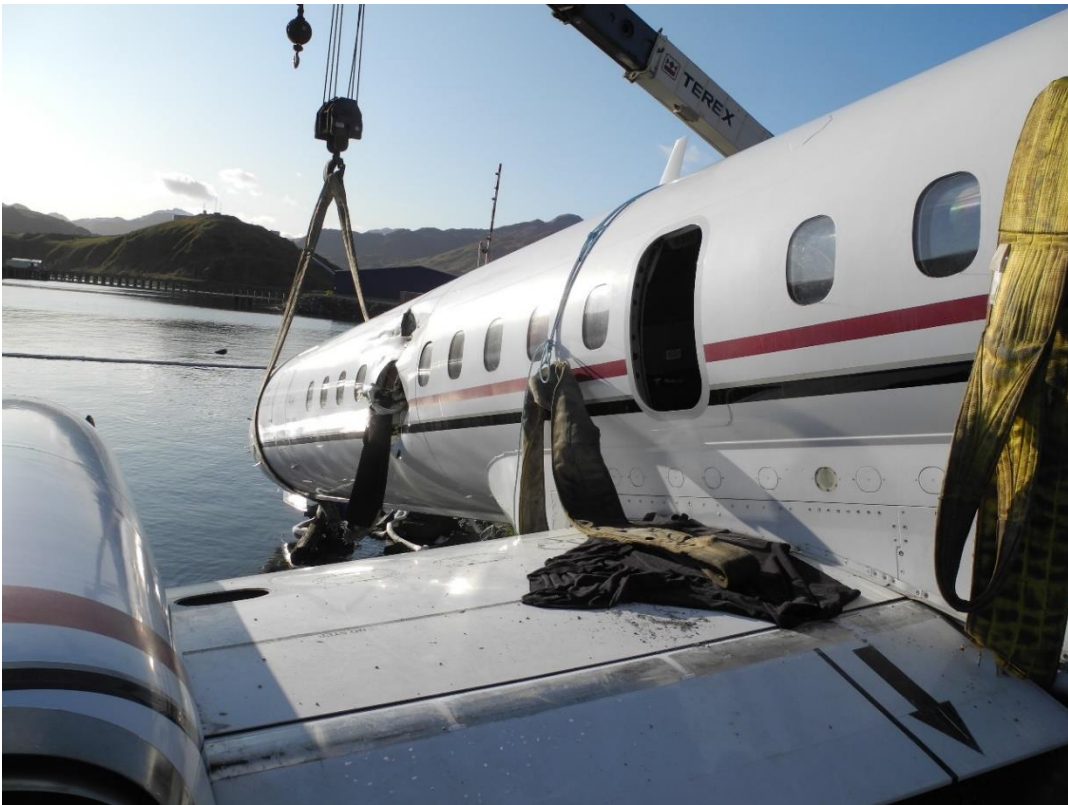
Figure 42 Inboard portion of flap and wing.

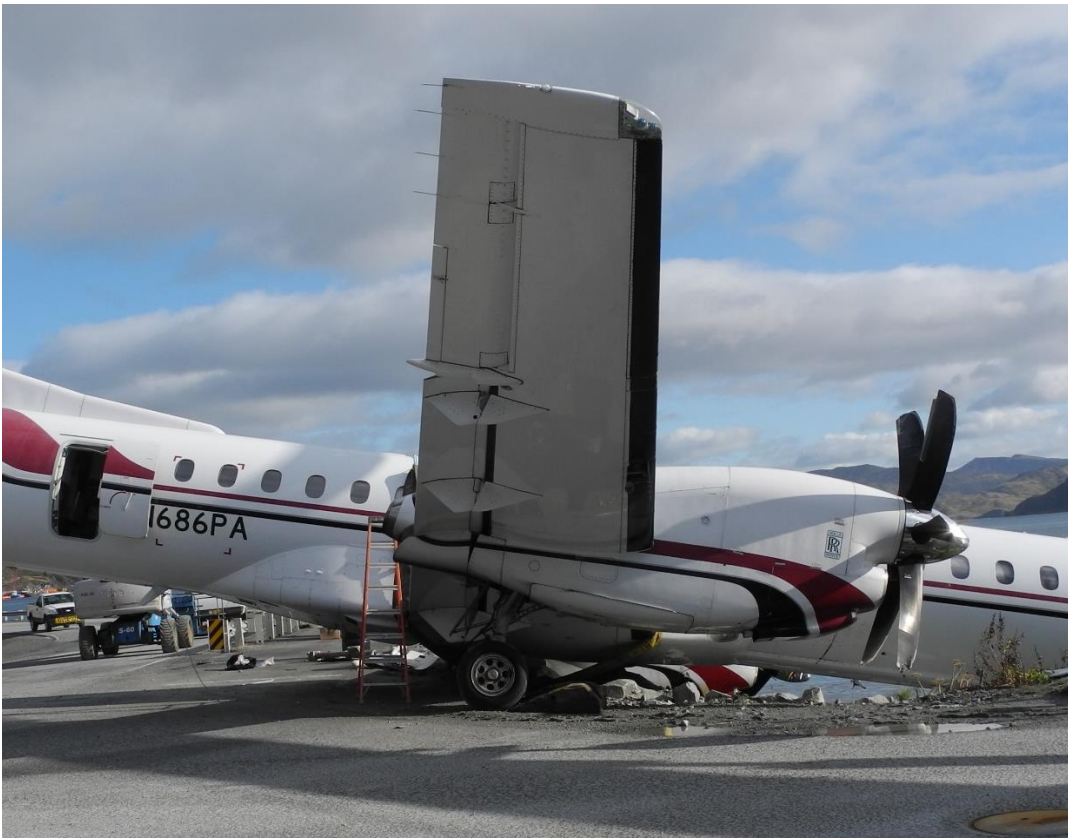
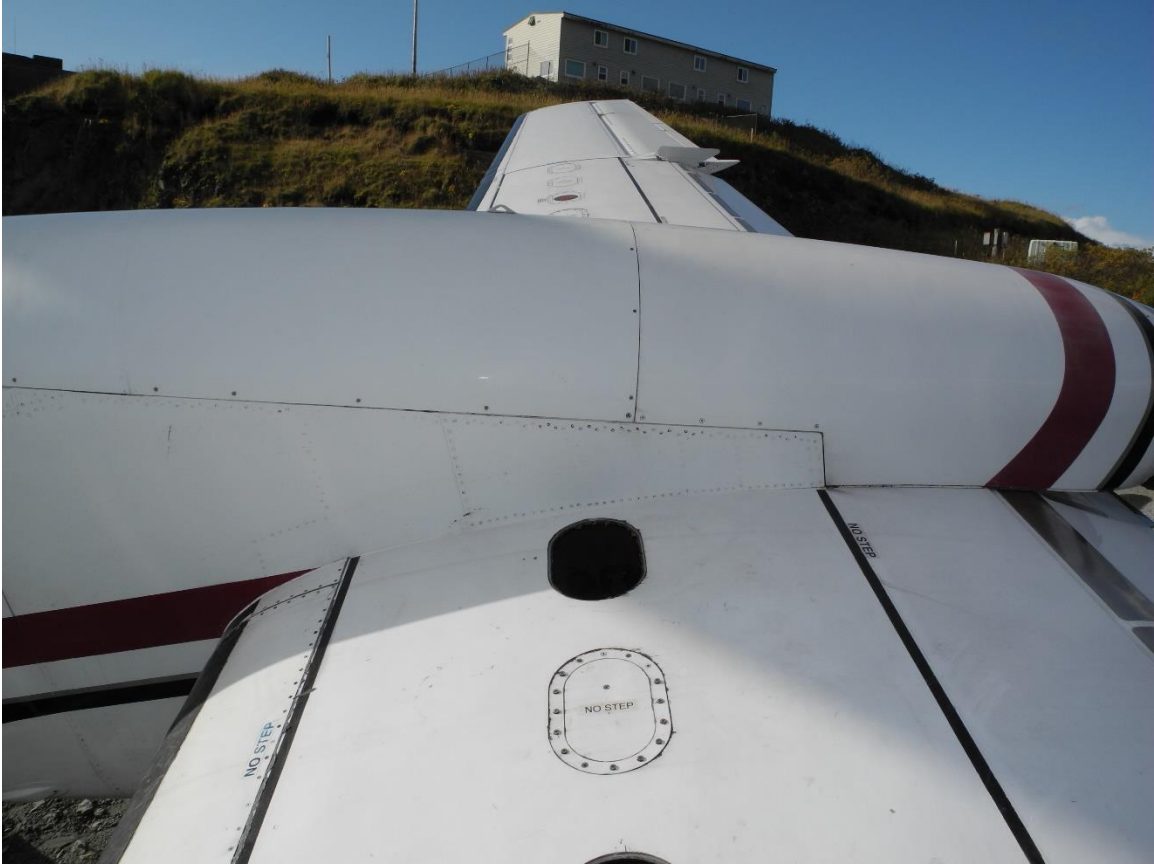
The wing was intact and had no apparent damage, Figures 44-45. During recovery the wing tip scraped a hillside which caused damage. The aileron and aileron trim surfaces were intact. The flaps were intact and partially extended to a similar position as the left flap. The right gear doors had impact damage and could not be opened by pulling the release mechanism, Figure 46.
