**NATIONAL TRANSPORTATION SAFETY BOARD
OFFICE OF AVIATION SAFETY
WASHINGTON, D.C. 20594**

Systems and Structures Group Chairman's Factual Report

DCA20MA002

Operator: PenAir
Aircraft: Saab 2000
Location: Dutch Harbor, AK
Date: October 17, 2019
Time: 1740 ADT

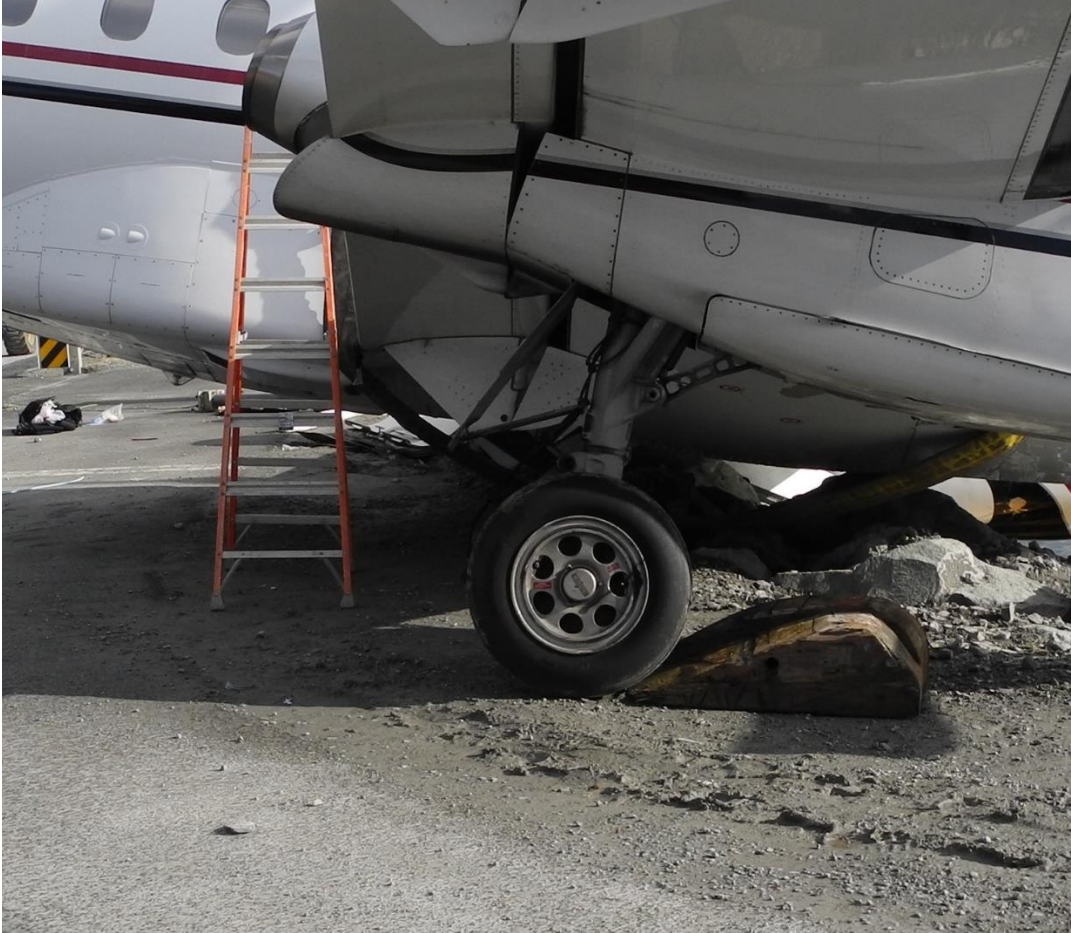
The right main gear was intact, down, locked and supporting the airplane, Figure 52. The lock pin was inserted to secure the gear for storage.

Figure 52 Right main gear

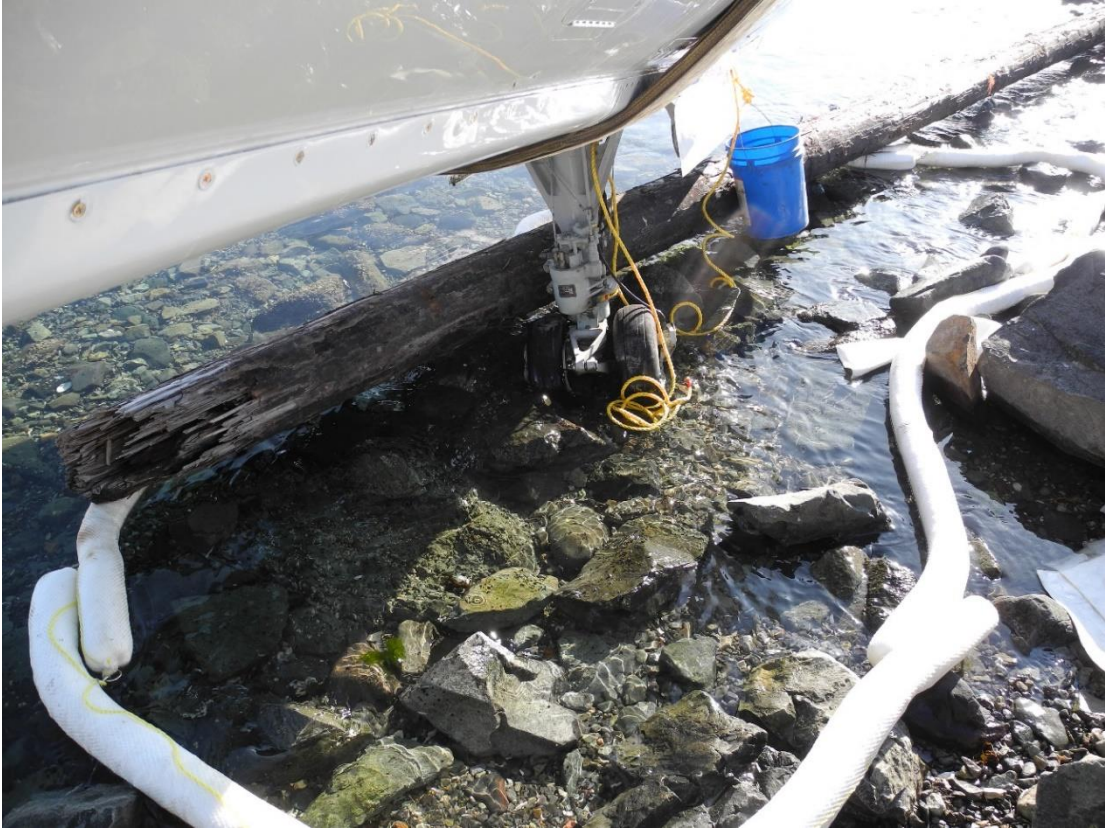
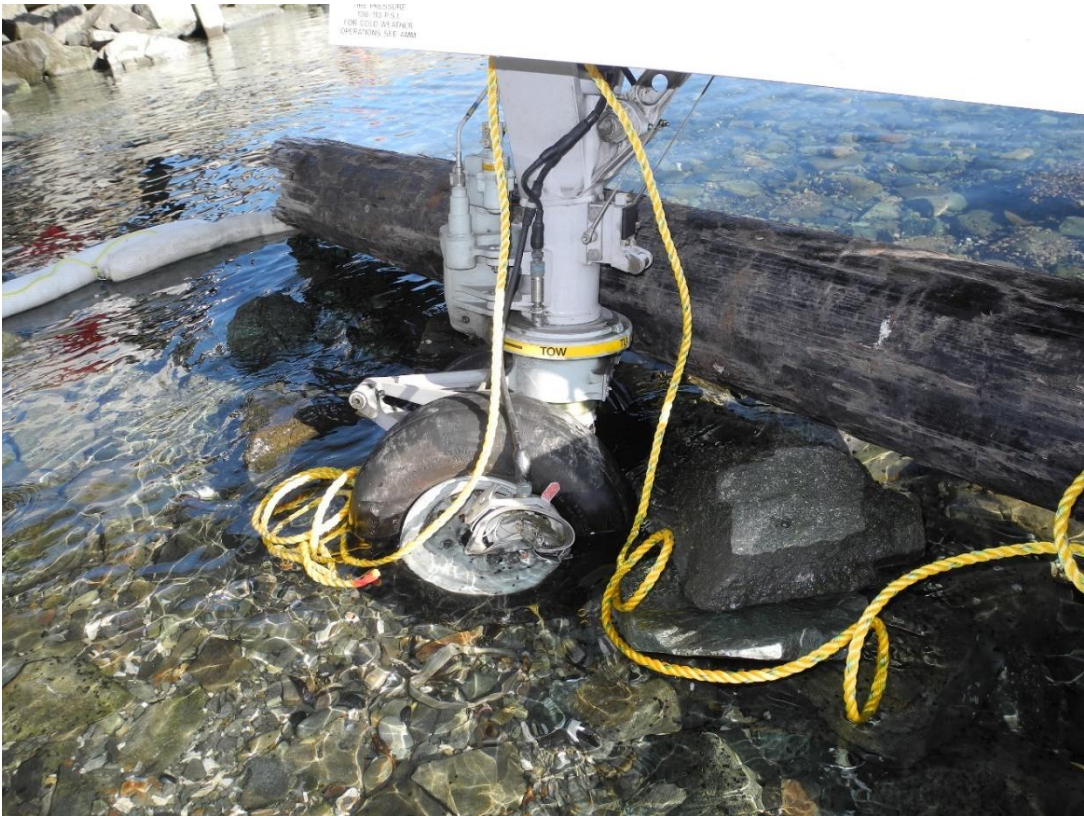
The nose gear was intact and supported the airplane post-accident in shallow water, Figures 58-59. To stabilize the airplane the nose was supported by a strap attached to a crane. The left tire was punctured and deflated. The right tire appeared to be partially inflated but could not be measured prior to transporting. The taxi light was detached and damaged. During recovery the wheels got turned 180 degrees and the inboard sidewall of the right tire impacted the loose taxi light, Figures 60-62. The final condition of the tire was deflated. The pin was placed in the gear and the nose was supported by the gear.

Figure 58 Nose gear and tires

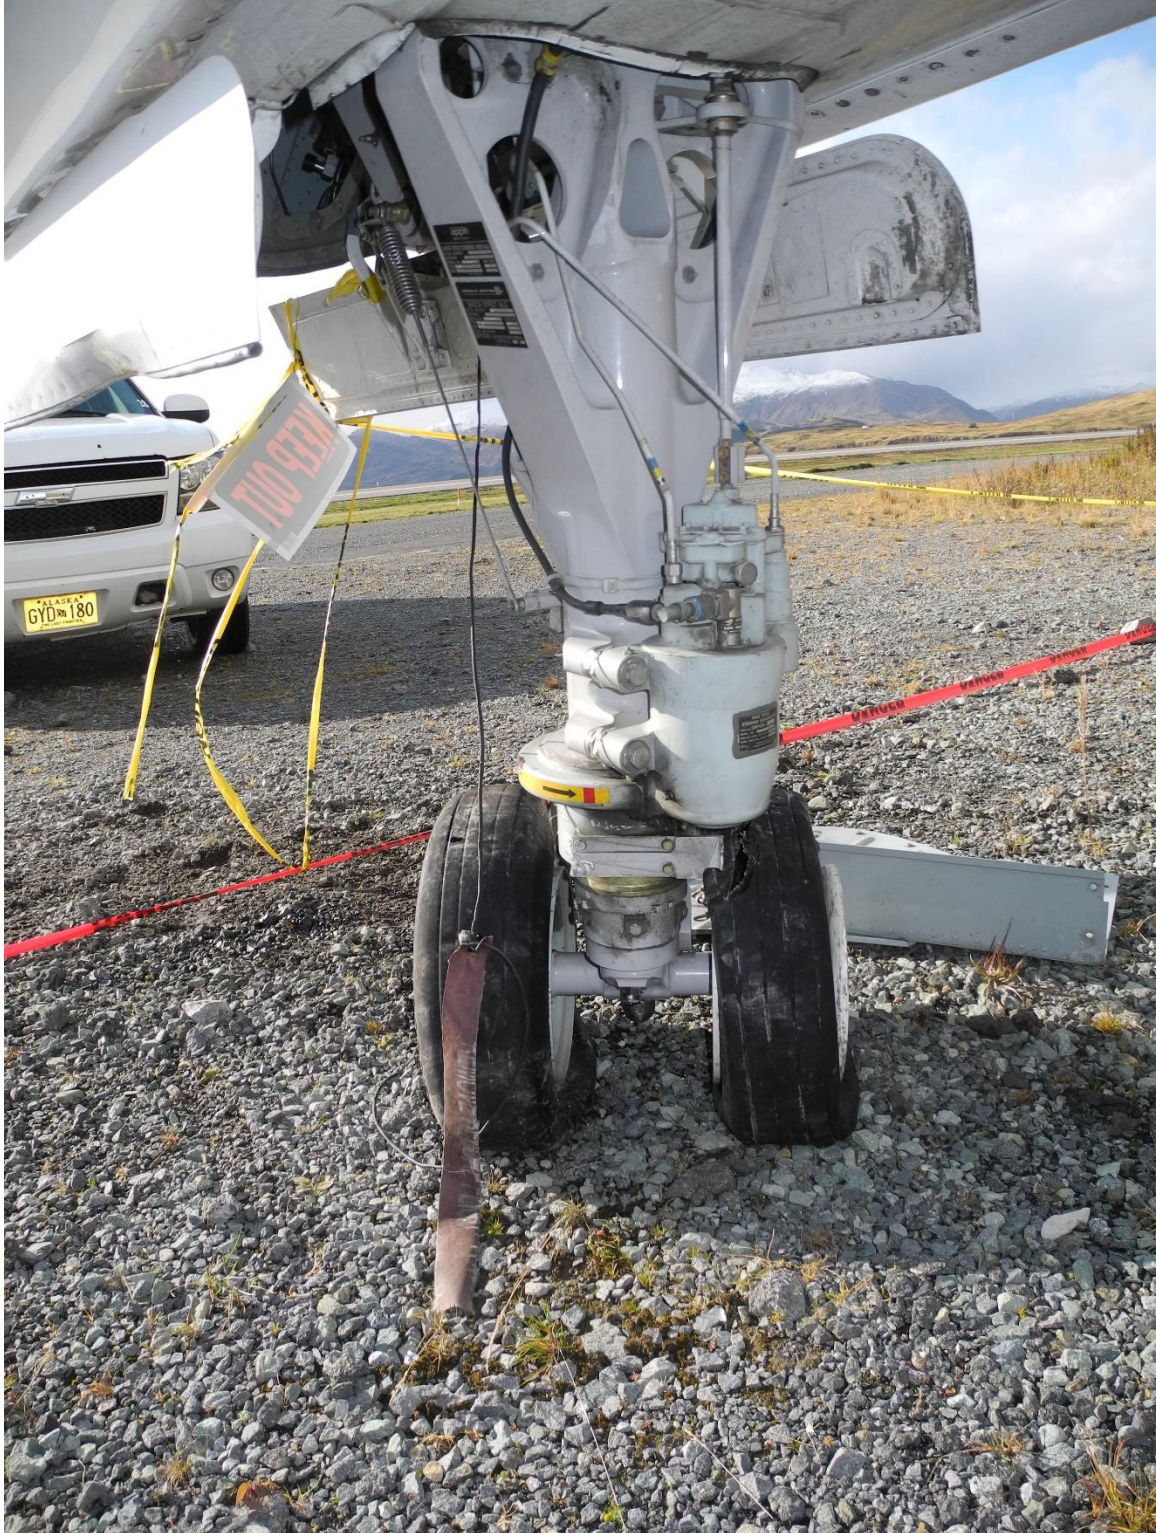
Figure 60 Nose gear and tires after recovery

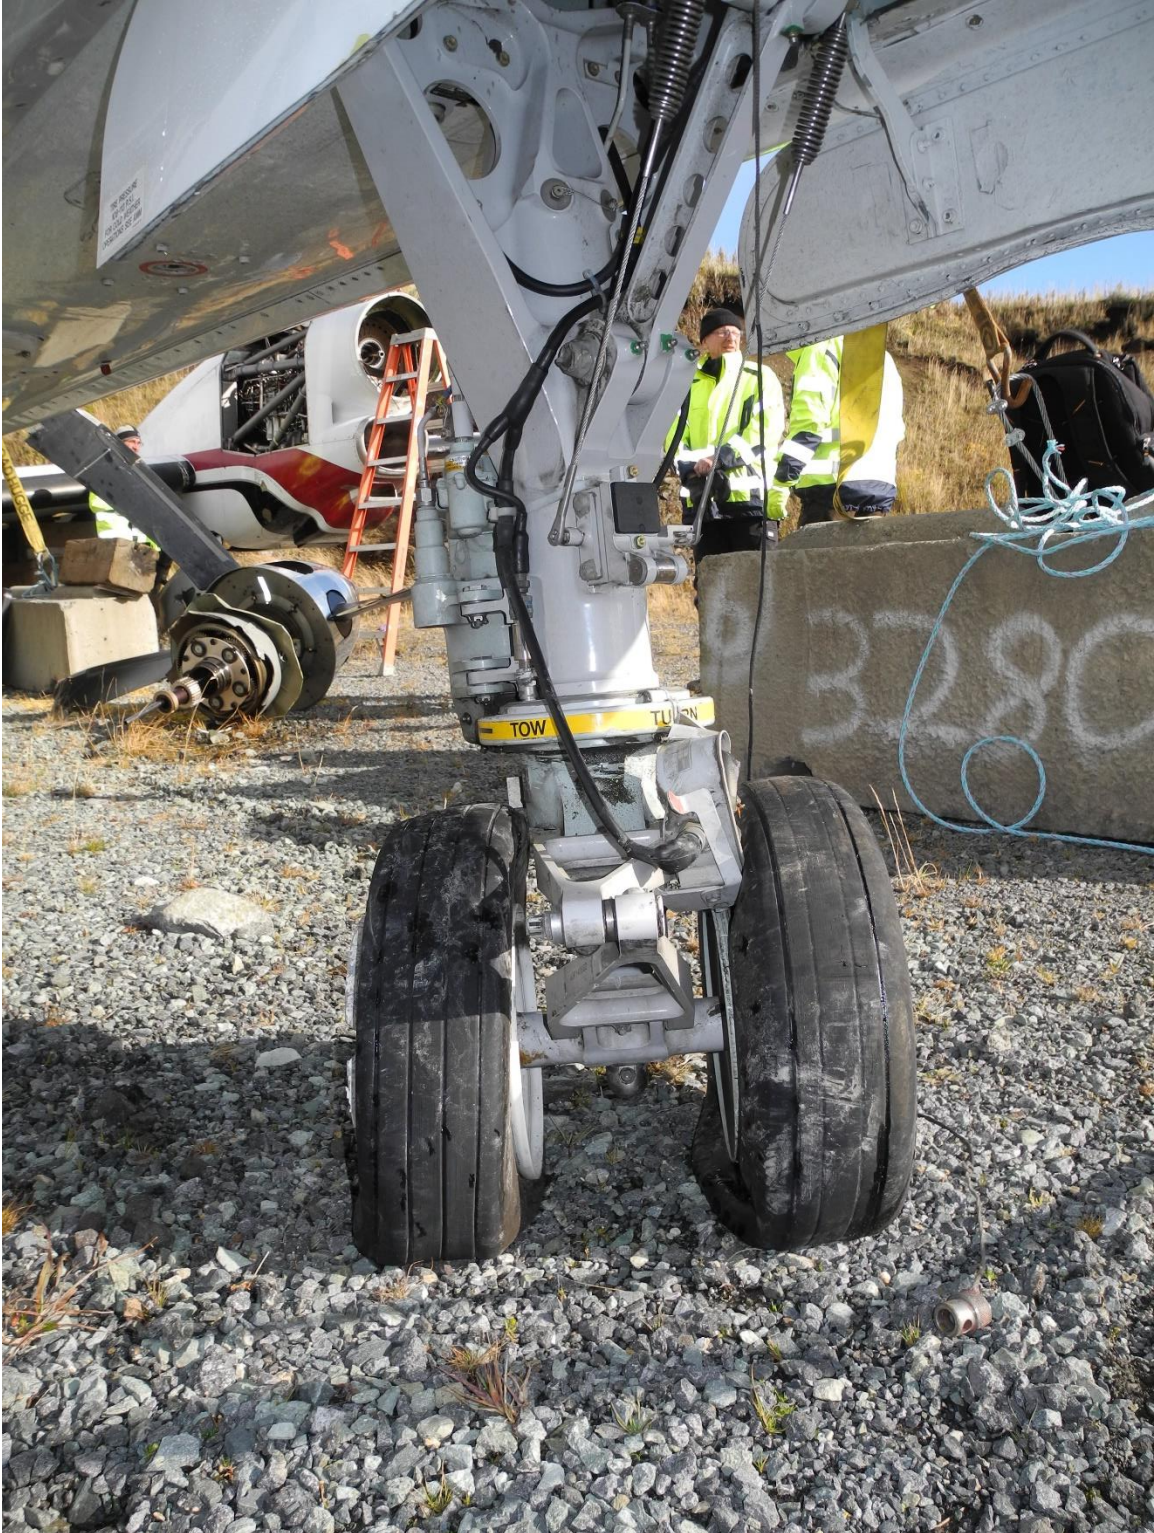
Figure 62 Nose gear and tires, right tire in contact with the light

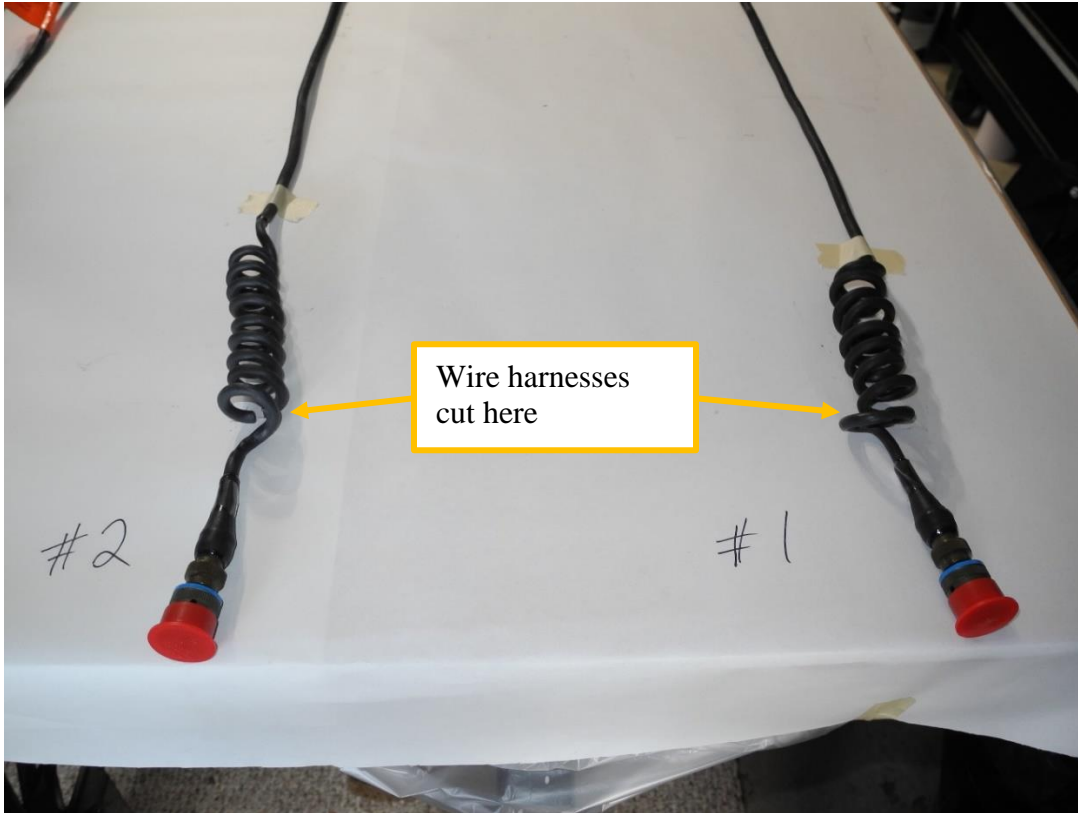
The #1 and #2 wheel speed transducer wire harnesses recovered initially were laid out on a table, measured and photographed, Figures A1-A4. The total length of #1 was approximately 104 inches, #2 was approximately 51 inches. This dimension included the portion of the connector which was cut when the wheel speed transducers were removed on-scene. According to the landing gear manufacturer's drawing the total length should be 2775 +10/-0 mm or 109.25 +0.4/-0 inches. The #1 harness fractured end was cut earlier to try to determine the wire numbers, but it was found that there were no wire numbers. There was 1 black wire, 1 white wire, and 1 white non-conducting filler wire for a total of 3 wires. According to the landing gear manufacturer's instructions the AIR 134485 drawing states 1 small filler wire, the AIR 134484 states filler, but does not specifically designate the number.

Figure A163 #1 and #2 wire harness segments with cut connector ends.

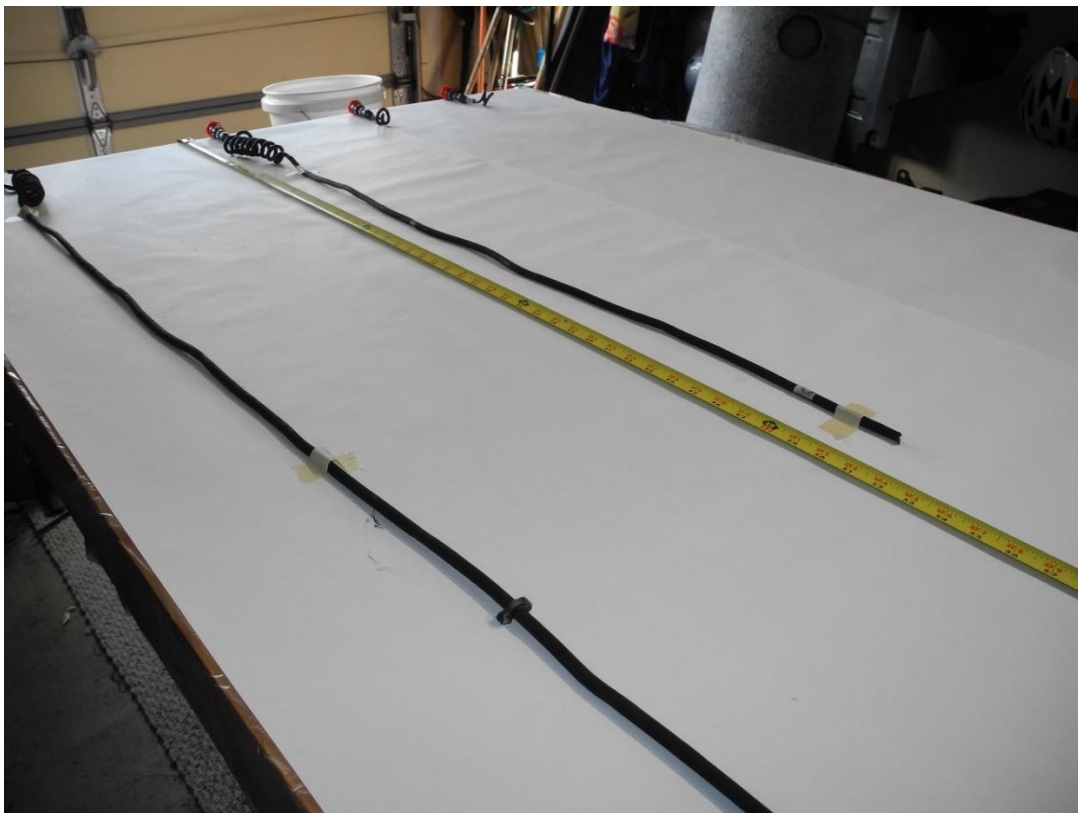
Figure A2 #1 and #2 wire harness segments

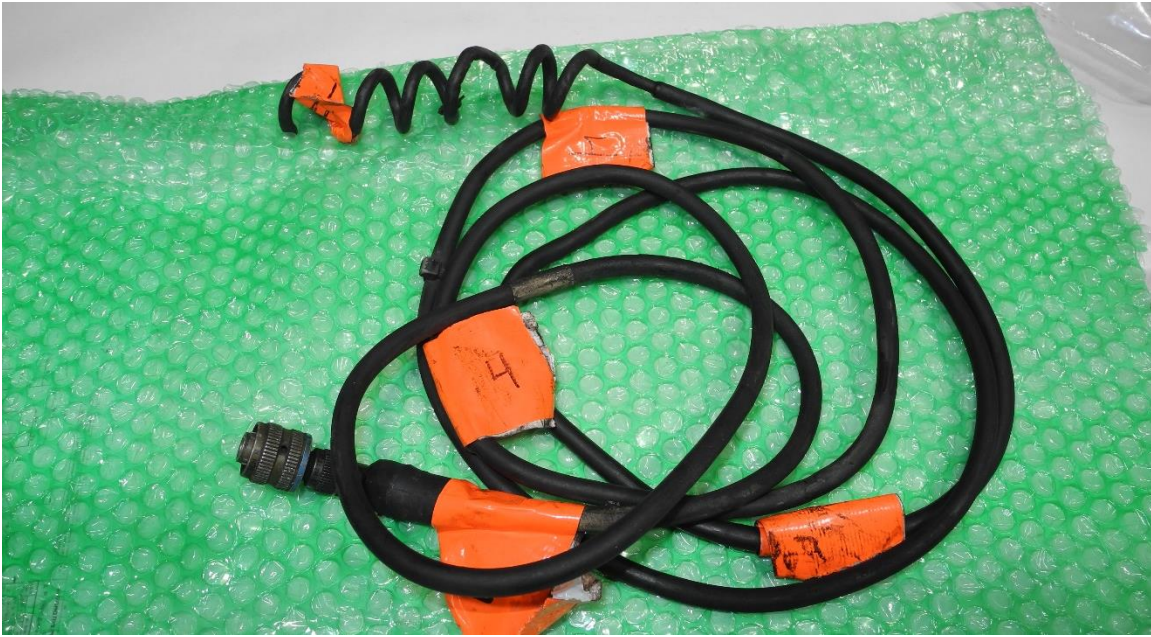
The shipping container was opened and the wire harness labelled #4 was removed, indicating it was removed from the #4 wheel, Figures A5-A6. The connector part number was MS27467T9B35P, the label closest to the connector was cleaned and it was 5/6GA-P4. The harness was laid out and it measured approximately 112.5 inches.

Figure A5 #4 wire harness

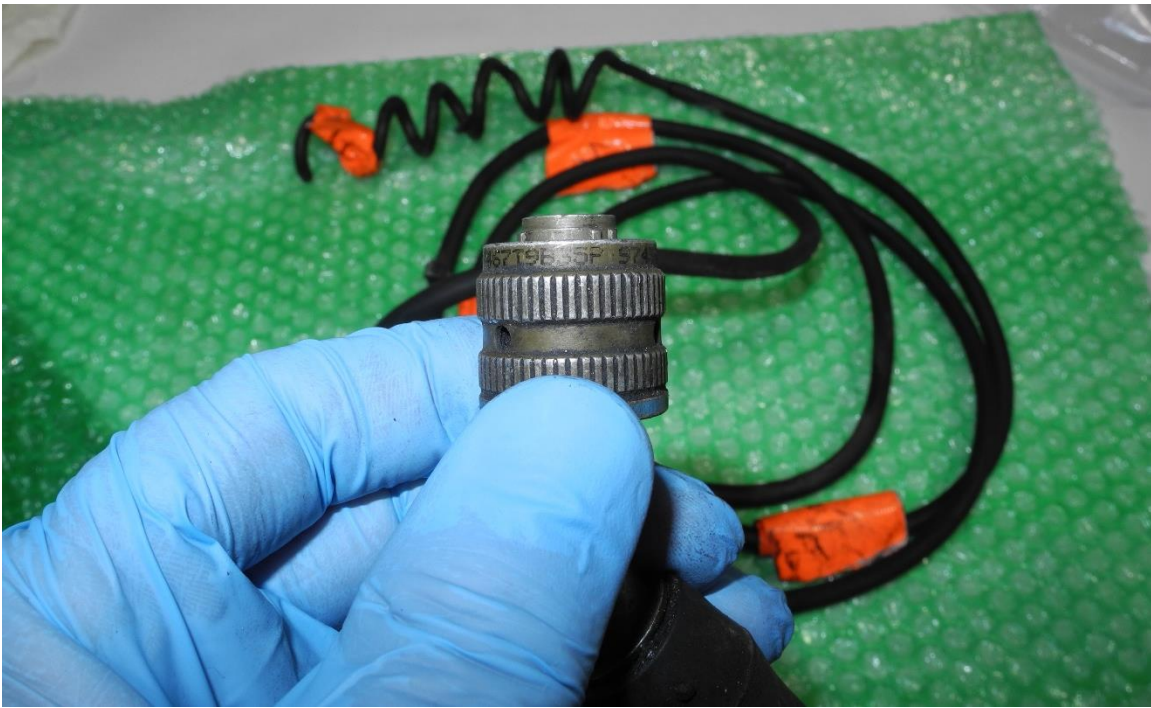
Figure A6 #4 wire harness connector

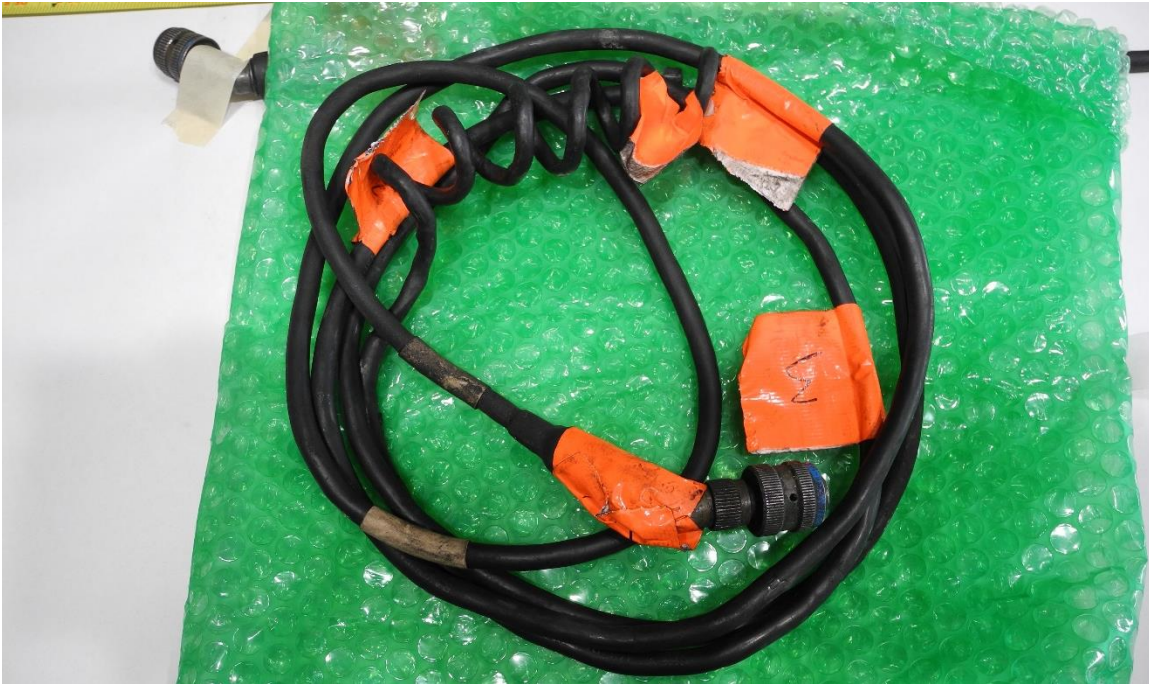
The wire harness labelled #3 was removed, Figures A7-A8. The connector part number was MS27467T9B35PA. The label was cleaned but could not be read. The harness was laid out and it measured approximately 112.5 inches.

Figure A7 #3 wheel speed transducer wire harness

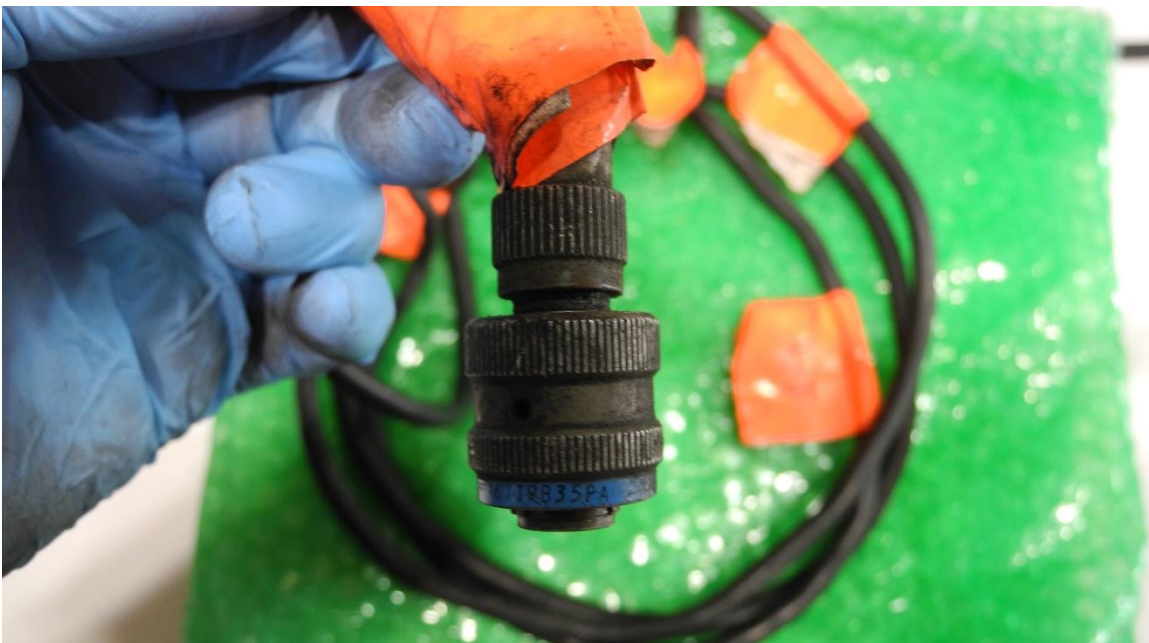
Figure A8 #3 wheel speed transducer wire harness upper connector

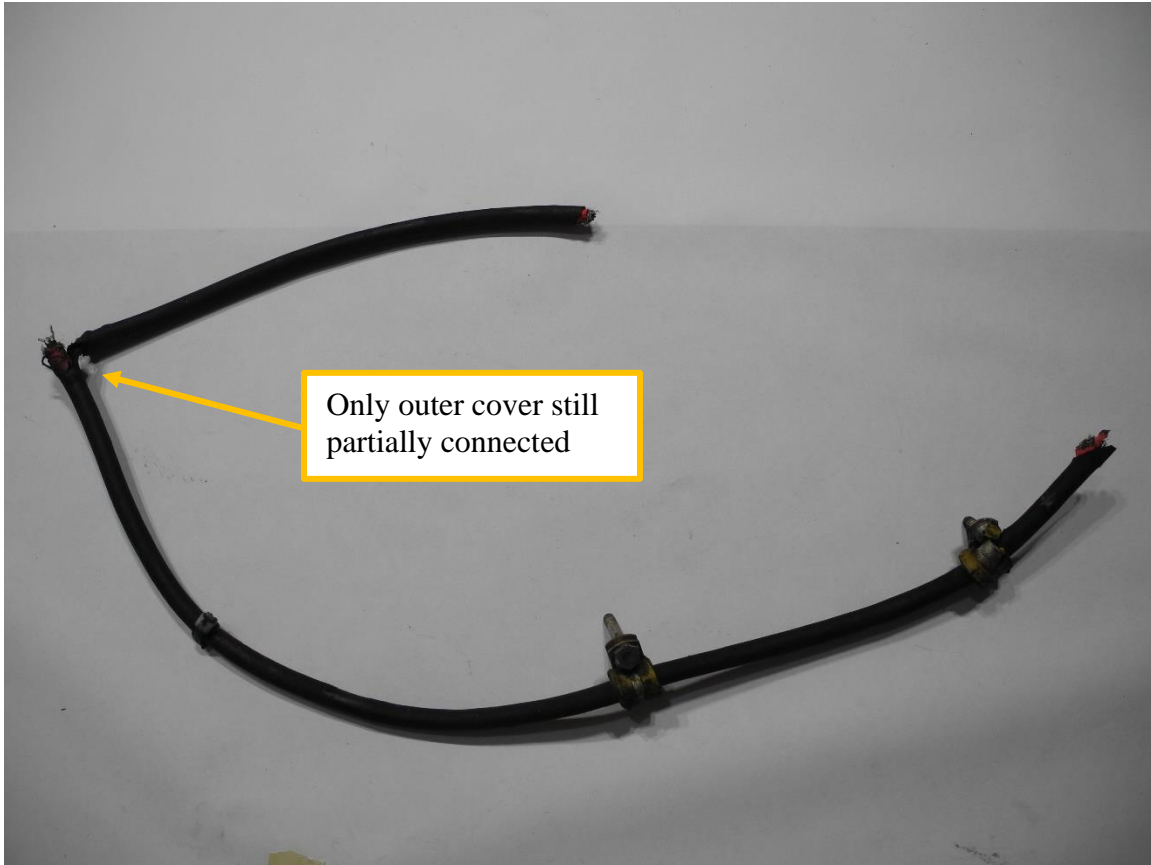
A harness segment was removed, which came from the left gear, Figures A9-A10. The segment had two yellow P clamps attached and it was almost completely fractured in one location. The segment measured approximately 2' 6" and will be referred to as the "Long segment" hereafter. The cable had two non-conductor white filler wires, one white wire, and one black wire, for a total of 4 wires, Figure A11.

Figure A9 Long segment of wire harness

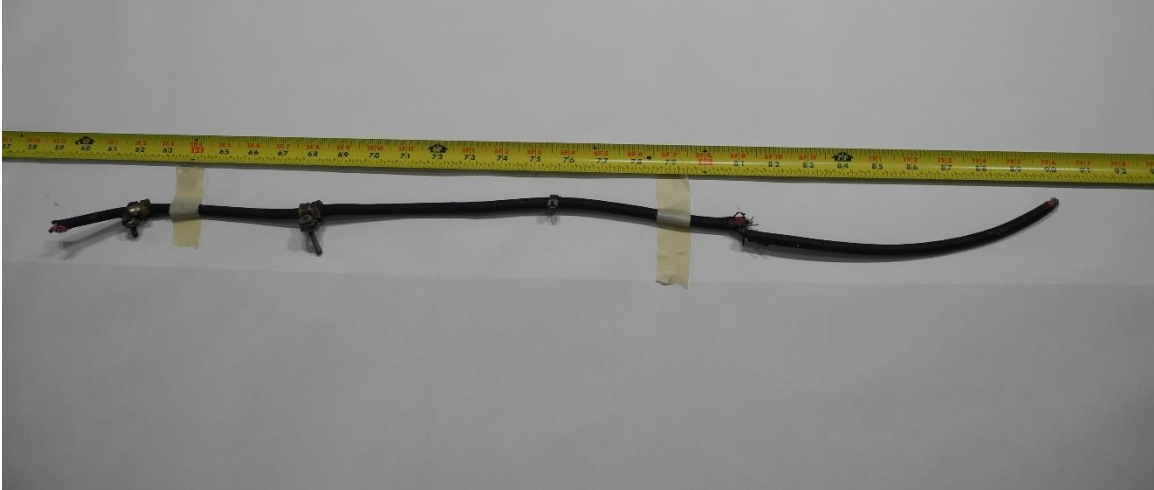
Figure A10 Long segment of wire harness

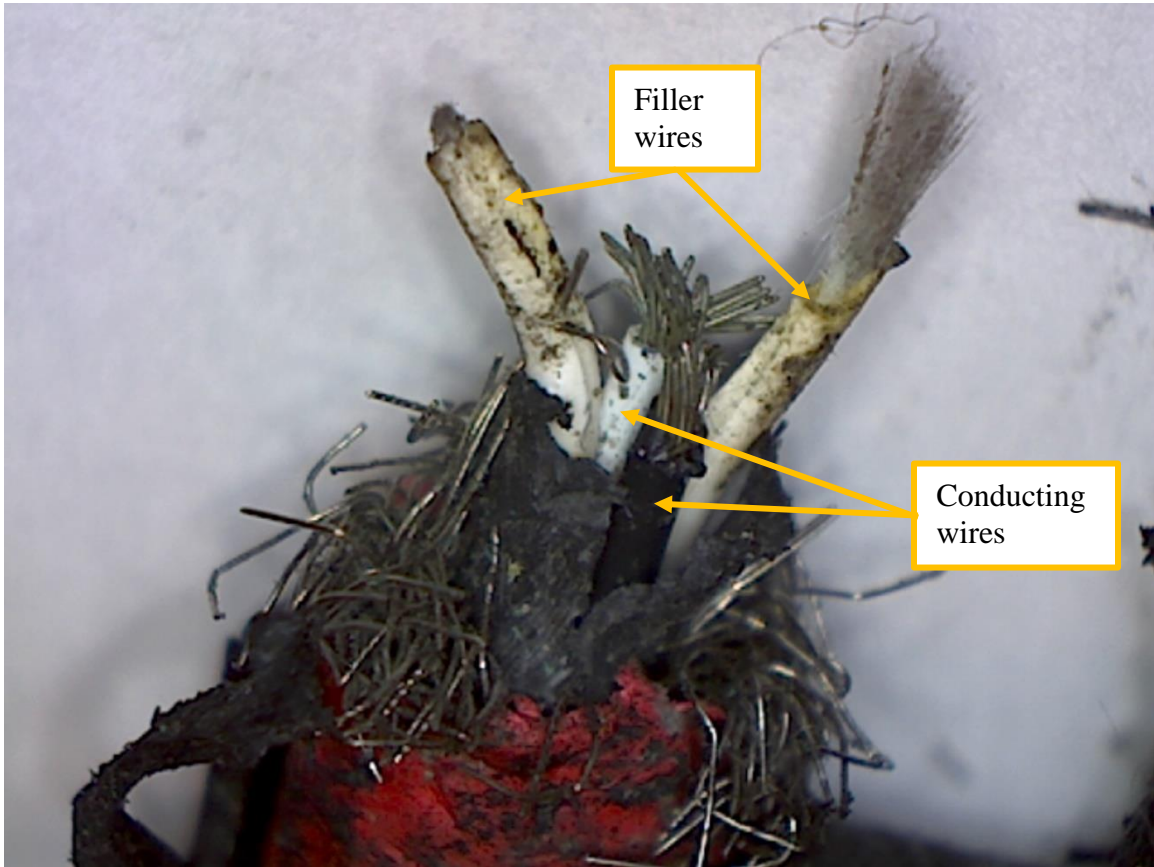
Figure A11 Long segment wire details

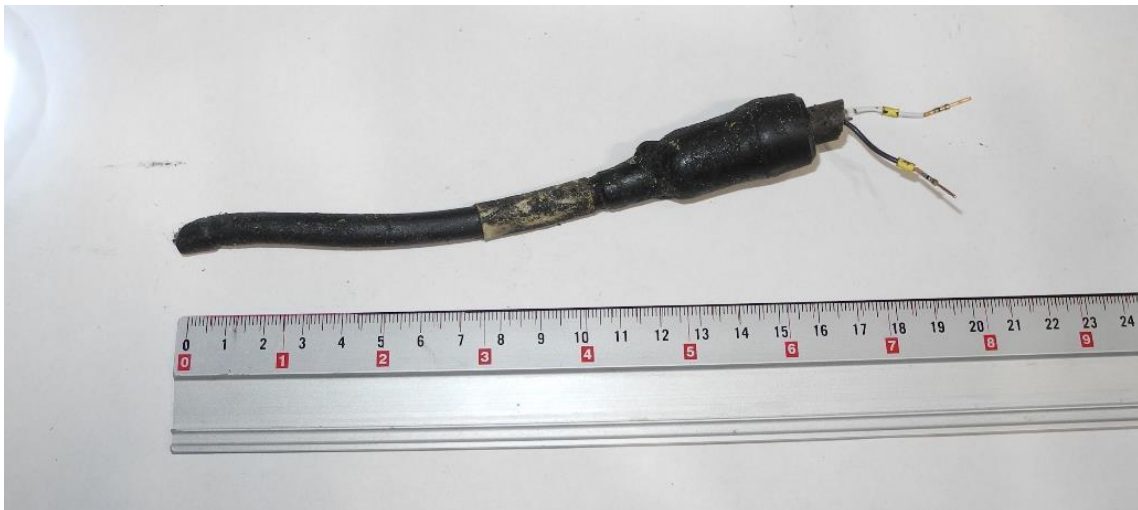
A harness segment was removed, which came from the left gear, Figures A12-A14. The cable segment had a portion of a connector attached and two wires with pins attached. The harness label read 5/6 GA-P4. One of the wires, the white, had separated. The wires had labels, 3 (white) and 4 (black). The wire segment was approximately 6.5 inches long, and will be referred to as the “Short segment” hereafter.

Figure A12 Short segment with connector portion and pins

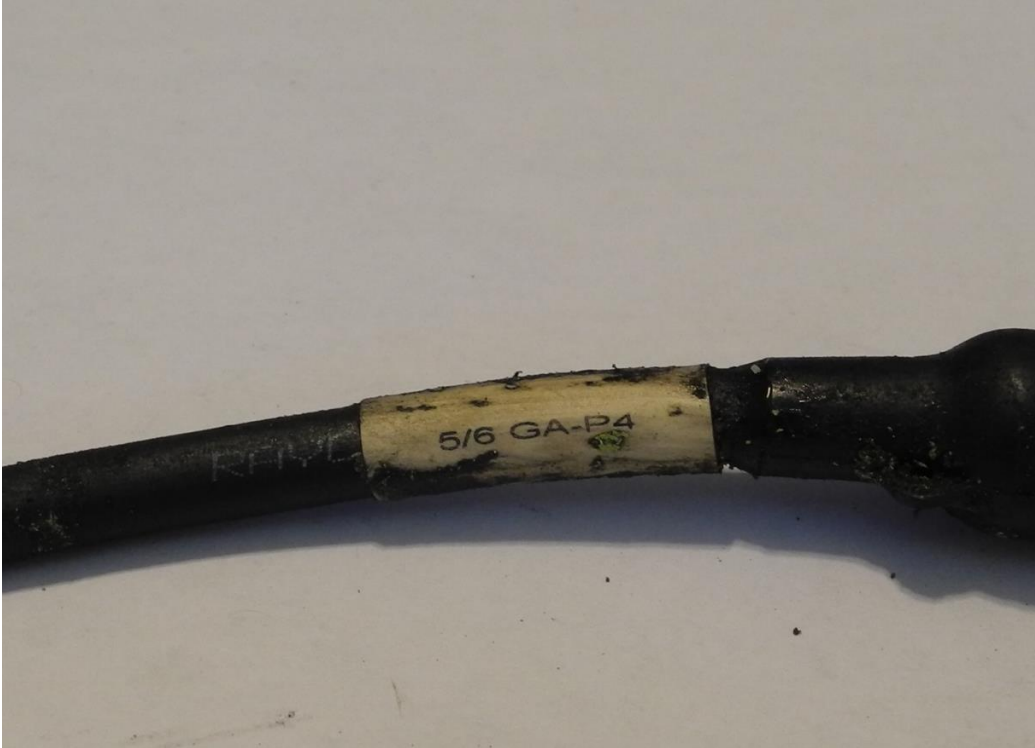
Figure A13 Short segment label info

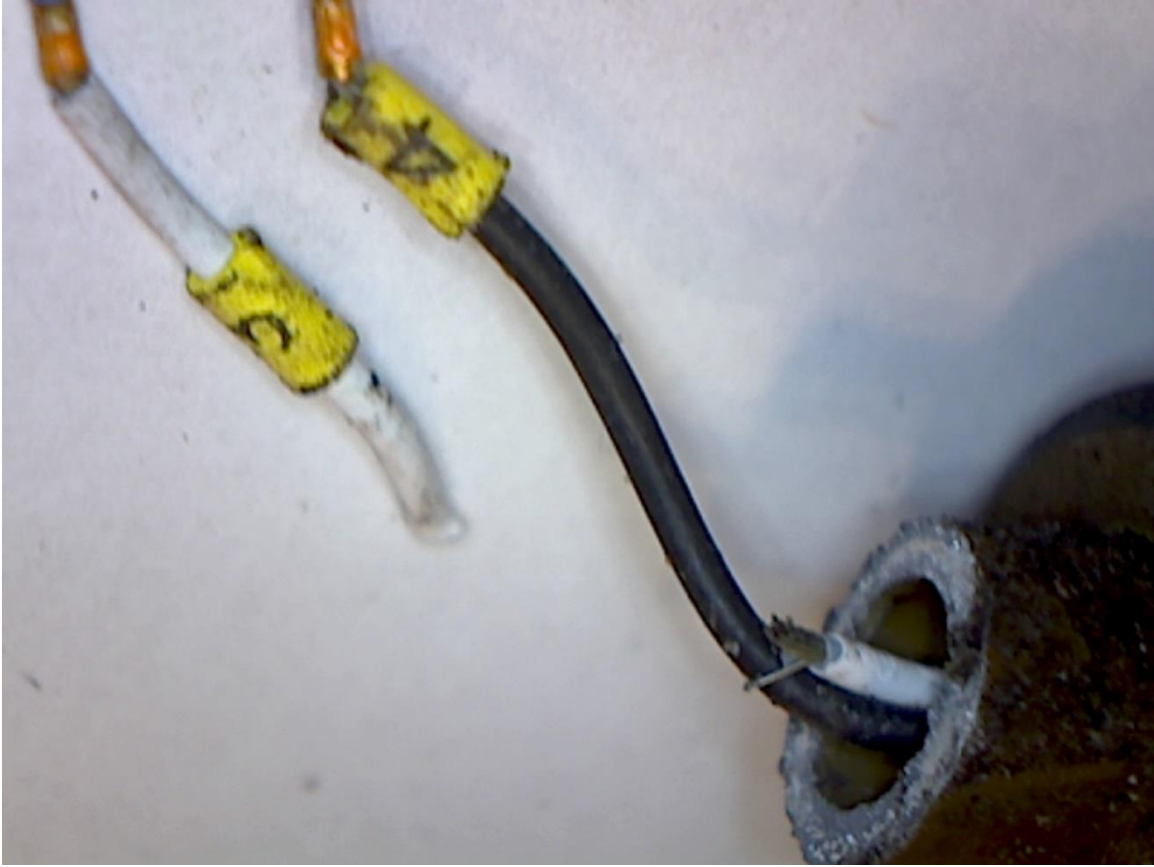
Figure A14 Short segment wire numbers

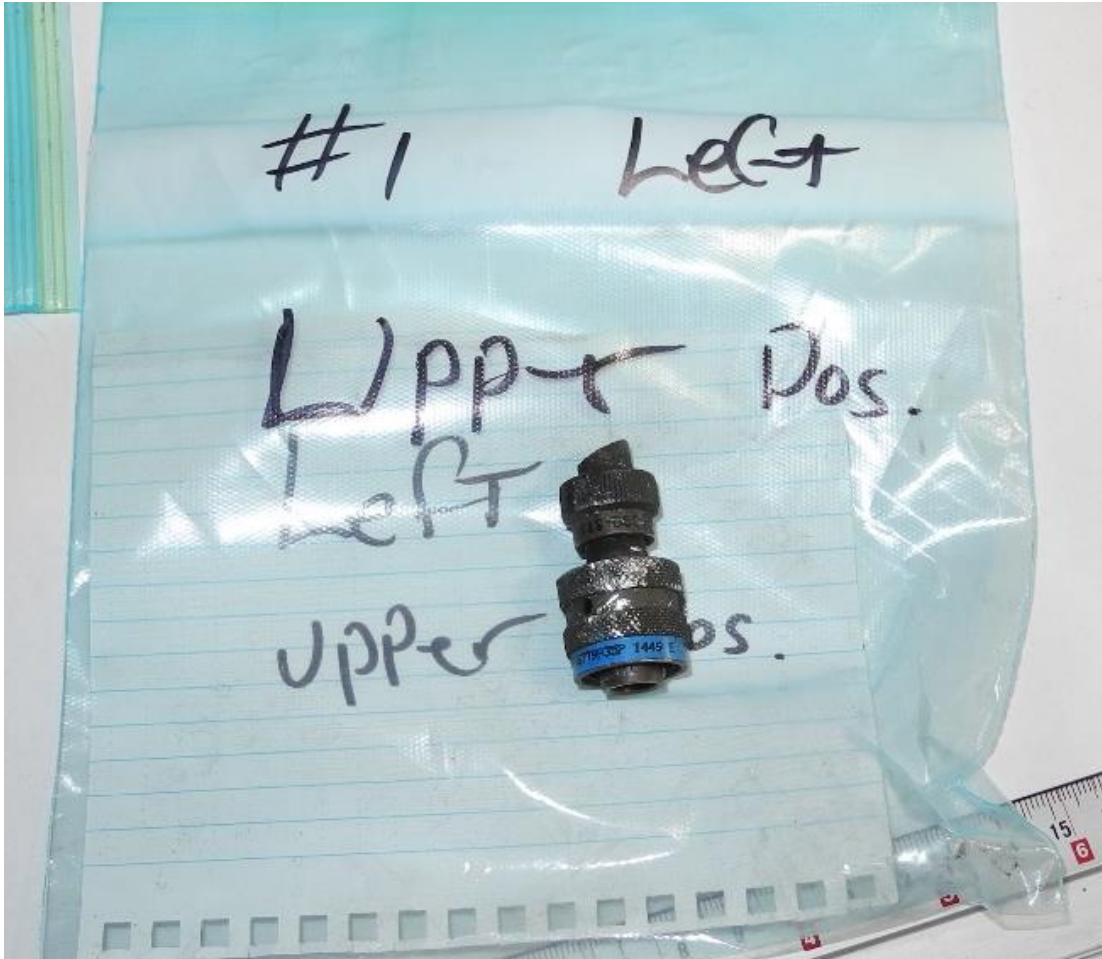
The connector labelled “#1 left upper position” was removed, Figures A15-A17. This was the connector attached to the upper bulkhead fitting in the wheel well. The connector number was MS27467T9B35P. The connector was missing pins 3 and 4.

Figure A15 Upper connector portion

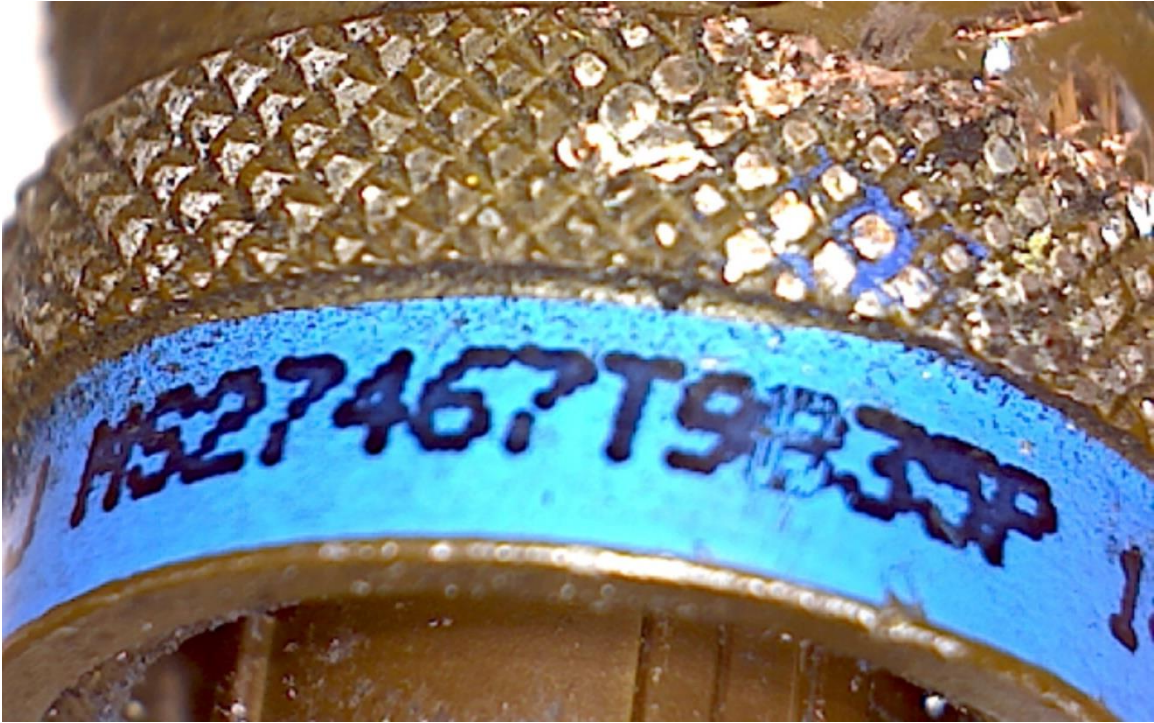
Figure A16 Upper connector part number

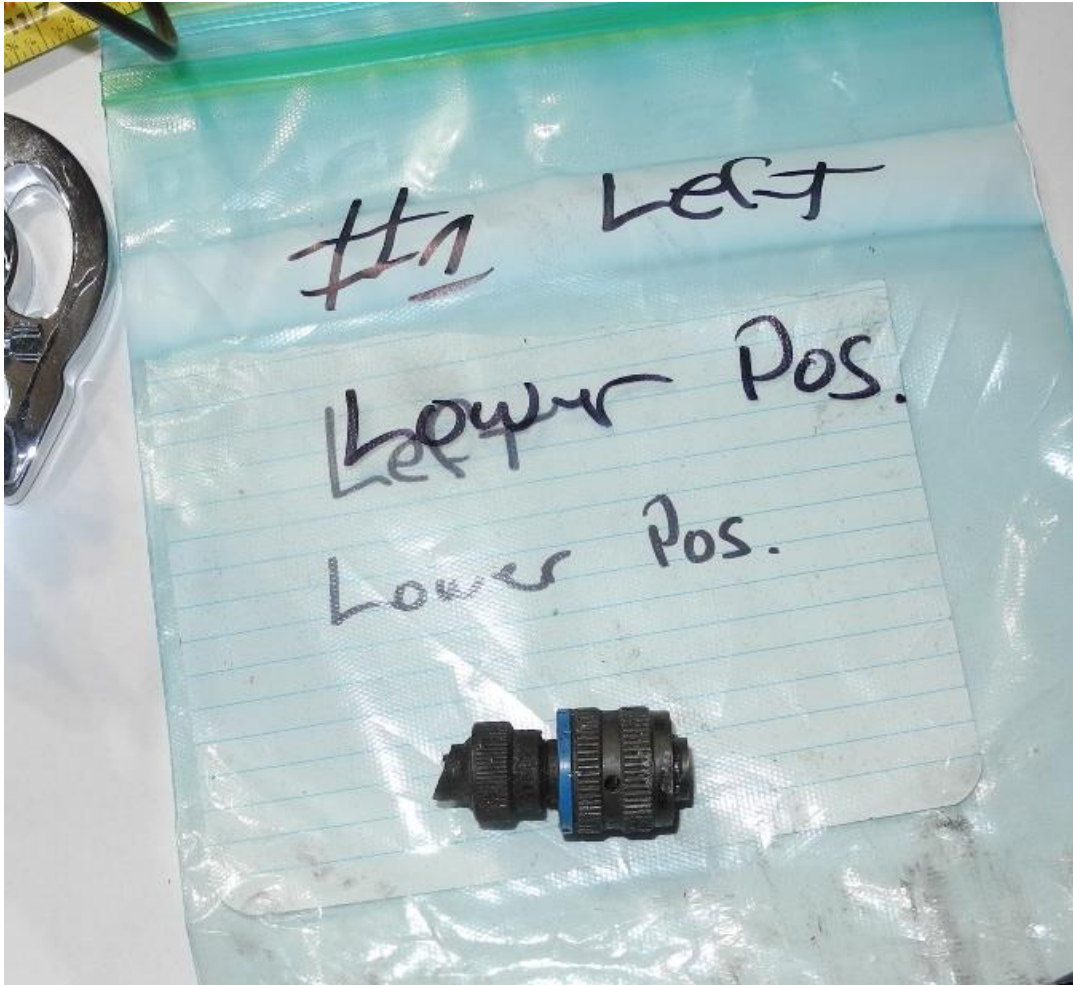
The connector labelled “#1 left lower position” was removed, Figures A18-A20. This was the connector attached to the lower bulkhead fitting in the wheel well. The connector number was MS27467T9B35PA. The connector had a white and black wire segment still attached. The black wire had a #4 label attached.

Figure A18 Lower connector portion

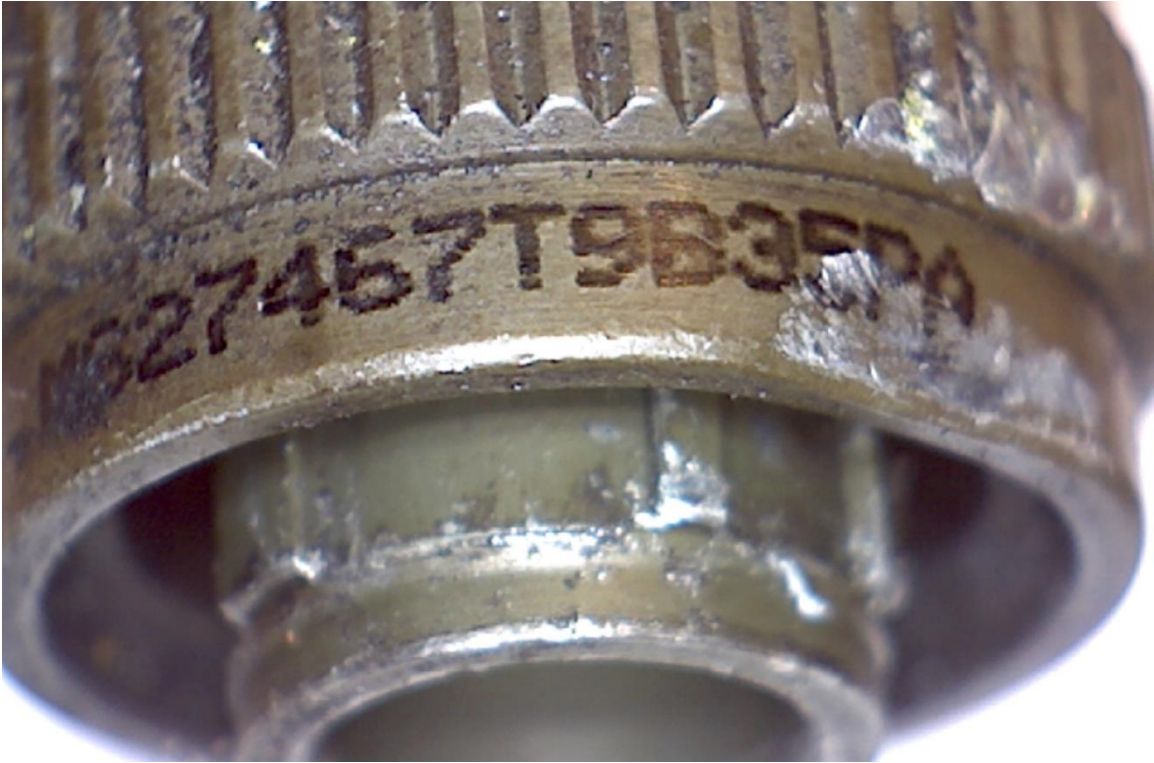
Figure A19 Lower connector part number

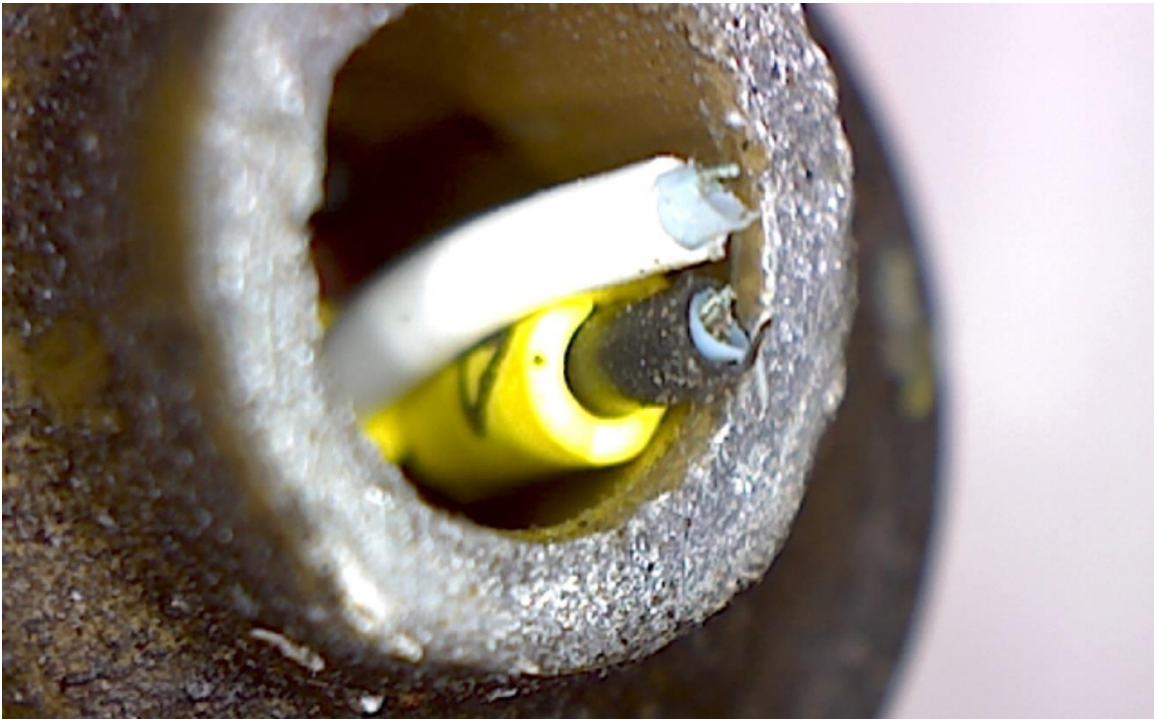
Figure A20 Lower connector wires still attached

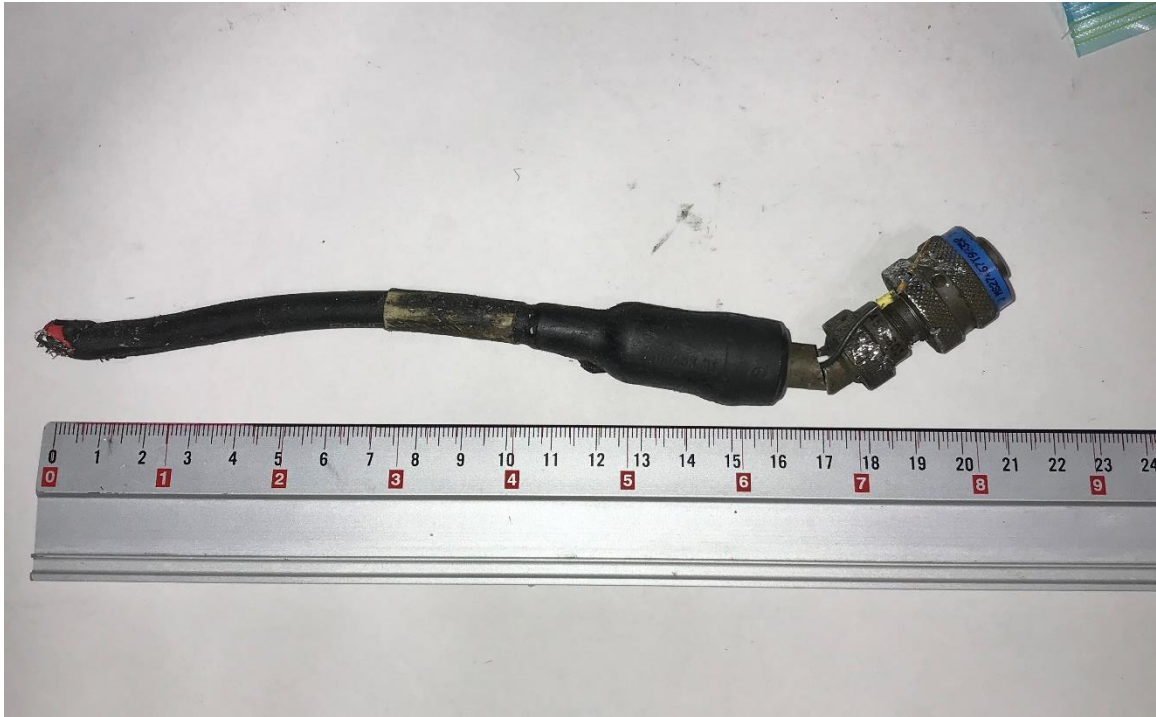
Figure A25 Short segment with upper connector dimension
