**NATIONAL TRANSPORTATION SAFETY BOARD
OFFICE OF AVIATION SAFETY
WASHINGTON, D.C. 20594**

Systems and Structures Group Chairman's Factual Report

DCA20MA002

Operator: PenAir
Aircraft: Saab 2000
Location: Dutch Harbor, AK
Date: October 17, 2019
Time: 1740 ADT

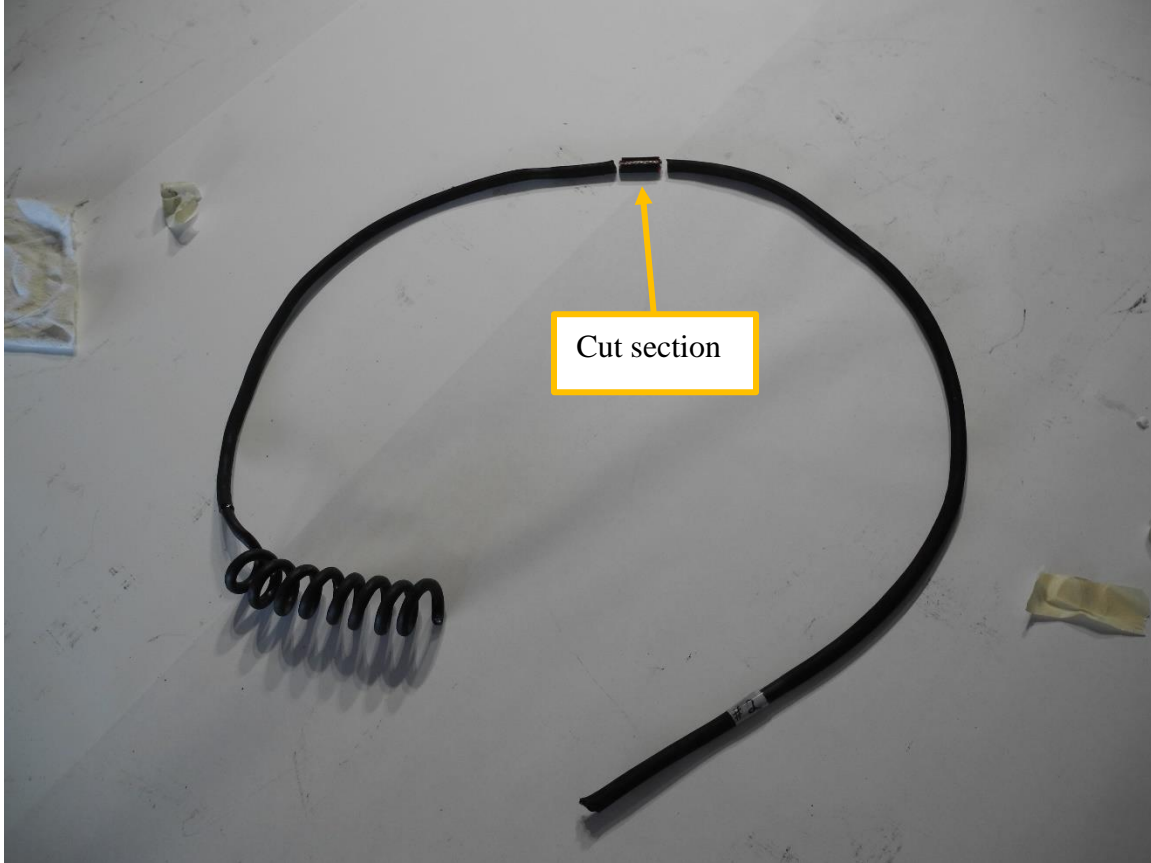
It was established above that the long segment had two conductor wires and two filler wires. Approximately 1 inch was cut from the #2 harness near the middle, Figure A26. The cut section was opened and there were 4 wires present, two conductor wires and two filler wires, Figures A27-A28.

Figure A26 #2 harness with small segment cut out of middle

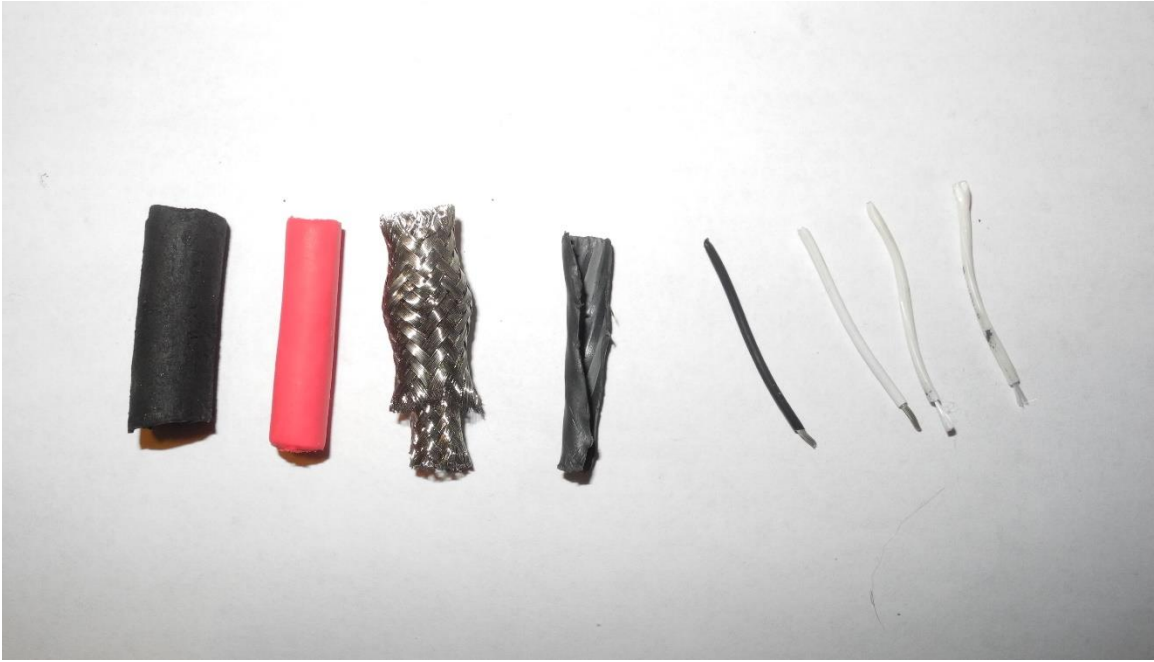
Figure A27 Disassembled #2 harness cut section

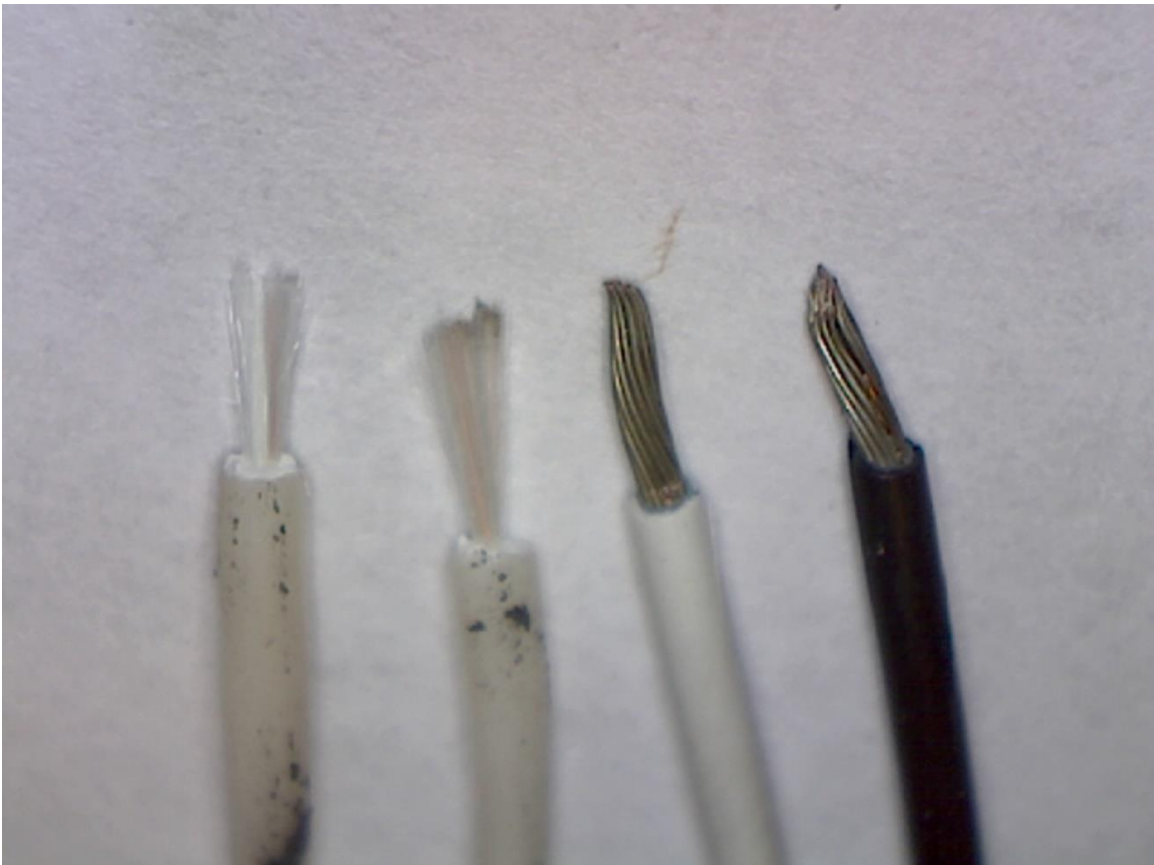
Figure A28 Magnified view of #2 harness wires

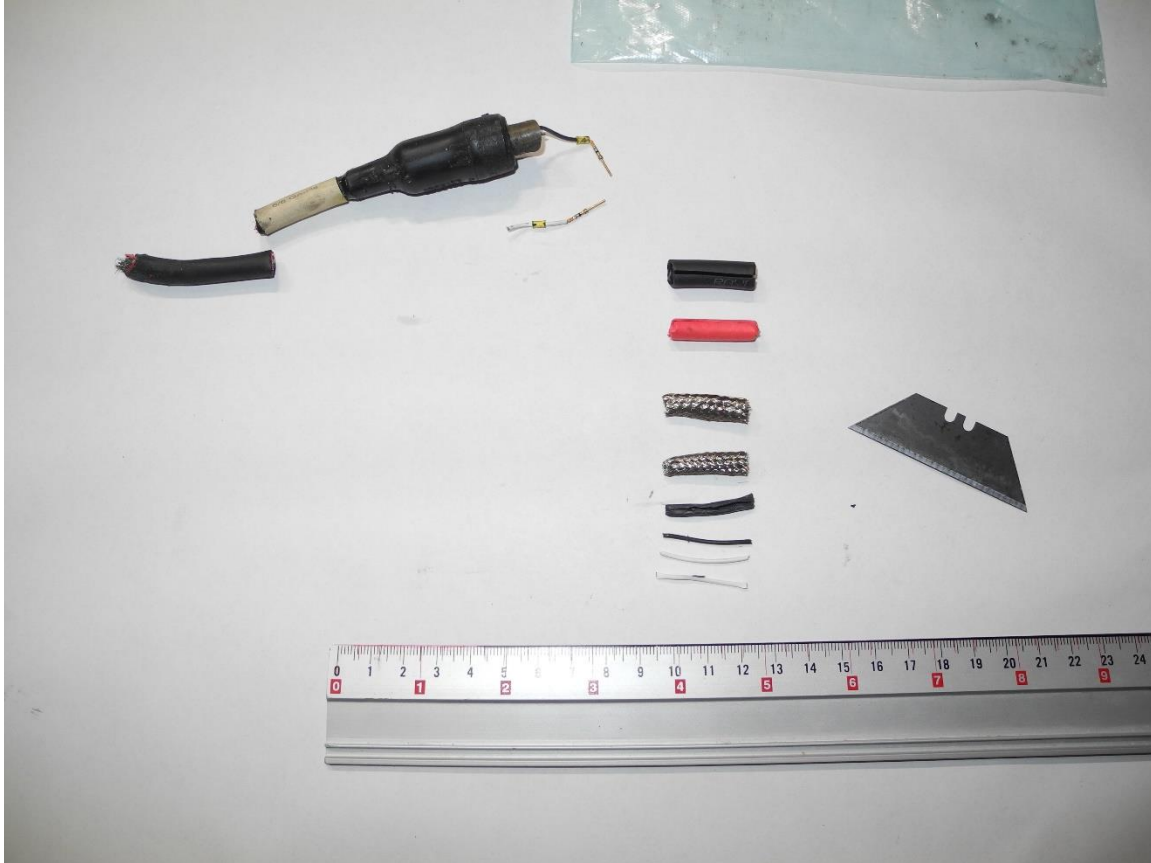
Approximately 1-inch was cut from the middle of the short segment below the label. The cut section was opened and there was 1 black wire, 1 white wire, and 1 non-conducting wire for a total of 3 wires, Figures A29-A30. This matches the number of wires in the #1 harness segment, Figure A3

Figure A29 Short segment with 1 inch segment cut from middle, shows 3 total wires

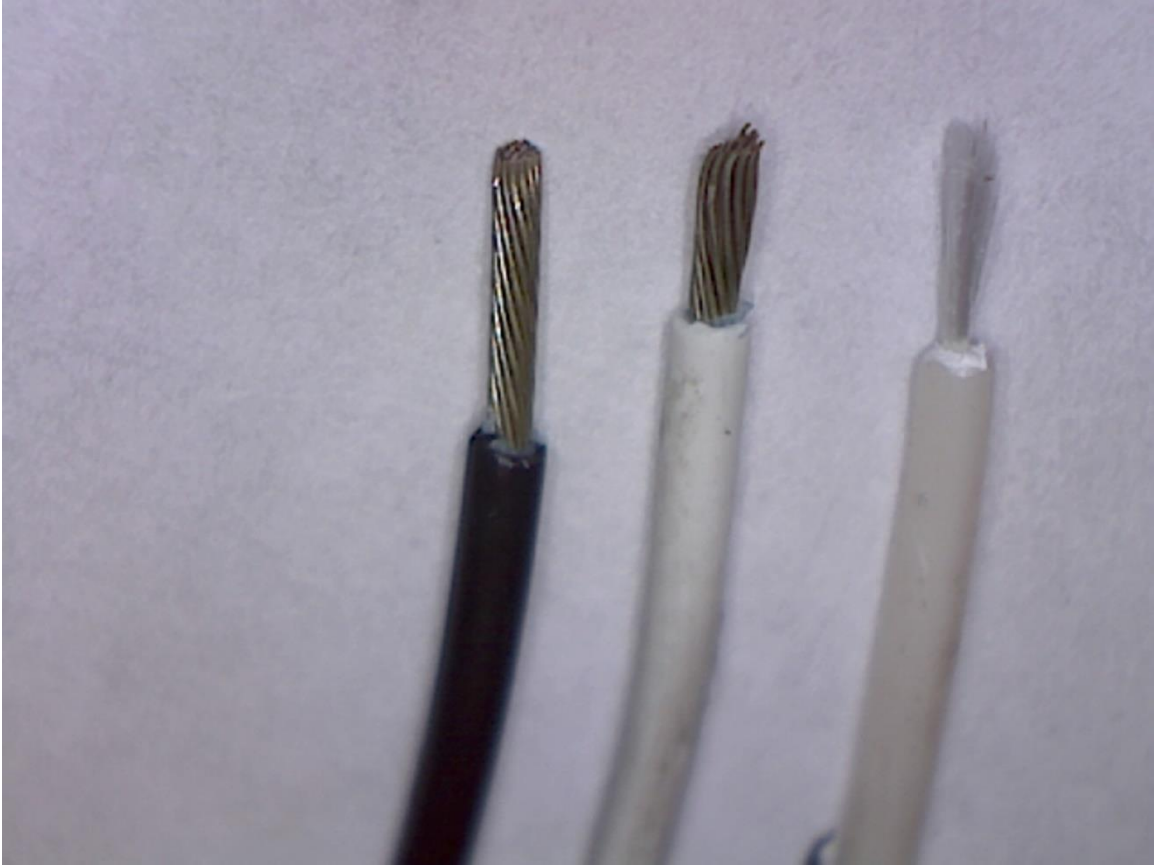
Figure A30 Short segment wire details.
