Runway Overrun During Landing PenAir Flight 3296 Saab 2000, N686PA

Unalaska, Alaska
October 17, 2019

Accident Overview

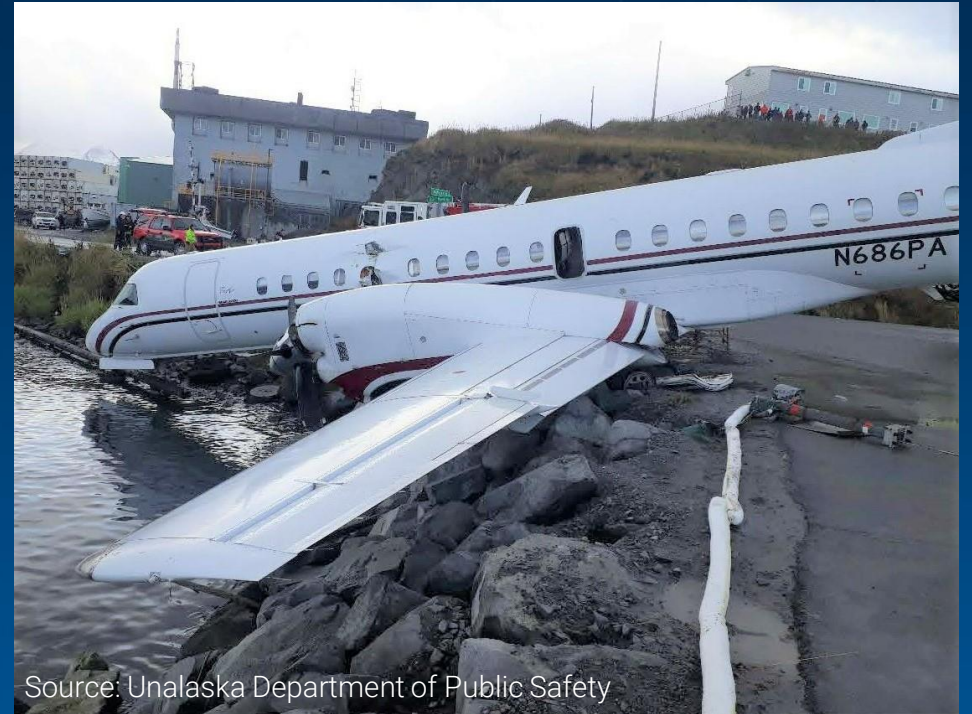
- October 17, 2019
- 5:40 p.m. Alaska daylight time
- PenAir flight 3296
- Saab 2000 substantially damaged during landing overrun at Unalaska Airport (DUT)
- Passenger injuries
 - One fatal
 - One serious
 - Eight minor

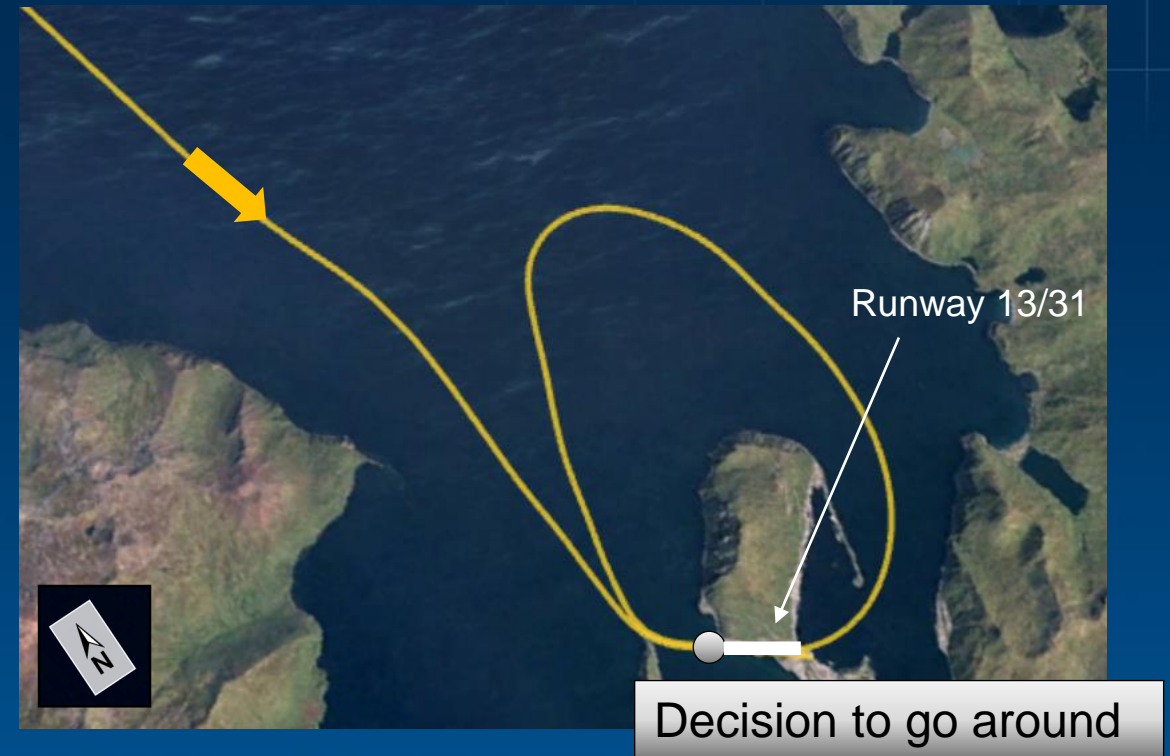
First Approach and Go-Around

- DUT runway 13/31
- Wind shifting and favored runway 31
 - Flight crew planned for runway 13
 - First approach became unstabilized
 - Flight crew conducted go-around

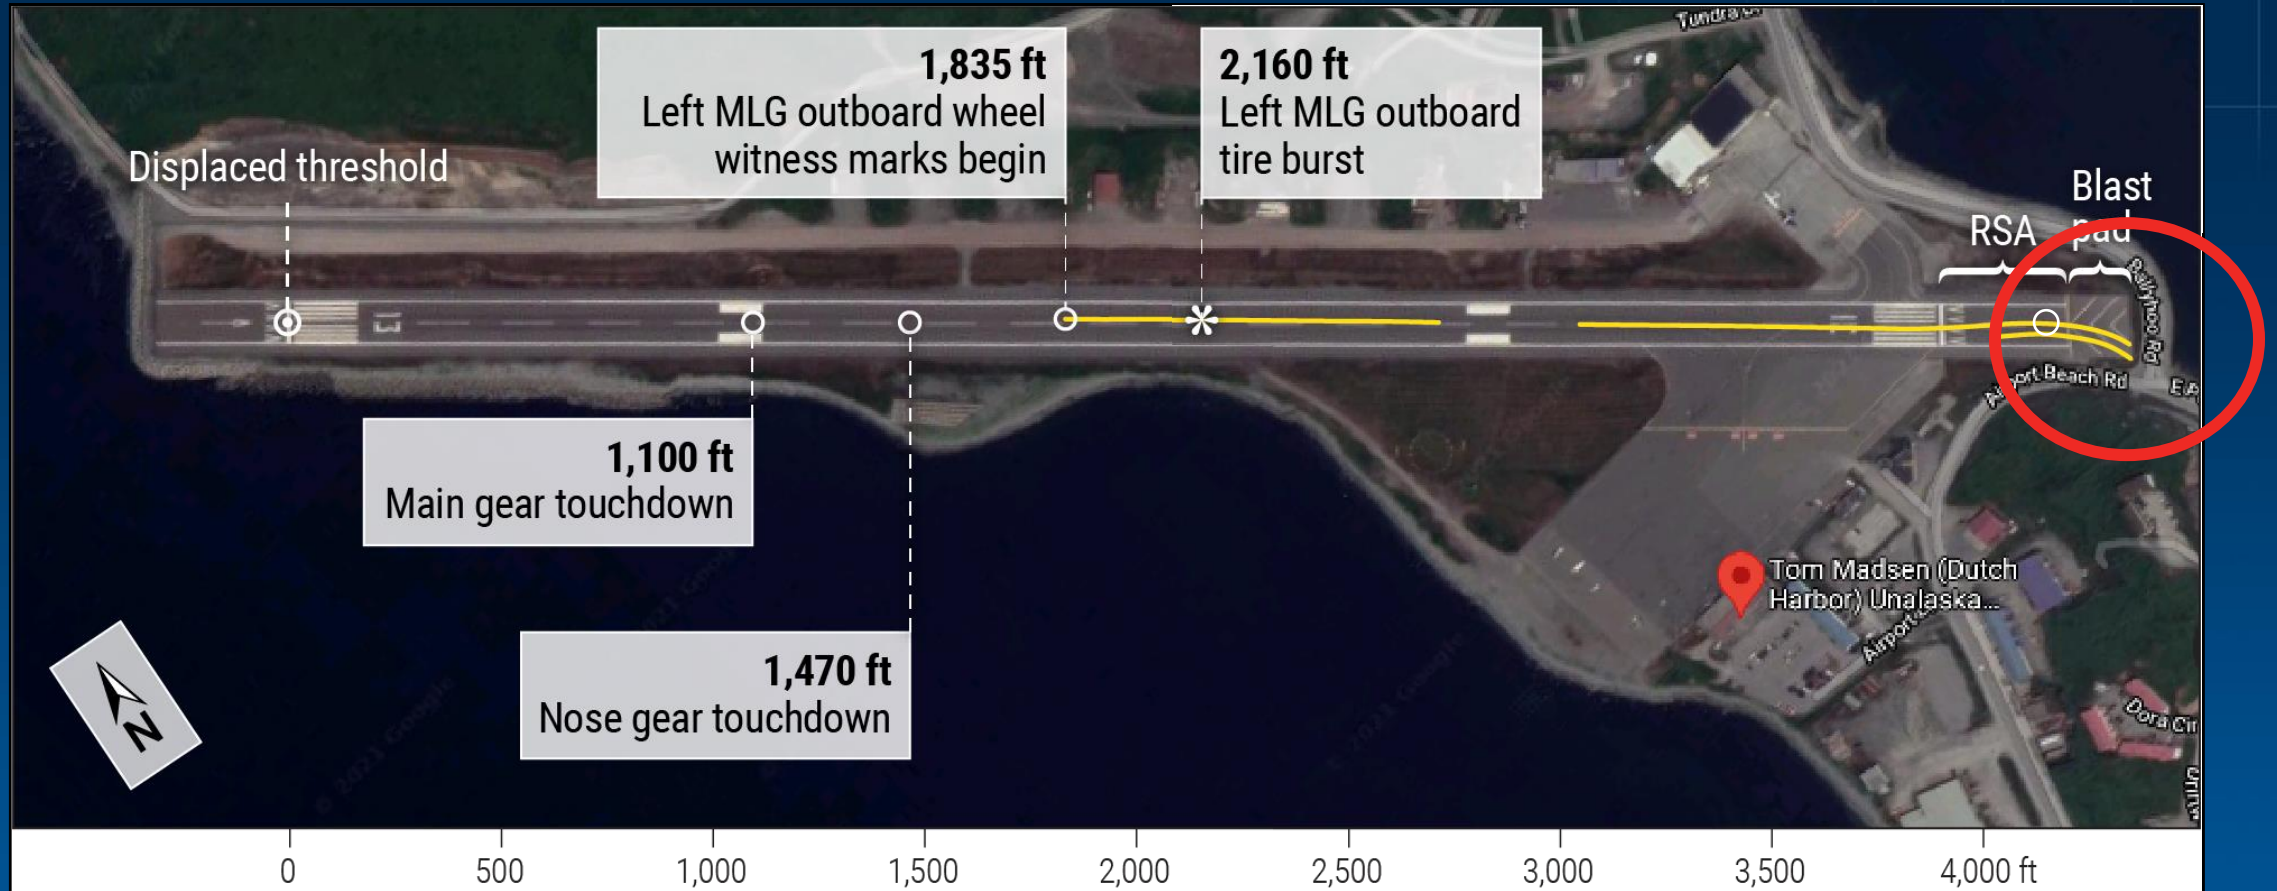
Touchdown and Landing Rollout

- Determined 15-knot tailwind existed at touchdown
- Calculations indicated airplane should have safely stopped with
 - Flaps: 20° or 35°
 - Wheel braking: Normal or up to 50% loss
- Deceleration during accident rollout worse than expected; skid marks and tire burst evidence indicated wheel brake system anomaly

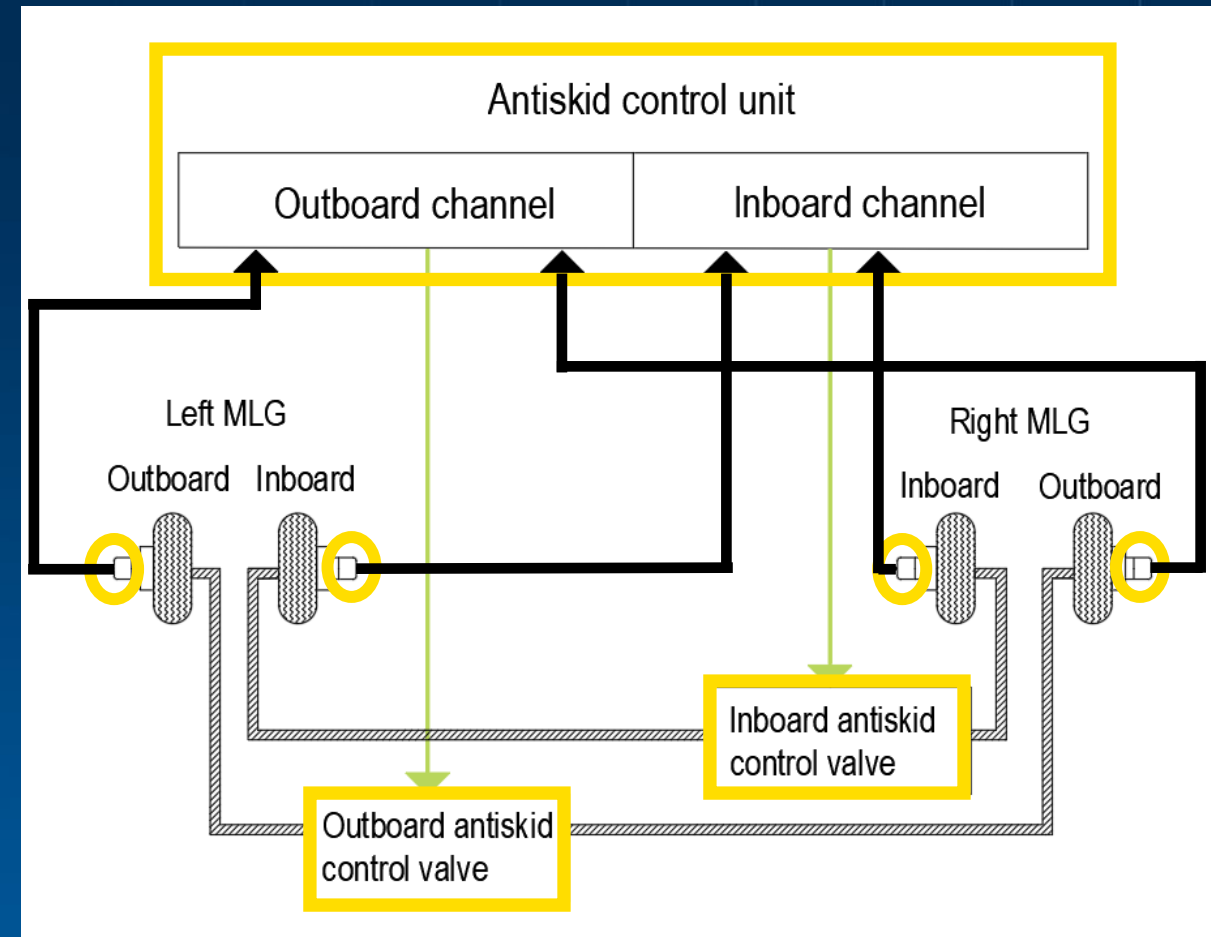
- Consists of antiskid control unit, wheel speed transducers, and hydraulic control valves
- Manages skids in pairs (inboard and outboard)
- When excessive skid sensed, brake pressure reduced to wheel pair to eliminate skid
