NATIONAL TRANSPORTATION SAFETY BOARD

Group Chairman's Factual Report

DCA21FA085

SUBJECT: *Right Engine Fan Blade Out and Inlet/Fan Cowl Departure – Examination of recovered Inlet Cowl, Fan Cowls, and Thrust Reversers*

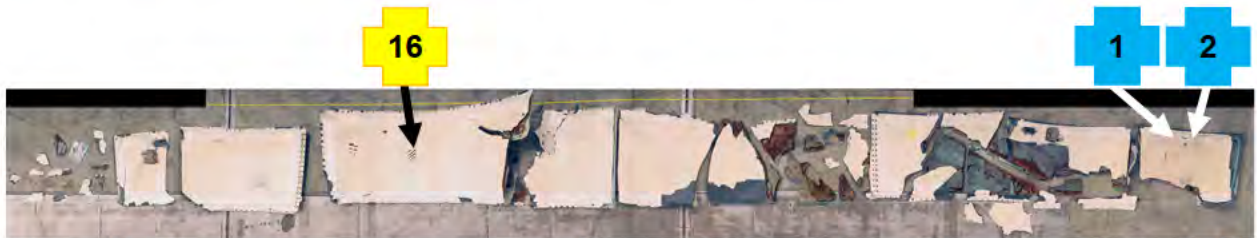
Figure 17: Inlet cowl outer barrel inner surface. Image created using merged photos. Zoom to view at full resolution.

Two fragments were located and removed from the Inlet cowl outer barrel inner surface from locations 1 and 2, as seen in Figure 17. Detailed location is seen in Figure 18. Initial material identification using an X-ray fluorescence (XRF) analyzer found sample #1 to contain 93.6% aluminum and sample #2 82.7% titanium. These samples were sent to Pratt & Whitney for further evaluation under direction of the NTSB.

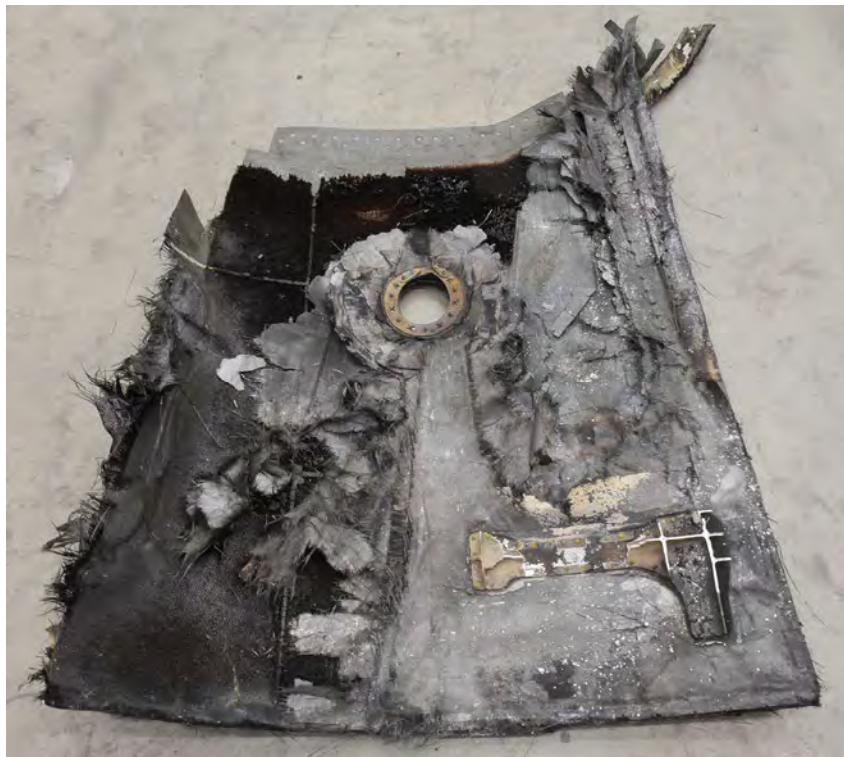
Figure 47: Translating sleeve separated from outboard thrust reverser, inner surface.

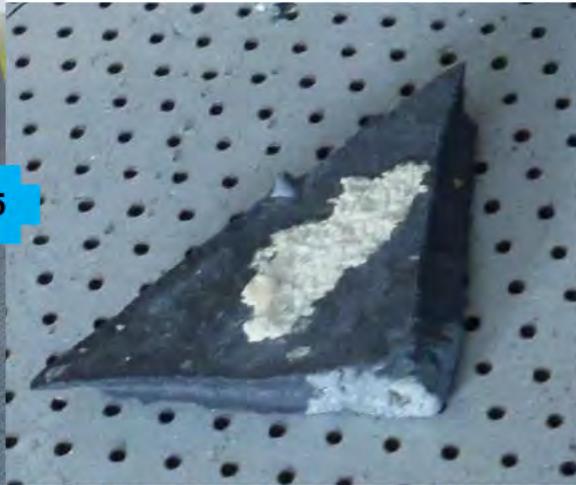
Figure 58: Outboard thrust reverser, fragment removed from near 3:30, detail.

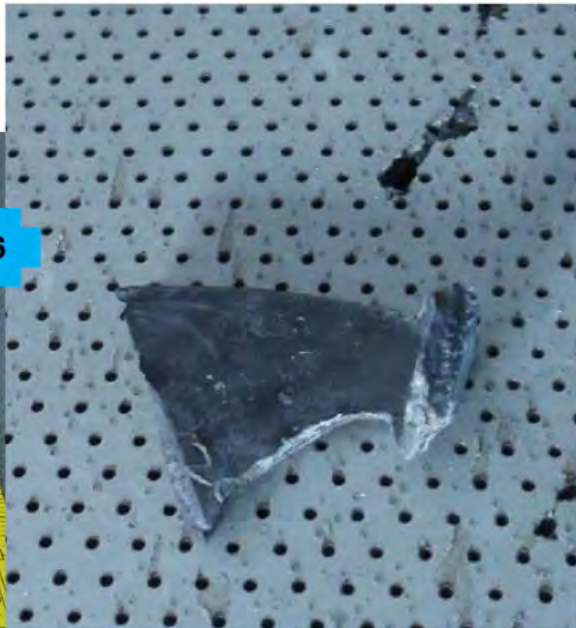
Figure 60: Outboard thrust reverser, fragment removed from near 3:00, detail.

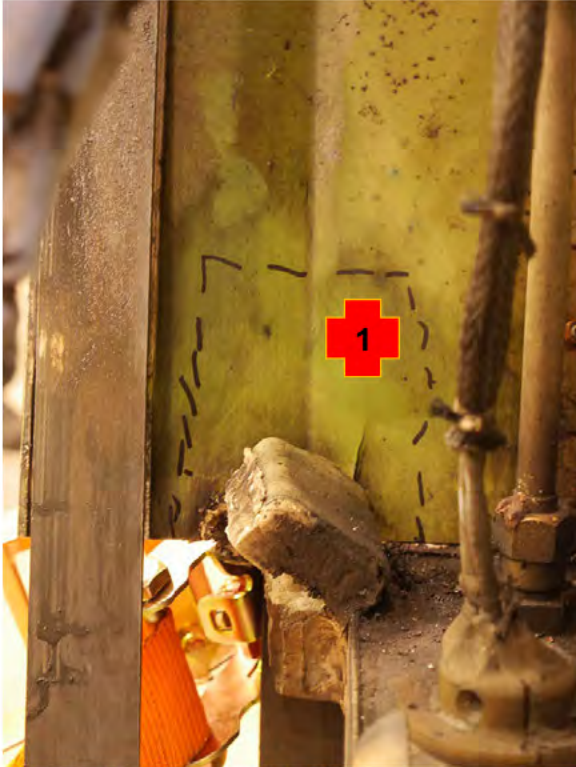
Figure 83: Outboard (right) thrust reverser crack at 12:00.

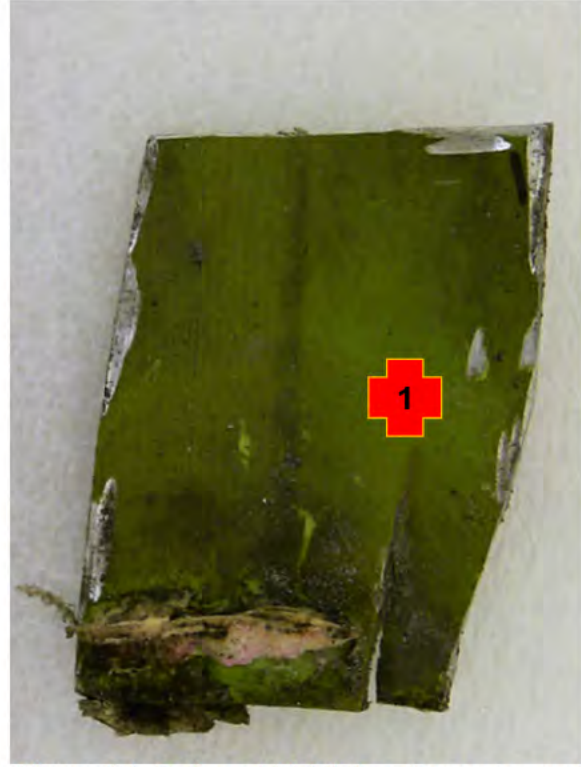
Figure 84: Outboard (right) thrust reverser crack at 12:00 removed.

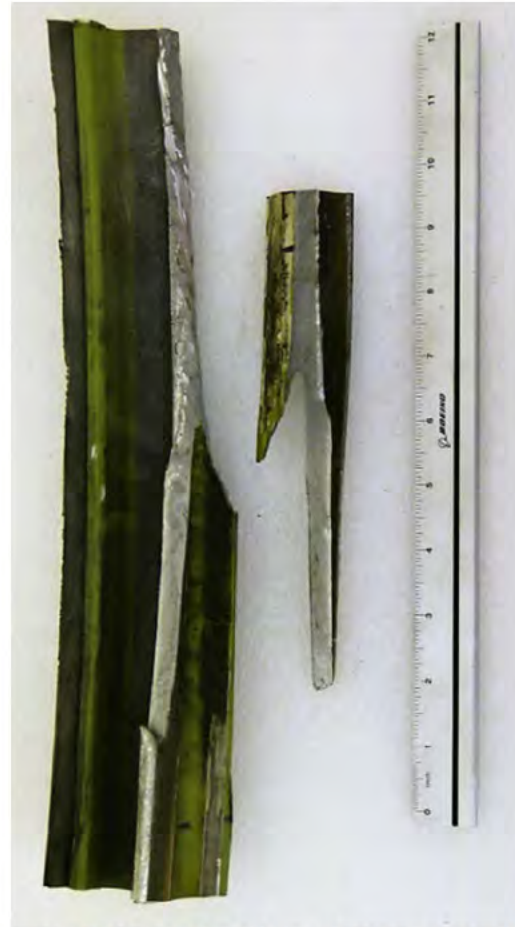
Figure 86: Inboard (left) thrust reverser crack at 7:00 removed.

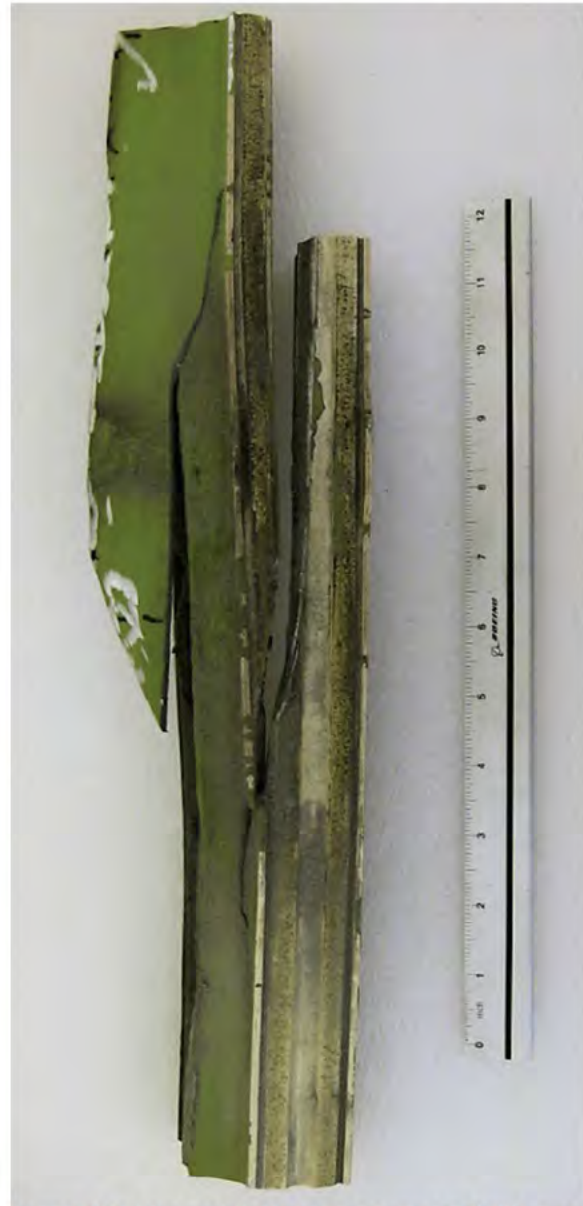
Figure 88: Inboard (left) thrust reverser 9:00 crack removed.

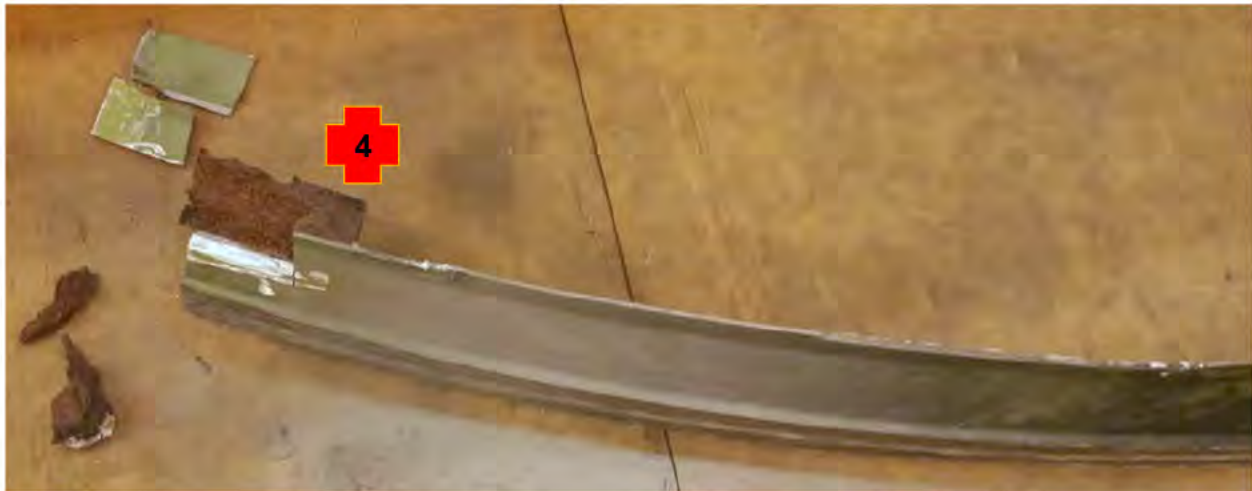
Figure 89: Inboard (left) thrust reverser crack at 12:00 removed.

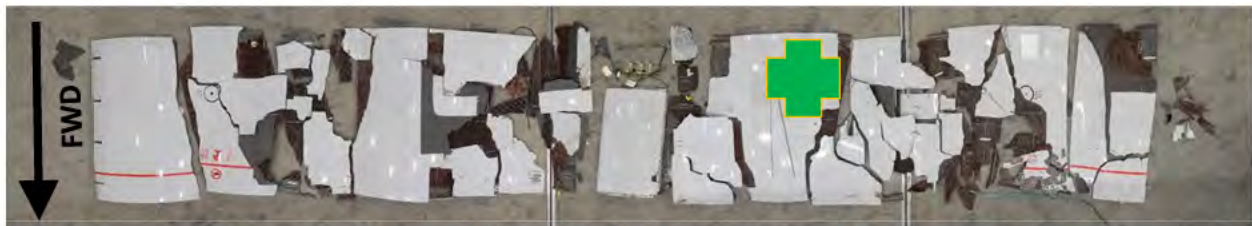
in Figure 90 and Figure 91 indicate fluid ingress. See enclosure C for details.

Figure 90: Fan cowl thermography results.

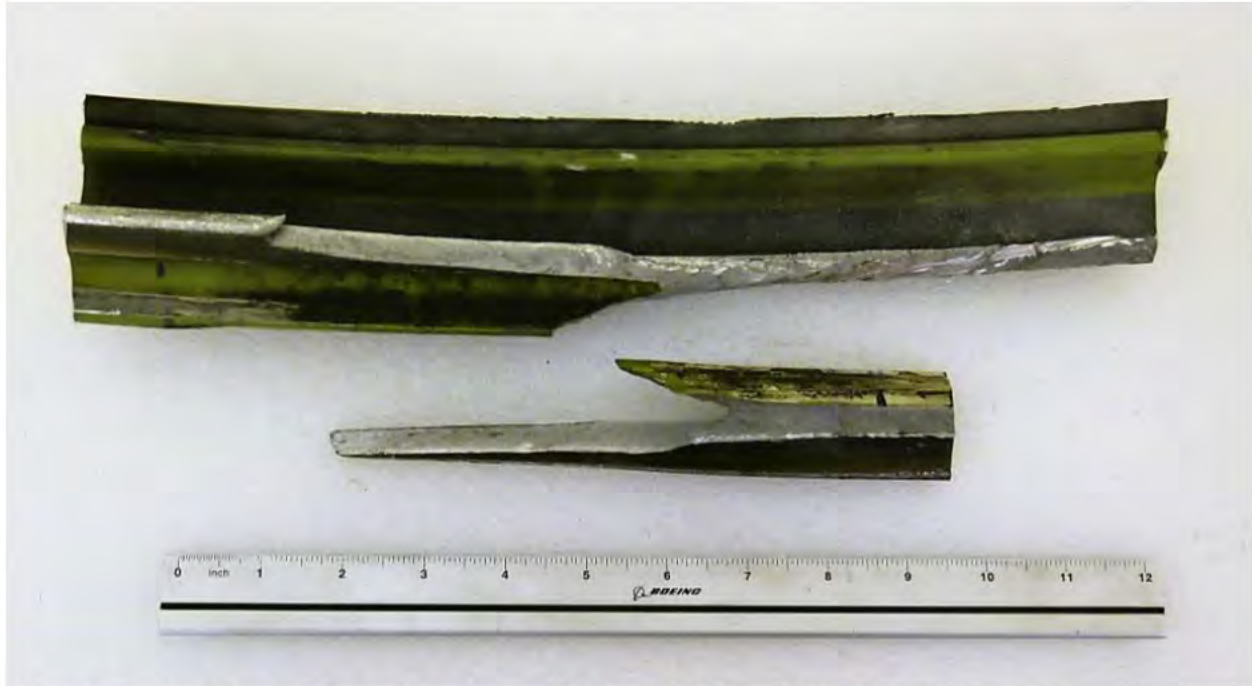
Figure 8. Left Thrust Reverser fracture at the 7:00 clock position after removal.

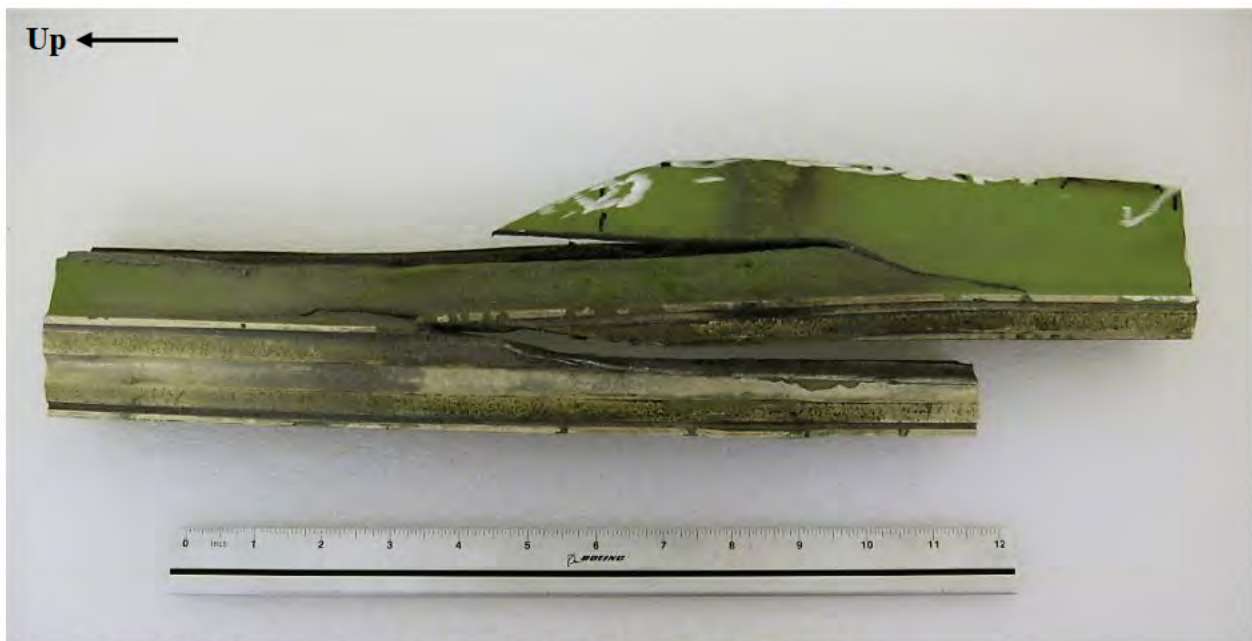
Figures 16 and 17 show the portion excised from the 7:00 location and further cut into five sections for SEM fractography. Figure 18 shows SEM images of the fracture surfaces of the lower portion of Section 1 from this region. The presence of striations on the fracture surface confirmed fatigue as the fracture mode in this region, propagating in a primarily downward direction. No obvious origins were found at the edge of the part, indicating the fatigue may have started at the termination of ductile separation fractures or may have been preexisting, but the cleanliness of the fracture surface indicates the fracture was a recent occurrence. Figure 19 shows SEM images of the fracture surfaces

Figure 16. Left Thrust Reverser fracture at the 9:00 clock position after removal.

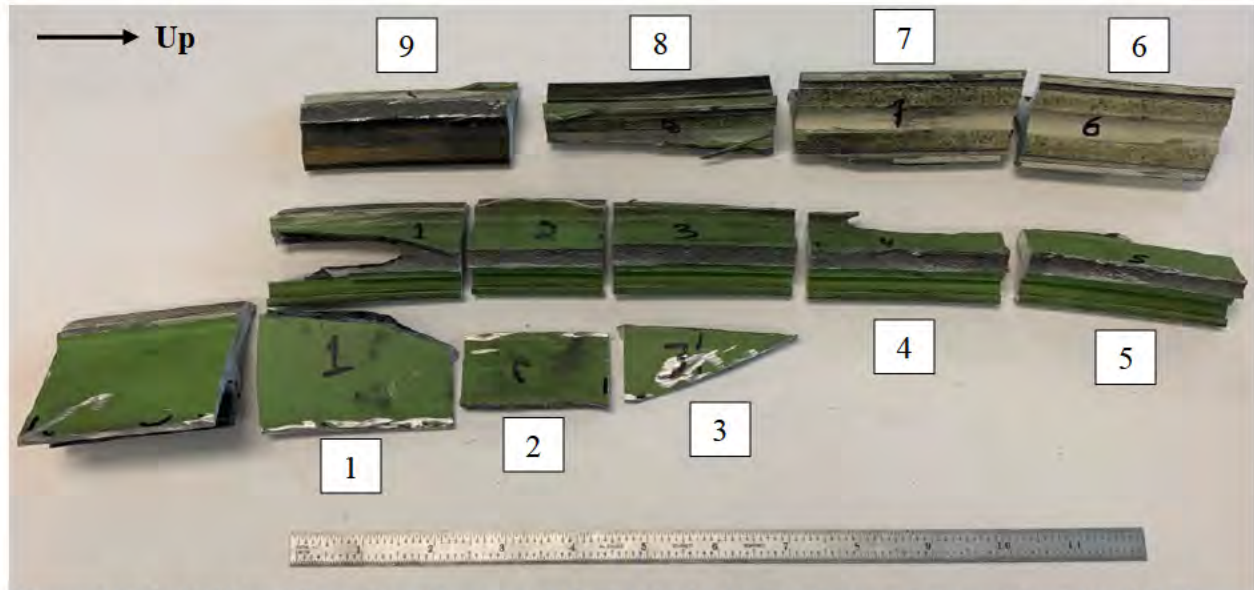
Figure 17. Left Thrust Reverser fracture at the 9:00 clock position cut into sections for SEM examination with the sections labeled.

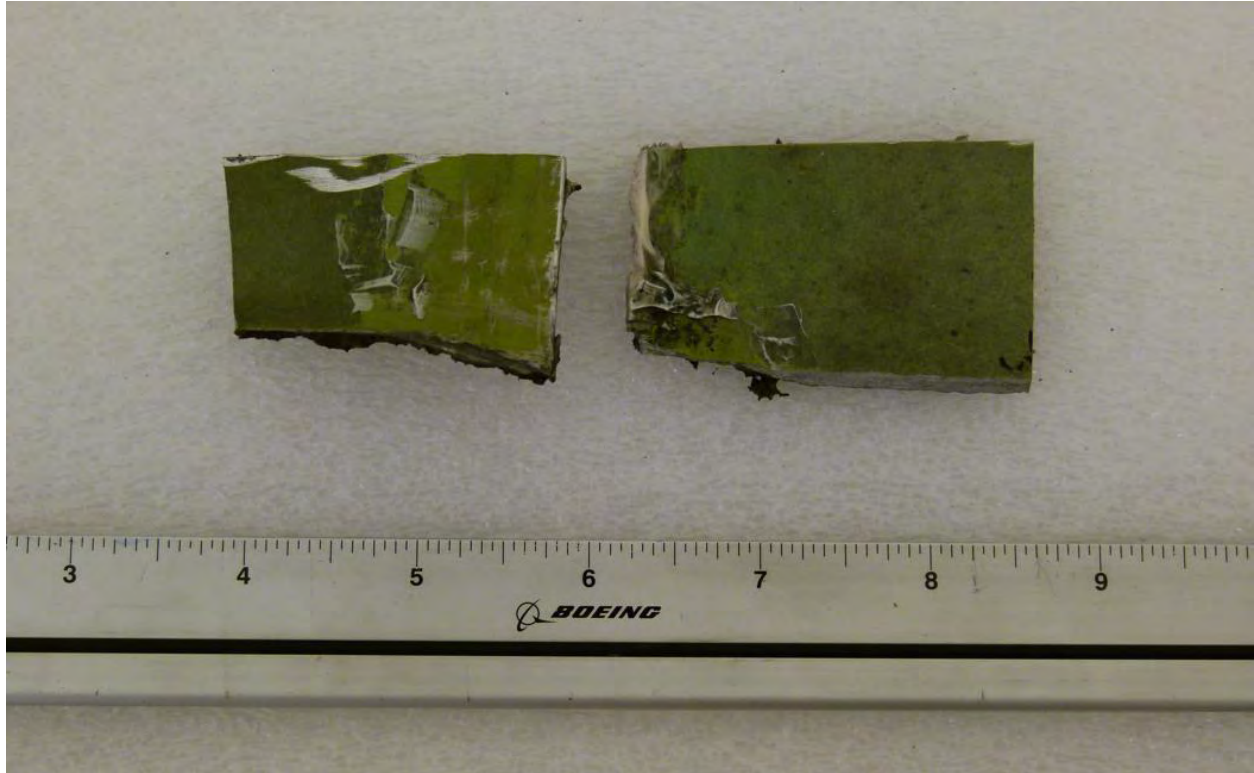
Figure 28 shows the smaller crack from the 12:00 location excised for examination. Figure 29 contains SEM images of the fracture surface of this portion of the crack. Some portions of the fracture surface were obscured by post fracture damage, but in the undamaged area the fracture mode was entirely ductile separation, consistent with a single event.

Figure 28. Left Thrust Reverser fracture at the 12:00 clock position after removal.

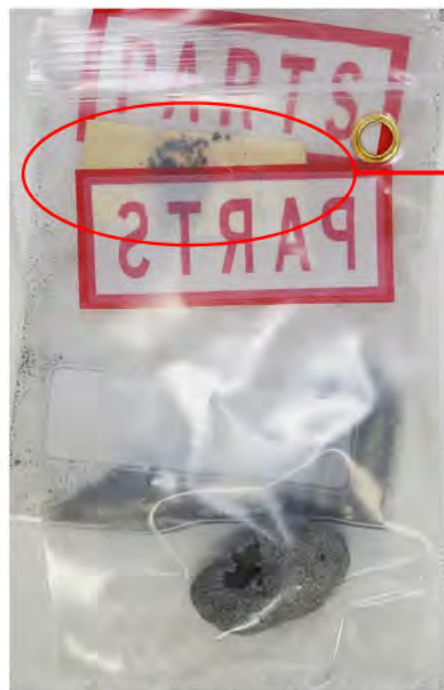
Figure 12 – Loose material “creek rock”

Loose material samples collected from the engine oil sump are shown in Figure 10 through Figure 12. The larger material samples were referred to by the investigative team as “creek rocks”, and this terminology was used in the material analysis. Sample 7 was stuck between the Figure 11 and Figure 12 parts bags, as shown in Figure 12.

Engine oil sump loose material samples, Figure 10, Figure 11, and Figure 12, were most consistent with cast aluminum and aluminum alloys.
