NATIONAL TRANSPORTATION SAFETY BOARD

Group Chairman's Factual Report

AIRWORTHINESS

DCA21FA085

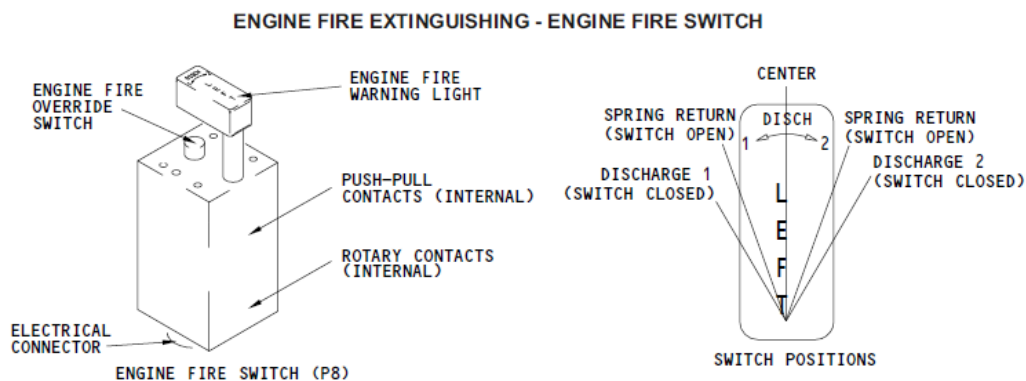
Figure 17 - Engine Fire Switch description and operation drawing

The engine fire switches and engine fire bottle discharge lights are located on the engine fire panel (P8) in the flight deck (Figure 17). The engine fire panel has a fire switch for each engine and a discharge light for each fire bottle. The engine fire switches will give an indication of an engine fire, shut down the engine if activated, isolate the engine from the airplane systems if activated, and controls the engine fire extinguishing system. A solenoid locks the fire switch so it cannot be pulled accidentally. When the sensors detect an engine fire, the fire warning light illuminates in the switch handle and the solenoid energizes to release the switch. When the fire switch is pulled, the push-pull switch contacts operate electrical circuits which shut down the engine and isolate it from the airplane systems. With the switch pulled, it can be rotated left or right to a mechanical stop at one of two discharge positions. The rotary switch contacts close and operate the fire extinguishing system.

When the fire switch is pulled, the engine is isolated as the system closes the fuel spar valve, de-energizes the engine fuel metering unit (FMU) cutoff solenoid, closes the engine driven hydraulic pump supply shutoff valve, depressurizes the engine driven hydraulic pump valve, closes the pressure regulator and shutoff valve, removes power from the thrust reverser isolation valve, trips the generator field, and trips the backup generator field.

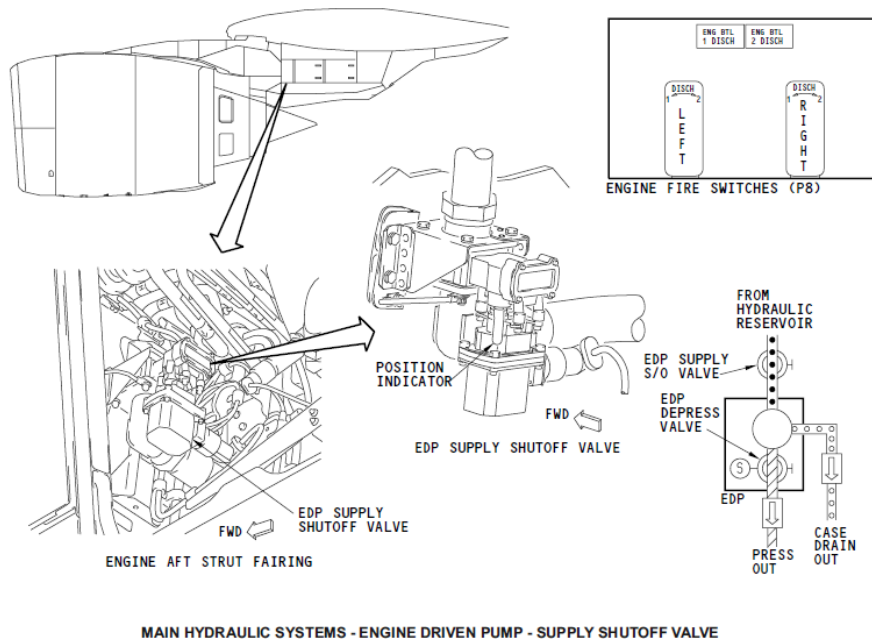
Figure 19 - Engine Driven Pump Supply Shutoff Valve description and operation drawing

The EDP supply shutoff valve stops hydraulic supply from the reservoir to the EDP when the engine fire switch is in the up position. The supply shutoff valve is a two-position valve operated by a 28v dc motor. A position indicator shows the position of the valve. The supply shutoff valve is located in the left side of each engine aft strut near the hydraulic reservoir (Figure 19).

The right EDP Supply Shutoff Valve on the event airplane was observed to be in the OPEN position with the right engine fire switch pulled (Figure 20).
