National Transportation Safety Board

DCA21FA174

STRUCTURES

Group Chair's Factual Report

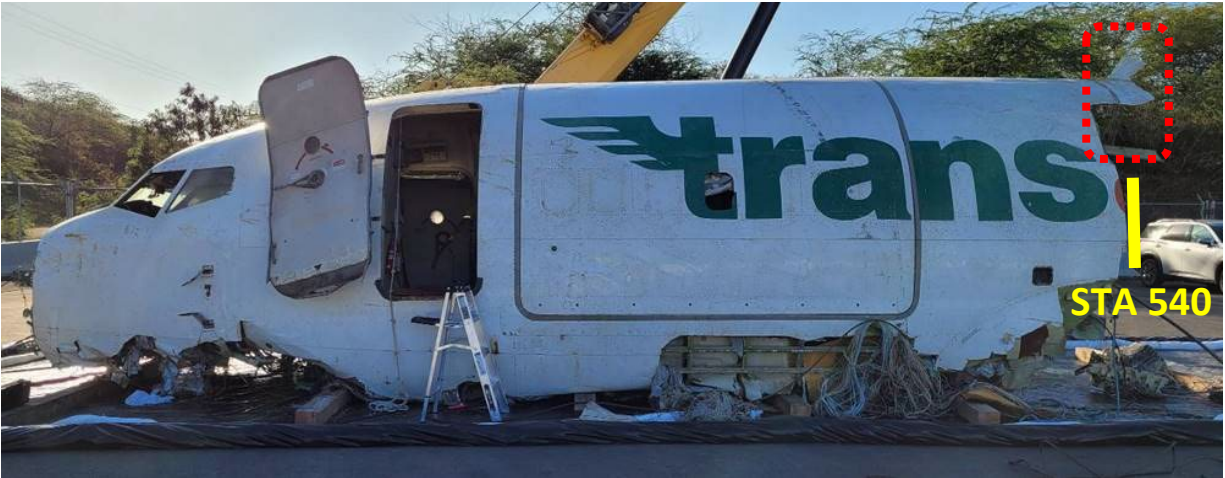
Figure 19. Left forward fuselage (Boeing photo)

Figure 20 shows a detailed view of the forward fuselage section upper left separation region near STA 540 as outlined in red in Figure 19. The STA 540 frame is also the wing attachment location (pickle fork attachment to center section front spar).

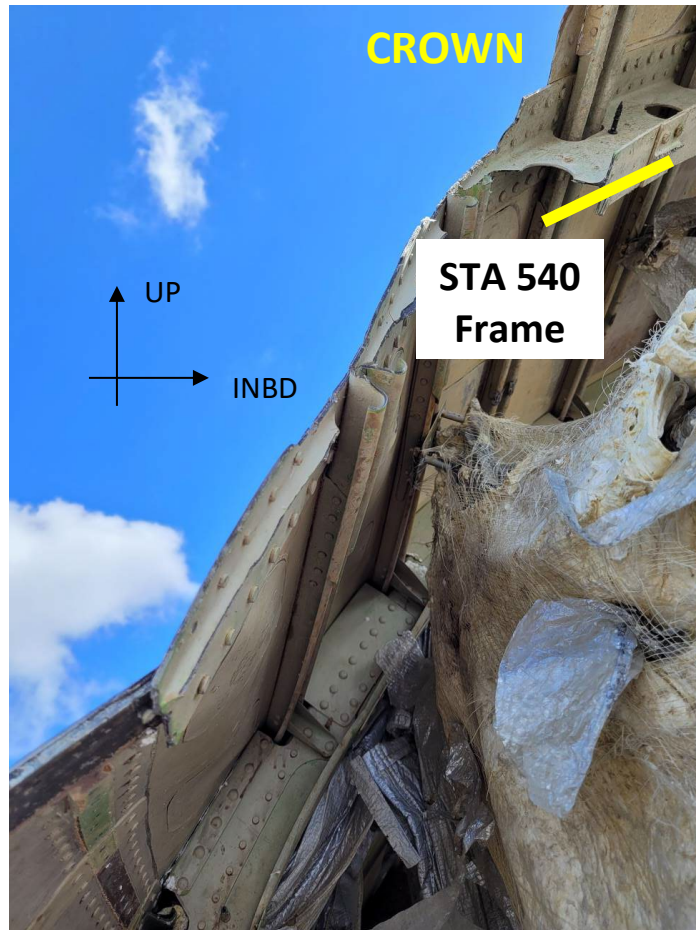
Figure 20. Left STA 540 separation location, looking up (Boeing photo)

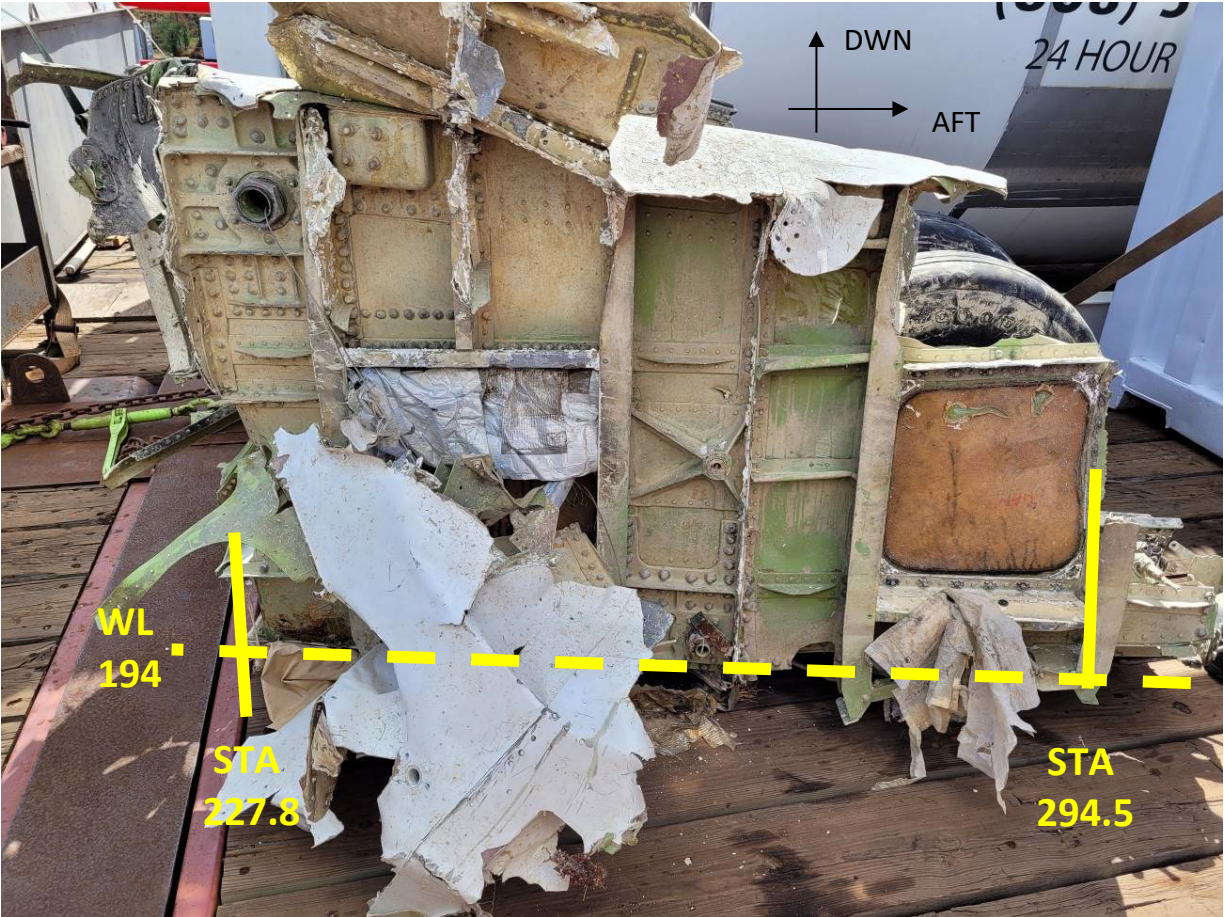
Figure 24 shows a right side view of the NLG and wheel well structure which separated from the forward fuselage section.

Figure 24. Right side view of NLG and wheel well structure (Boeing photo)

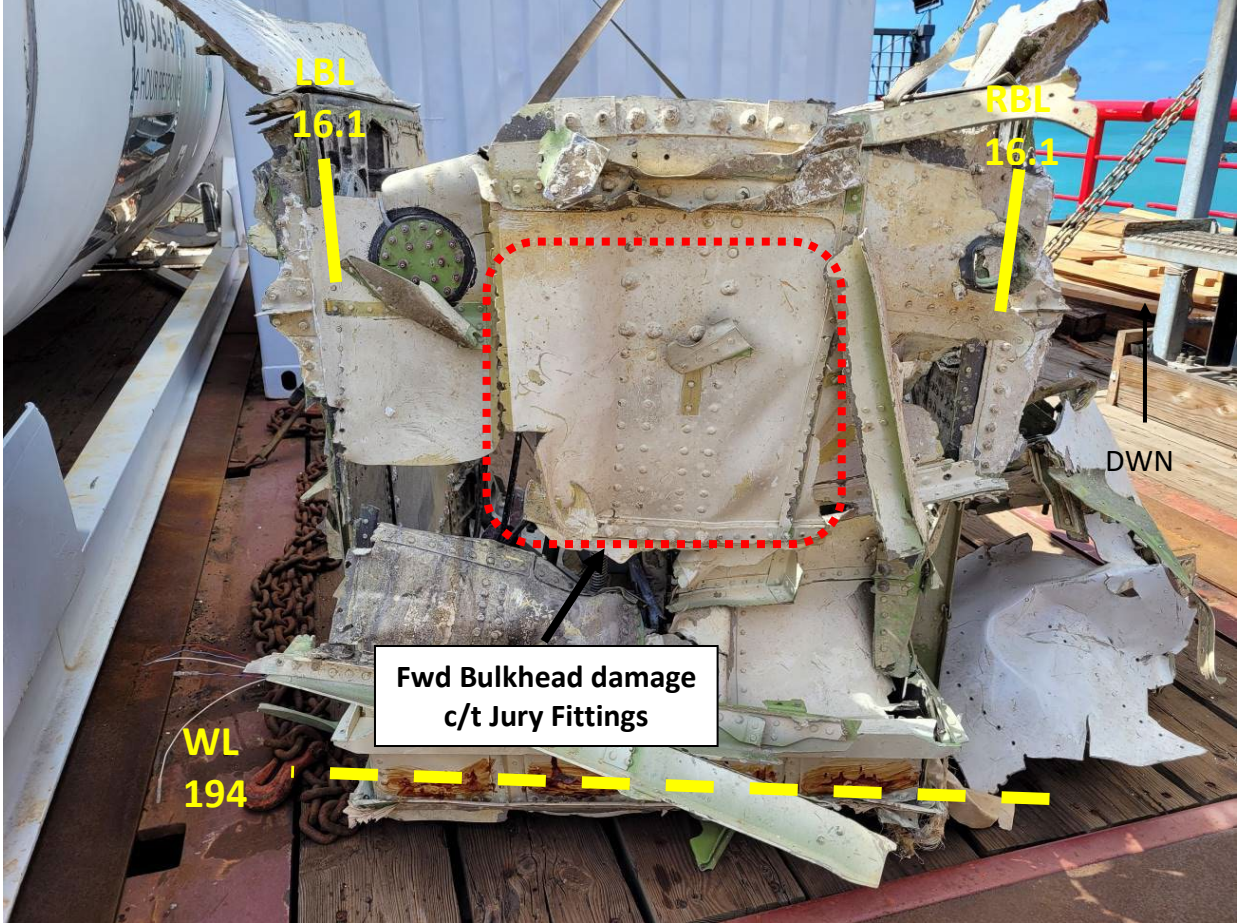
Figure 26 shows a forward side view (looking aft) of the NLG and wheel well structure which separated from the forward fuselage section. The center portion of the wheel well forward bulkhead common to the Jury Fitting was deformed aftward (i.e. into landing gear bay) as outlined in red.

Figure 26. Forward side view of NLG and wheel well structure and forward bulkhead, looking aft (Boeing photo)

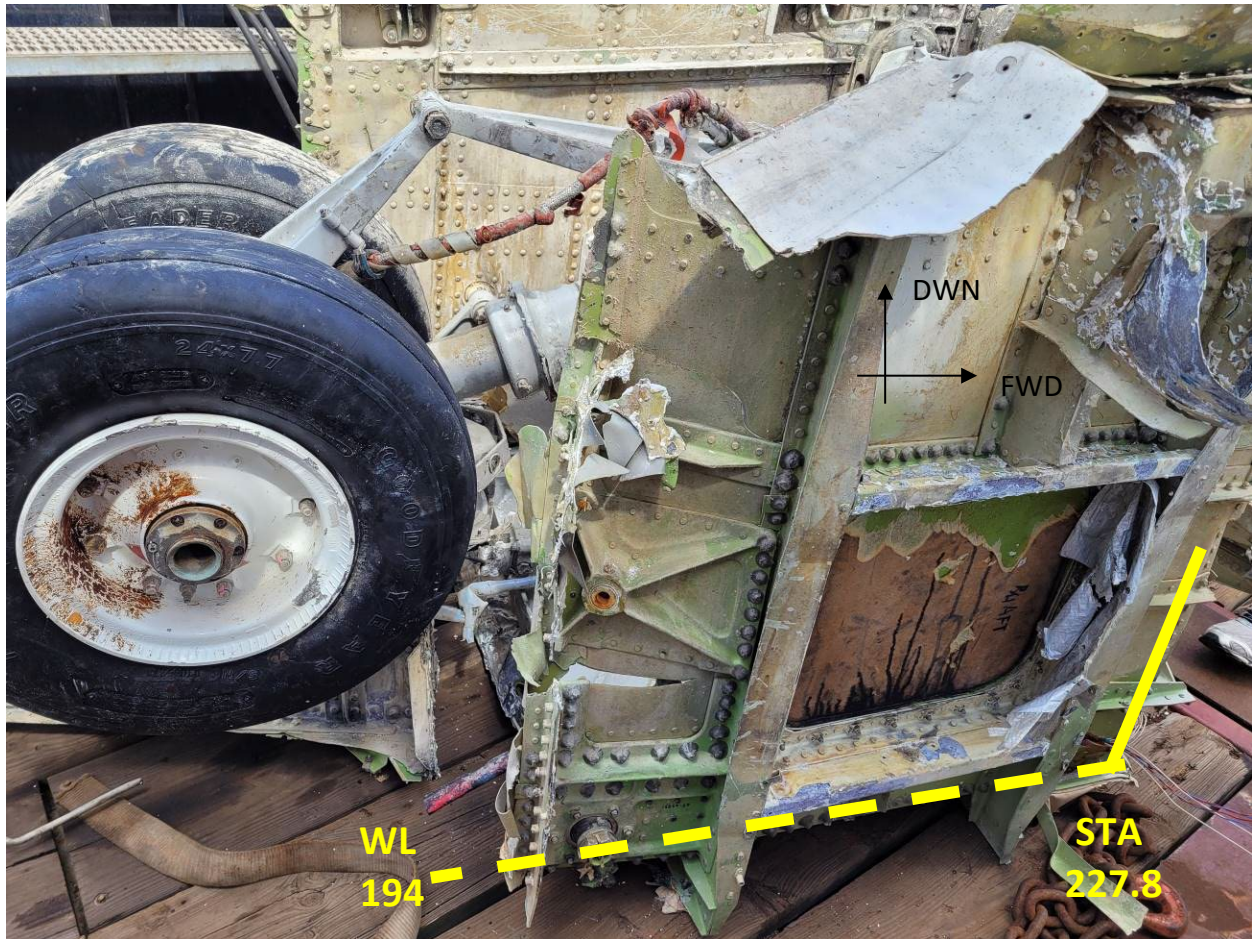
Figure 27 shows a left side view of the NLG and wheel well structure which separated from the forward fuselage section.

Figure 27. Left side view of NLG and wheel well structure, looking right (Boeing photo)

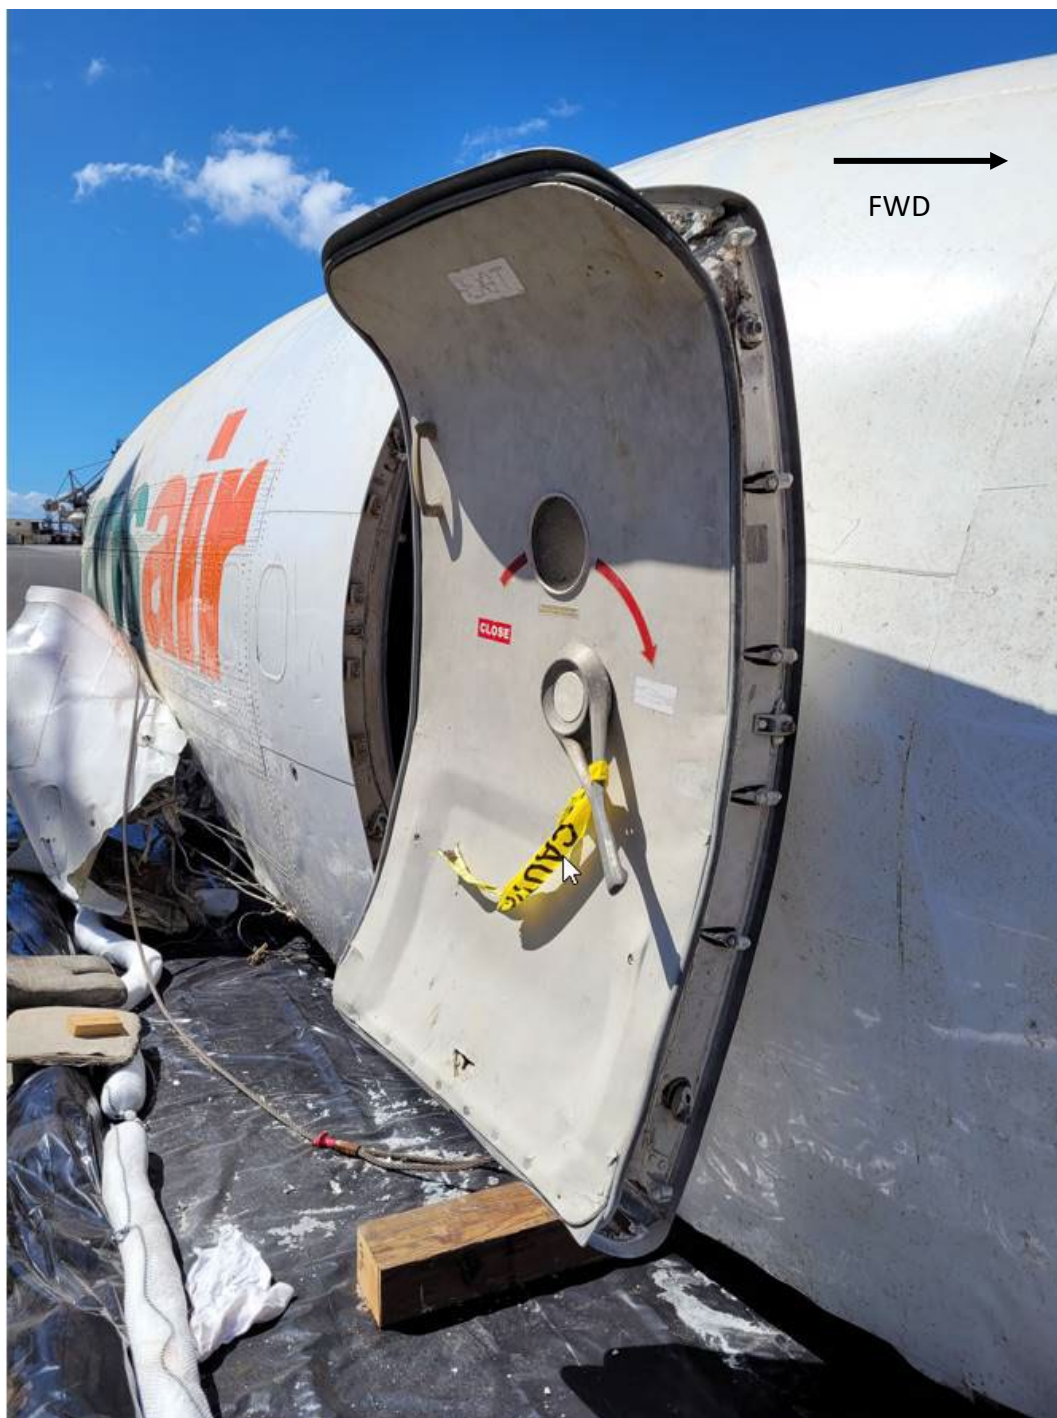
Figure 34 shows the RH Forward Entry Door for comparison, relatively undamaged.

Figure 34. Right Forward Entry door, looking aft (Boeing photo)

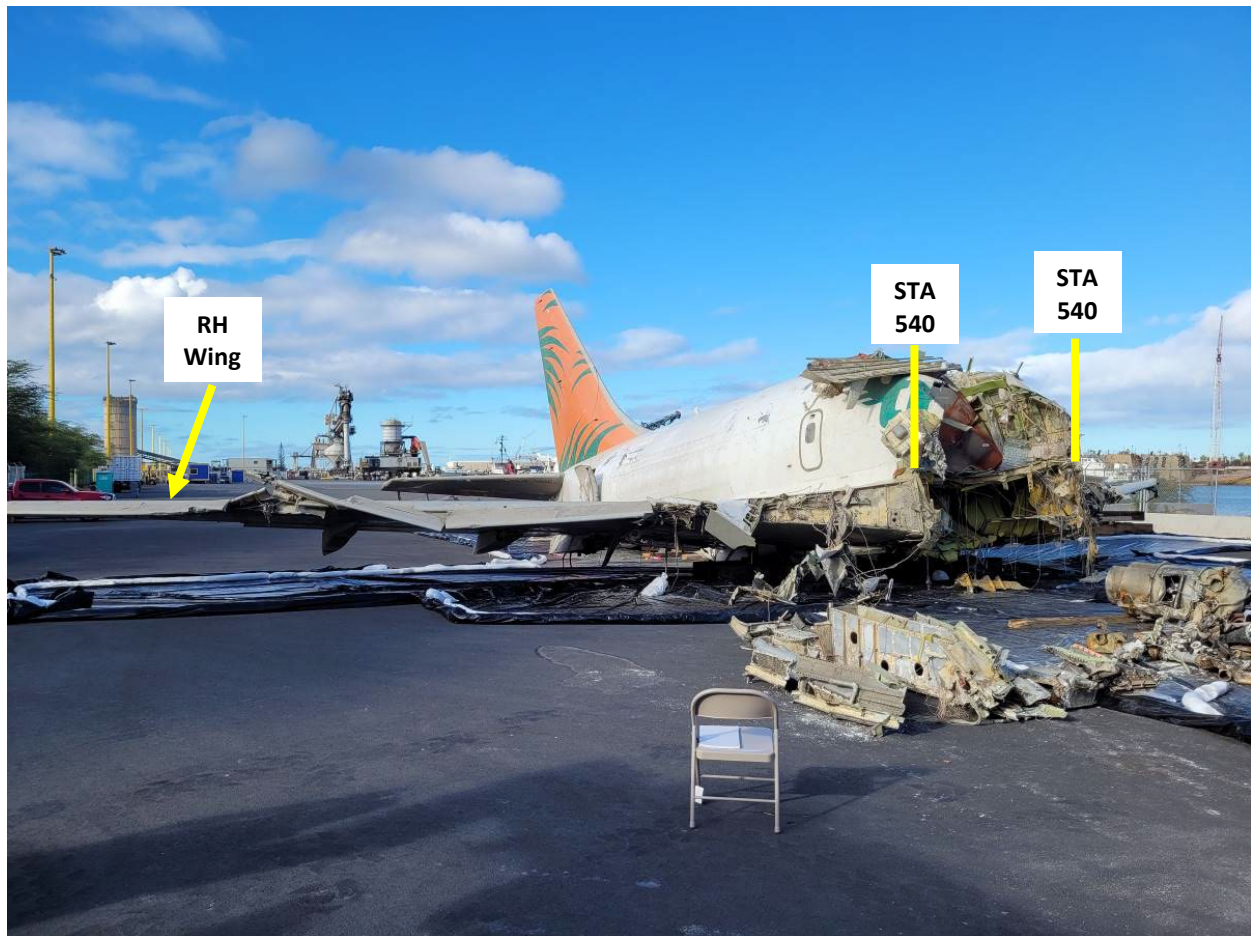
Figure 36 shows a view of the forward right side of the aft fuselage and right outboard wing portion of the recovered airplane. Figure 36 also shows the STA 540 separation location from the forward fuselage.

Figure 36. Right forward view of aft fuselage section (Boeing photo)

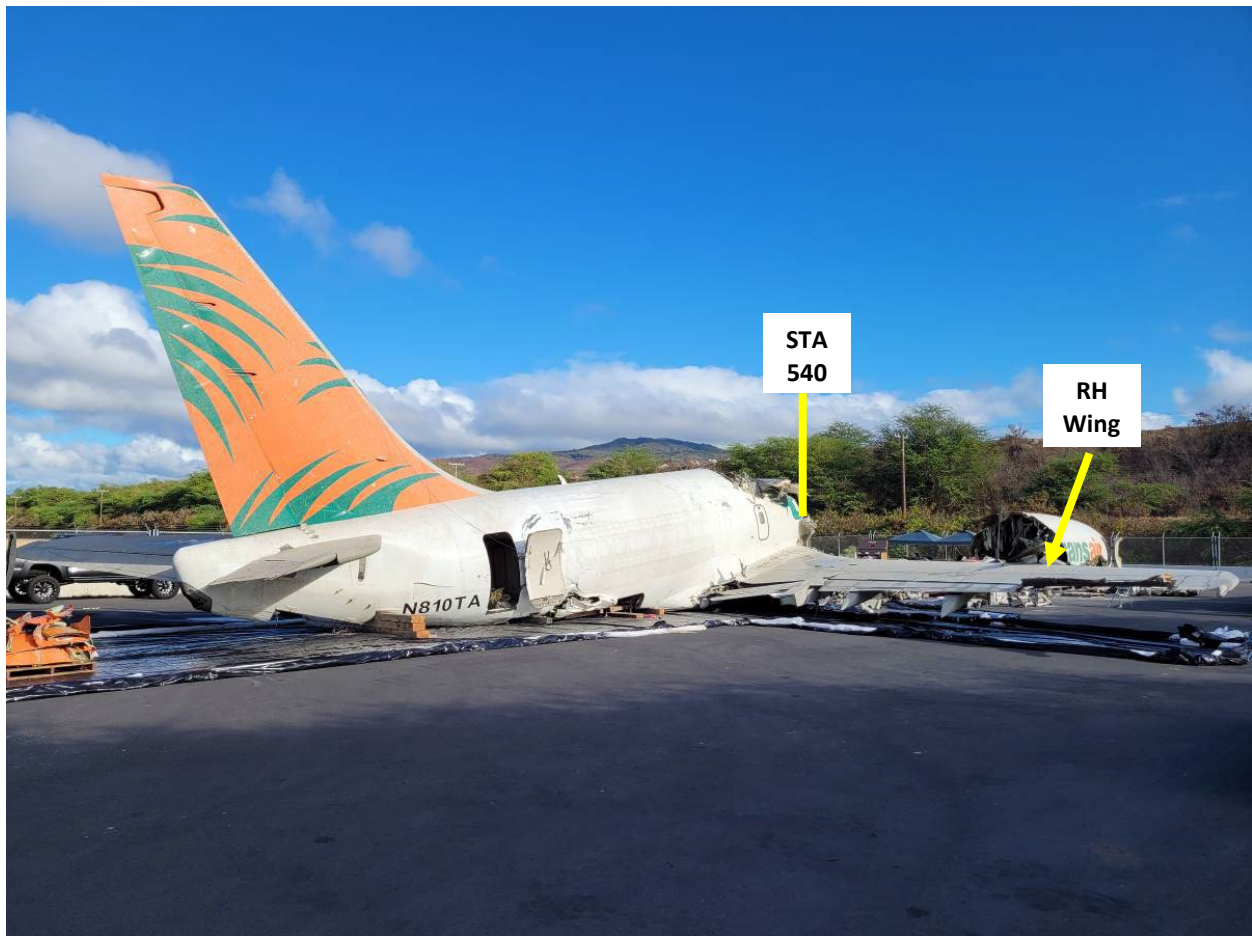
Figure 37 shows a view of the aft right side of the aft fuselage and right outboard wing portion of the recovered airplane. Figure 37 also shows the STA 540 separation location from the forward fuselage.

Figure 37. Right aft view of aft fuselage section (Boeing photo)

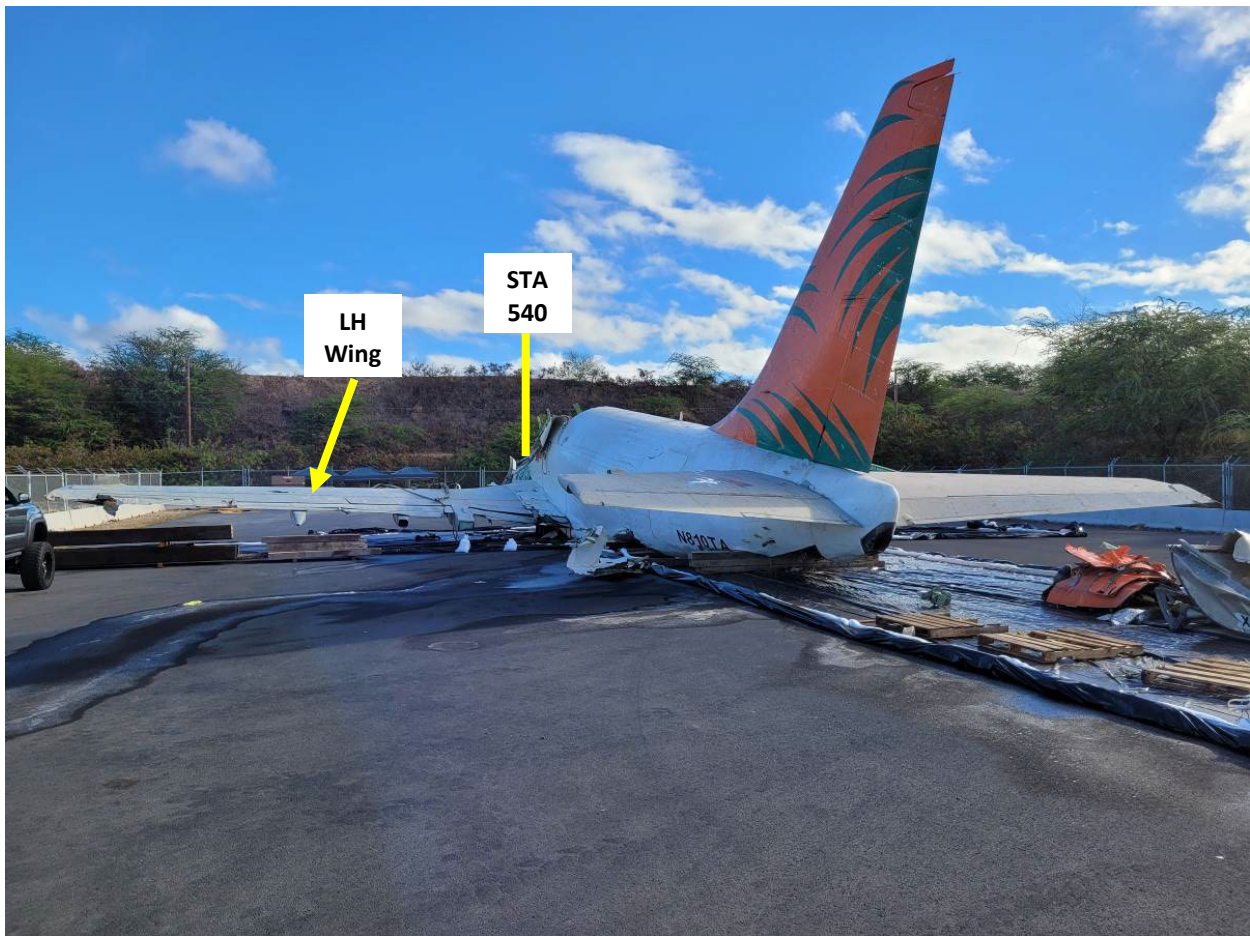
Figure 38 shows a view of the aft left side of the aft fuselage and left outboard wing portion of the recovered airplane. Figure 38 also shows the STA 540 separation location from the forward fuselage.

Figure 38. Left aft view of aft fuselage section (Boeing photo)

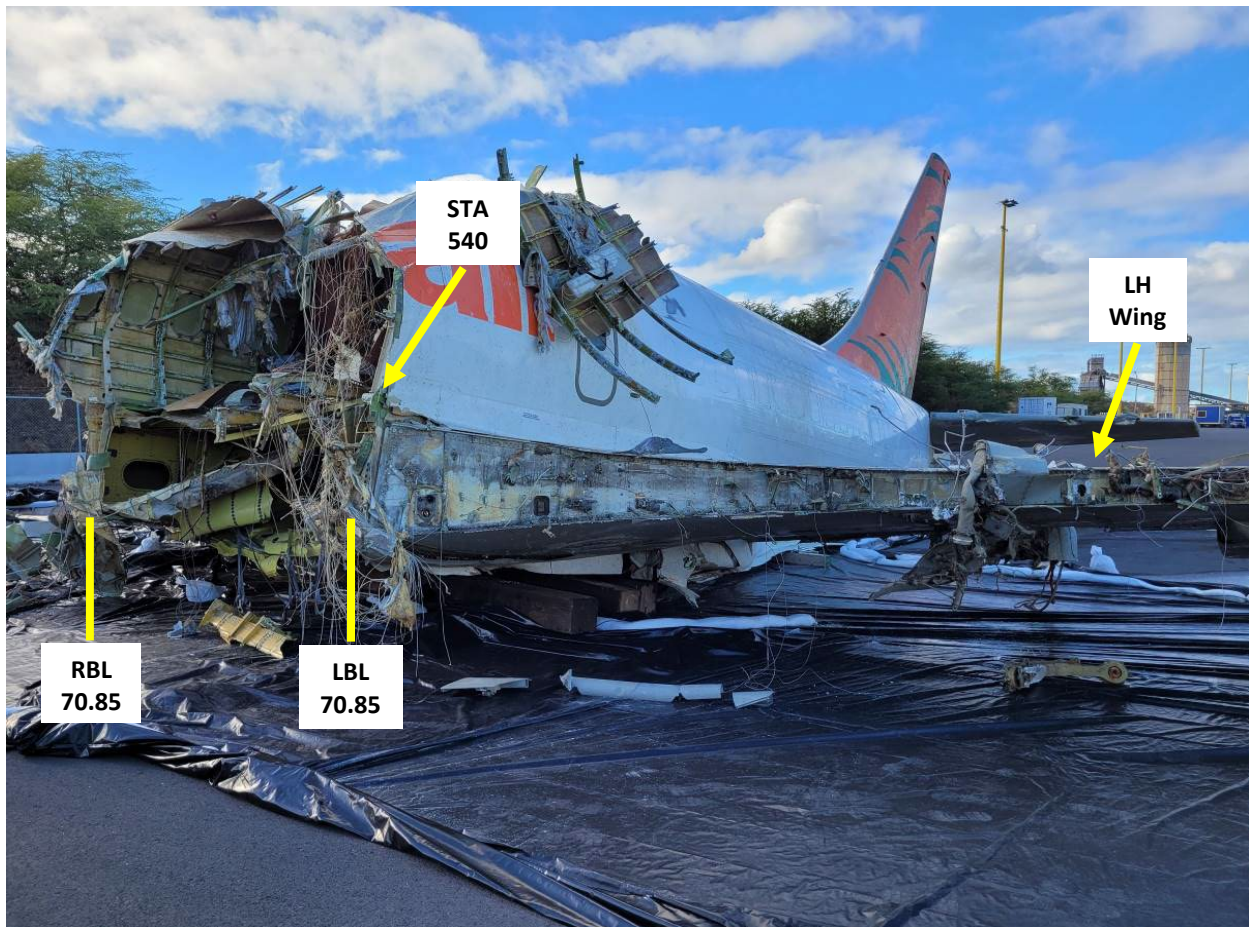
Figure 39 shows a view of the left forward side of the aft fuselage and left outboard wing portion of the recovered airplane. Figure 39 also shows the STA 540 separation location from the forward fuselage.

Figure 39. Left forward view of aft fuselage section (Boeing photo)

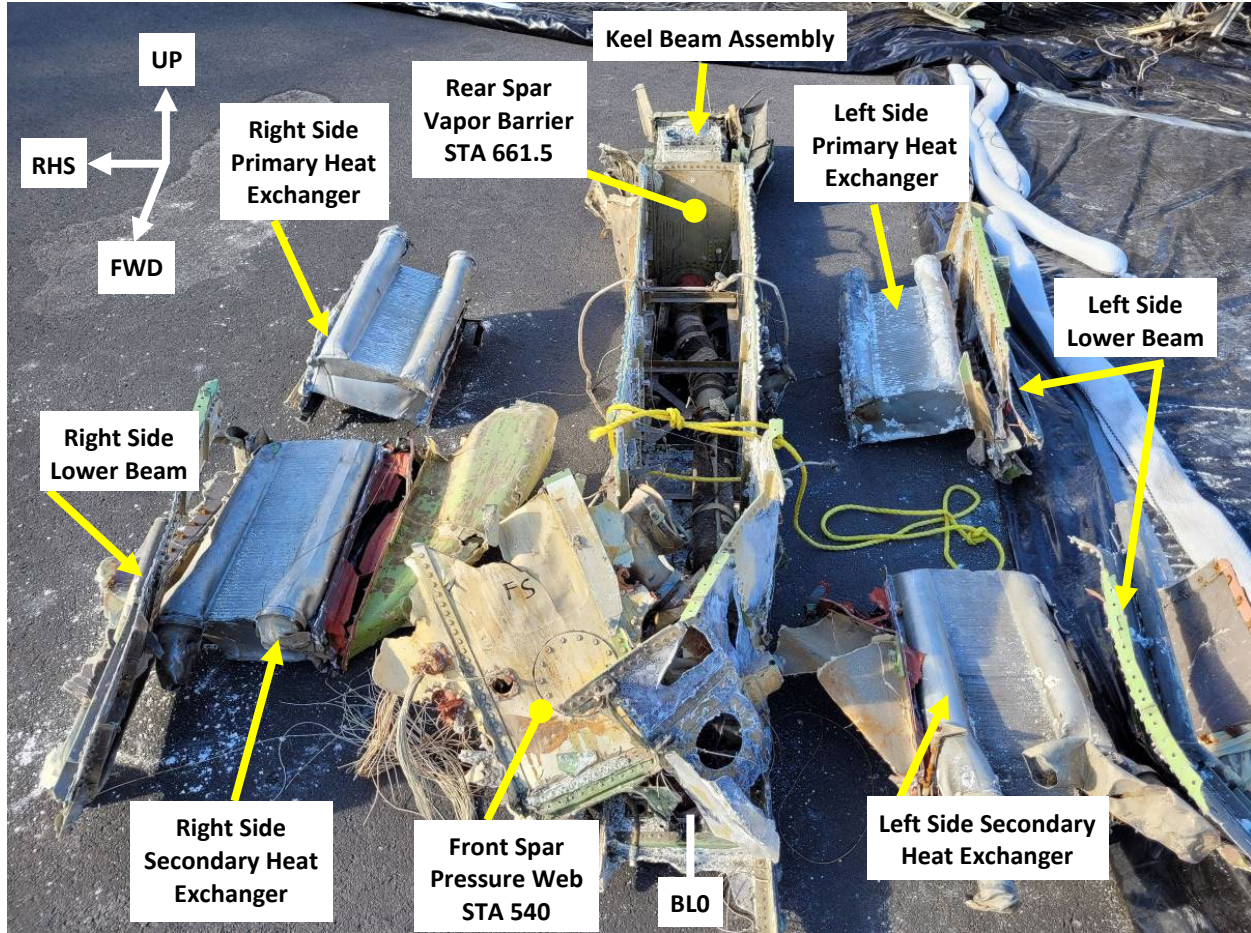
Figure 41 shows a forward side view looking aft of multiple recovered portions of the Keel Beam Assembly, Lower Beams & Heat Exchangers arranged as they were relationally oriented on the airplane. There was aftward deformation of the lower BL 0 portion of the Front Spar Pressure Web into the Keel Beam Assembly.

Figure 41. Forward side view of Keel Beam Assembly, looking aft (Boeing photo)

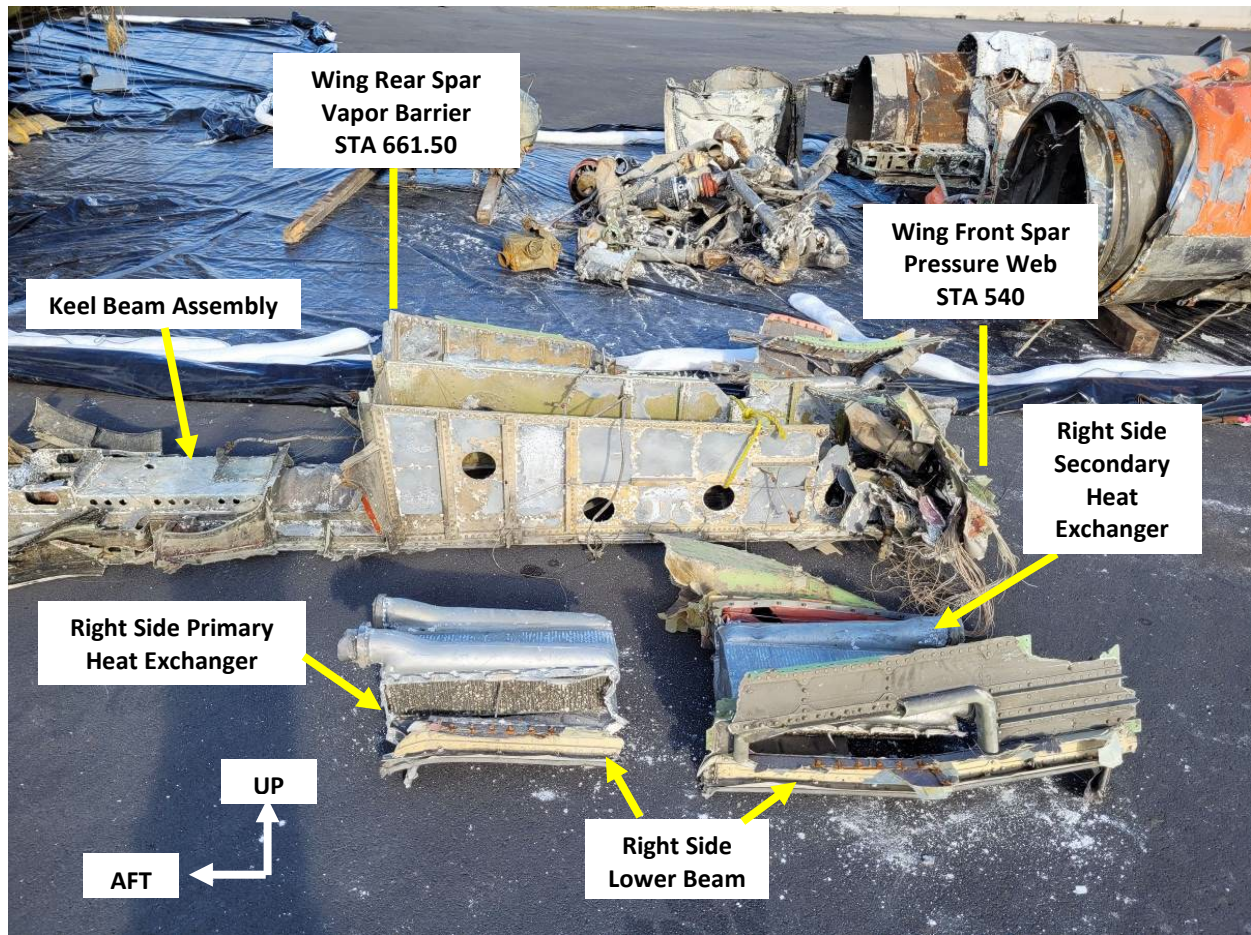
Figure 42 shows a right side view looking left of multiple recovered portions of the Keel Beam Assembly, Lower Beams & Heat Exchangers arranged as they were relationally oriented on the airplane. There was aftward deformation of the lower BL 0 portion of the Front Spar Pressure Web into the Keel Beam Assembly. The right side primary heat exchanger had a portion of the right lower beam lower chord still attached. The remaining aft portion of the lower beam remained attached in its production location on the airplane WCS.

Figure 42. Right side view of Keel Beam Assembly, looking left (Boeing photo)

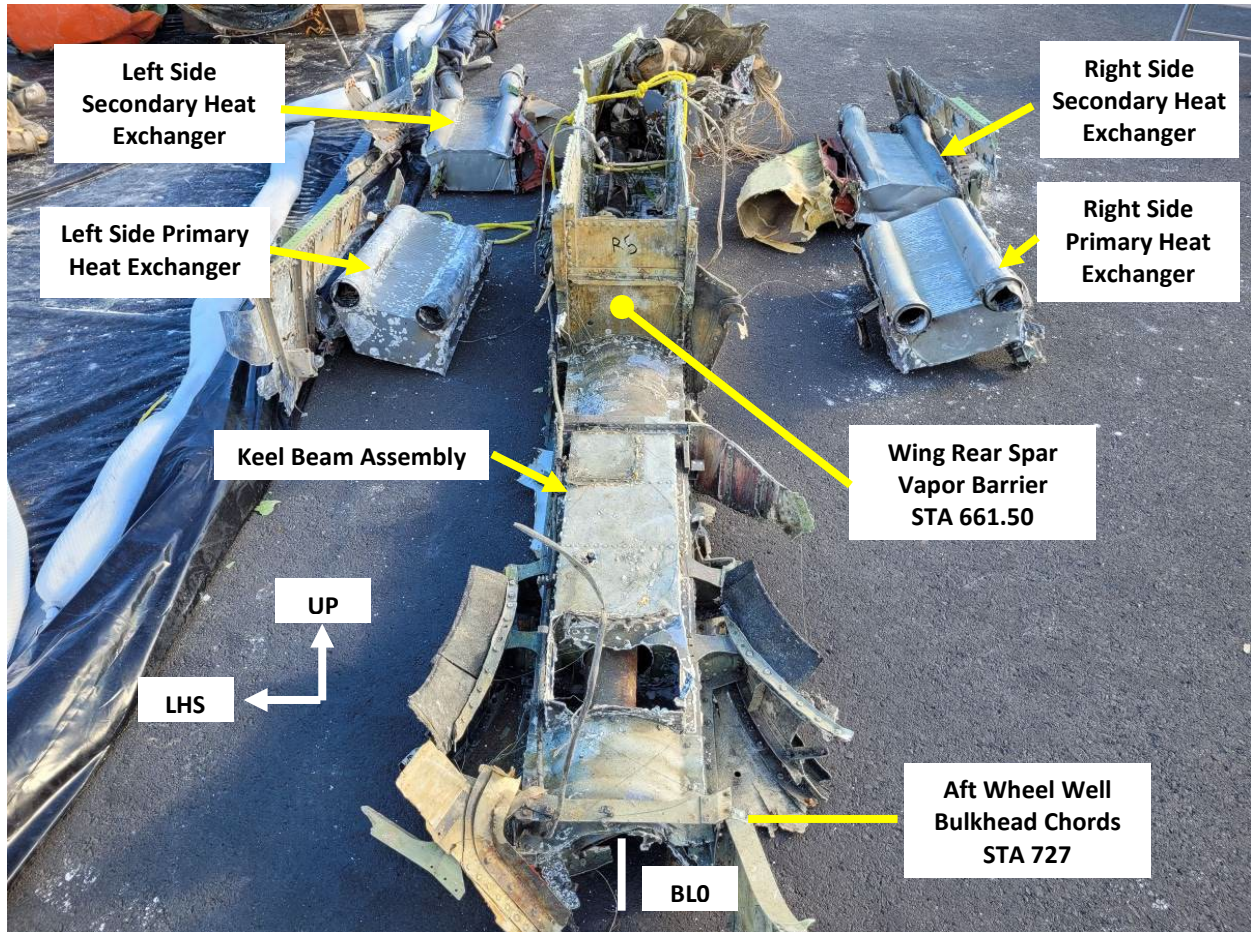
Figure 43 shows an aft view looking forward of multiple recovered portions of the Keel Beam Assembly, Lower Beams & Heat Exchangers arranged as they were relationally oriented on the airplane. The aft wheel well bulkhead chords were separated from the Keel Beam Assembly at STA 727.

Figure 43. Aft view of Keel Beam Assembly, looking forward (Boeing photo)

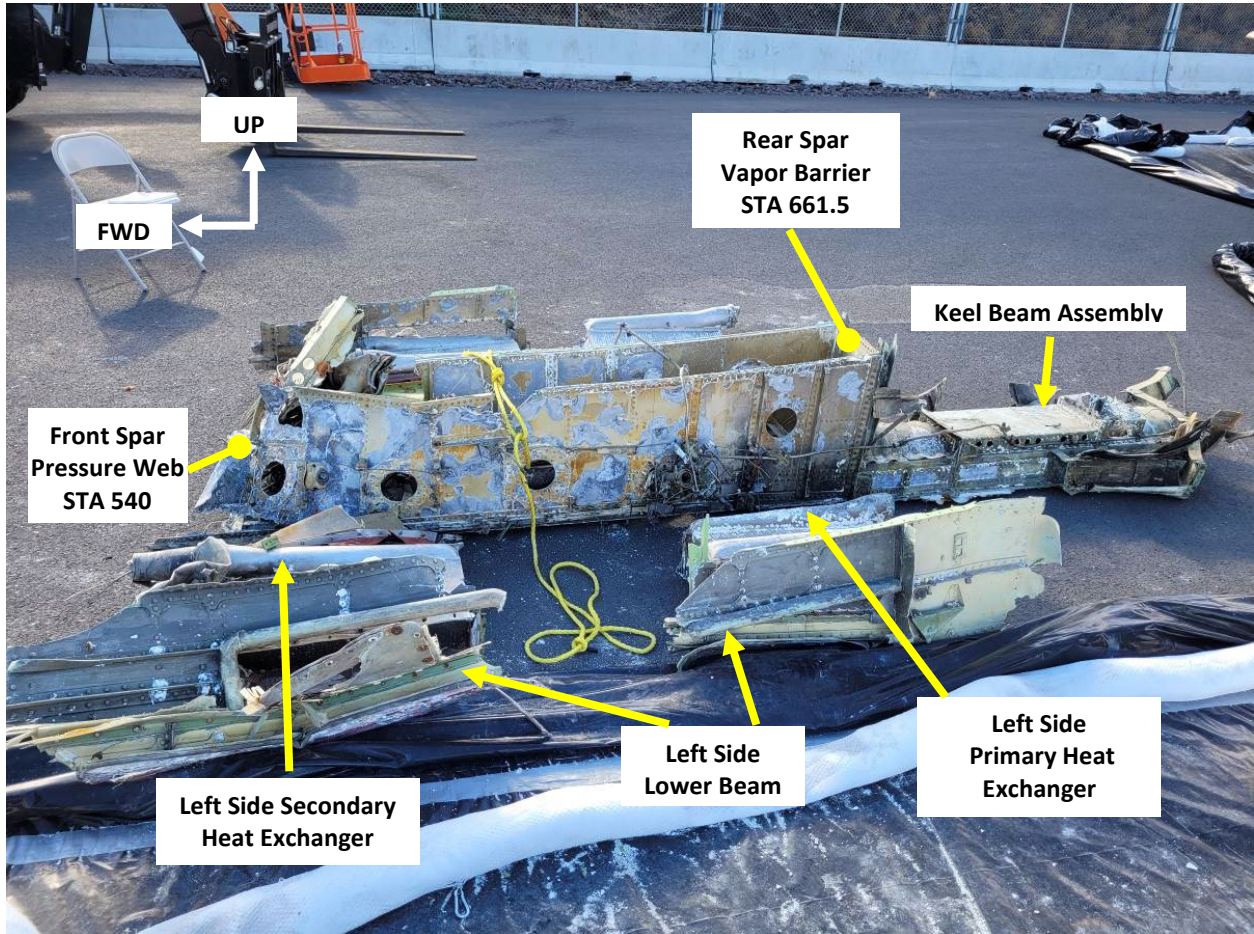
Figure 44 shows a left side view looking right of multiple recovered portions of the Keel Beam Assembly, Lower Beams & Heat Exchangers arranged as they were relationally oriented on the airplane. Portions of the left side lower beams were attached to the heat exchangers. The remaining portion of the left side lower beams remained attached in their production locations on the airplane WCS.

Figure 44. Left side view of Keel Beam Assembly, looking right (Boeing photo)

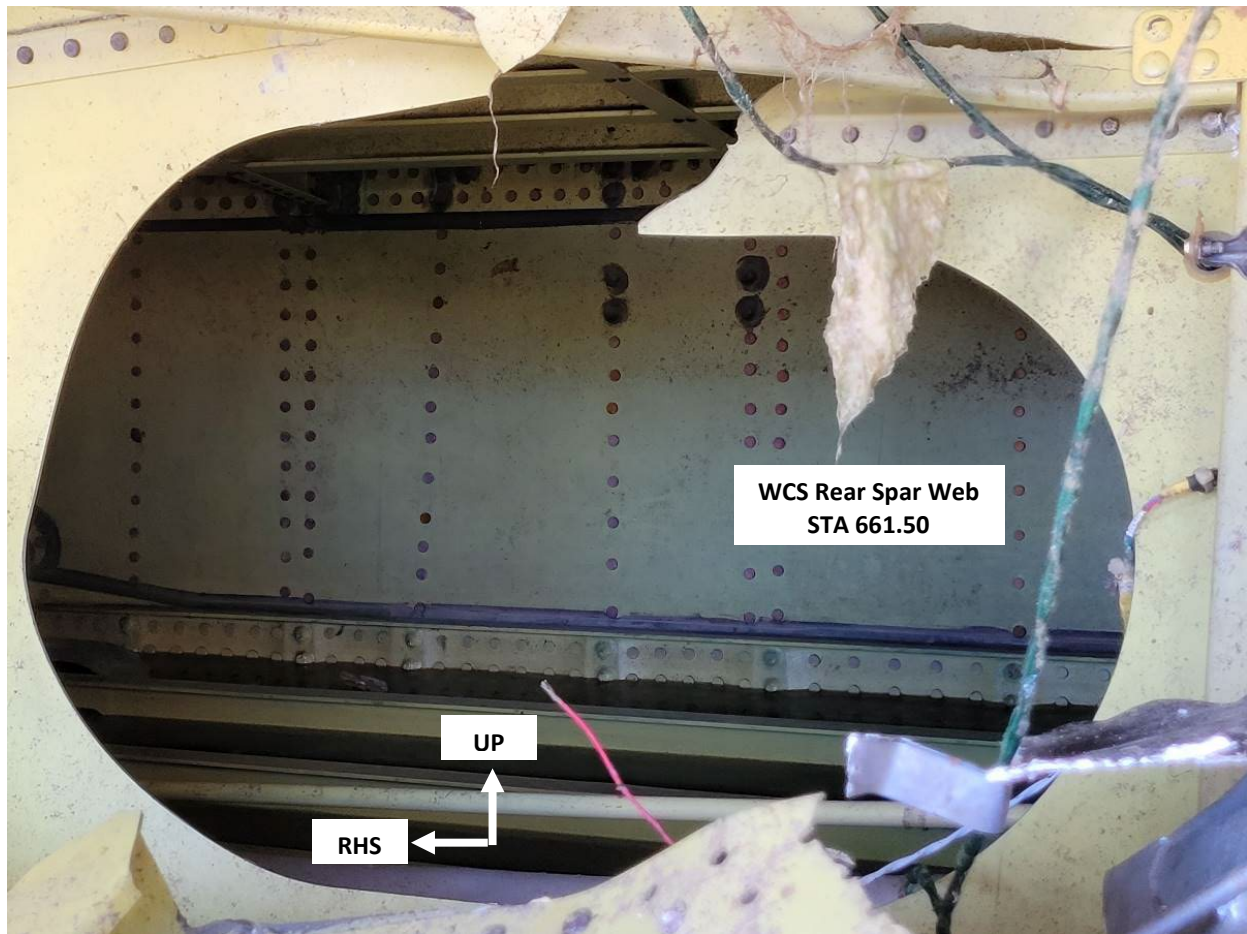
Figure 52 shows a view of the WCS rear spar looking through the damaged Spanwise Beam 1 pass-through. The rear spar was the only undamaged spanwise shear structure in the Wing Center Section.

Figure 52. Rear Spar web and chords viewed through Spanwise Beam 1 pass-through (Boeing photo)

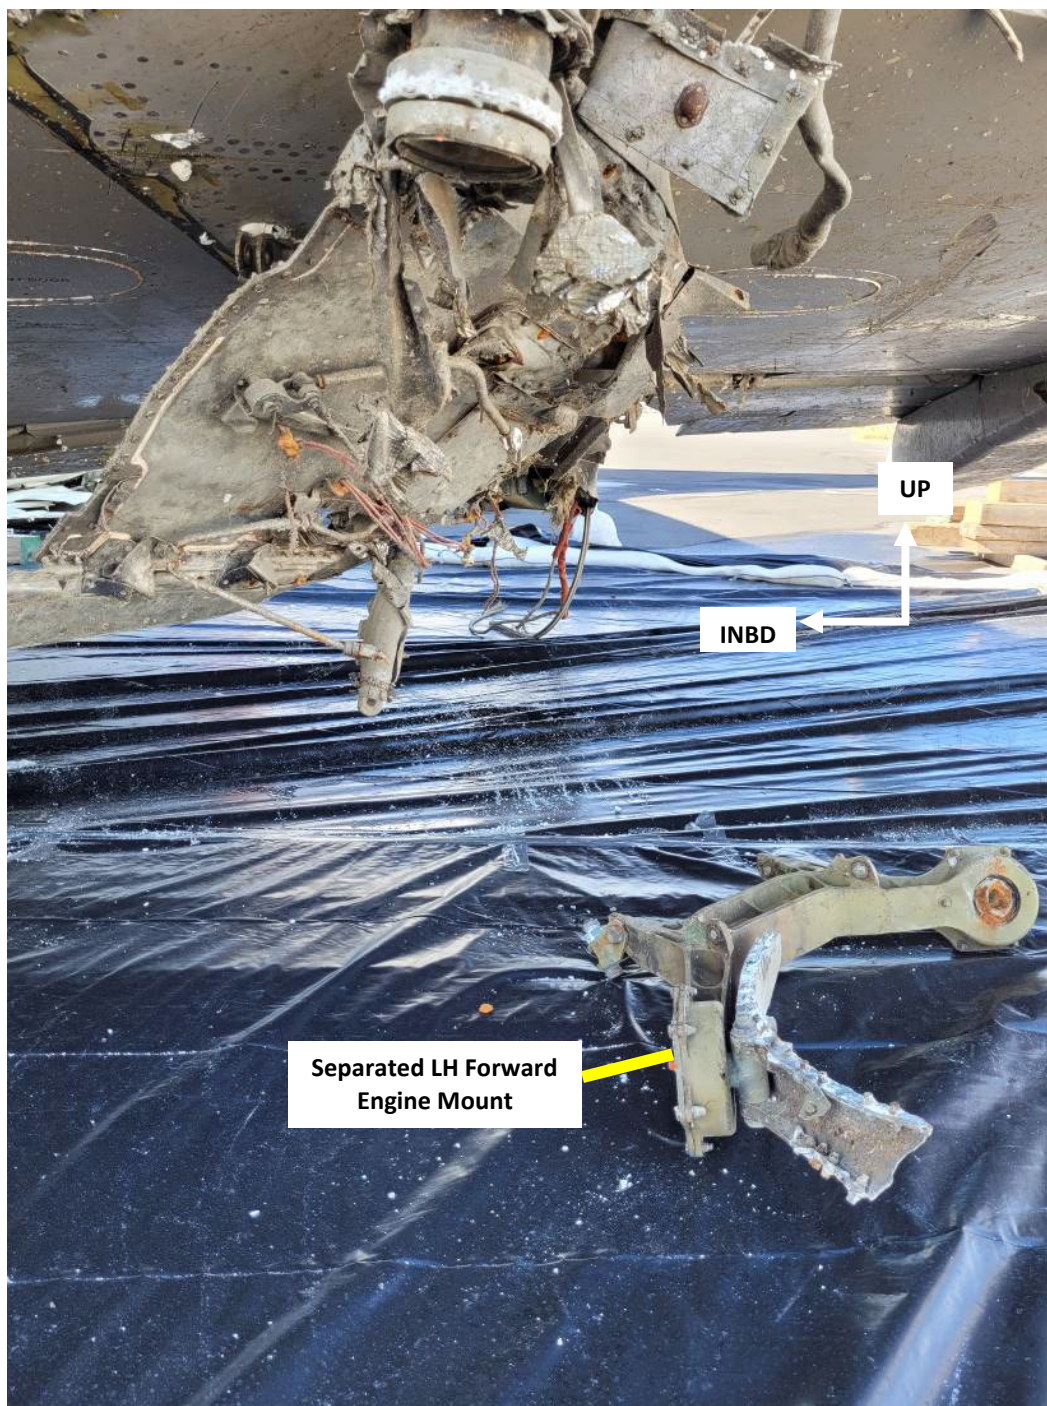
The left engine separated from the wing during the accident. The forward engine mount was separated from the wing and recovered on the seafloor. The forward inboard engine mount to wing bolt was separated and not recovered. The lug on the engine mount and the clevis on the wing fitting were intact but the outboard tang on the wing fitting clevis was deformed outboard. The forward outboard engine mount wing fitting was fractured through the three clevis lugs. The bolt remained installed in the intermediate fitting trapping the aft piece of the fractured clevis lug. The intermediate fitting remained installed on the forward engine mount. The inboard cone bolt was

Figure 68 shows the left engine pylon area with the recovered forward engine mount.

Figure 68. Left engine pylon area and separated forward engine mount (Boeing photo)

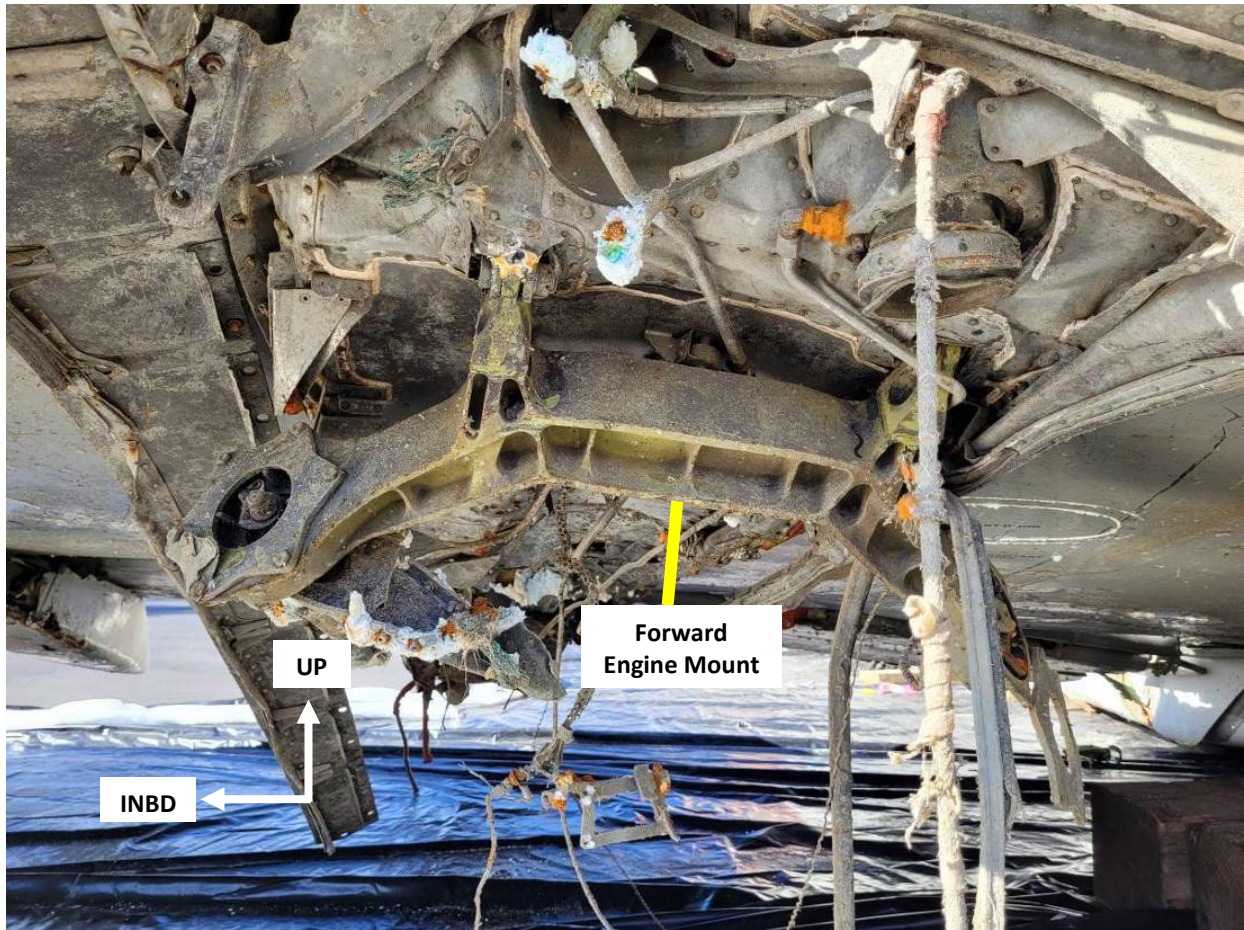
Figure 69 shows the right engine pylon area with the forward engine mount still attached.

Figure 69. Right engine pylon area (Boeing photo)

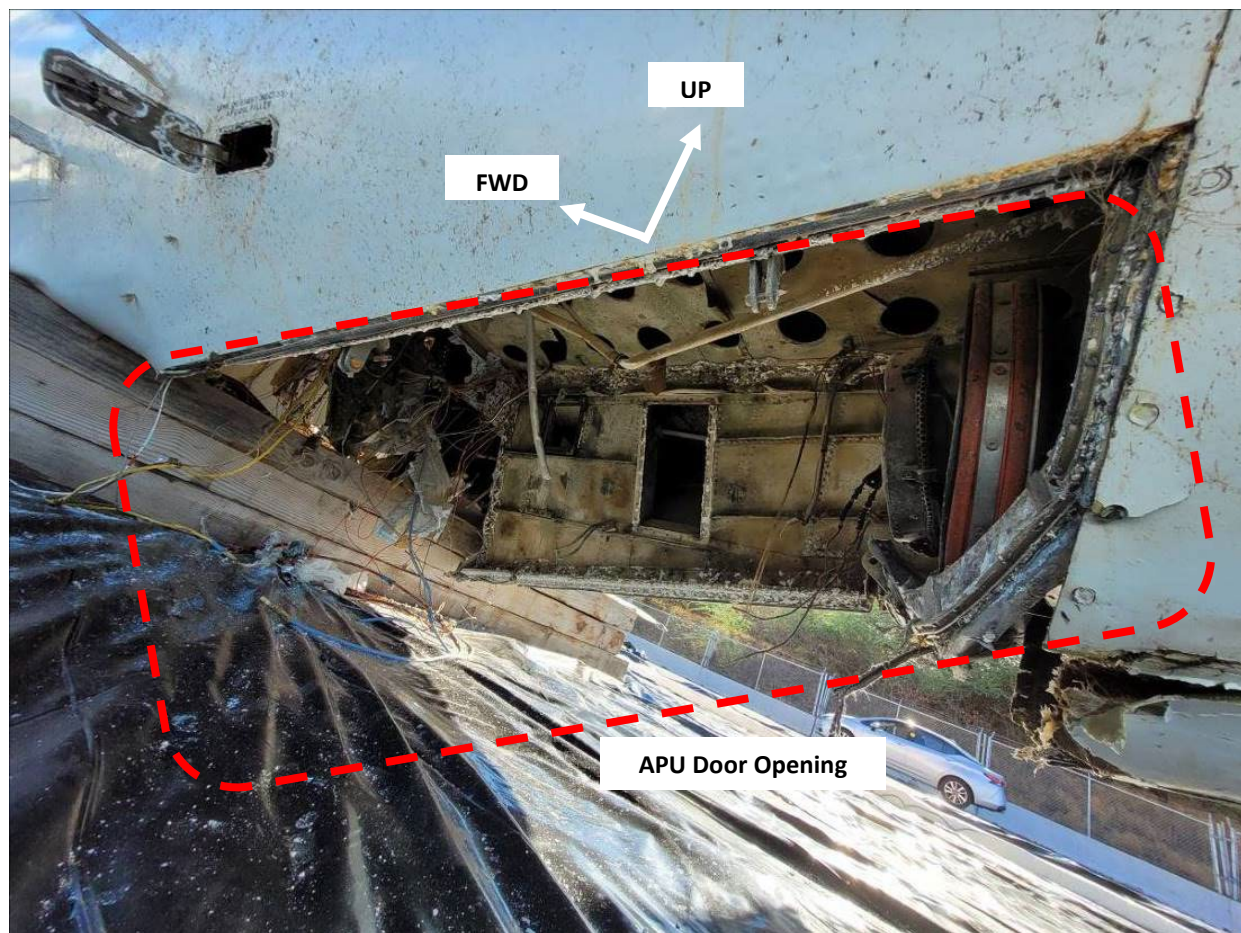
Figure 72 shows the APU door opening in the lower aft fuselage. The APU doors were not recovered.

Figure 72. APU door opening (Boeing photo)

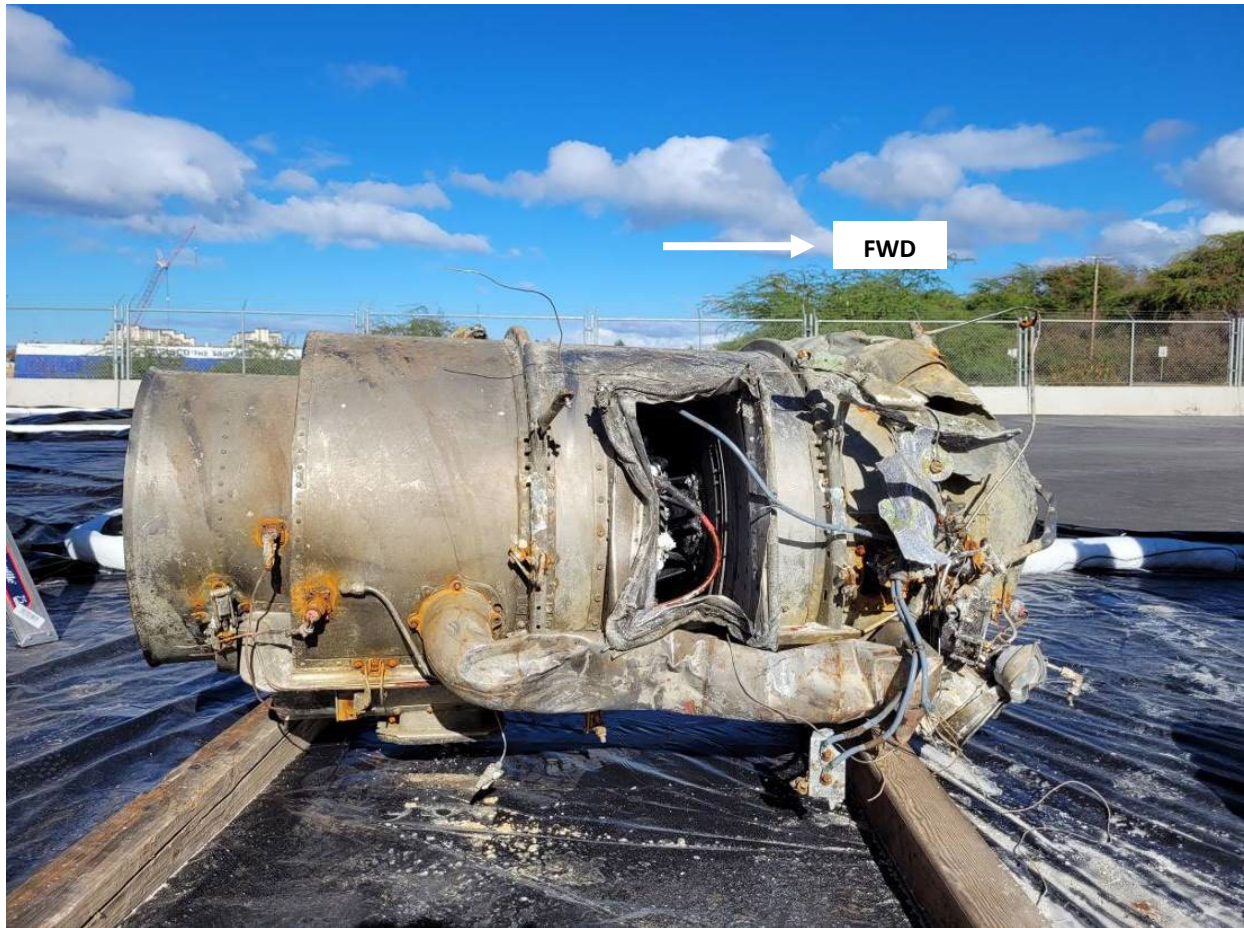
Figure 73 shows the APU that was separated from the airplane and recovered in the debris field.

Figure 73. Recovered APU (Boeing photo)
