National Transportation Safety Board

DCA21FA174

STRUCTURES

Group Chair's Factual Report

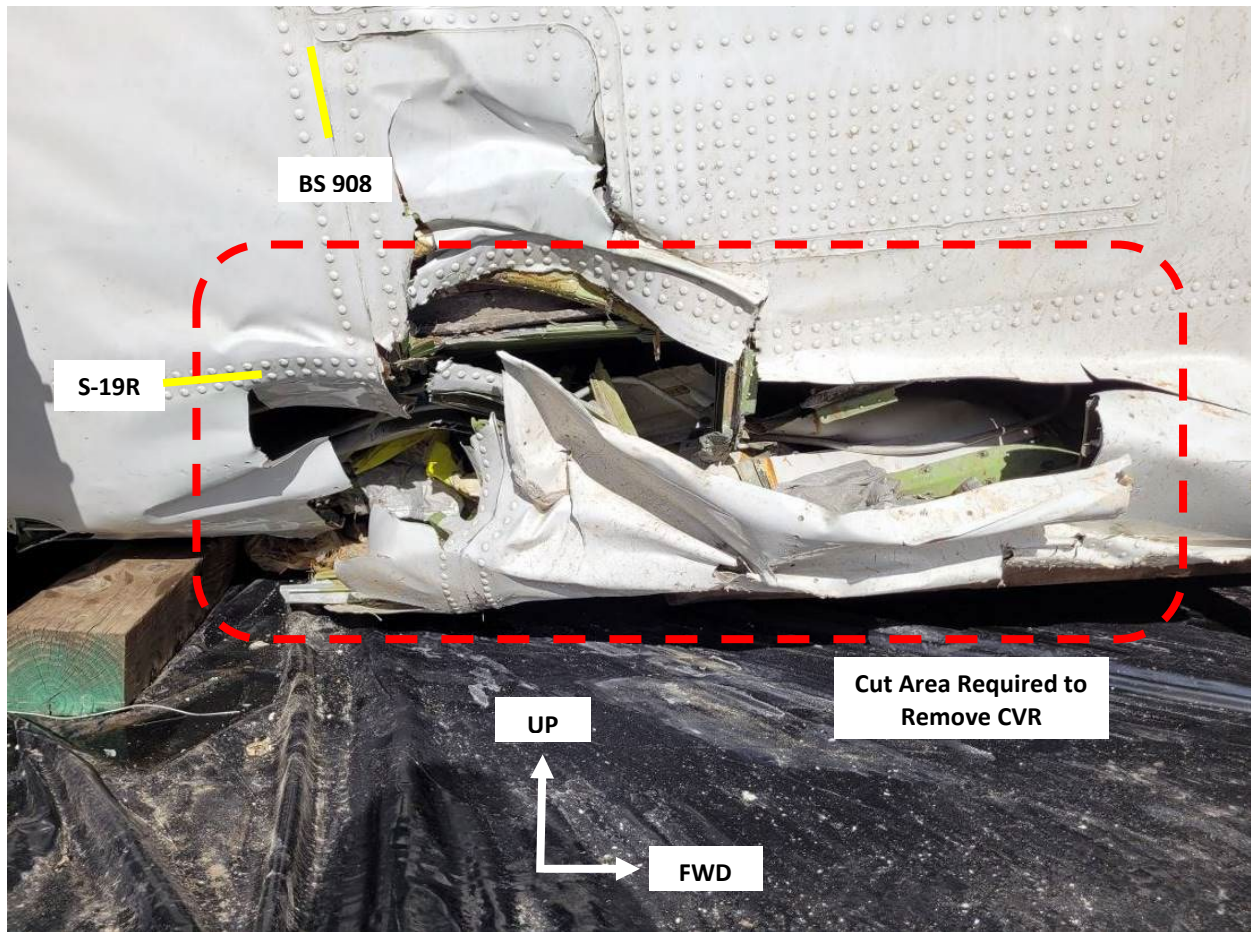
Figure 74 shows the cut area on the lower right fuselage skin required to remove the Cockpit Voice Recorder (CVR).

Figure 74. Right lower fuselage cut area (Boeing photo)
