National Transportation Safety Board

DCA22FA082

VIDEO STUDY

Location: Jolon, CA
Date: February 16, 2022
Time: 09:58 pacific standard time (PST)
UAS: Joby Aero Inc. JAS4-2, N542AJ

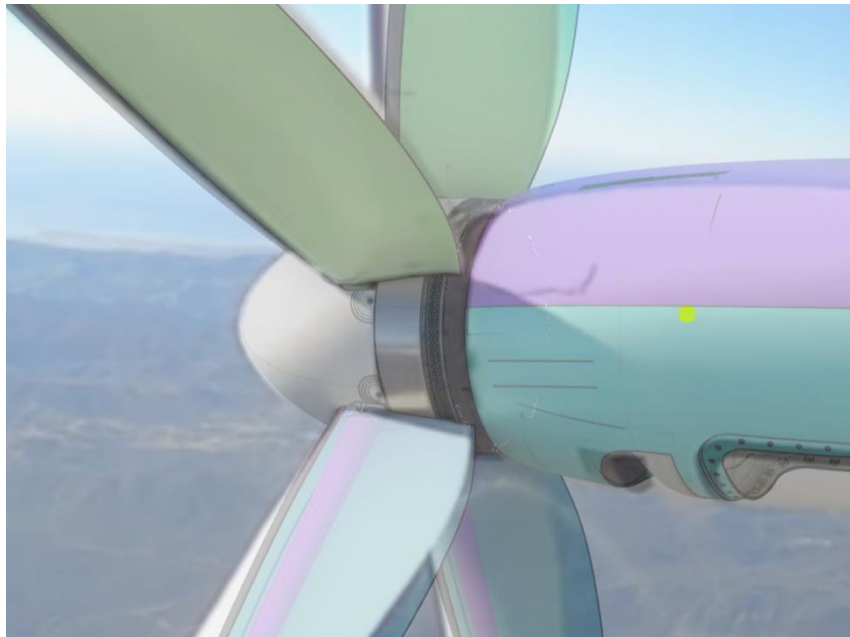
Using a CAD model of the aircraft, Joby created a method that allowed blade angle of visible propellers on station 3 to be estimated. Joby validated this method using images recorded prior to the test anomaly. Figure 2 is an overlay of the CAD model and station 3 of N543AJ showing a nominal position of [REDACTED] degrees. Note the CAD model's opacity has been altered to show internal structure such as the blade roots.

Figure 2. CAD overlay at nominal position of [REDACTED] degrees.
