National Transportation Safety Board

DCA22FA132

SYSTEMS AND STRUCTURES - FACTUAL REPORT

Location: Miami, FL
Date: June 21, 2022
Time: 1738 EDT
Airplane: McDonnell Douglas MD-82

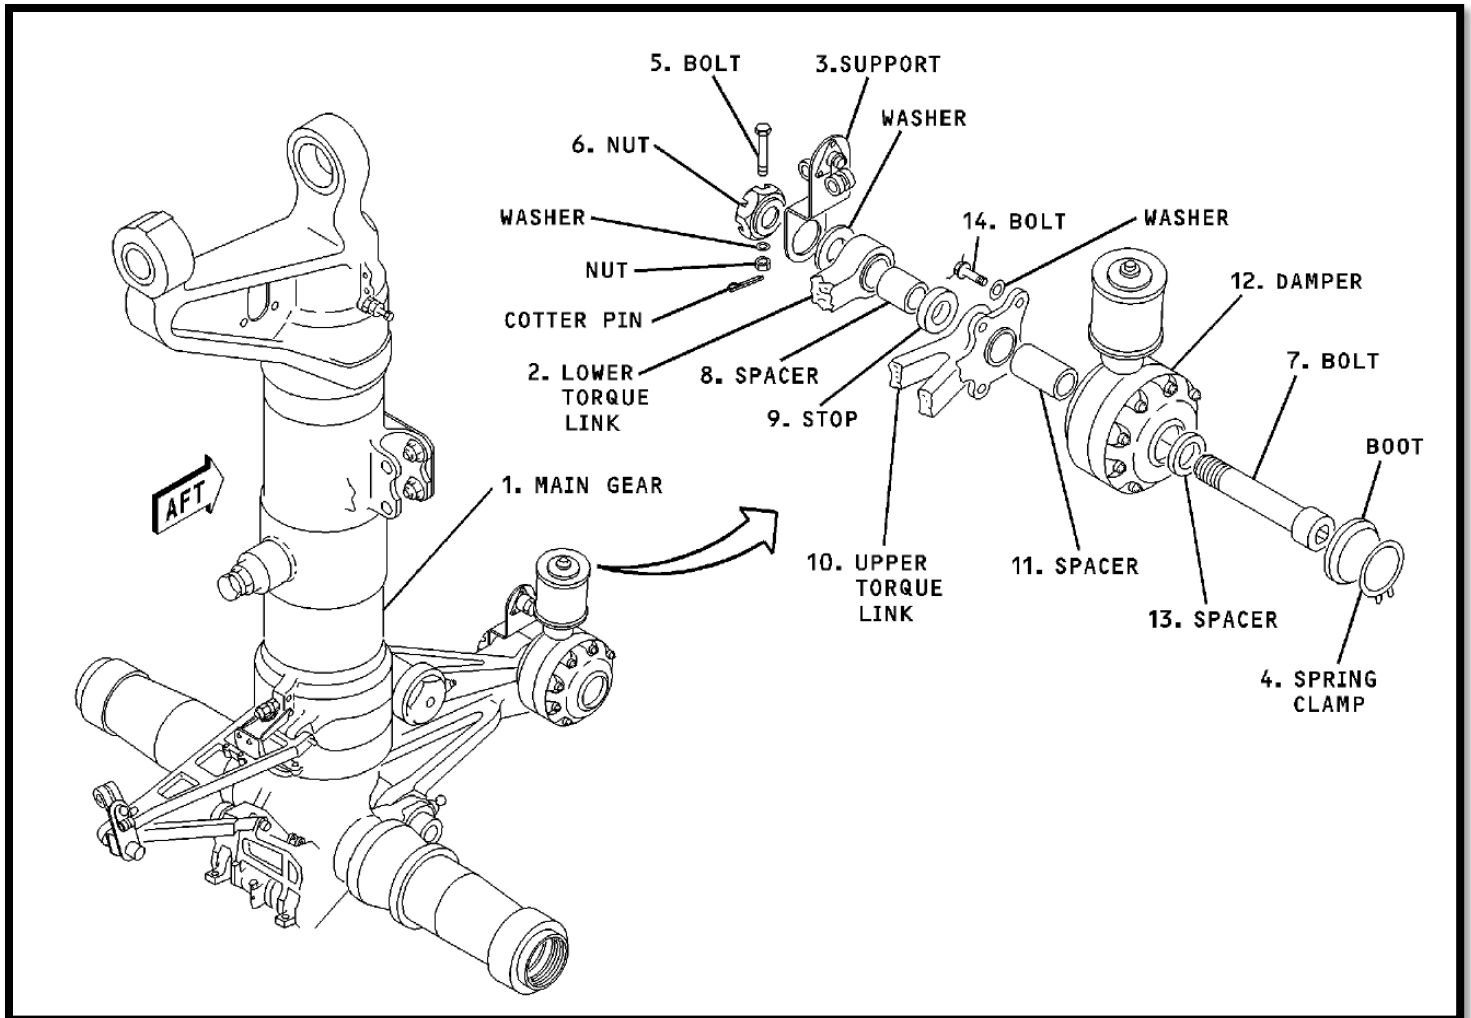
Figure 10 Landing gear torque links and shimmy damper installation. Image Copyright © Boeing. Reproduced with Permission. Note: illustration has been altered for clarity from original source.

The mating structure from the lower torque link lug remained attached to the item 7 bolt (apex bolt, Figure 10).

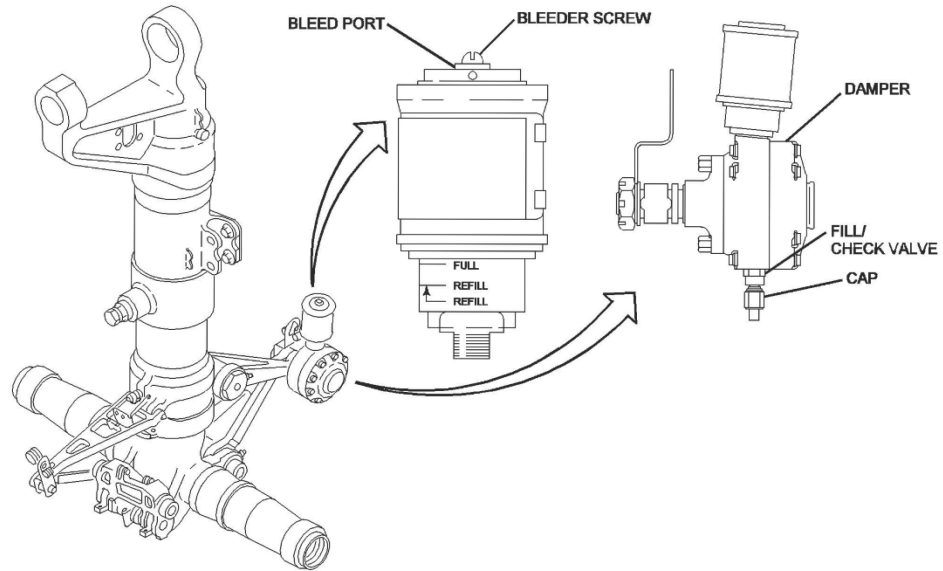
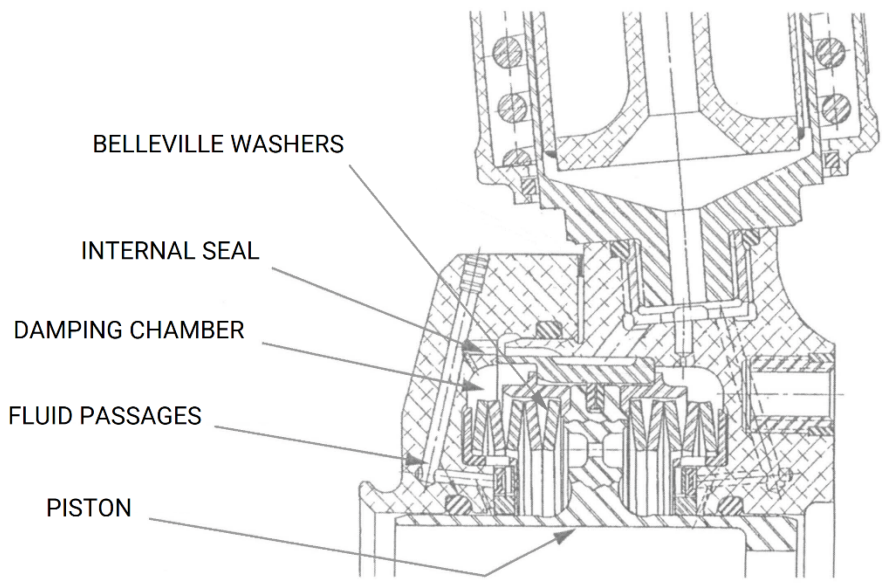
DAMPER CROSS-SECTION

The damper housing contains a piston, which separates two chambers that must be filled with hydraulic fluid for proper operation. As the piston moves back and forth between the chambers, the motion is dampened by restricting hydraulic fluid flow between the chambers through orifices in the piston. The damper also employs a Belleville spring arrangement, to keep the piston centered in the damper.

A hydraulic fluid reservoir is attached to the damper housing. The reservoir contains a spring which pressurizes the hydraulic fluid in the reservoir and damper to 40 to 55 PSI. There is a bleed port at the top of the reservoir. A check valve and cap is located at the bottom of the damper housing. The damper may be serviced by adding fluid using either the bleed port at the top or the check valve on the bottom, and air is removed from the damper via the bleed port. Markings on the reservoir indicate the hydraulic fluid level in the reservoir and a label on the side of the reservoir provides servicing instructions.

Figure 17 Shimmy damper details. Image Copyright © Boeing. Reproduced with Permission.
