National Transportation Safety Board

DCA22MA009

AIRWORTHINESS GROUP

Location: Brookshire, Texas
Date: October 19, 2021
Time: 1000 central daylight time (CDT)
Aircraft: McDonnell Douglas DC-9-87, Registration N987AK

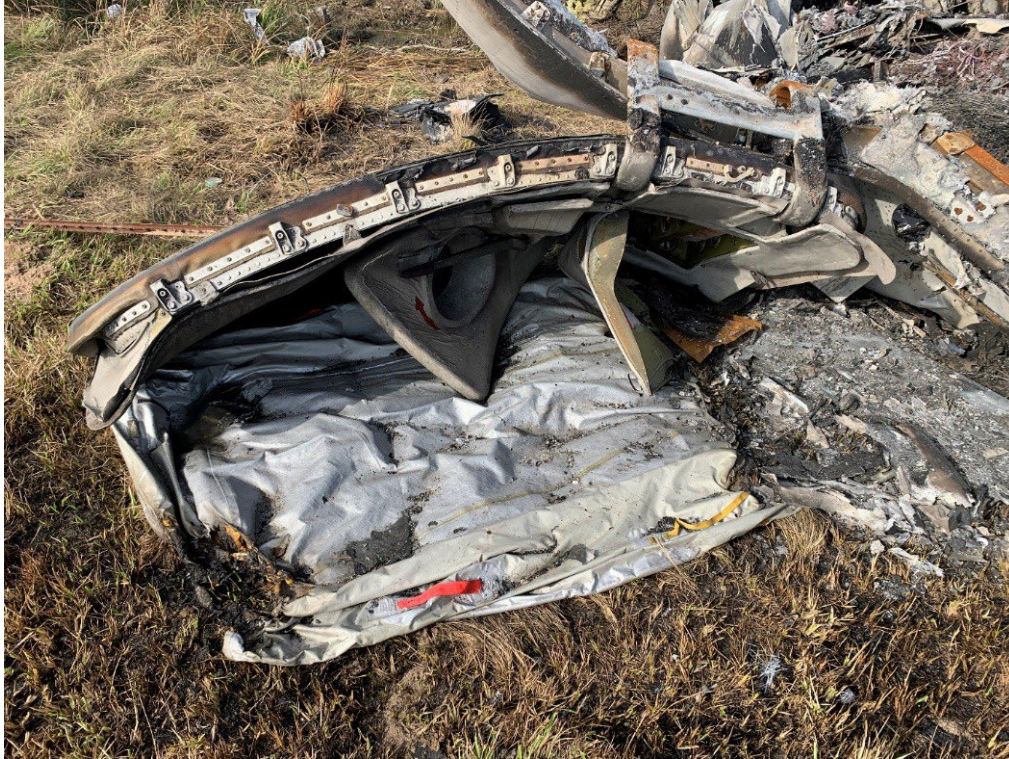
The L1 Door slide was found connected to the door. See Figure 15.

Figure 15. Front left entry door and evacuation slide, looking forward.

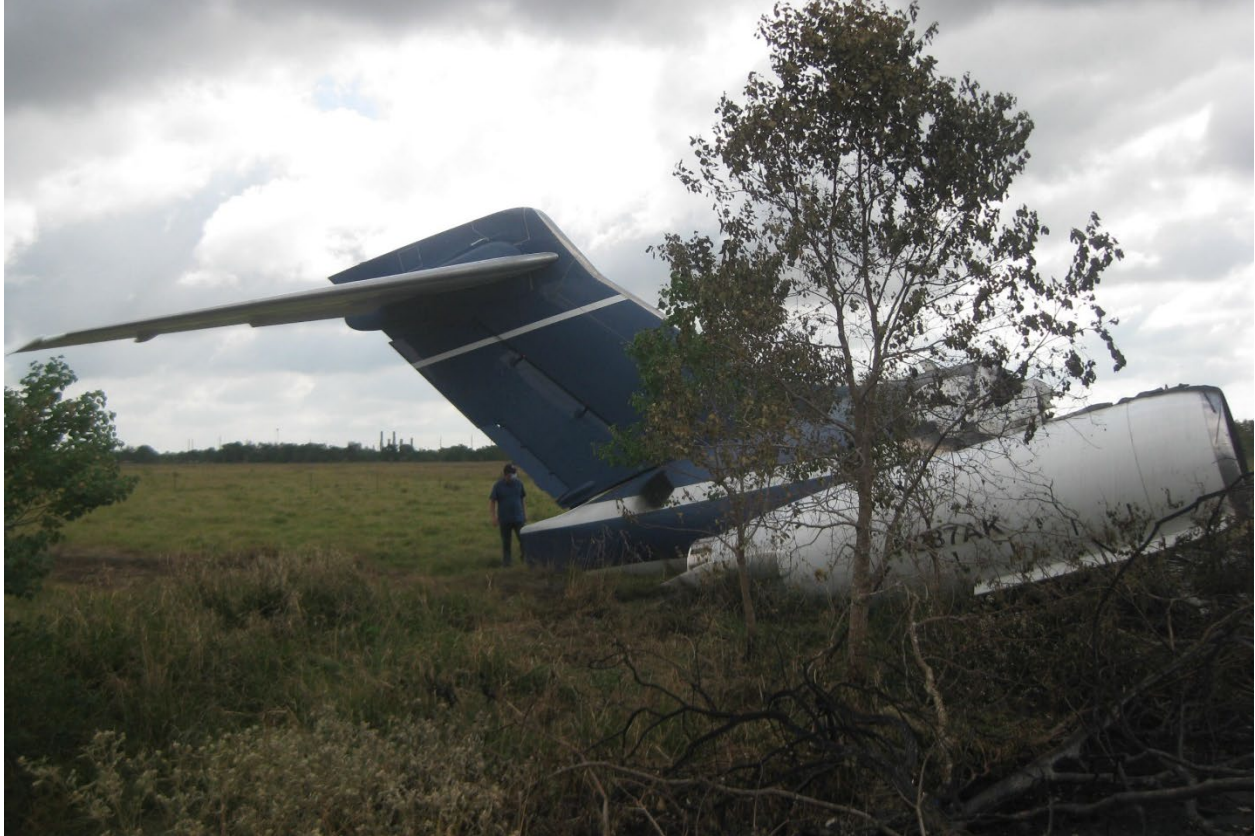
Both the vertical stabilizer and rudder exhibited no obvious evidence of structural damage when viewed from the ground. See Figures 20 and 21.

Figure 20. Right side of the vertical stabilizer, rudder, and engine number two.

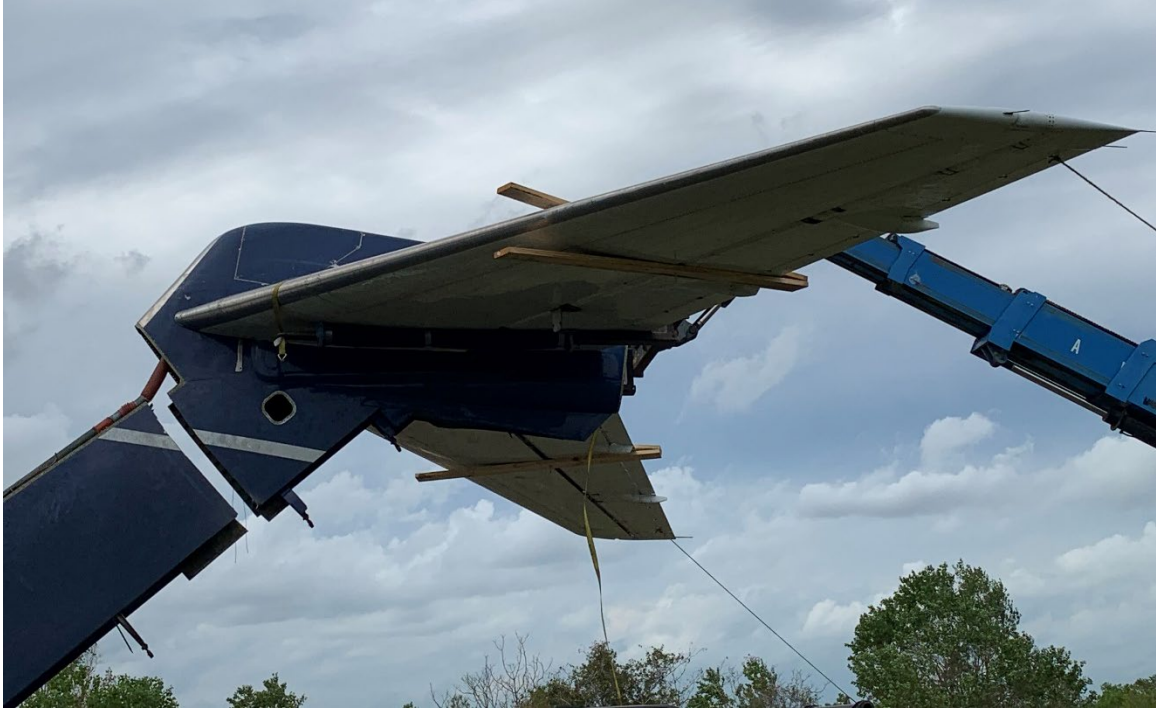
The airplane's rudder and vertical stabilizer leading edge spar cap were removed and then the vertical stabilizer was cut below the horizontal stabilizer. Aside from the removed linkage hardware, the structure was moved as is, with the elevator clamped in a faired position to prevent further movement. See Figure 29.

Figure 29. Cutting of the vertical stabilizer after the rudder and stabilizer spar cap were removed. Note the wood planks clamped to secure the elevators.

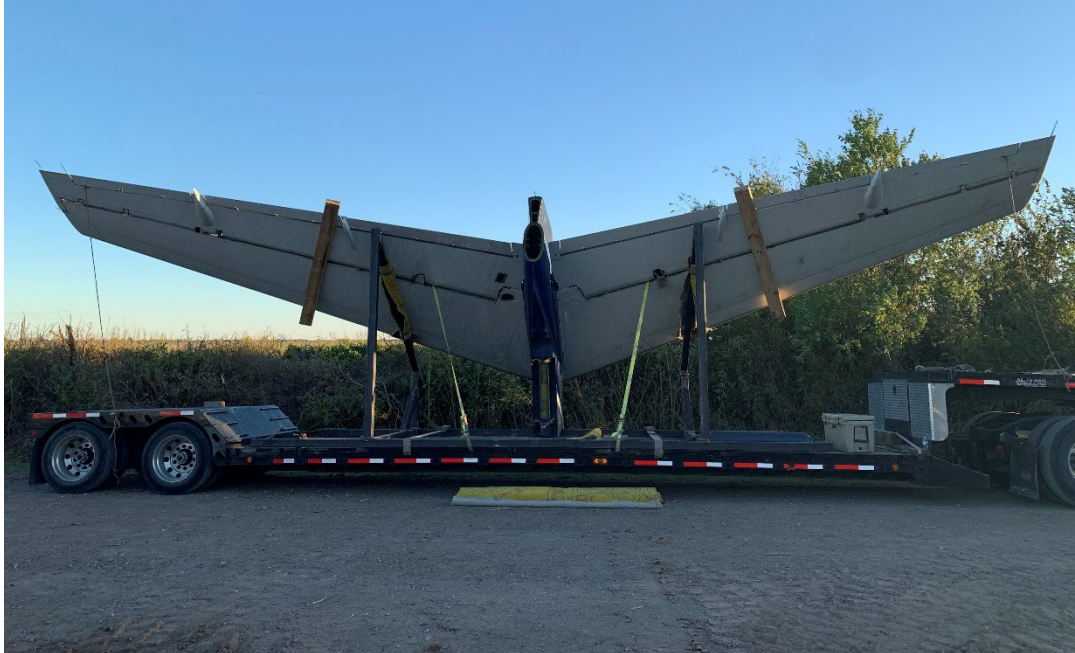
The removed structure was then placed onto a semitruck trailer and moved to the wreckage storage facility for further examination. See Figure 30. See Section 6.0, Further Examination of Removed Structure and Systems Components, for further information.

Figure 30. The airplane's tail structure placed onto trailer prior to movement to the wreckage storage facility.

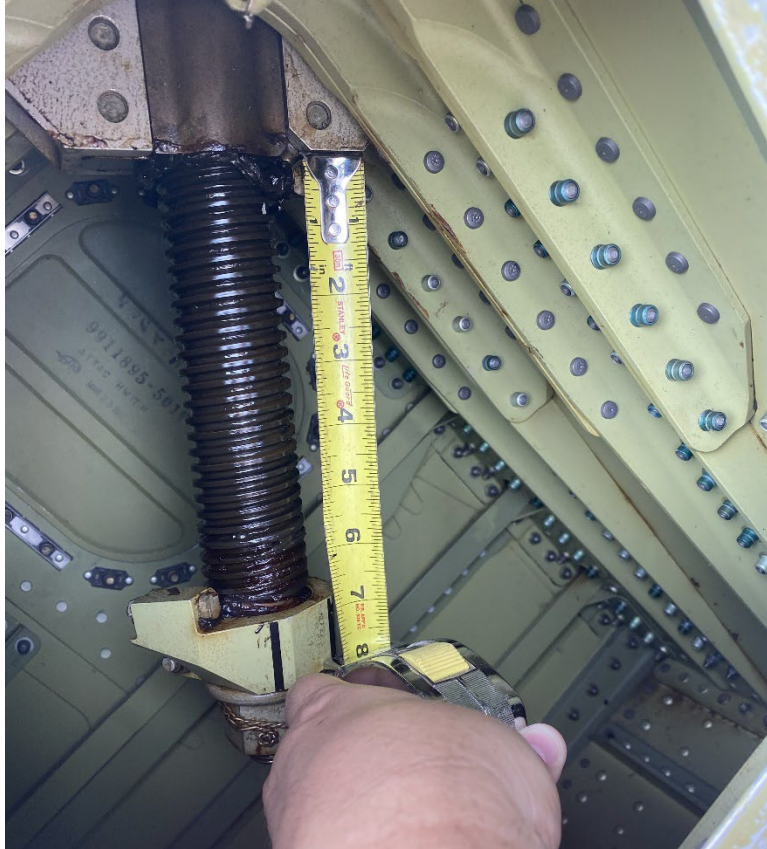
The horizontal stabilizer trim actuator was inspected through the access panel on the left-hand side of the vertical fin. The jack screw was noted as lubricated, and no metal filings or debris were noted on the exposed threads. To determine the as-found position, a measurement was taken of the position of the jack screw. The "BG" measurement was determined by measuring the acme screw protrusion below the acme nut in the stabilizer actuator. The measurement was 6.8 inches. See Figure 31.

Figure 31. The horizontal stabilizer jackscrew actuator and "BG" measurement.

According to Boeing, a BG measurement of 6.8 inches corresponds to a horizontal stabilizer position of 4.8 degrees airplane nose up, which is within the range of a normal horizontal stabilizer position for takeoff.

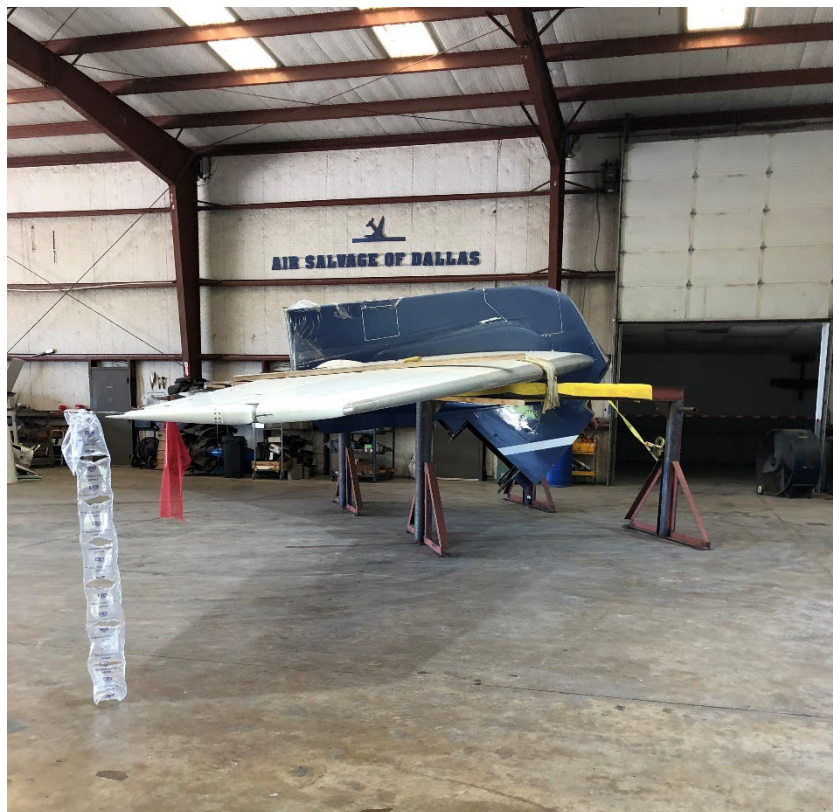
Figure 33. Airplane's tail section prior to disassembly and examination by the group.

The group inspected the tail section and confirmed no appreciable damage during transport except for the following observations:

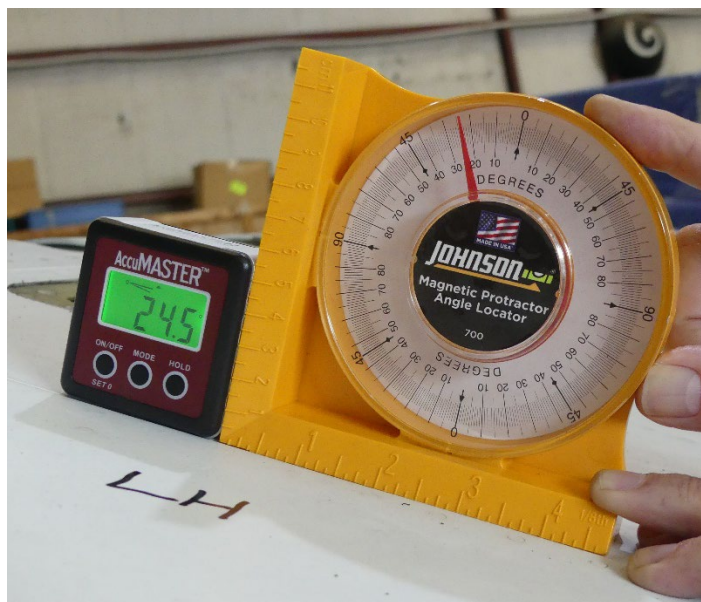
The elevator throw movement was measured using a calibrated inclinometer⁶. See Figure 36.

Figure 34. Digital calibrated inclinometer showing elevator throw movement measurement.

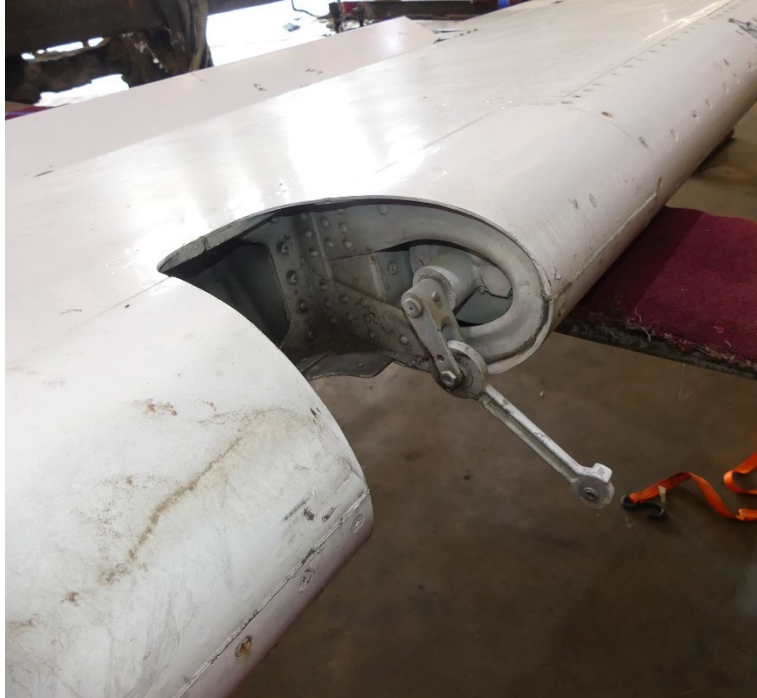
The elevator dampers rotated smoothly with no binding through full range of motion. The fuse rivets at the inboard crank were noted as intact. No visible anomalies were observed. See Figures 37 and 38.

Figure 35. The left elevator damper, as installed, with linkage extended.

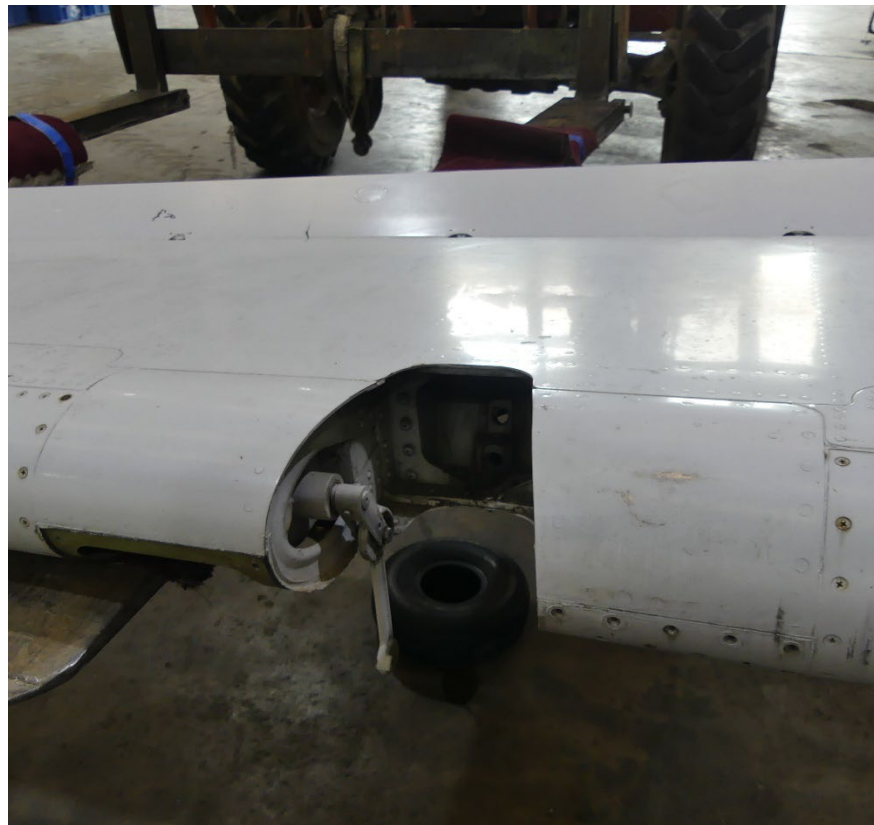
Figure 36. The right elevator damper, as installed, with linkage extended.

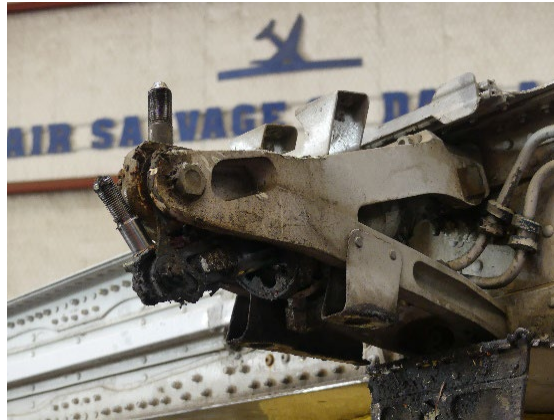
No noticeable anomalies were observed. See Figures 39 and 40.

Figure 37. The left-hand hydraulic boost cylinder, as installed.

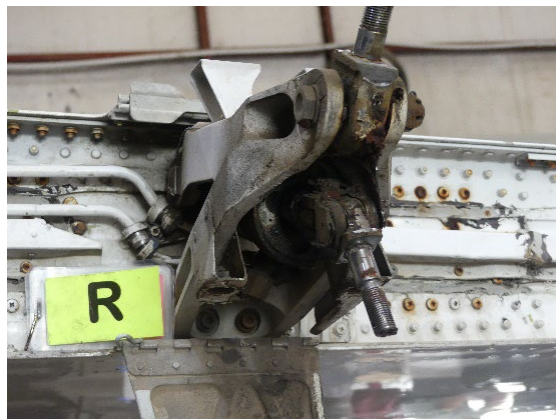
Figure 38. The right-hand hydraulic boost cylinder, as installed.

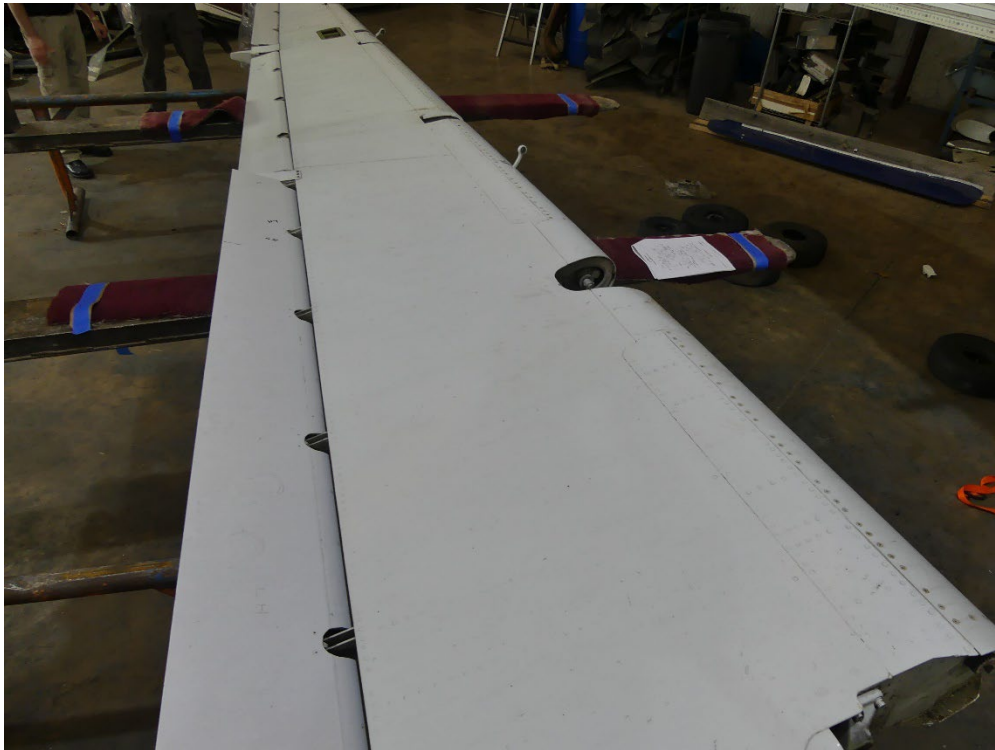
Figure 39. The left elevator control surface after removal, looking outboard.

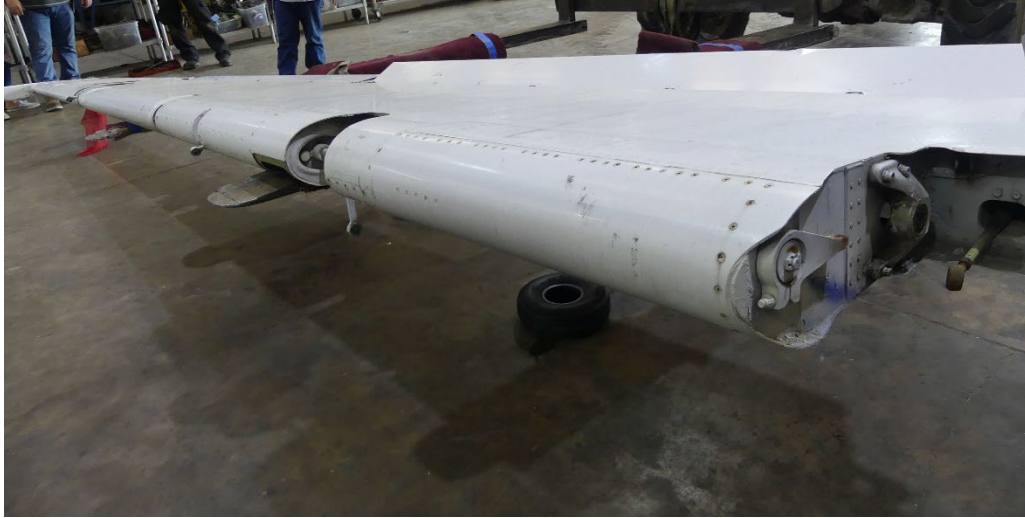
Figure 40. The right elevator, inboard leading edge, looking outboard.

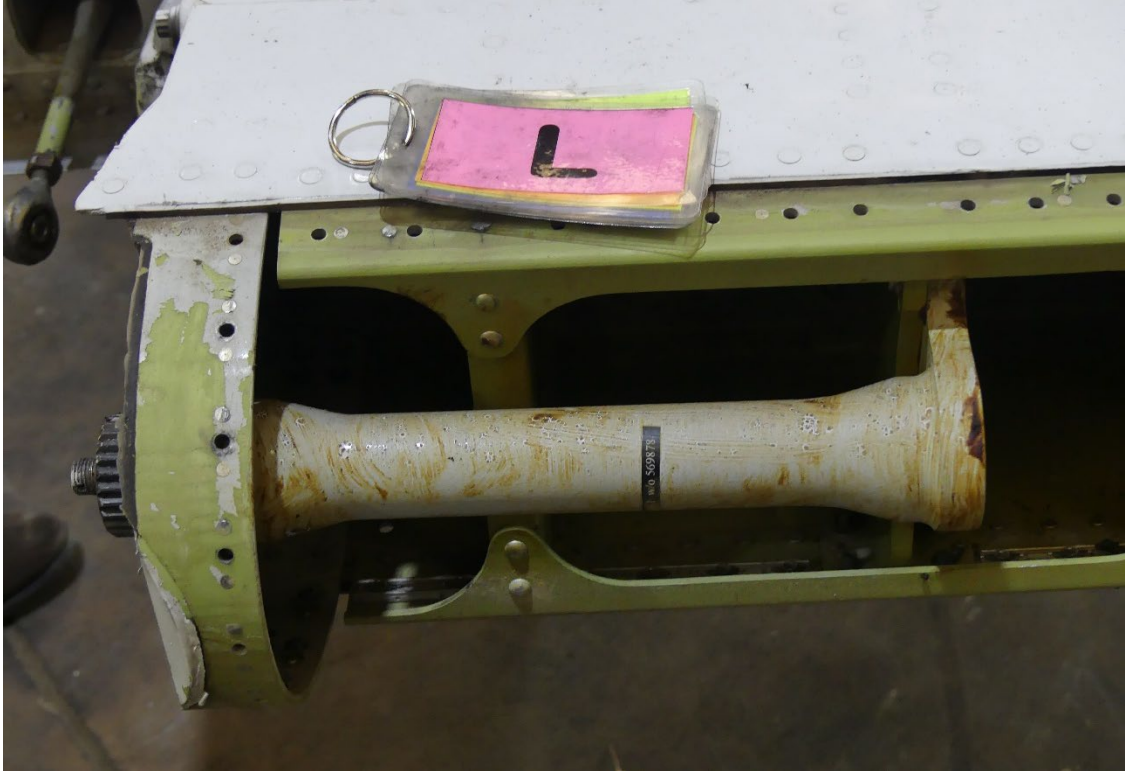
The stop arm and torsion bar on the left and right elevators were examined. The mating splines on the arm and torsion bar were undamaged. No noticeable anomalies were observed. See Figures 43 and 44.

Figure 41. The left elevator torsion bar, as installed.

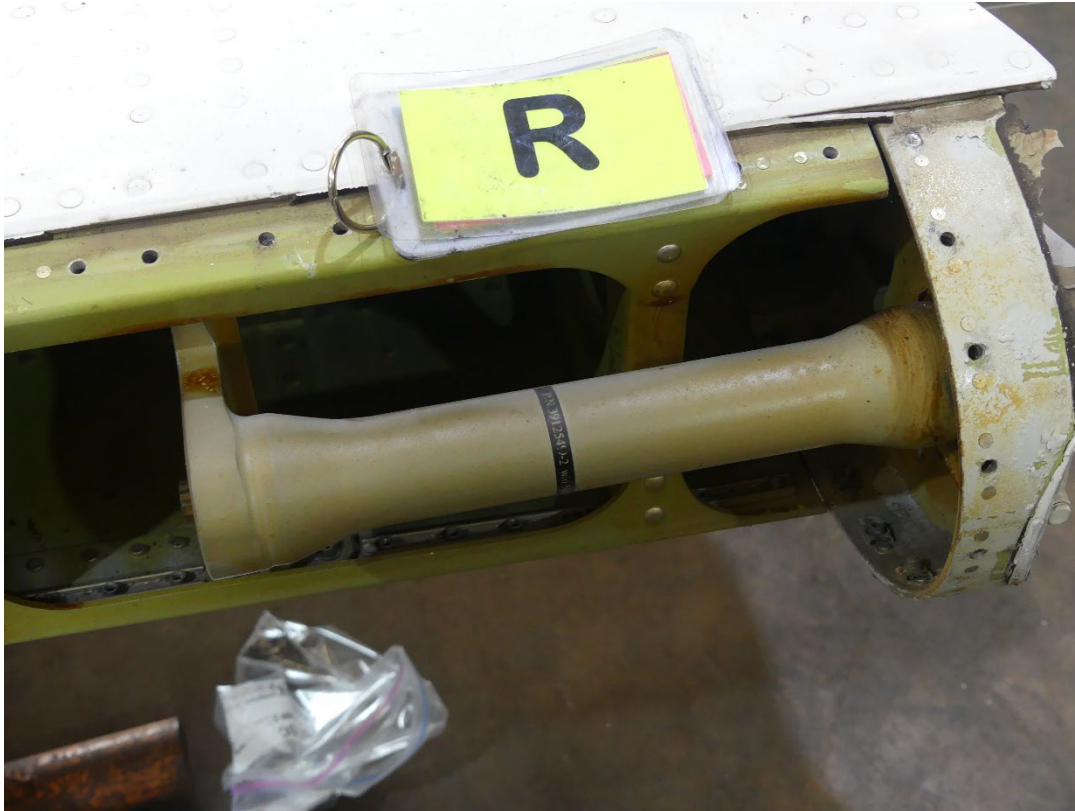
Figure 42. The right elevator torsion bar, as installed.
