National Transportation Safety Board

DCA22MA009

OPERATIONAL FACTORS/HUMAN PERFORMANCE

Group Chair's Factual Report

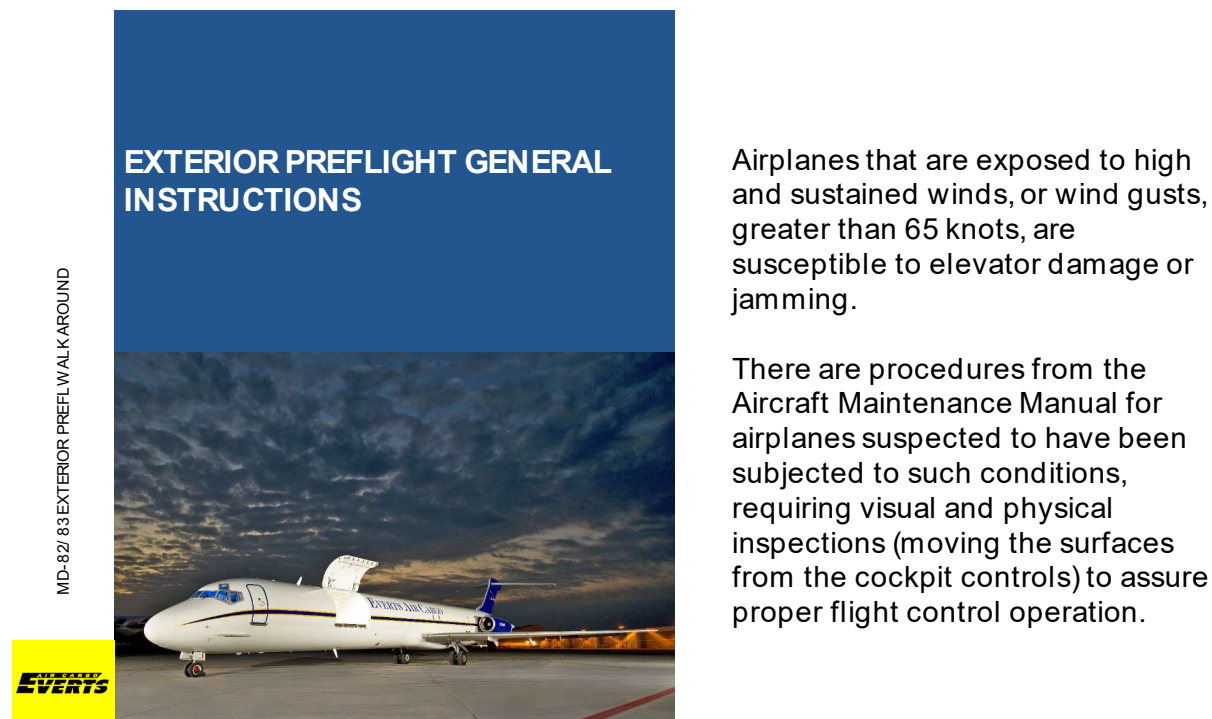
Figure 6: Everts Air Cargo General Preflight Instructions. (Source: Everts Air Cargo Training Walkaround)

aircraft in a clockwise direction and end at the main cabin door. The pictorial included a slide informing flight crews that if an airplane had been exposed to high and sustained winds, or wind gust, greater than 65 knots that the airplane may be susceptible to elevator damage. (See Figure 6).

Airplanes that are exposed to high and sustained winds, or wind gusts, greater than 65 knots, are susceptible to elevator damage or jamming.

There are procedures from the Aircraft Maintenance Manual for airplanes suspected to have been subjected to such conditions, requiring visual and physical inspections (moving the surfaces from the cockpit controls) to assure proper flight control operation.

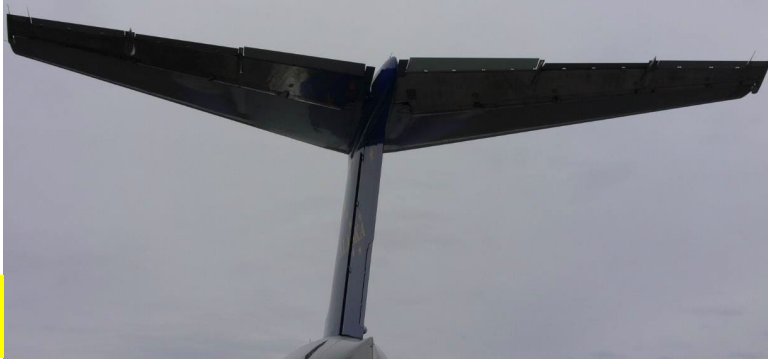
Figure 7: Elevator and Rudder Preflight Inspection. (Source: Everts Air Cargo Training Walkaround)

The guidance went on to provide details textual and pictorial of each step in performing an exterior preflight inspection, including five slides detailing what the flightcrew should look for when conducting the preflight on the elevator. The details included observing the leading edge of the horizontal and vertical stabilizer, observing that the Ram Air Inlet is unobstructed, the six static wicks on the tips of the elevator, the two static wicks on the tailcone, and the other static wick on the top of the vertical stabilizer aft fairing. Additionally, it described to view the elevator and rudder attach points and that they were not obstructed. (See Figure 7).

If the rudder is powered the rudder tab should be faired with the rudder.
If the rudder is unpowered and deflected, the control tab should be in the position that would take the rudder back to zero deflection.

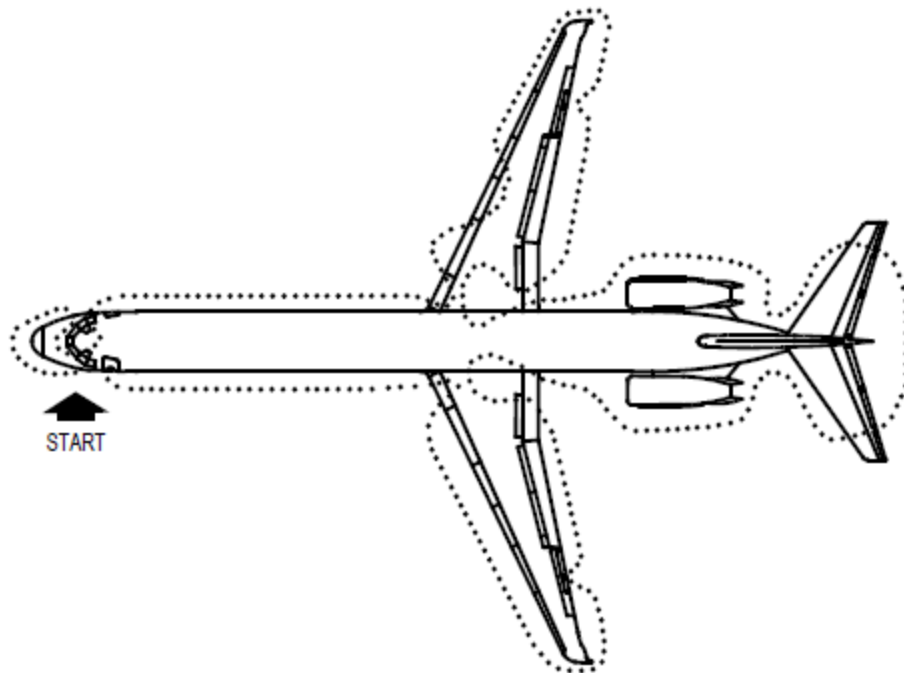
WARNING: Prior to every flight, elevator surfaces must be confirmed as not jammed in the Trailing Edge Down (TED) position. If both elevators are faired with or above the stabilizer surface, confirmation is complete.
