National Transportation Safety Board
Office of Research and Engineering
Washington, D.C. 20594

Airplane Performance Study

Specialist Report
Timothy Burtch

Location: Brookshire, Texas
Date: October 19, 2021
Time: 1500 GMT (1000 CDT)
Airplane: McDonnell Douglas DC-9-87, N987AK
NTSB Number: DCA22MA009

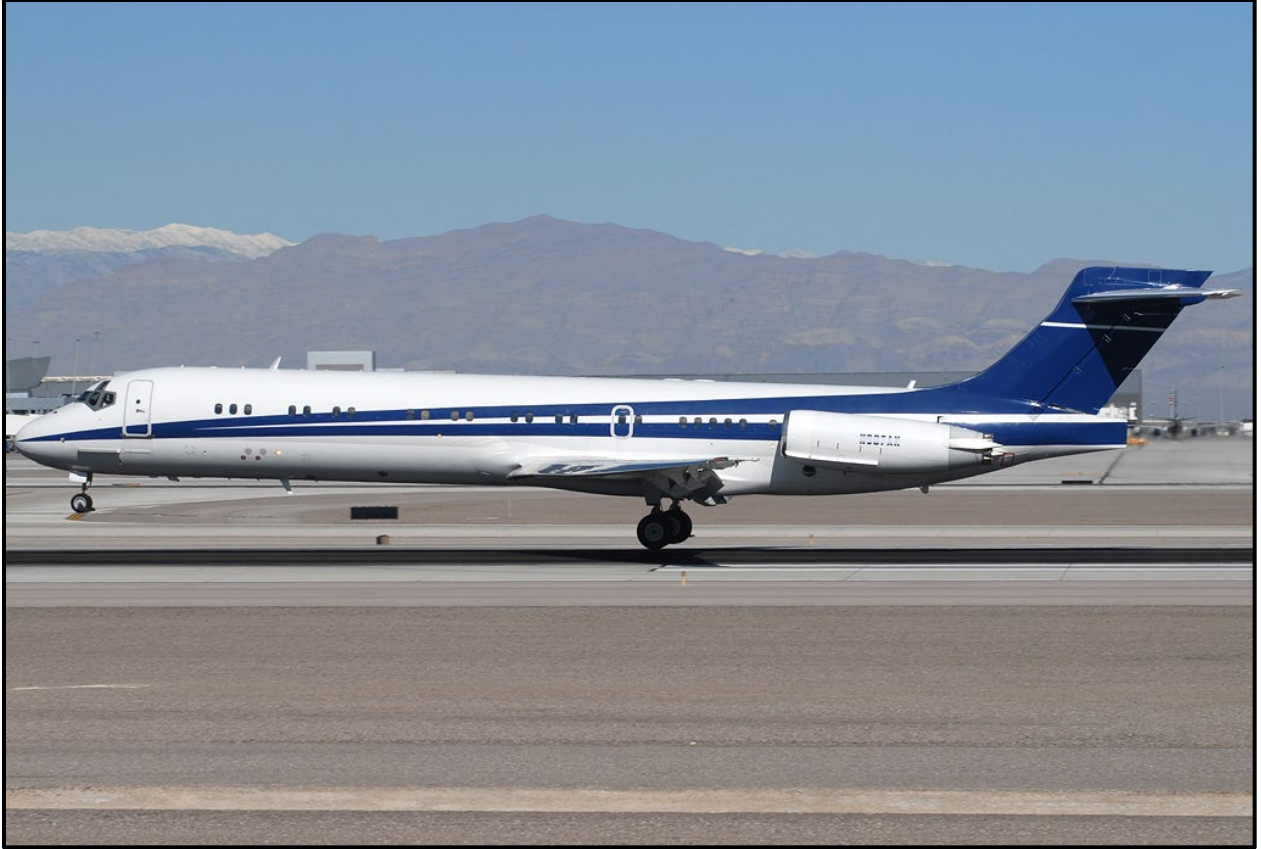
Figure 2: Accident Airplane, N987AK, a McDonnell Douglas DC-9-87

A picture of the accident airplane, a McDonnell Douglas DC-9-87, is shown in Figure 2. The airplane was manufactured by McDonnell Douglas in 1987 and registered to 987 Investments, LLC.
