National Transportation Safety Board

DCA22MA193

AIRWORTHINESS

Group Chair's Factual Report

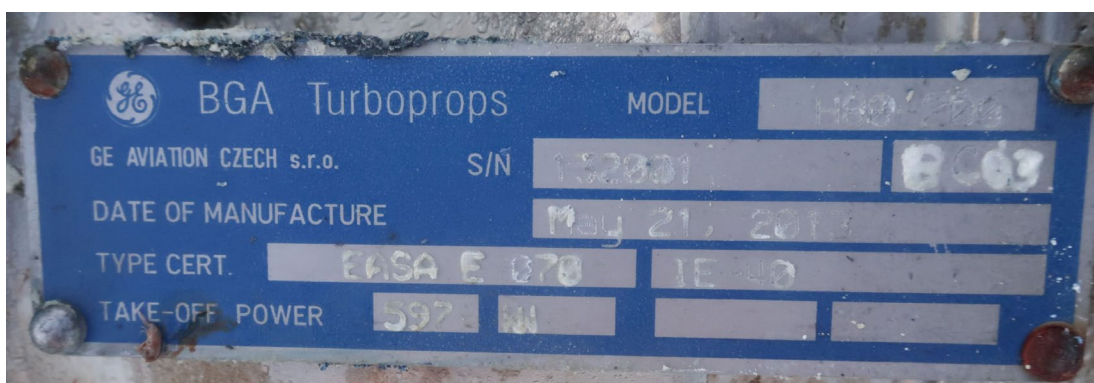
Figure 8. Engine data plate (NTSB photo)

The engine date plate had the following information (Figure 8):

General Electric (GE) BGA Turboprops
Model: H80-200
S/N: 132001
Date of Manufacture: May 21, 2013
Type Cert: EASA E 070 IE-40
Takeoff Power: 597 KW
