National Transportation Safety Board

DCA22MA193

AIRPLANE PERFORMANCE STUDY

Location: Mutiny Bay, Whidbey Island, Washington
Date: September 4, 2022
Time: 1509 PDT
2209 GMT
Airplane: De Havilland DHC-3 Turbine Otter Seaplane, N725TH

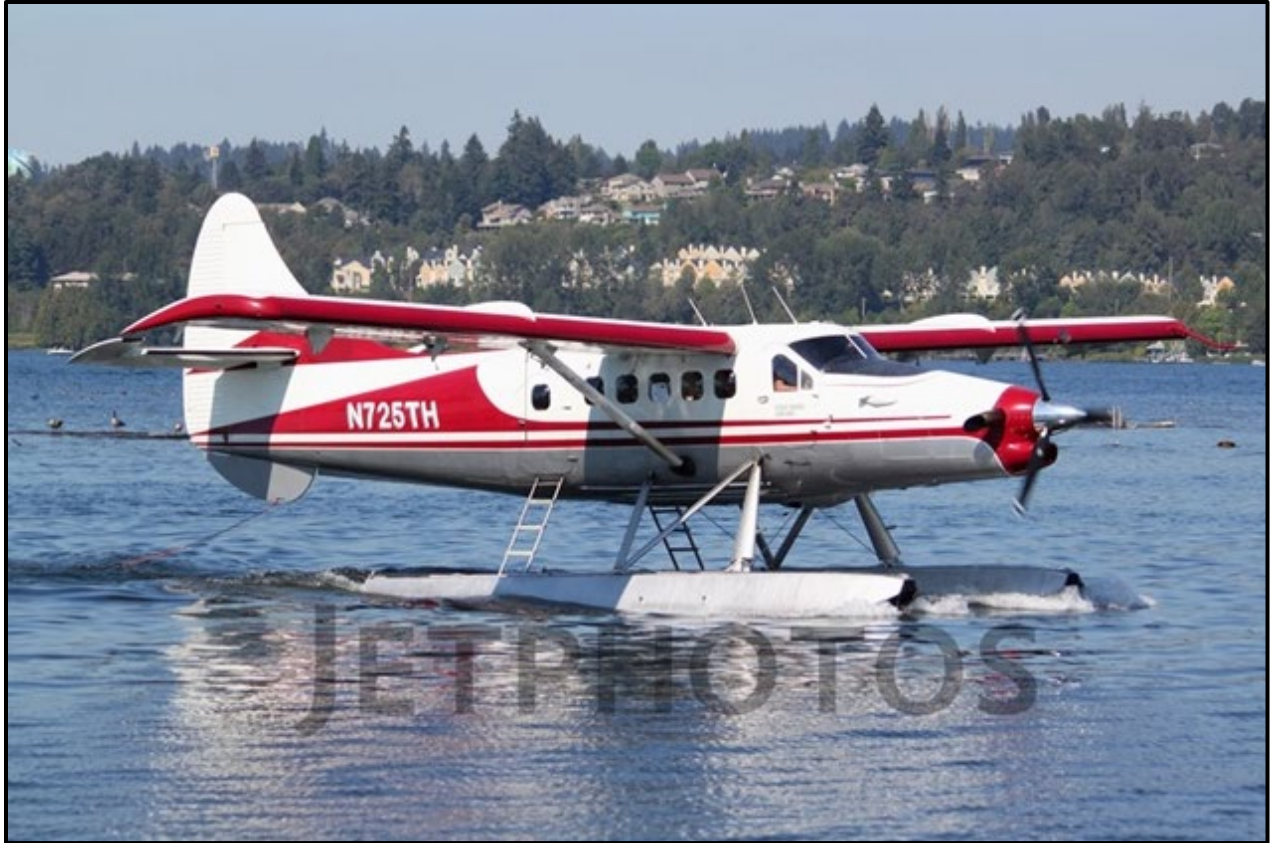
A picture of the accident airplane, a de Havilland DHC-3 Turbine Otter seaplane, serial number 466, is shown in Figure 2. The airplane was manufactured in 1967 and is registered to Northwest Seaplanes, Inc.

Figure 2: Accident Airplane, N725TH, Serial Number 466, a 1967 a de Havilland DHC-3 Turbine "Otter" Seaplane
