National Transportation Safety Board

DCA23LA125

AIRPORTS

Specialist's Factual Report

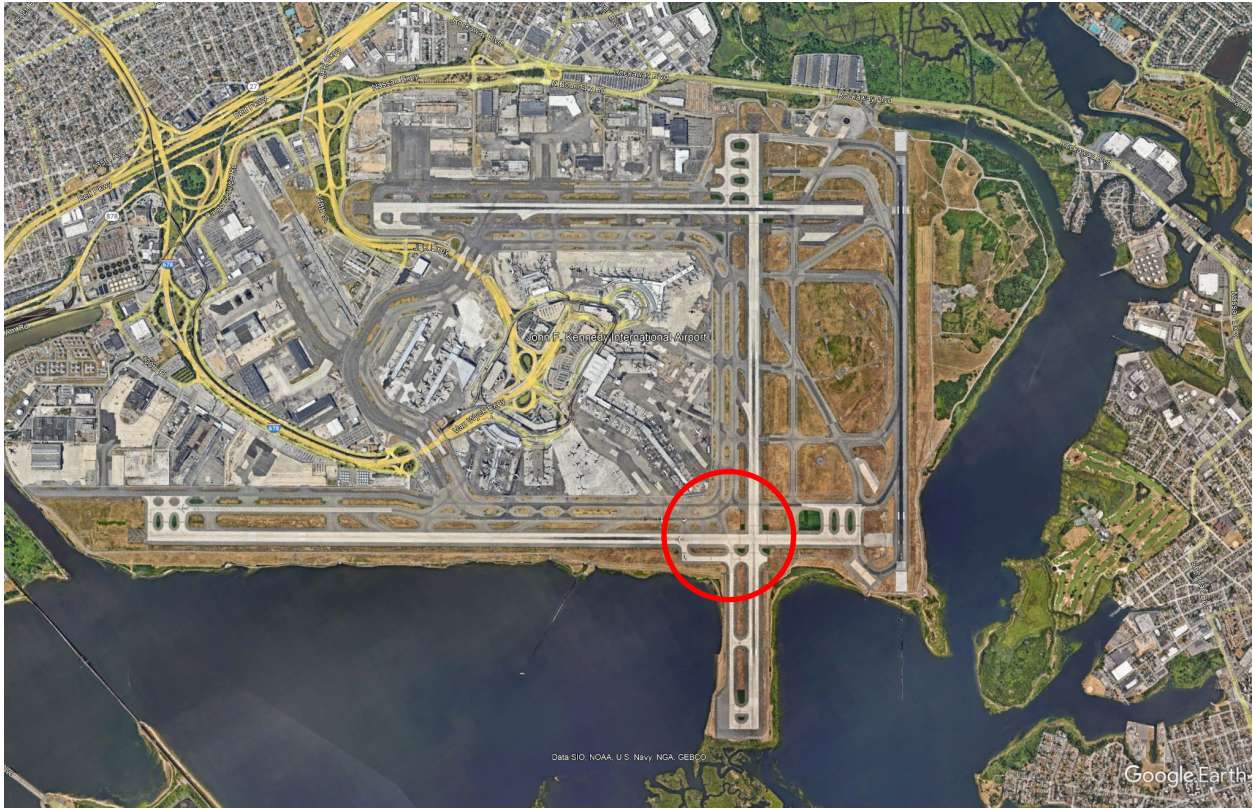
Figure 1. Google Earth image of JFK, with the incident area circled in red.

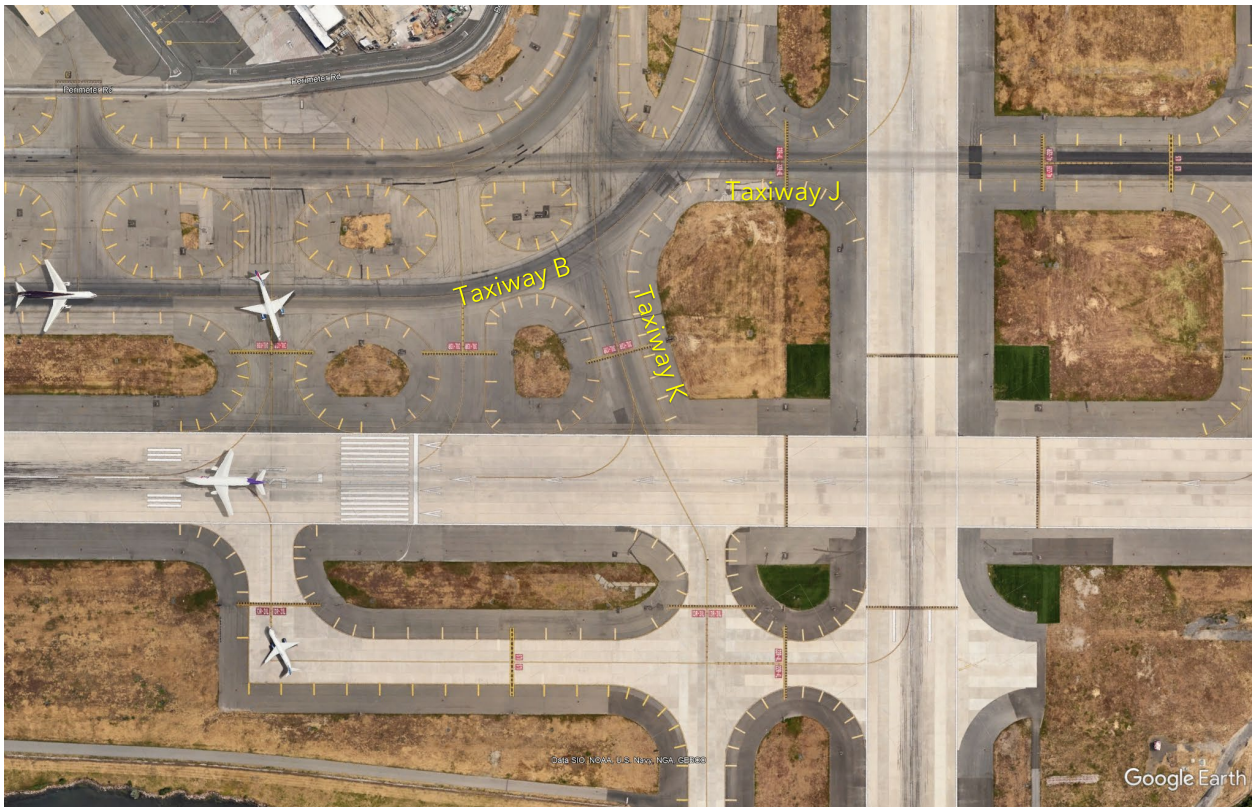
Figure 2. Google Earth image of the incident area.

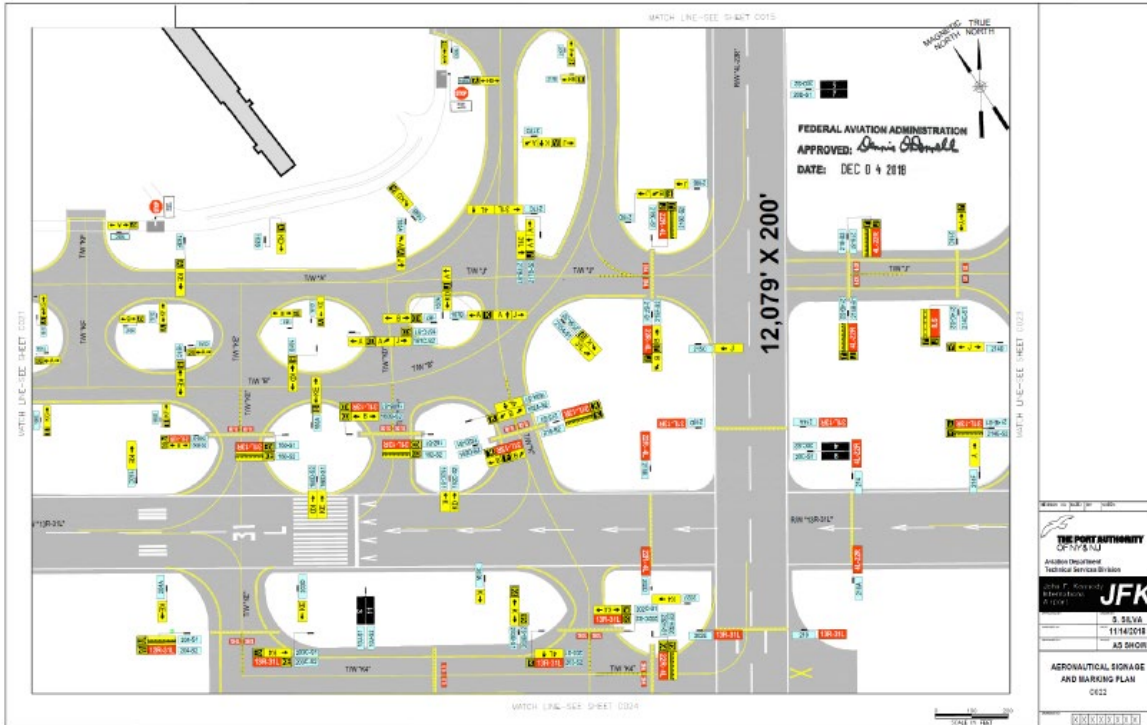
The taxiway J/runway 04L/22R intersection was lighted and marked with taxiway edge lights, taxiway edge markings, an enhanced taxiway centerline, both elevated and in-pavement runway guard lights, hold short markings, and two surface painted holding position markings. See figure 3. The Port Authority provided the FAA-approved signage and marking plan from JFK's Airport Certification Manual (ACM). See figures 4 and 5.

Figure 4. JFK's signage and marking plan for the incident area. [Source: Port Authority of NY and NJ.]

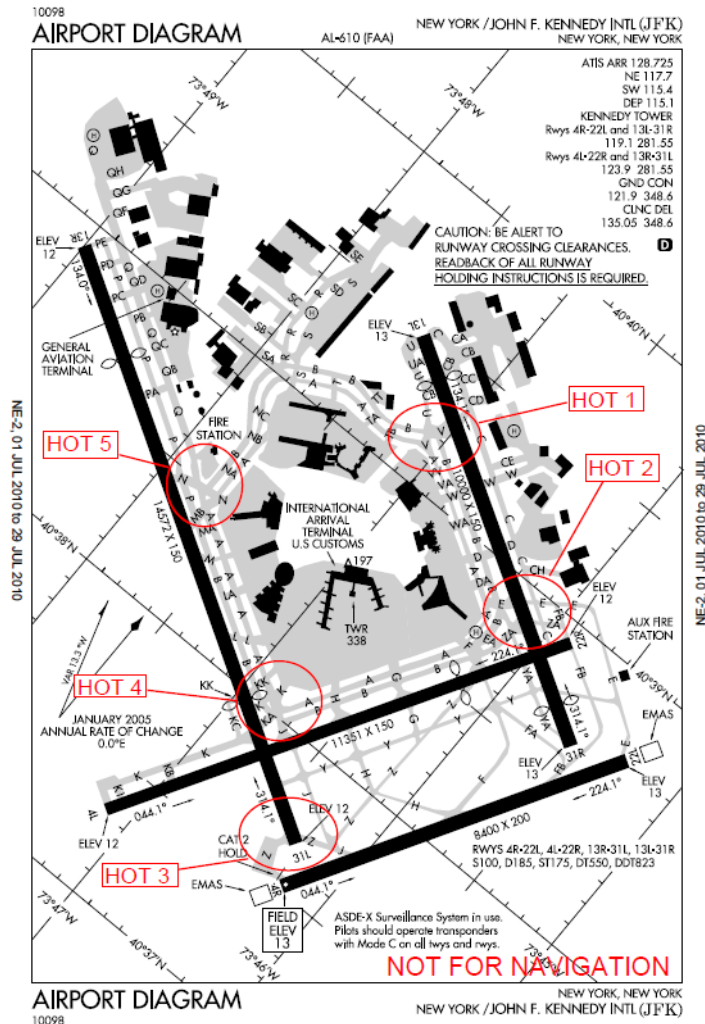
Figure 16. JFK’s published July 2010 Jeppesen chart showing 5 hot spots.

According to the FAA, during a subsequent RSAT meeting it was noted, “JFK Airport has indicated the original Hot Spots depicted in Jeppesen are complex spots where many taxiways come together and is why they were originally identified as Hot Spots but have not had an incursion at these areas. They do not want to publish these locations in NACO as Hot Spots and would like to remove these depicted locations from Jeppesen.” The hot spots were then removed from the JFK Jeppesen chart in 2010.
