# National Transportation Safety Board

DCA23LA125

## **FDR AND ADS-B STUDY**

Aircraft Performance Study

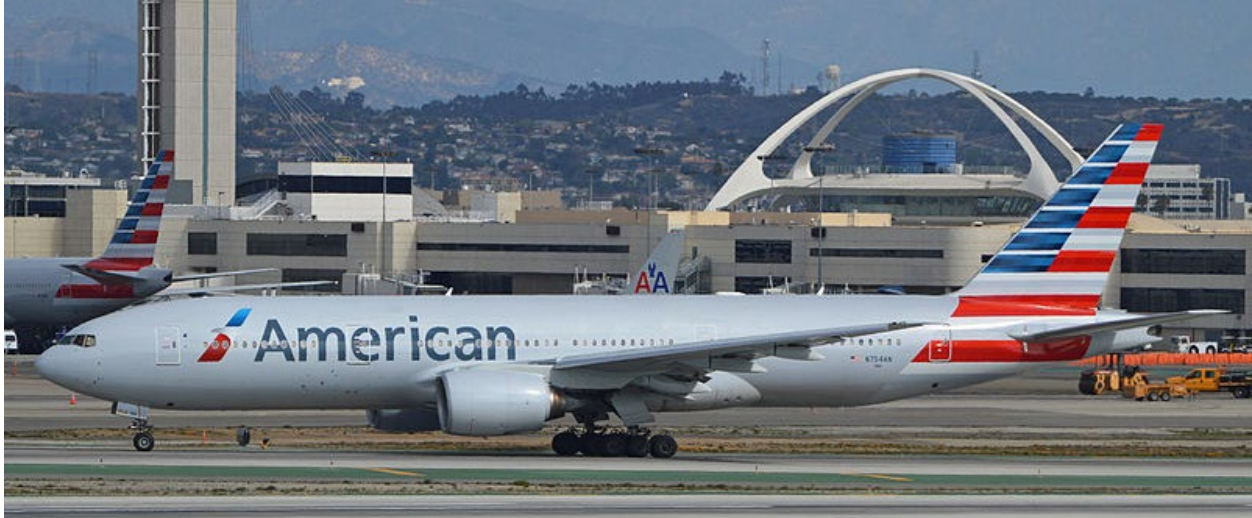
The Boeing 777-200 is a wide-body jet aircraft, which is 209 ft 1 in (63.7 m) long, has a wingspan of 199 ft 11 in (63.7 m), and is 60 ft 9 in (18.5 m) tall at the tail. Figure 1 is a photograph of the American Airlines aircraft involved in the runway incursion, N754AN. The airplane will be referred to as AA106 in this report.

**Figure 1.** American Airlines flight 106 (AA106), a Boeing 777-200, N754AN.

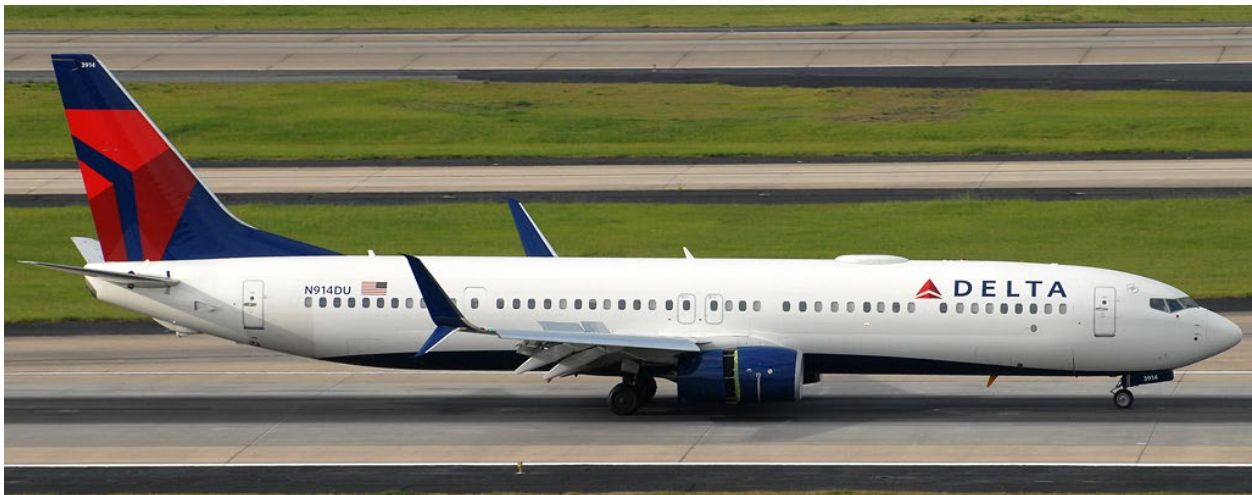
The Boeing 737-900ER is a narrow-body jet aircraft, which is 138 ft 2 in (46 m) long, has a wingspan of 117 ft 5 in (35.8 m), and is 41 ft 2 in (12.5 m) tall at the tail. Figure 2 is a photograph of the Delta aircraft involved in the runway incursion, N914DU. The airplane will be referred to as DAL1943 in this report.

**Figure 2.** Delta Air Lines flight 1943, (DAL1943), a Boeing 737-900ER, N914DU.
