NATIONAL TRANSPORTATION SAFETY BOARD
Investigative Hearing

Alaska Airlines Flight 1282

Left Mid Exit Door Plug Separation in Portland, OR

**Survival Factors Group Chair's
Factual Report**
(56 Pages)

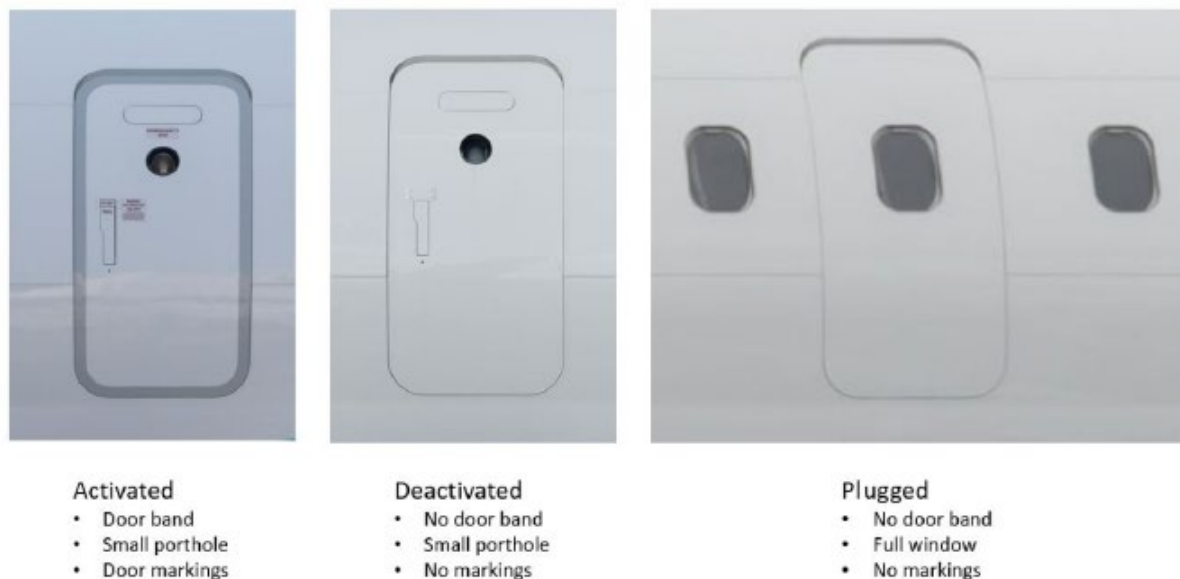
were no distinguishing features in the cabin to indicate to passengers that MED plugs were present at row 26, as the interior panels concealed evidence of the door frame and were identical to other sidewall panels. Additionally, a full-size passenger window was installed. When viewed from the exterior, the outline of the MED plug door frame was noticeable; however, the lack of a door band indicated that the plug was not a usable exit. See figure 8.

Figure 8. Comparison photograph of the exterior of an airplane fuselage with an activated door (l), a deactivated door (c), and a MED plug (r).

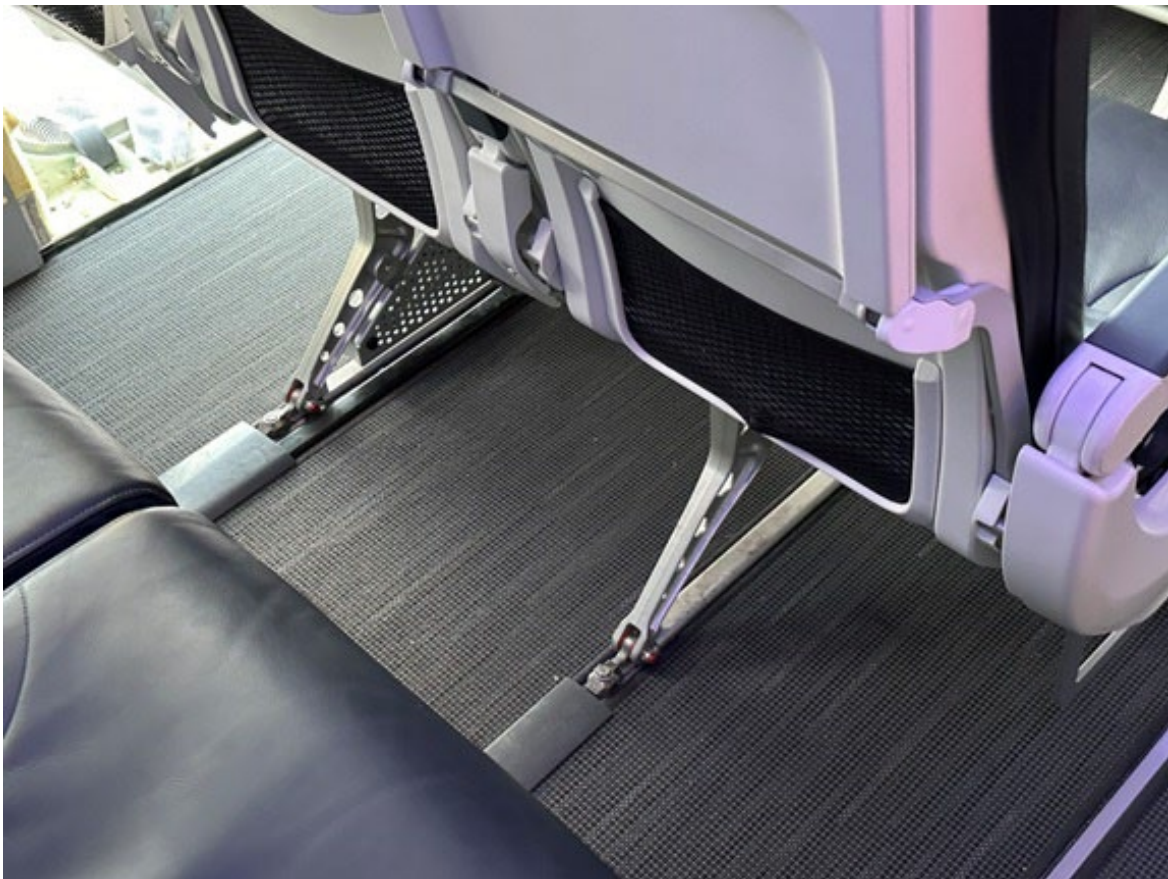
unit frame was structurally intact and undamaged. It was connected firmly to the floor with spacers in place between row 25 and 26. Seat 26A's seatback cushion and covering was missing but the seat bottom cushion was present and clipped in place. The seatback was rotated forward and outboard. The forward support tube under the seat bottom cushion had orange oil/grease droplets present. The outboard armrest was deformed outboard approximately 15 degrees. The armrest had an abrasion on the upper surface, mid-armrest. There was no other wear, tears or abrasions on the other armrests of the seat unit. The tray table of seat 26A (for use by the passenger in 27A) was missing. The lower supports of the tray table had been fractured approximately ¼-inch aft of their connection with seat 26A. The tray table (with support legs) was later located during the ground search for the MED door plug. See figure 11. Seats 26B and 26C were undamaged with both the seatback and seat bottom cushions clipped in place. There was no damage to any of the seat belts.

Figure 12. The undamaged aft seat legs of seat unit 26ABC.

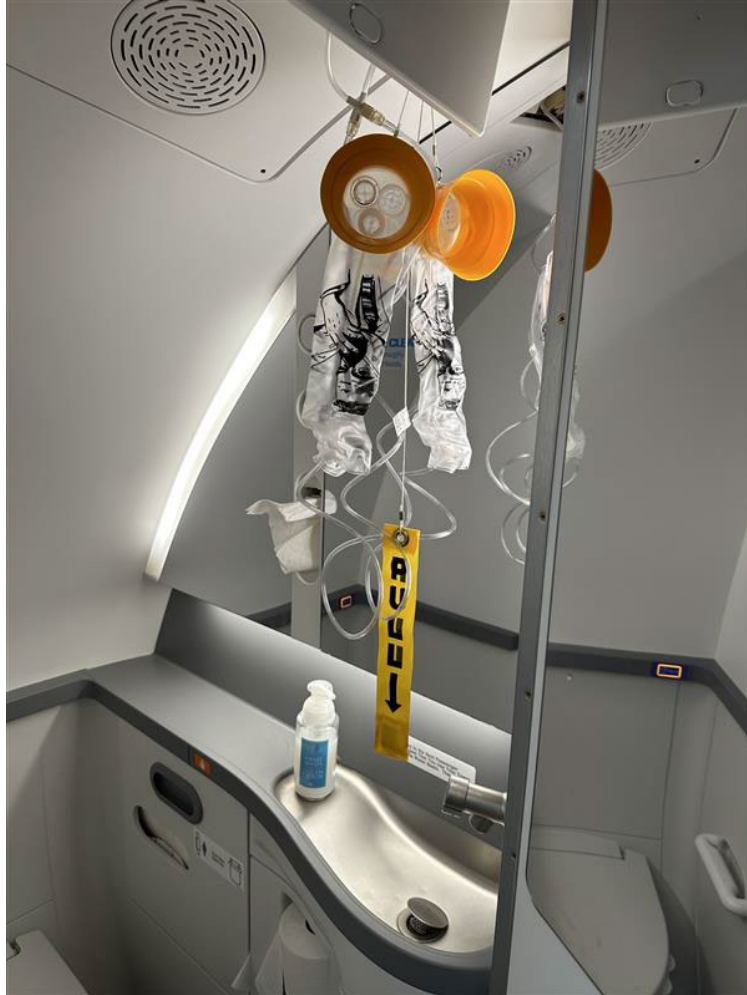
The four lavatories were inspected and all overhead oxygen compartments had opened. The masks had deployed with the pull tab extended down. See figure 18. The four lavatories each had a lavatory service unit (LSU) with a constant flow dispensing system¹¹ (CDS) oxygen cylinder that, when activated, supplied oxygen directly to the masks in the lavatories. None of the pull tabs had been pulled and all the lavatories' CDS bottles remained fully charged. The following information was obtained from the CDS bottle in Lav A:

Figure 18. Deployed oxygen masks (with pull tab) in Lav A.

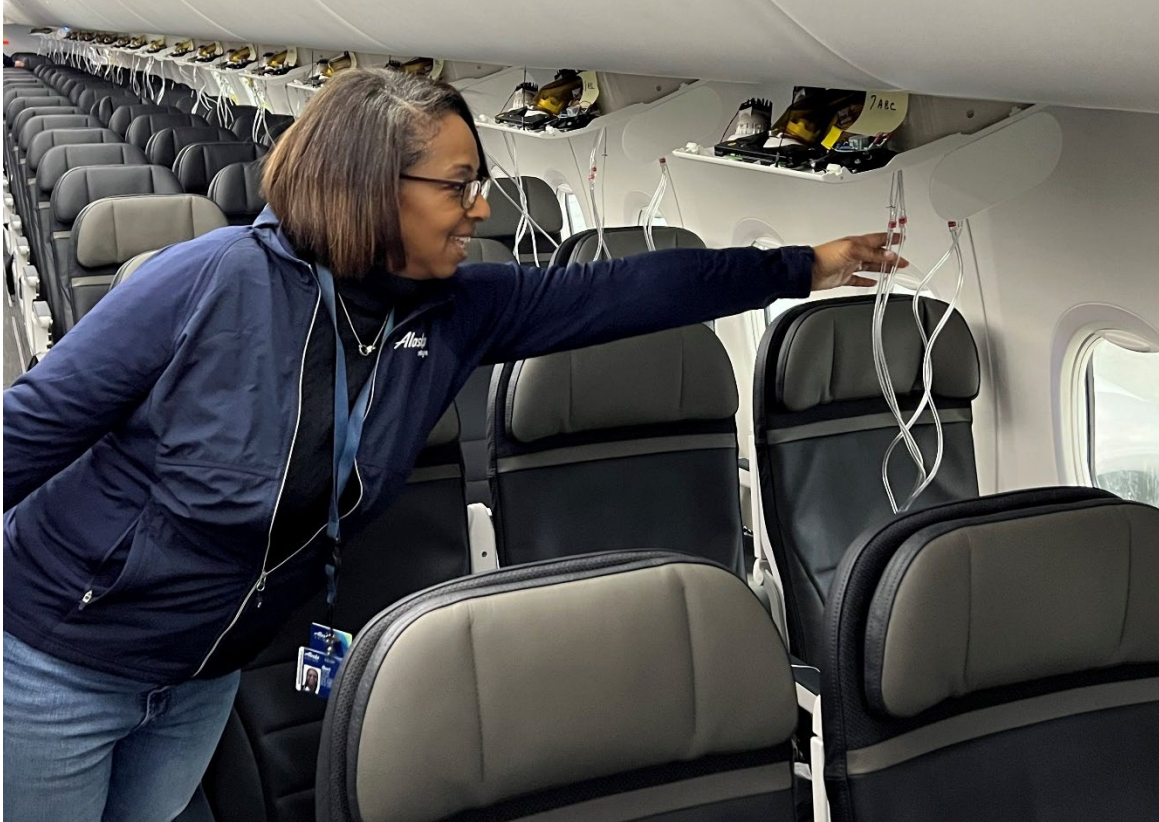
Finally, it was noted that, due to the design of the overhead bins and PSUs, the masks deployed above the window seat (A and F seats) of each seat unit. See figure 20.

Figure 20. Deployment location of the oxygen masks above the window seat on the left side of the airplane.

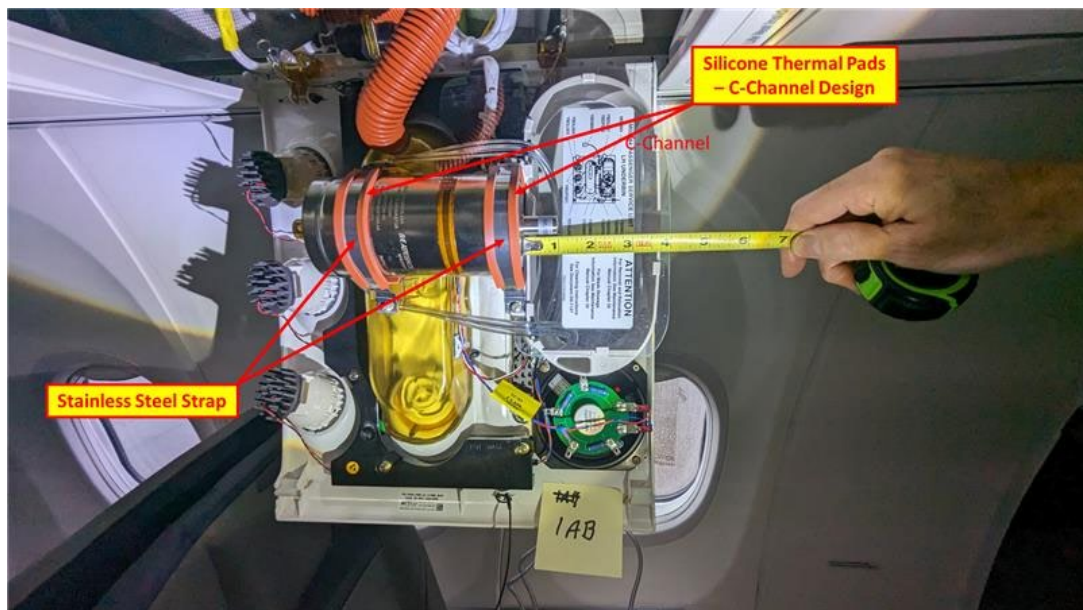
All of the generators equipped with flat pads migrated aft and some generators migrated far enough aft to be completely free of the forward stainless steel strap; however, no generators disengaged from the oxygen tubing. A second type of silicone thermal pad was found on only two generators - 1AC and 25DEF. This type had a c-channel where the edges of the pad wrapped around the edges of the stainless steel straps. These two generators did not move from their original positions.

Figure 22. Chemical oxygen generator with c-channel silicone thermal pad at seat 1AC that had not migrated aft.

On June 17, 2024 Boeing issued multi-operator message MOM-MOM-24-0316-01B to 737MAX/NG to operators notifying them of the published service bulletins (SB 737-35-1210 for the 737 MAX and SB 737-35-1211 for the 737NG) to inspect and replace (as needed) the PSU chemical oxygen generator retention straps on affected aircraft. The MOM also referenced the potential upcoming release of an FAA Immediate Adopted Rule (IAR) Airworthiness Directive (AD).¹³ Finally, the MOM noted that temporary revisions of the 737 NG/MAX Aircraft Maintenance Manuals (AMMs) were targeted for release on June 20, 2024.

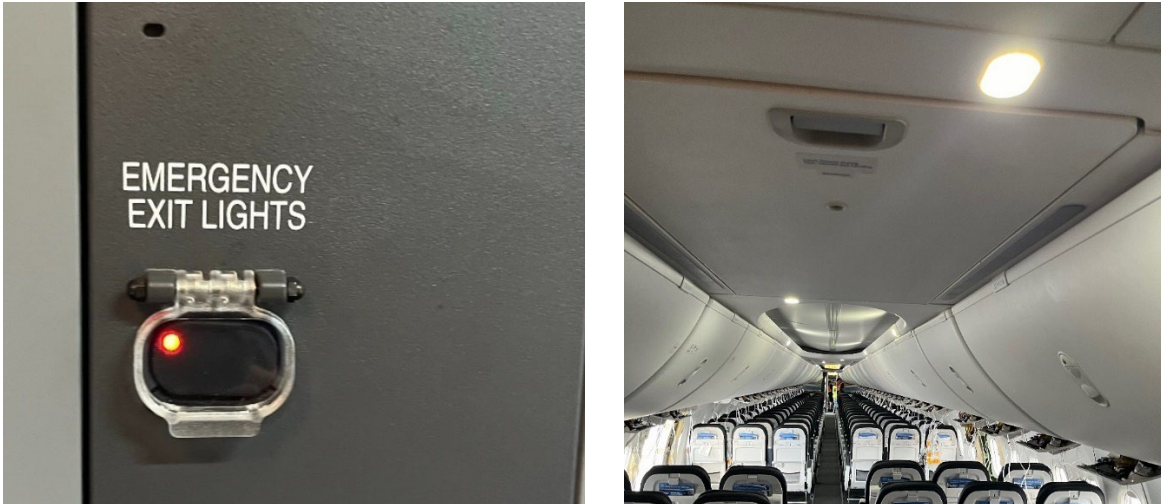
The Cabin Emergency Lighting System was tested by activating the aft flight attendant lighting switch that activated internal and external emergency lighting. No discrepancies were noted in the operation of the lighting system.

Figure 24. Emergency lighting activation switch at the door L2 F/A location and illuminated overhead light fixtures in the cabin.

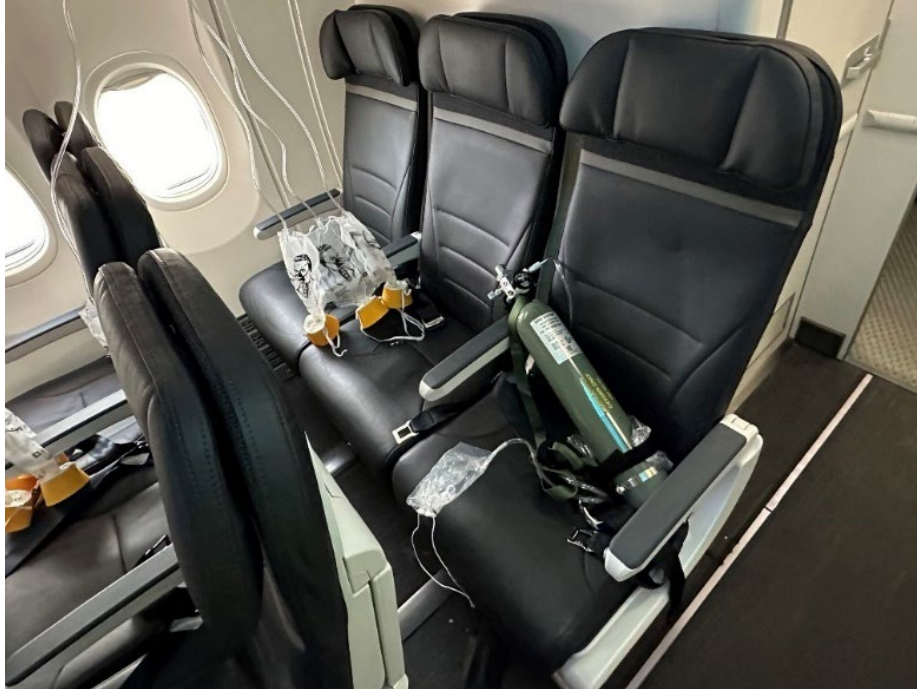
A second used POB was located lying on passenger seat 34D. The gauge on the POB indicated that approximately 1,400 psi remained in the cylinder. The following information was placarded on the cylinder:

The attached mask was out of its packaging and was unfolded with the spare mask still attached to the bottle. See figure 28. The mask (identical to that used by F/A D) consisted of a plastic bag with two exhalation (vent) holes, a flexible metal nose strip, and a thin elastic strap. See figures 29 and 30.

Figure 28. Portable oxygen bottle and mask found on seat 34D.
