National Transportation Safety Board

ERA22LA145

LANDING DOLLY FACTUAL REPORT

Location: Abingdon, Virginia
Date: March 6, 2022
Time: 2359 local
Airplane: Eurocopter Deutschland GMBH MBB-BK-117 C-2 (N29VA)

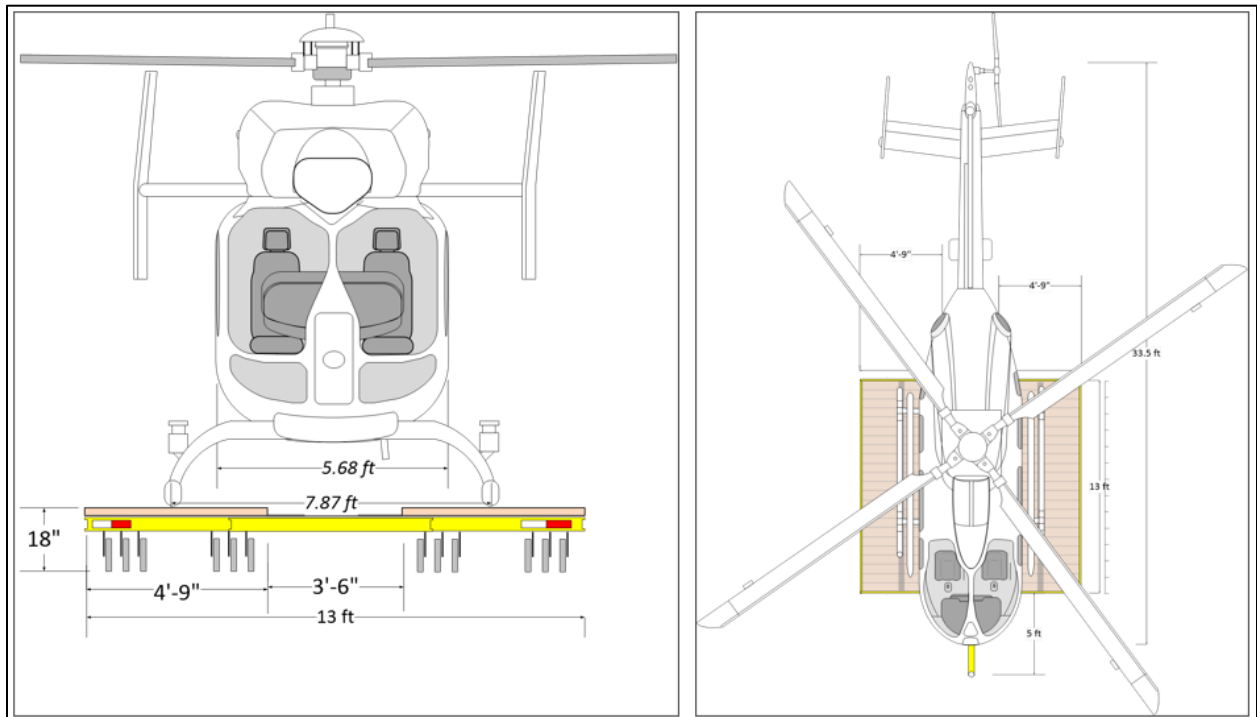
The dolly was placarded as a Main Line Corporation, Helicopter Handler Dolly, Bar Code #073373 (Wilmington, DE, USA). The dolly sat 18 inches from the ground on wheels and it possessed an open center gap that was 3 ft 6 inches wide. Figure 4 provides an overview of the landing dolly as depicted in a model created by Airbus Helicopters, which was based upon NTSB measurements.

Figure 4: Forward and top down model view of the helicopter and dolly (Models Courtesy Airbus Helicopters)
