Accident Investigation
Aero Commander 500B
National Transportation Safety Board

This document provides the investigation report for Tank Unit Part Number EA515B-1404M, being returned to Collins Aerospace as part of an accident investigation. This Tank Unit was equipped on the Aero Commander 500B which had a flight accident on January 28, 2023.

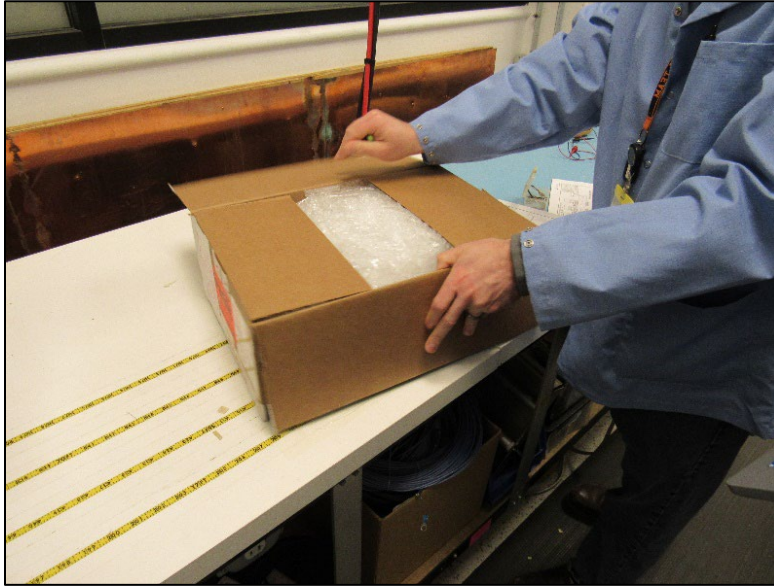
- **Unboxing**

There was no sign of external damage to the box. The tank unit was well wrapped and secure within the center box and encased in bubble wrap. There were no signs of damage incurred during shipping. The Tank Unit was removed from its container and packaging and placed on a lab bench. The article was visually examined and photographed from all sides. Examiners looked at the following per Test Plan E-8082.
