NATIONAL TRANSPORTATION SAFETY BOARD

Group Chairman's Factual Report

ERA18FA120

Attachment 3 – USAF Wing Spar Analysis Results (38 pages)

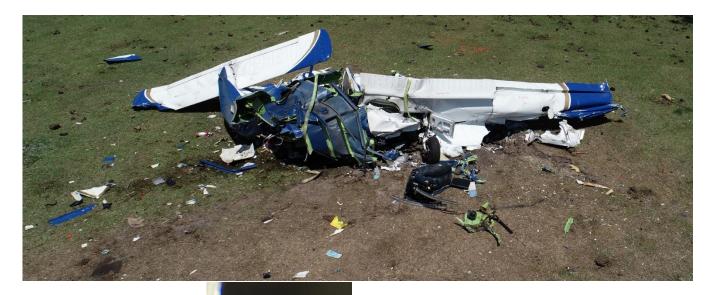
Why did mishap aircraft experience catastrophic failure while only one other aircraft inspected showed a crack indication?

Crack on sister aircraft

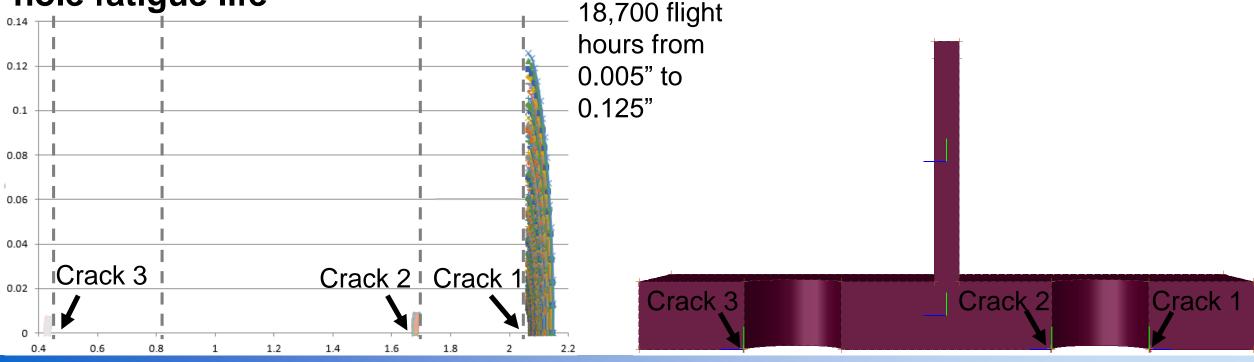
Near Pristine Analysis (0.005" cracks) (14 ksi peak)

- USAF durability analysis typically assumes an initial crack of 0.01"
- Continuing damage analysis typically assumes a 0.005" crack in the secondary location
- Analysis was completed with three 0.005" cracks to estimate pristine open hole fatigue life
 18 700 flight

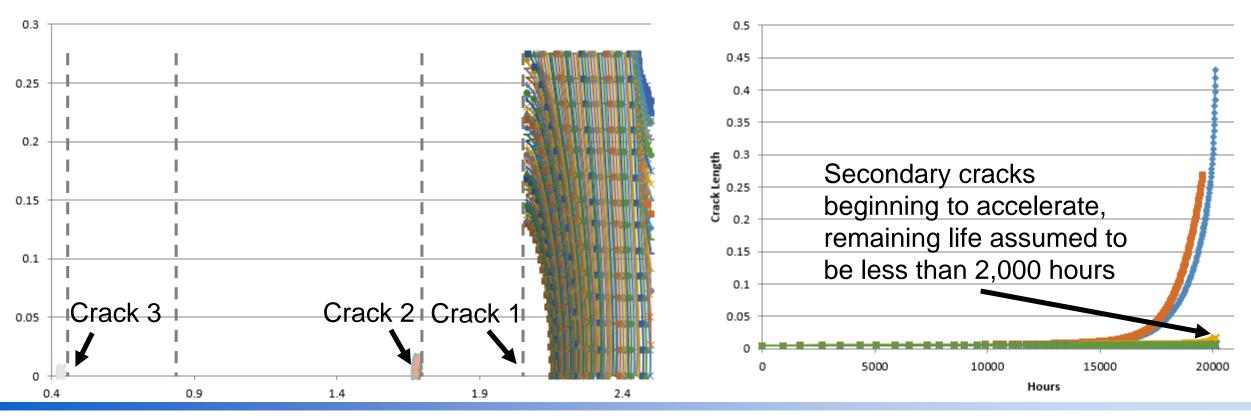
Near Pristine Analysis (Continued) (14 ksi peak)

Model refined/adjusted for transition to a thru crack
 ~1,400 flight hours from 0.125" crack to ligament failure
 ~20,100 flight hours total to ligament failure

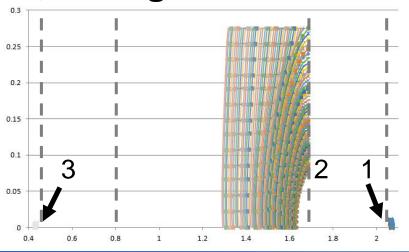
Durability Crack Analysis (14 ksi peak)

- Crack 2 selected to be primary flaw
 - Longest life scenario
 - Large flaw on ligament fails rapidly
- Metallurgical results did not indicate which crack was first
- Standard 0.005" crack in secondary locations
- ~6,700 flight hours shown below

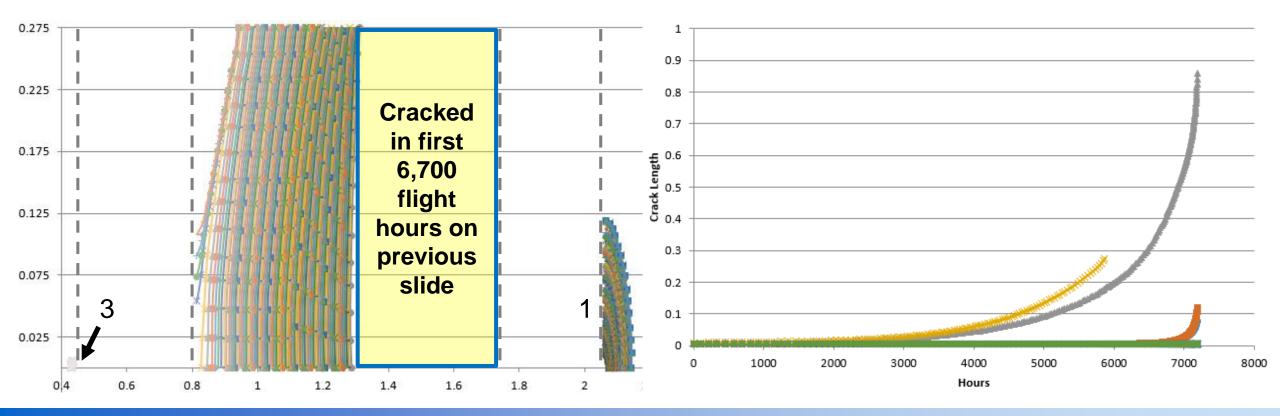
Durability Crack Analysis (Continued) (14 ksi peak)

Remaining center section of spar fails rapidly

- ~500 additional hours across remaining center spar section
- ~7,100 total flight hours

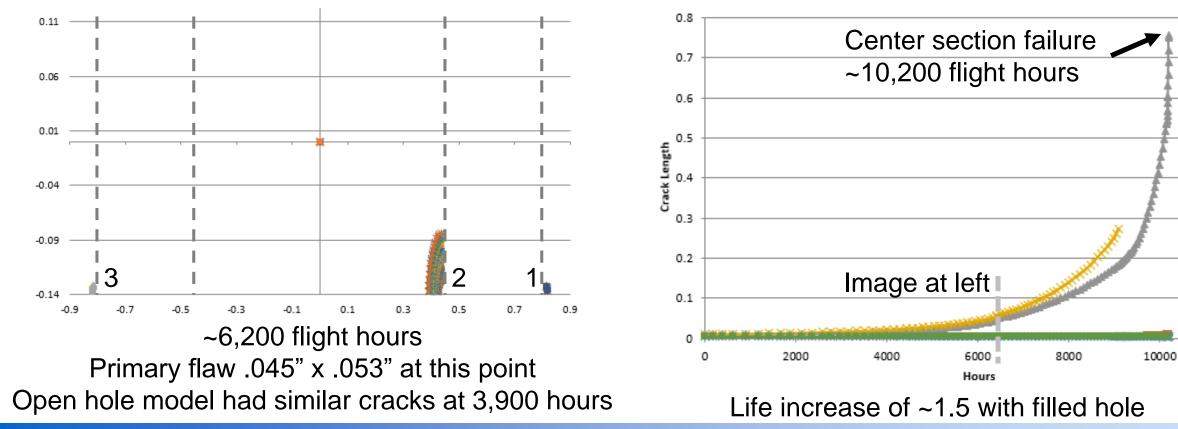
Filled Hole Durability Analysis

Filled holes can have significantly longer fatigue lives in tension dominated structure

Steel pins were included in another model for comparison

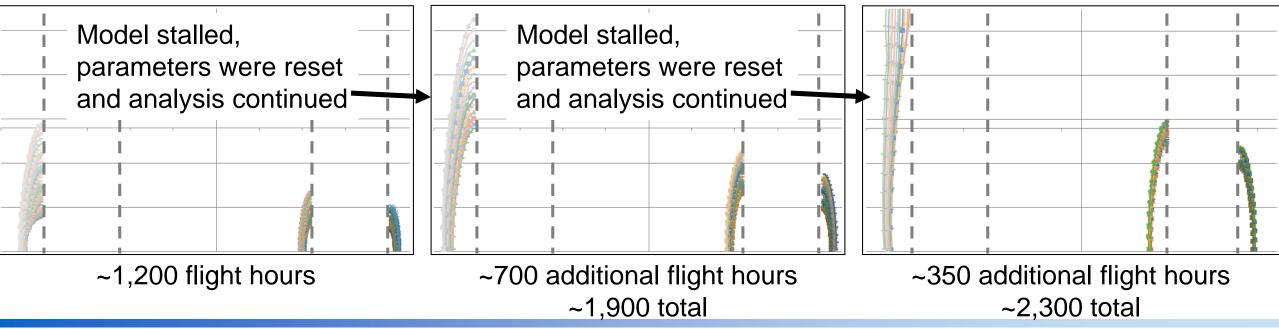
Mishap Damage Size Analysis Open Hole

- Durability analysis showed minimal growth on secondary cracks
- This analysis shows significant growth for all cracks
- All cracks growing rapidly with minimal ligament remaining on dominant crack, estimate less than 1,000 hours remaining life
- Initial damage size has significant impact on fatigue life

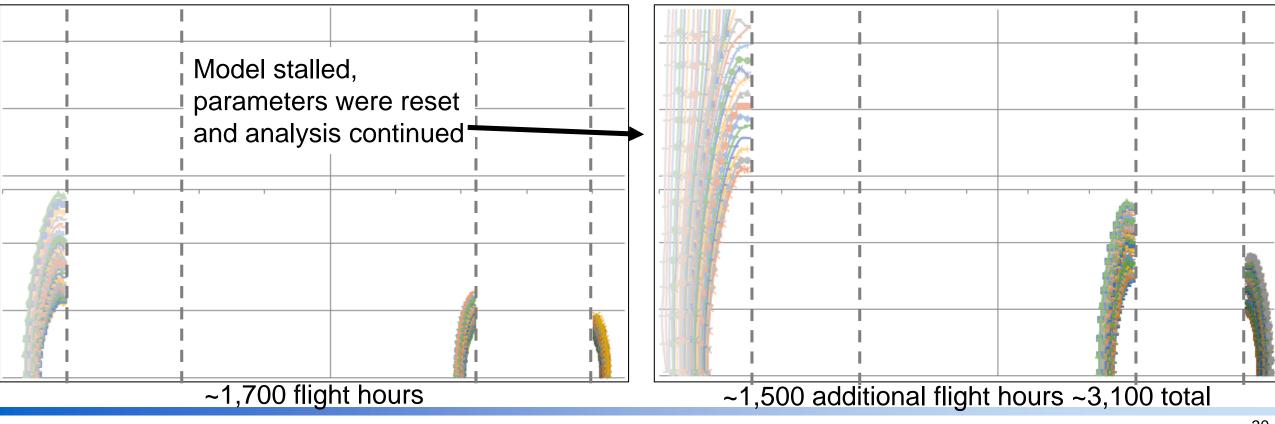
Mishap Damage Size Analysis Filled Hole

- Filled hole again showed a life improvement of roughly 1.5
 - Related observation in reduction of K for filled hole with small cracks
 - •Bombardier, Y, Renaud, G, Li, G, "Prediction of Fatigue Crack Growth at Cold Expanded Fastener Holes with ForceMate Bushings," AFGROW Workshop 2018, pages 49-50.

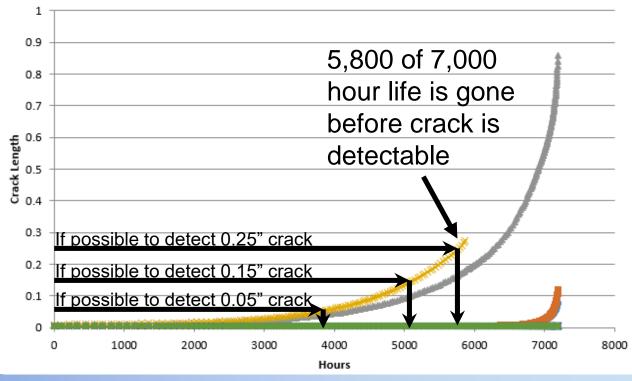
- The models herein only address the crack growth portion of the structural life, there is some life prior to detectable crack propagation
- Damage tolerance analysis is based on inspection capability
- Depending on NDI approach cracks of differing sizes can be detected
- Since most of the fatigue life is prior to a crack being detectable, caution must be used to determine appropriate actions necessary for continued safe operation
- Note, sister aircraft crack appeared to be ~0.18", indicating it was less than 2,000 hours from failure
