----- SYSTEMS GROUP CHAIRMAN'S FACTUAL REPORT -----

Location: Greenville, South Carolina  
Date: September 27, 2018  
Time: About 1840 GMT (1340 LCL)  
Aircraft: Dassault Falcon 50  
Serial Number: 17  
Registration: N114TD

#### **3.2 Systems Group Summary**

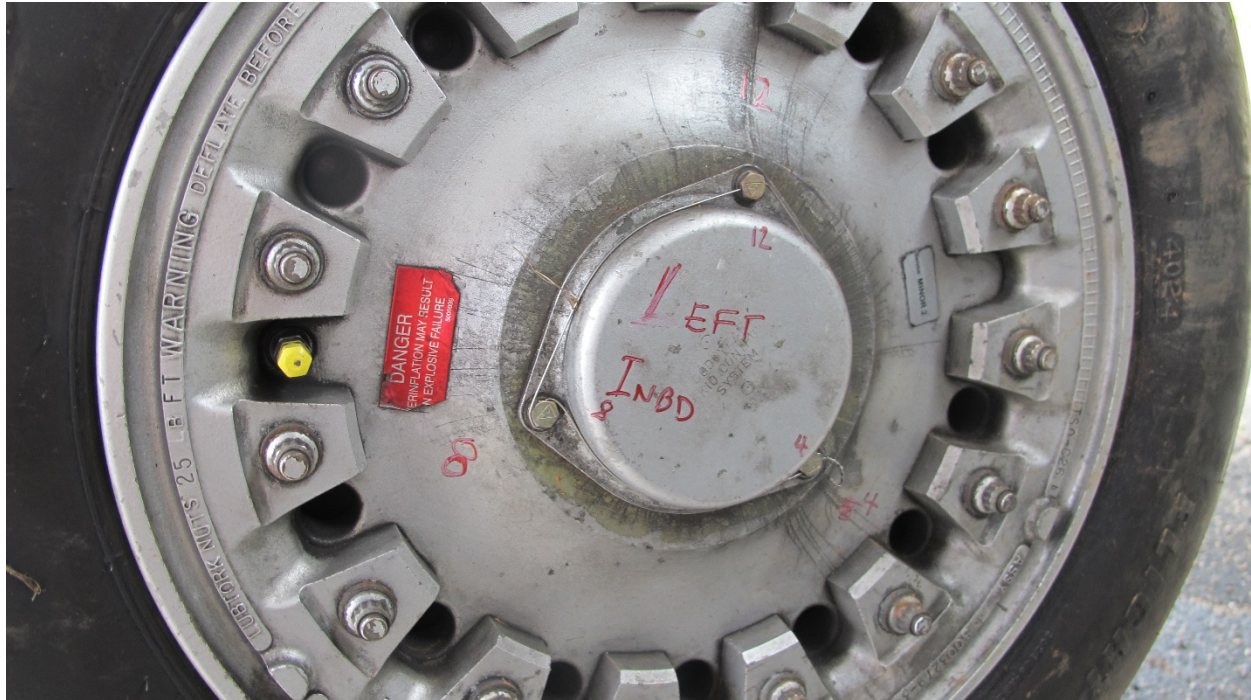
Figure 9 - Left inboard wheel/tire assembly prior to hub removal

All four wheel speed transducers were recovered from the accident aircraft. Prior to removal, engagement of the wheel hub to the each wheel speed transducer shaft was confirmed during the removal of the wheel hub and transducers, ref Figure 9 and Figure 10. No anomalies were noted on all four hub assemblies, ref Figure 11. Each transducer was removed following AMM procedures, except the cannon plugs were not disconnected, but the wiring was cut upstream of the plug to retain the condition of the connector/component interface.

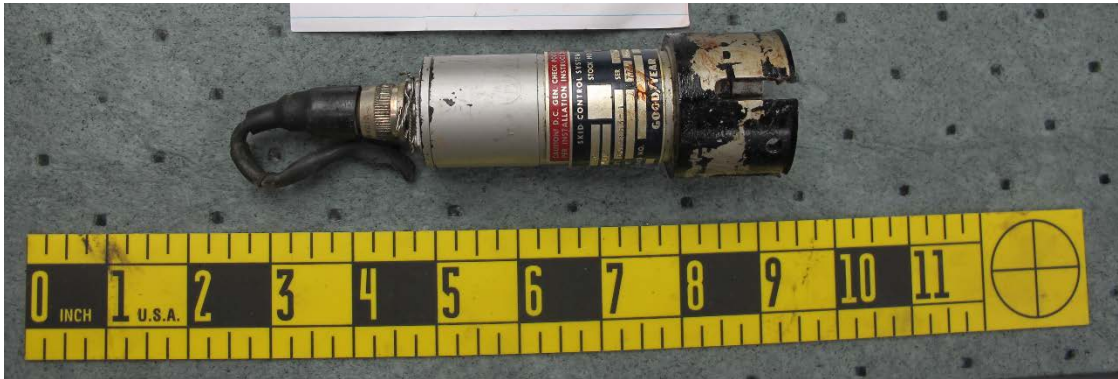
Figure 15 – LH outboard transducer

No notable signs of visible damage were noted, ref Figure 15. The aircraft wiring harness had no indications of any field splice on the wiring.

The unit passed all tests within expected results, with and without the aircraft wiring harness installed.

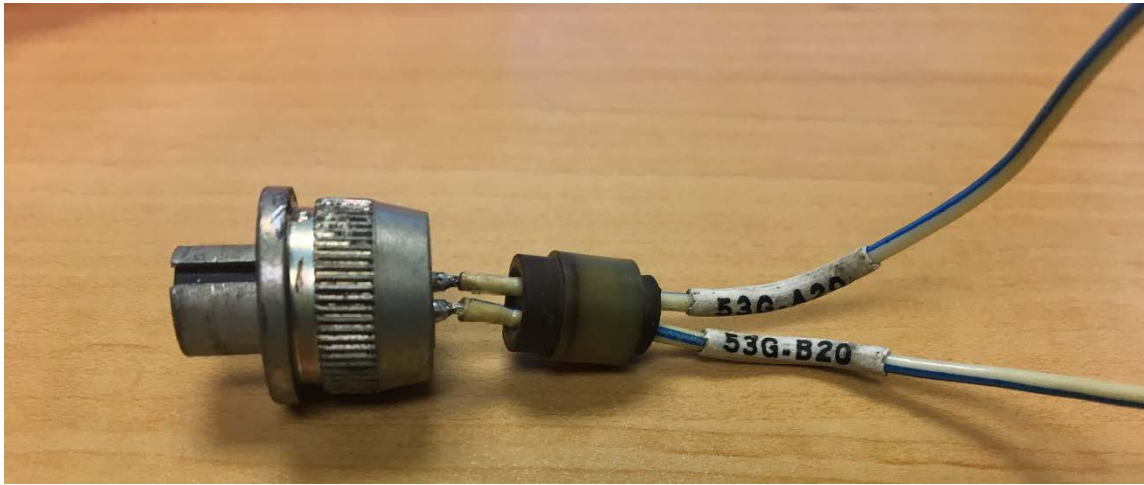
Figure 16 - LH outboard wiring with original wire markings

After the testing the insulation was removed from the wiring harness, Figure 16. The original wiring identifying tags were located close to the connector.

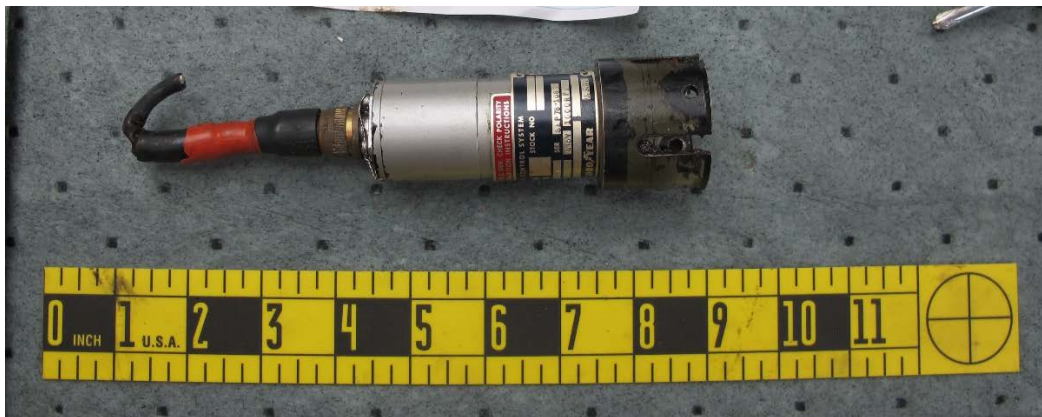
Figure 17 – LH inboard transducer

No notable signs of visible damage were noted, Figure 17. The aircraft wiring harness had no indications of any field splice on the wiring. There was some additional orange seal tape on the wiring harness.

With the aircraft harness installed, the unit passed the insulation resistance and dielectric test points. All remaining tests failed. If the harness was lightly moved, an intermittent voltage could be read from the device, but could not be sustained and resulted in a failed test.

After the testing the insulation was removed from the wiring harness, ref Figure 18. The solder connection at Pin B was found to be fractured and not making solid contact with the pin.

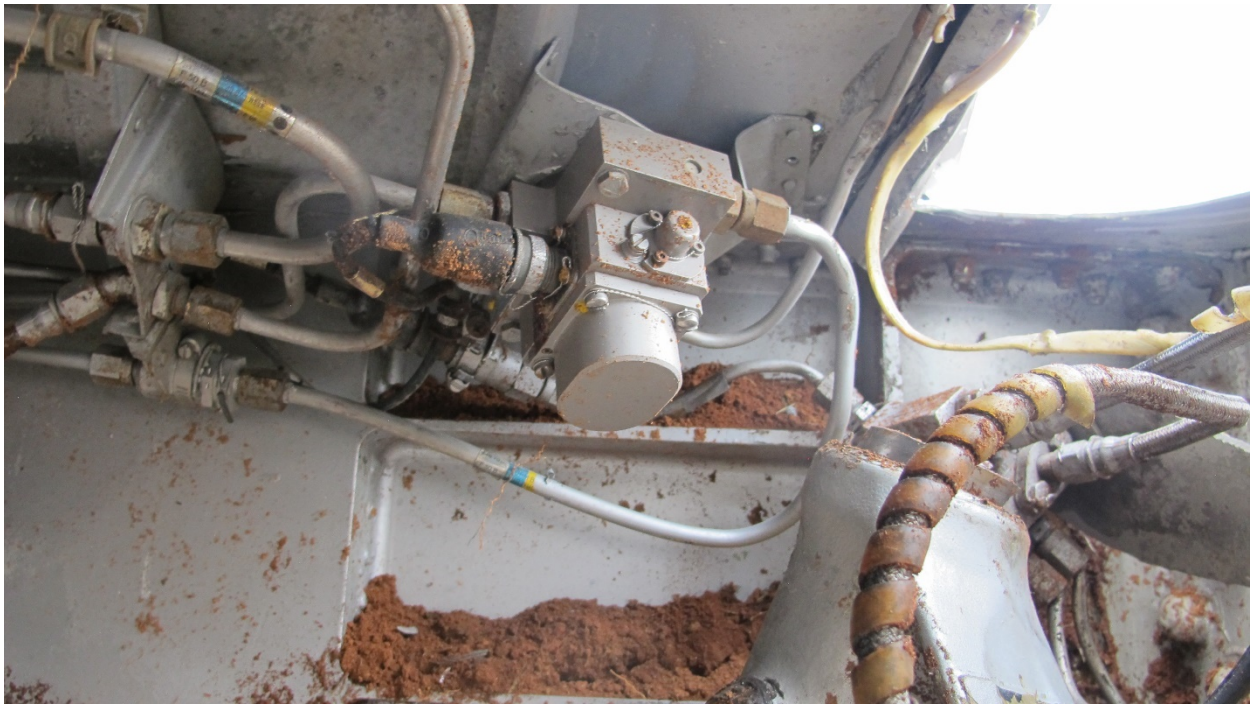
**Figure 21 - RH Servo-Valve as installed**

The servo-valves were mounted in the left and right main landing gear bays, ref Figure 21 and Figure 22. Due to the damage to the landing gear attachment points, some hydraulic lines were damaged in the local area. Each servo valve was removed along with a portion of the hydraulic line to each of the ports. The hydraulic lines were cut upstream of check valves within the system. The flex hoses from the distribution blocks to manufacturing breaks on the main landing gear yokes were disconnected. Electrical connections were cut, upstream of the connector and the connectors were not removed.

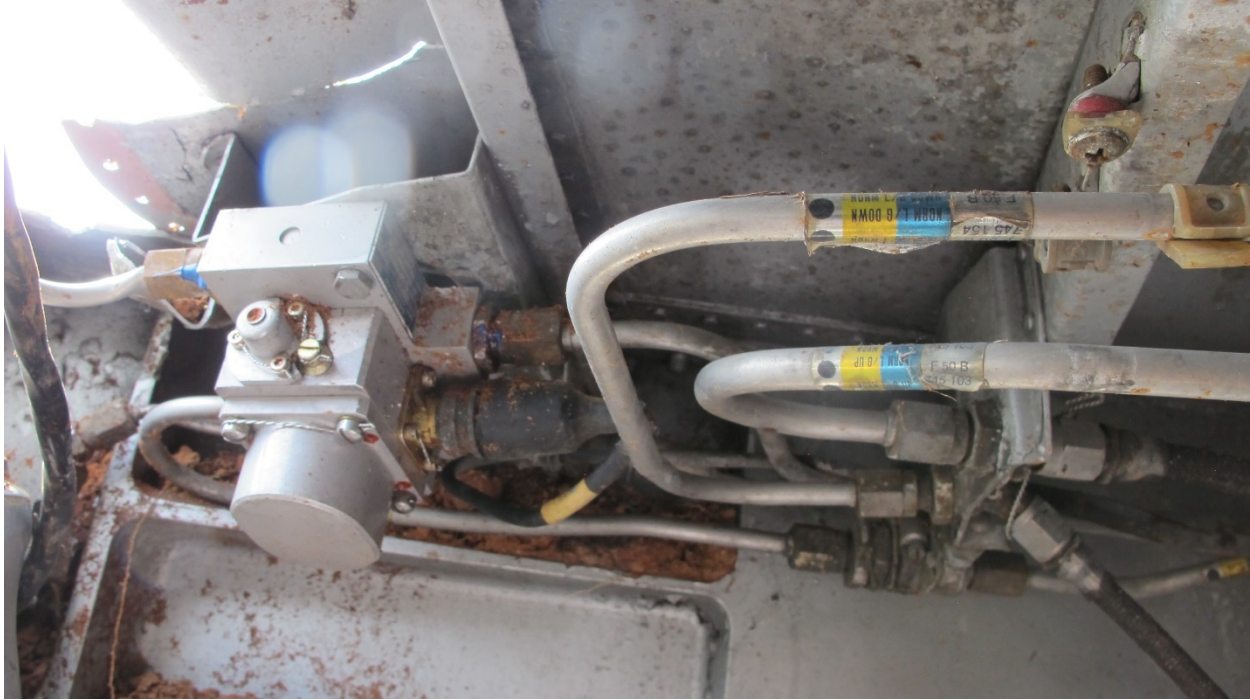
**Figure 22 - LH Servo valve installed**

The valve passed the coil resistance and insulation resistance, leakage and proof pressure tests. The valve failed the pressure control checks and the pressure drop tests.

The spool and sleeve were removed. The sleeve and packing material were inspected under a microscope. The seals visually appeared to be intact and installed correctly. Areas of discoloration and corrosion were noted on some of the spool surfaces. The spool would move freely in the spool when acted upon by gravity. No obvious signs of friction were noted.

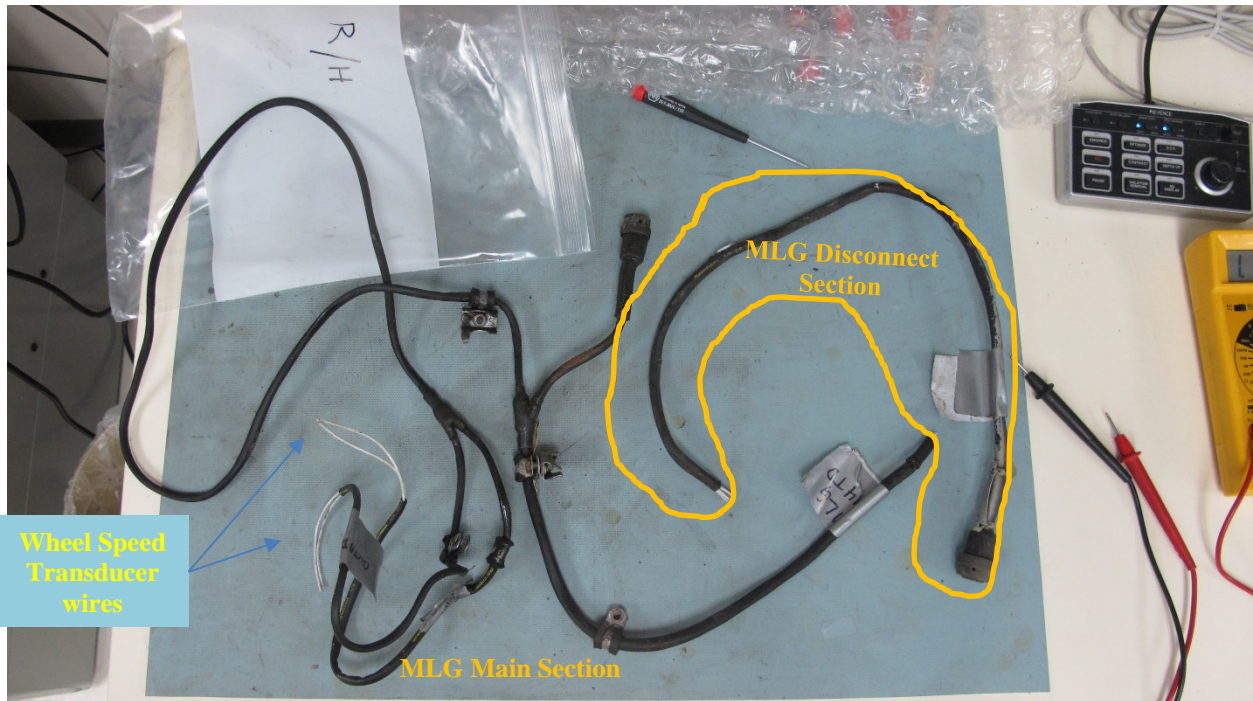
Figure 28 - RH MLG harness as received

The RH MLG harness was received in a protective bag and contained two separate sections of the harnesses, ref Figure 28 after being removed from the aircraft. During the aircraft wreckage removal process, the harness was cut approximately 1-2 feet from the MLG disconnect (P182), which is located in the RH gear wheel well, to allow for gear removal, ref Figure 29. Prior to removal from the MLG, each wheel speed transducer location was marked on the two-wire set that was a part of the transducer system wiring. The transducers wires were cut from the aircraft during the initial inspection by the systems group.

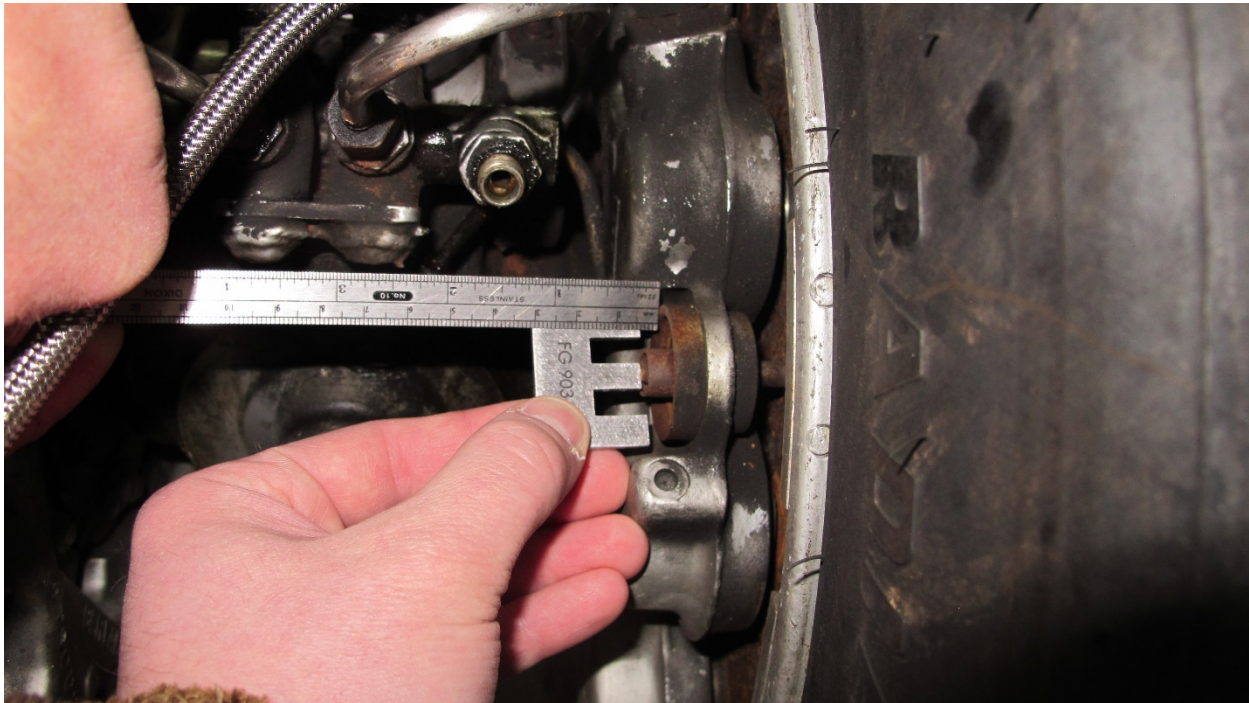
**Figure 32 - LH Inboard Brake Wear Check**

Brake	1,500 psi Pressure Check		Wear Gage Check	Distance from Wear Gage and Spring Housing (System Pressurized)
	System A	System B		
LH Inboard	Pass	Pass	Serviceable	~4 mm (Sys A)
LH Outboard	Pass	Pass	Serviceable	~3 mm (Sys B)
RH Inboard	Pass	Pass	Serviceable	~2 mm (Sys B)
RH Outboard <sup>10</sup>	Pass	Pass	Serviceable	~3 mm (Sys A)

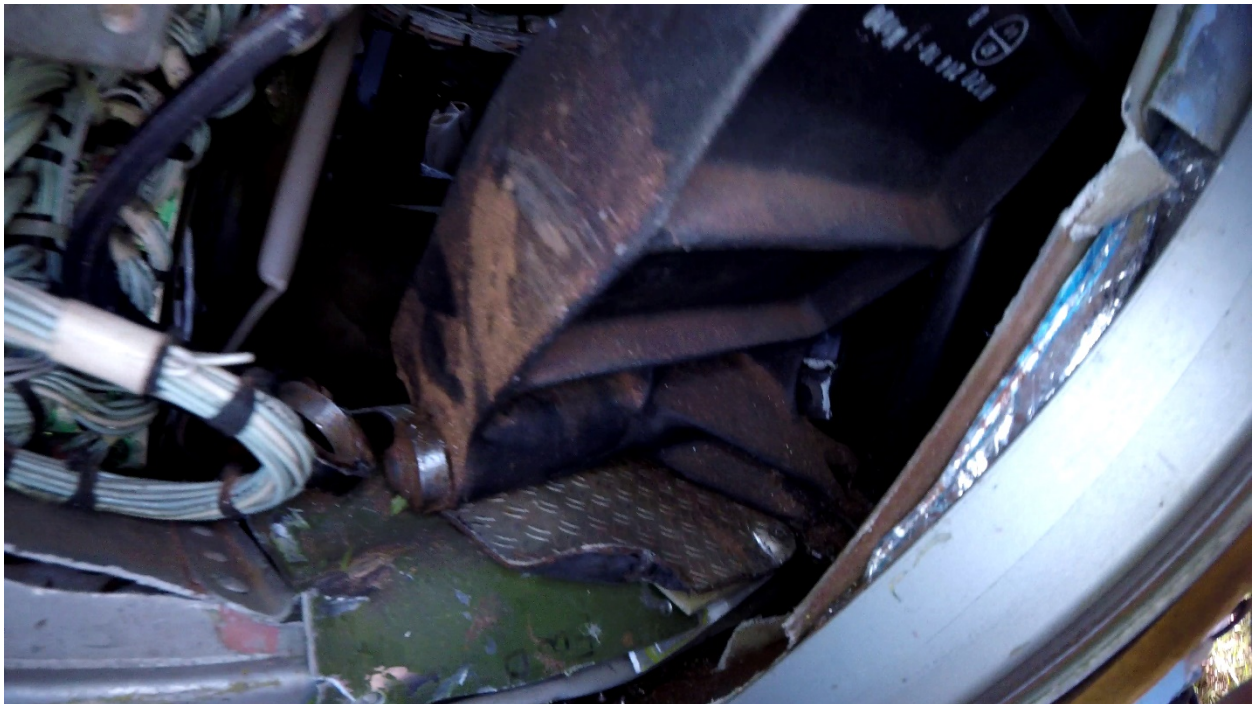
**Figure 35 - View of pilot brake pedal area on accident aircraft**

Access to visually inspect the brake pedal linkages was gained through an access panel on the forward pressure bulkhead. Figure 34 contains a view of the pilot side brake pedals from an exemplar aircraft. The area where the brake pedals were located sustained crushing damage which precluded any operation of the individual brake pedals and limited the visual inspection, ref Figure 35. Of the area that could be viewed, all the brake connections were per specification and all attaching hardware was present. The brake pedal connecting rods were bent in directions consistent with the crush damage to the surrounding area.

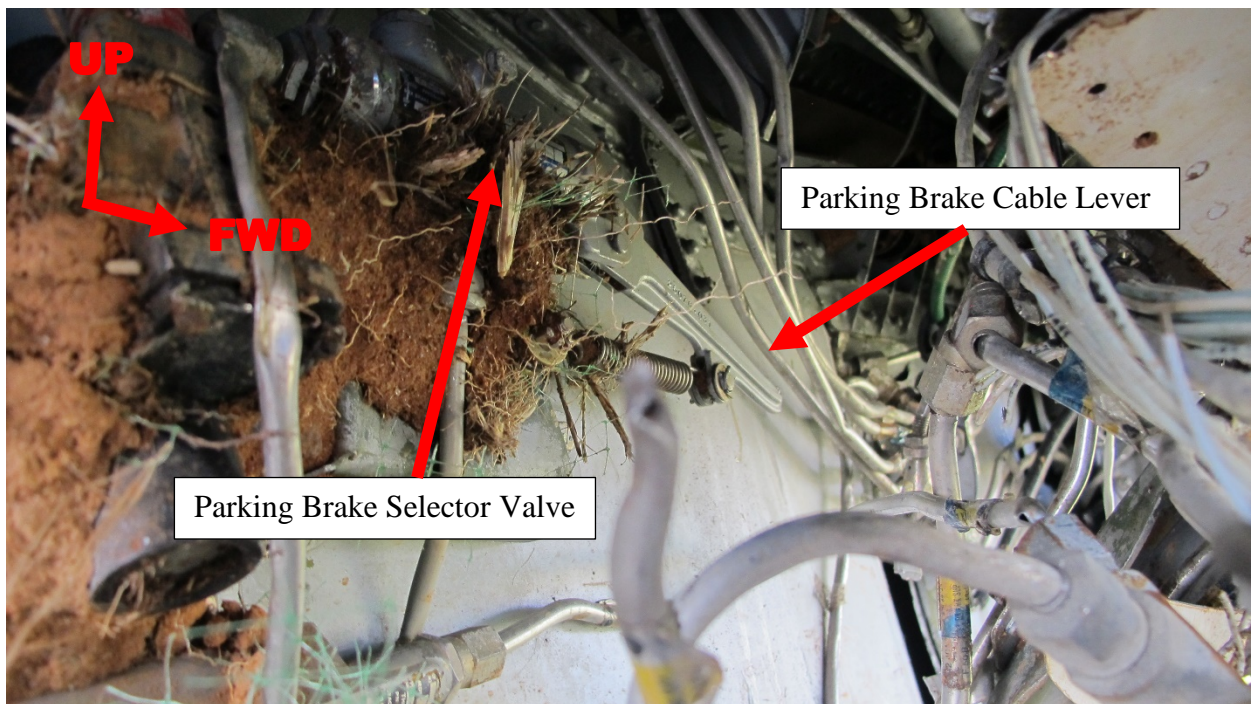
Figure 40 - Accident aircraft location of parking brake selector valve

The cable end in the fuselage section was also located and it was attempted to be moved. The lower fuselage area where the control cable ran had areas of crushing damage and required portions of the skin and structural frames to be pried away from each other to gain access to the area. Due to the crushing damage of the fuselage, the control cable would not move and additionally, the control cable end at the parking brake selector valve was broken at the lever arm.

The hardware to attach the parking brake control cable to the selector valve lever arm were present and secure, except for the cotter pin. The fracture surface on the lever arm was consistent with an overload failure. The parking brake selector valve was also displaced from its normal mounting location and rotated by approximately 90 degrees and impacted against the frame assembly. Figure 39 contains an image of the parking brake selector valve installed in an exemplar aircraft. Figure 40 and Figure 41 show the parking brake selector valve as found in the accident aircraft and includes the fractured end of the selector valve lever arm. The hydraulic lines in the area had multiple areas of crushing damage and breaches in the line runs.
